## Inspection Report (Vibratory Compactor)

Year	2015
Make	Bomag
Model	BW 213 PDH-4i
Serial Number	101585321054
Hour Meter Reading	2,437 Hrs.
Previous Application (e.g., earth moving, mining, demolition, etc)	Finish Grading General Construction

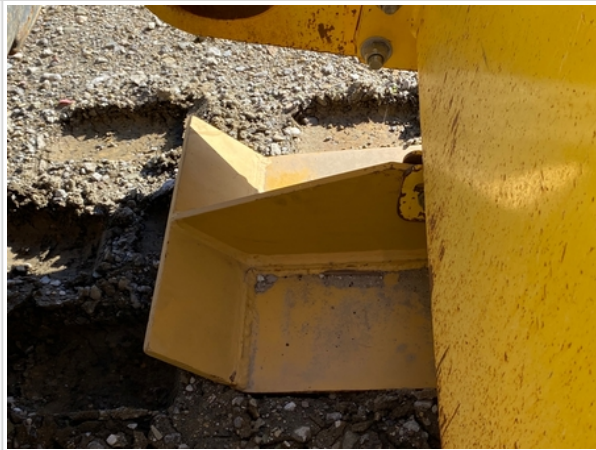
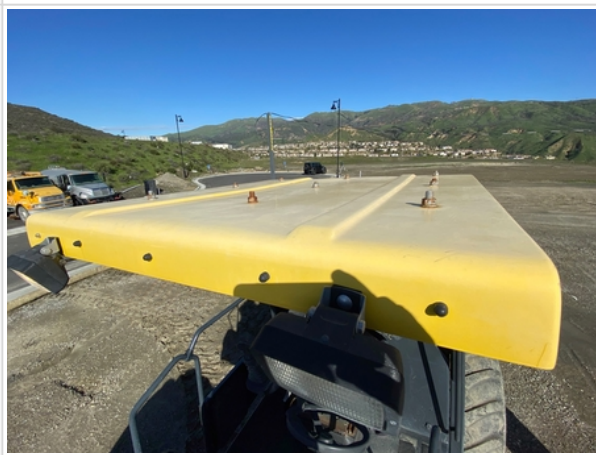
<b>Body Panels</b>	3 - Normal Wear & Tear	
<b>Body Panel Condition</b>	No visible damage, good paint condition and panel fitment	
<b>Doors / Canopy Latches</b>	3 - Normal Wear & Tear	
<b>Doors / Canopy Latches Condition</b>	Other (see comments), No visible damage	
<b>Comments</b>	Rear hood left side latch bracket missing hardware (minor fix) Hood still locks in place	
<b>Steps / Ladders</b>	3 - Normal Wear & Tear	
<b>Handrails</b>	3 - Normal Wear & Tear	
<b>Glass</b>	0	
<b>Mirrors</b>	3 - Normal Wear & Tear	
<b>Mirror Condition</b>	Mirrors present and intact, no visible damage	
<b>Exterior Lights</b>	3 - Normal Wear & Tear	
<b>Exterior Lights Condition</b>	No visible damage, lighting system is operational, One or more exterior lights are non-operational, Other (see comments)	
<b>Comments</b>	Front left side HeadLight bulb inop.

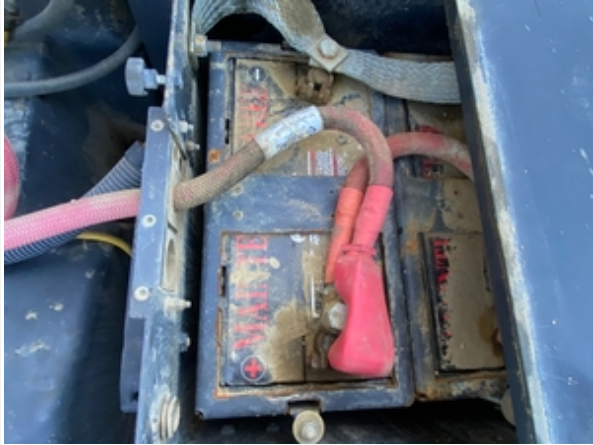
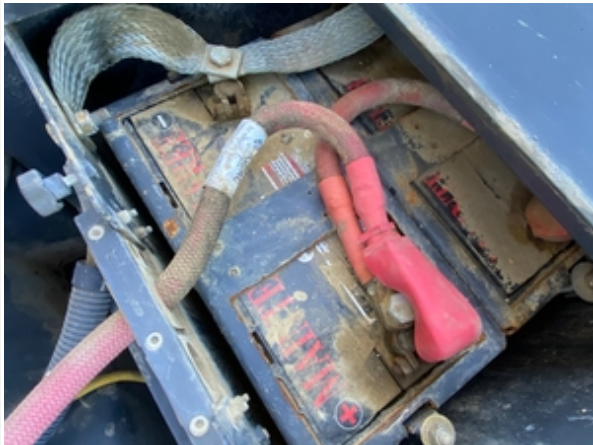
<b>Blow-by (Visual Observation Check)</b>	No
<b>Unusual Noises (Upon Start-up, Idle, Shutdown)</b>	No
<b>Unusual Noise Notes</b>	No unusual noises heard
<b>Engine Smoke (Upon Start-up, Idle, Shutdown)</b>	No
<b>Engine Smoke Notes</b>	No engine smoke issues observed
<b>Engine Exhaust Color</b>	Clear
<b>Battery</b>	3 - Normal Wear & Tear
<b>Battery Condition</b>	Dusty & dirty appearance, Clean & dry appearance, tight connections
<b>Battery Condition Photos</b>

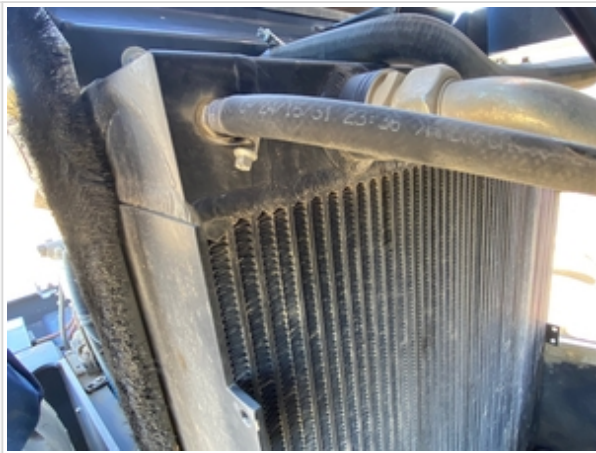
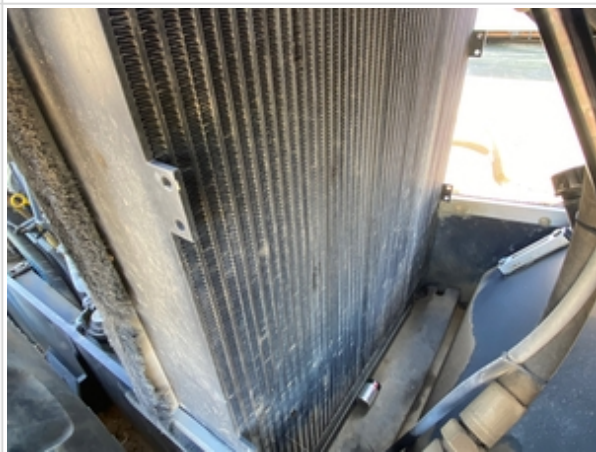
<b>Radiator Photos</b>

<b>Radiator</b>	3 - Normal Wear & Tear
<b>Radiator Condition</b>	Radiator fins & components appear to be in good working order, no signs of damage or leaks

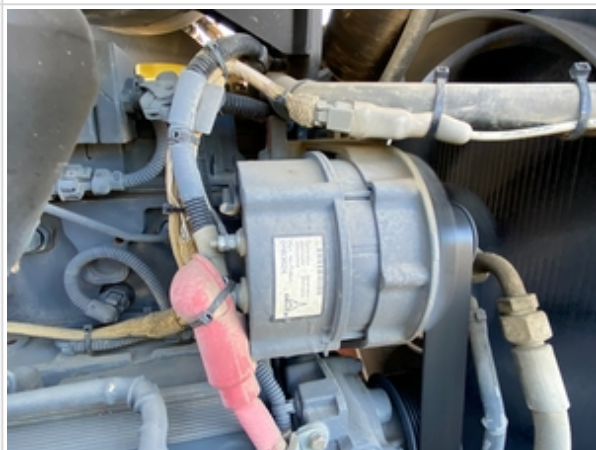
<b>Belts</b>	3 - Normal Wear & Tear
<b>Belt Condition</b>	Belts appear in good condition & alignment with proper tension
<b>Belt Photos</b>

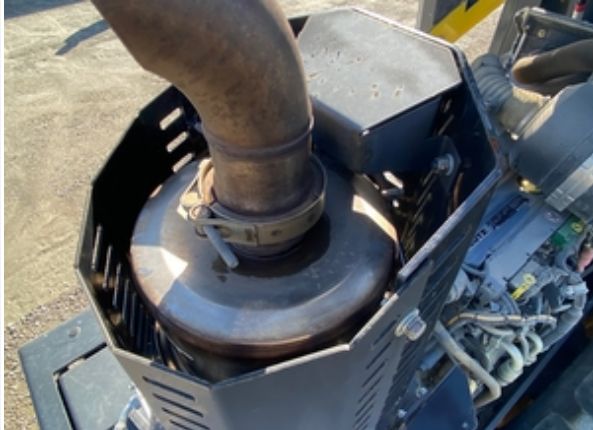
<b>DPF Photos</b>

<b>Hoses</b>	3 - Normal Wear & Tear	
<b>Hose Condition</b>	Firm, pliant hoses with no signs of wear or leaks	
<b>Water Pump</b>	3 - Normal Wear & Tear	
<b>Water Pump Condition</b>	No unusual pump noises heard	
<b>Cooling System Leaks</b>	No	
<b>Coolant Color / Appearance</b>	3 - Normal Wear & Tear	
<b>Coolant Color/Appearance Notes</b>	Normal Translucent appearance, no visual signs of contamination	
<b>Oil Leaks</b>	No	
<b>Oil Color / Appearance</b>	3 - Normal Wear & Tear	
<b>Oil Color / Appearance Notes</b>	Clean oil appearance, no signs of cross contamination, Appropriate oil level	
<b>Fuel Leaks</b>	No	
<b>Equipped with DPF (Diesel Particulate Filter)</b>	Yes	
<b>DPF Condition</b>	4 - Like New, Recently Replaced	
<b>DPF Condition Notes</b>	Filter housing is intact with no signs of damage or malfunction, DPF indicator is not illuminated, Other (see comments)	
<b>Comments</b>	Recently replaced and updated with only about 20 to 50 hours of run time.

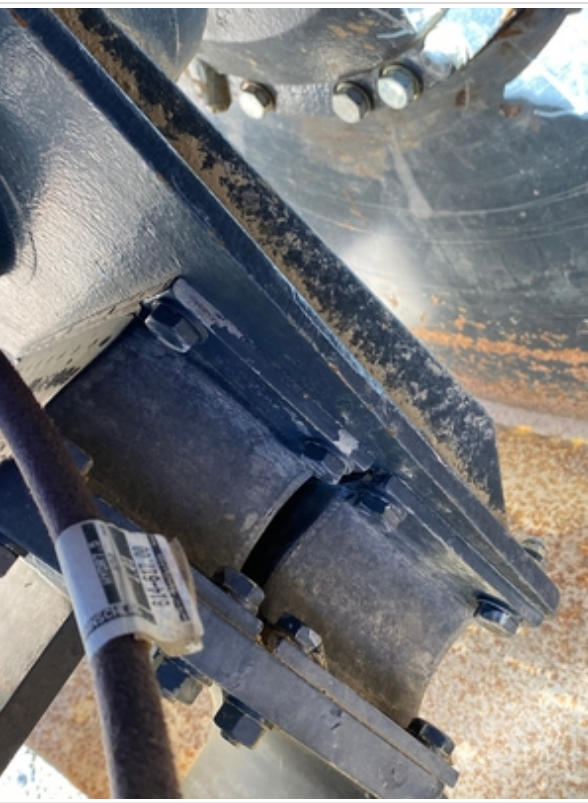
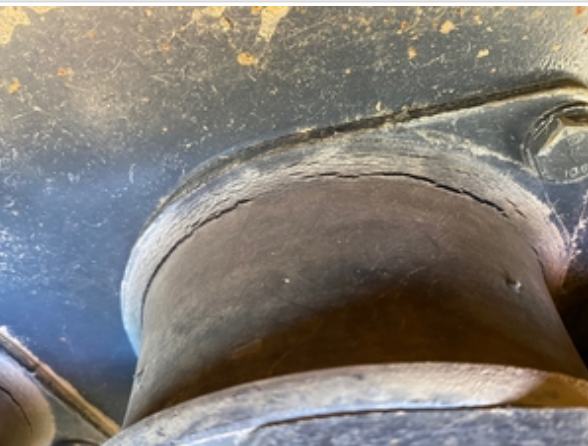
Vibratory Rubber Mounts (Front & Rear) Photos

Frame	4 - Like New, Recently Replaced
Level Stance	4 - Like New, Recently Replaced
Drum(s) Condition	3 - Normal Wear & Tear
Vibratory Rubber Mounts (Front & Rear)	3 - Normal Wear & Tear
Comments	Some isolator rubber mounts showing surface cracks

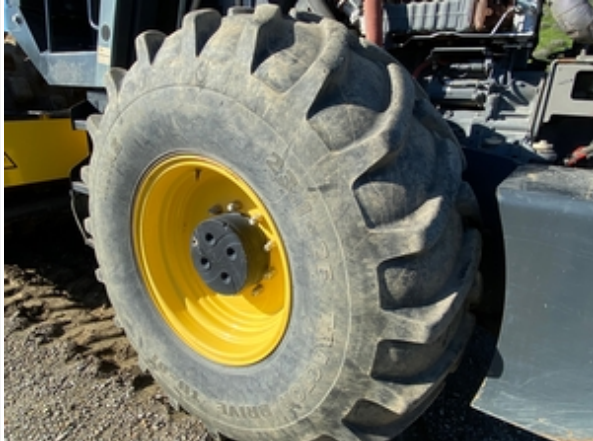
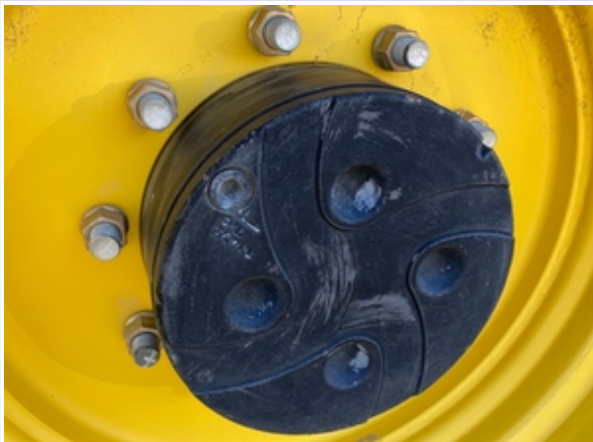
<b>Drum Scraper</b>	4 - Like New, Recently Replaced	
<b>Comments</b>	All front drum scraper tips recently replaced (excellent condition )	
<b>Wheels &amp; Hub Condition</b>	4 - Like New, Recently Replaced	
<b>Comments</b>	Tires have over 70% of tread life left	
<b>Wheels &amp; Hub Condition Photos</b>

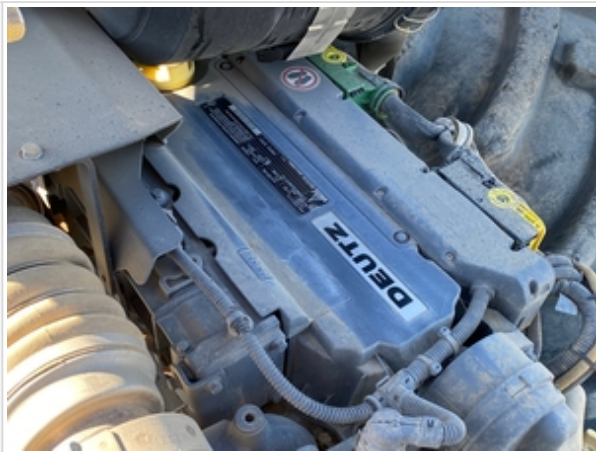
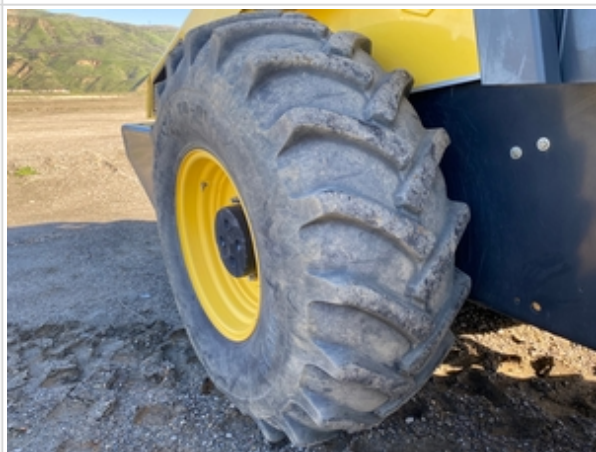
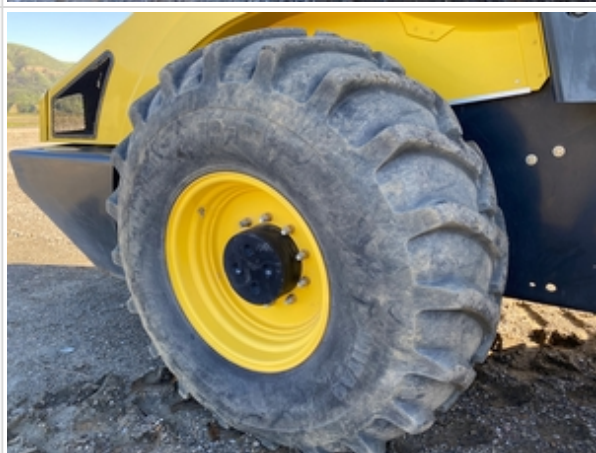
<p>Right Tire Photos</p>

Right Tire - Ratio Remaining	70%

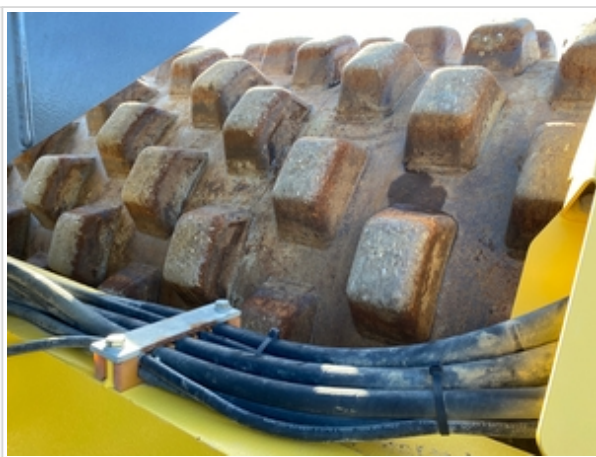
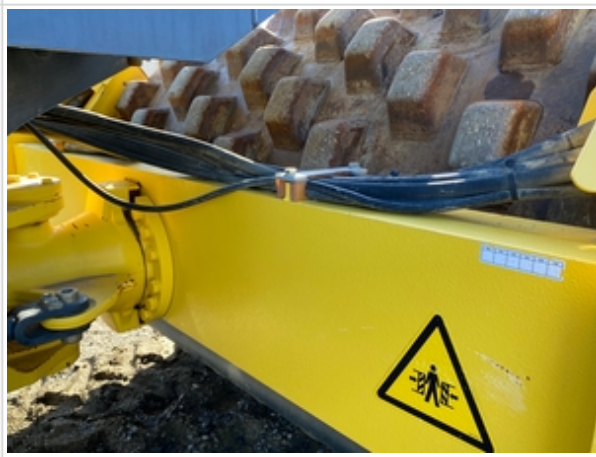
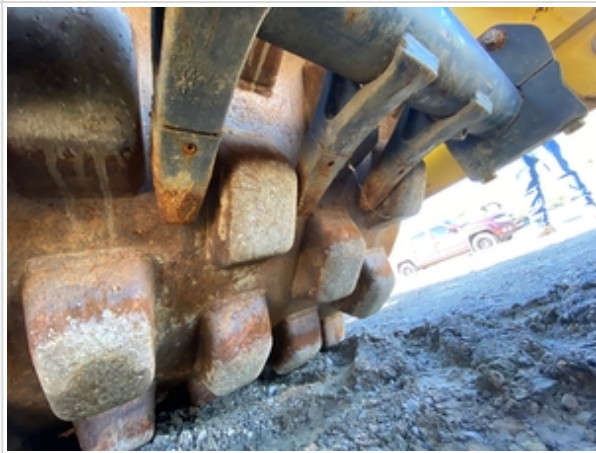
<p>Padfoot Feet Condition Photos</p>

<p>Padfoot Feet Condition</p>	<p>3 - Normal Wear &amp; Tear</p>

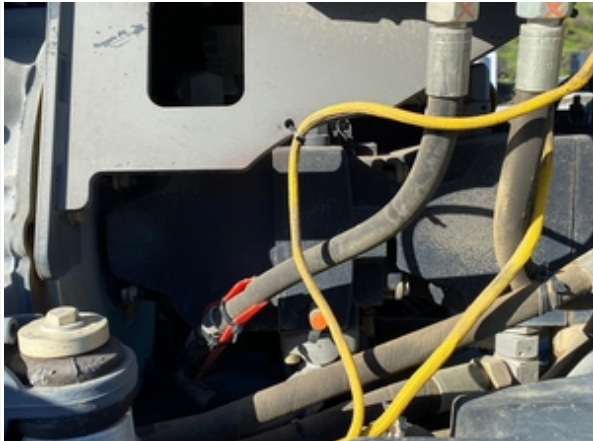
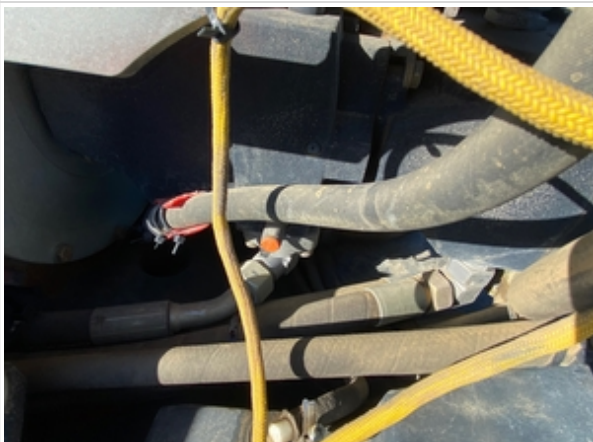
<b>Wet or Damp Hydraulic Lines / Fittings</b>	No	
<b>Appearance of Hydraulic Lines / Fittings</b>	3 - Normal Wear & Tear	
<b>Hydraulic Lines / Fittings Condition</b>	Hydraulic lines & fittings are clean and in good condition	
<b>Appearance of Hydraulic Lines / Fittings Photos</b>

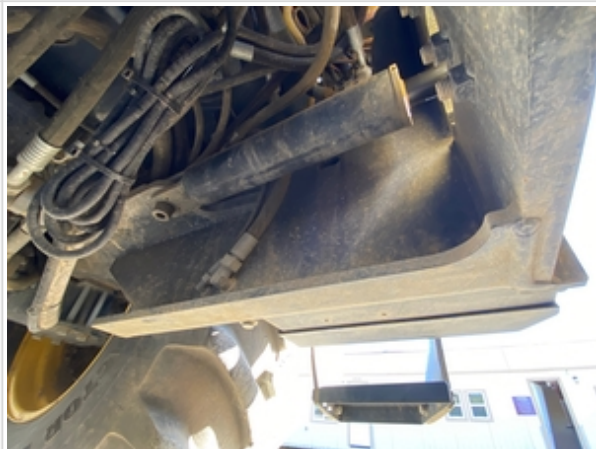
Steering Cylinders	Check the steering cylinder. Note any wear, pitting, discoloration, etc. Take photos.
Steering Cylinders: Mounting Pin	3
Steering Cylinders: Oil Leaks	No
Steering Cylinders Photos
