Inspection Report (On-Highway Dump Truck)

Year	2011
Make	Peterbilt
Model	367
Serial Number	1NP - TLUOX - 2 - BD127975
Truck Odometer Reading	423,441
Previous Application (e.g., earth moving, mining, demolition, etc)	Asphalt Construction

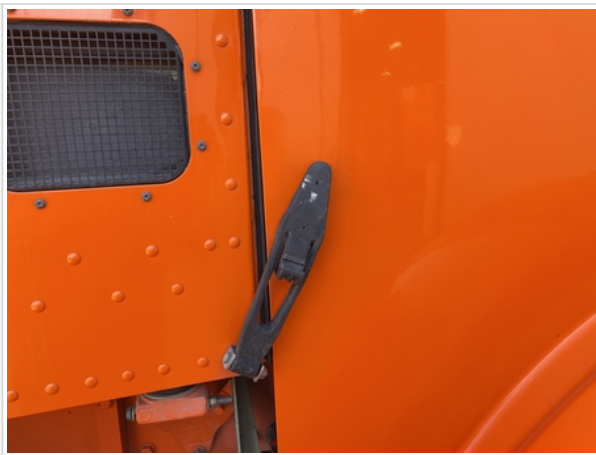
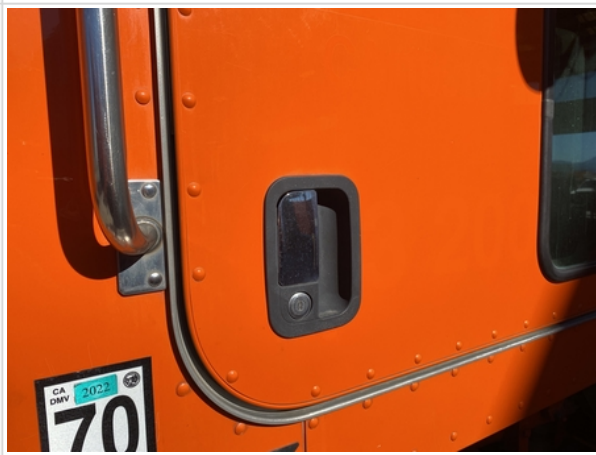
Body Panels (Any Rust Damage?)	3 - Normal Wear & Tear	
Body Panel Condition	No visible damage, good paint condition and panel fitment, Other (see comments)	
Doors / Canopy Latches	3 - Normal Wear & Tear	
Doors / Canopy Latches Condition	No visible damage	
Doors / Canopy Latches Photos

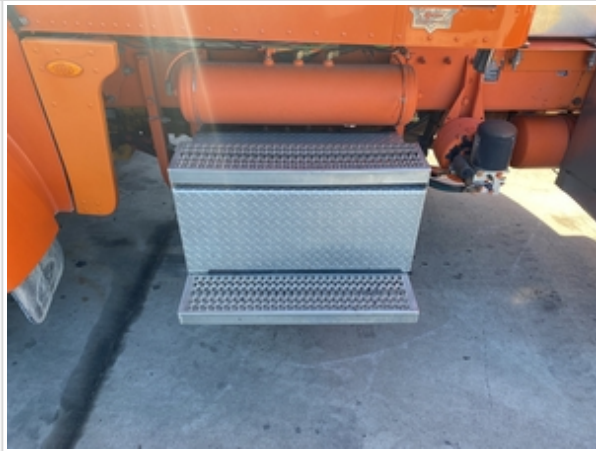
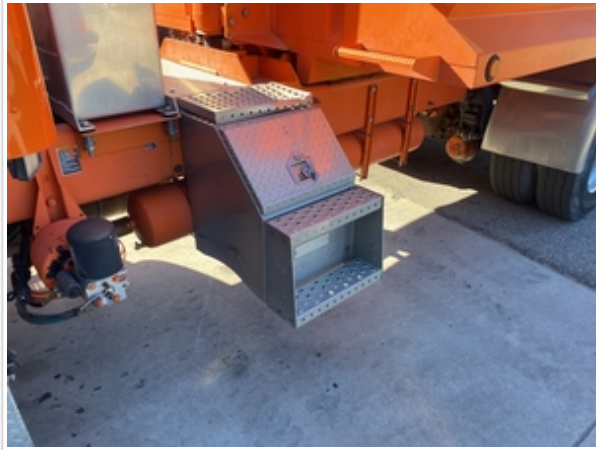
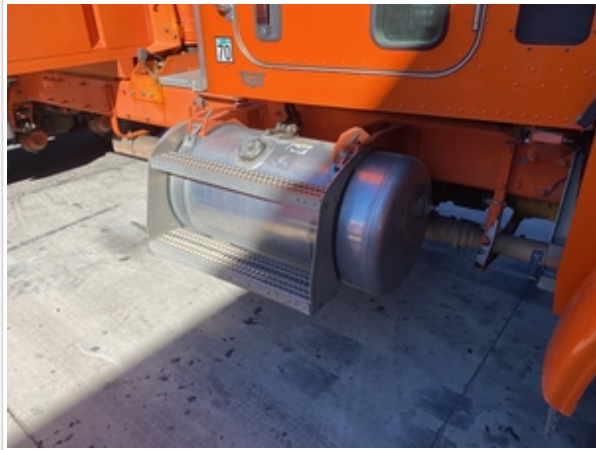
Steps / Ladders	3 - Normal Wear & Tear	
Steps / Ladders Condition	Steps/ladders are fully intact and appear structurally sound	
Steps / Ladders Photos

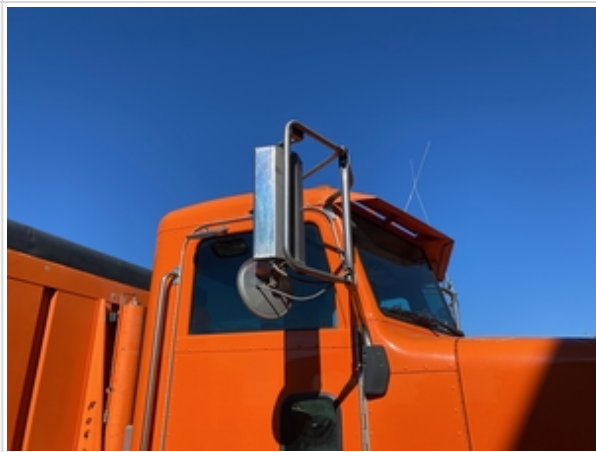
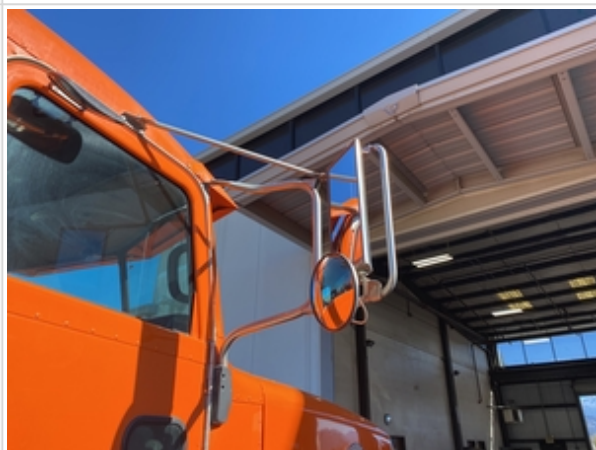
Mirrors	3 - Normal Wear & Tear	
Mirror Condition Notes	Mirrors present and intact, no visible damage	
Mirrors Photos

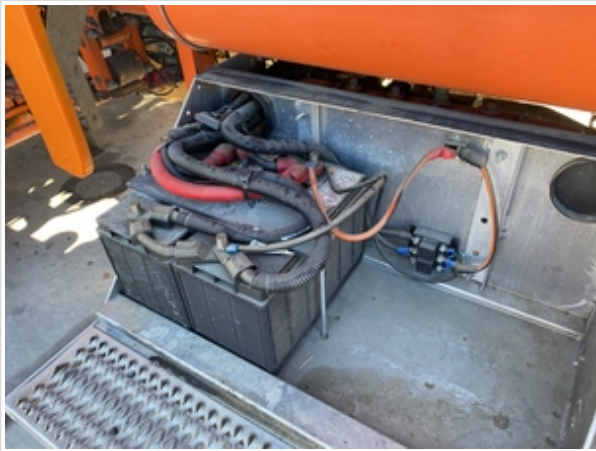
Blow-by (Visual Observation Check)	No	
Unusual Noises (Upon Start-up, Idle, Shutdown)	No	
Unusual Noise Notes	No unusual noises heard	
Engine Smoke (Upon Start-up, Idle, Shutdown)	No	
Engine Smoke Notes	No engine smoke issues observed	
Engine Exhaust Color	Clear	
Battery	2 - Above Average Wear	
Battery Condition	Needs charge or replacement	
Comments	Engine starter hesitation observed	
Battery Condition Photos

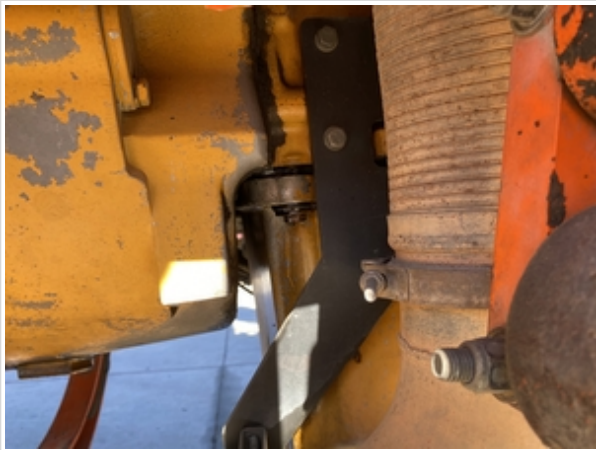
Cooling System Leaks	No
Coolant Color / Appearance	3 - Normal Wear & Tear
Coolant Color/Appearance Notes	Normal Translucent appearance, no visual signs of contamination
Oil Leaks	Yes
Oil Leak Notes	Wet areas with drops forming due to oil leakage, Other (see comments)
Comments	Oil leak at rear top side of oil pan and around bell housing
Oil Leak Photos

Requires DEF (Diesel Exhaust Fluid)	No
Overall Engine Appearance	Clean & dry, Areas of dried seepage seen on engine hoses & components
Overall Engine Comments	Minor oil leak may be coming from engine oil pan and around bell housing.

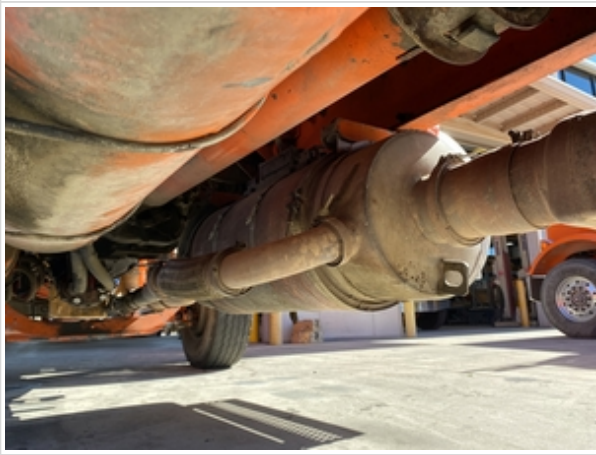
Oil Color / Appearance	3 - Normal Wear & Tear	
Oil Color / Appearance Notes	Clean oil appearance, no signs of cross contamination, Appropriate oil level	
Fuel Leaks	No	
Equipped with DPF (Diesel Particulate Filter)	Yes	
DPF Condition	3 - Normal Wear & Tear	
DPF Condition Notes	Filter housing is intact with no signs of damage or malfunction, DPF indicator is not illuminated	
DPF Photos

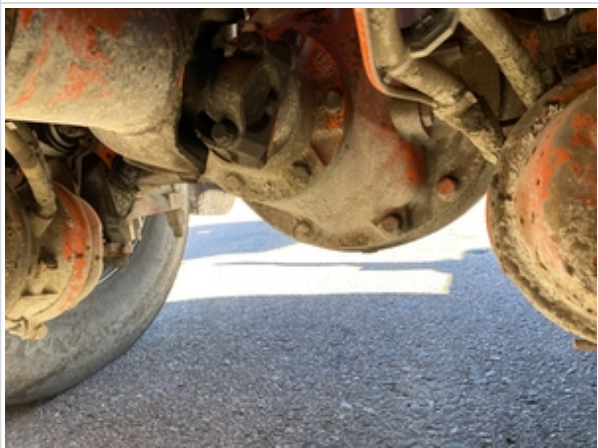
Differential	Check condition of the differential(s). Take photos and notes as relevant.	
Rear Differential	3 - Normal Wear & Tear	
Rear Differential Condition	Dry housing appearance, no unusual noises heard during operation	
Rear Differential Photos

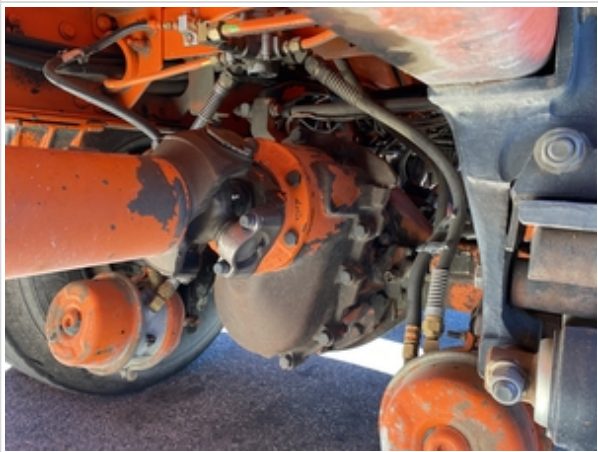
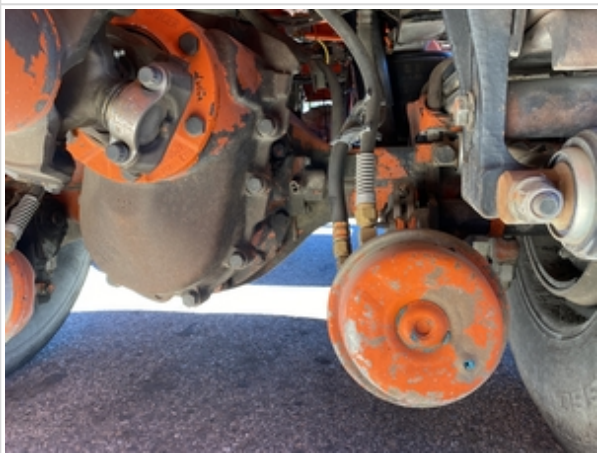
Front Differential	3 - Normal Wear & Tear	
Front Differential Condition	Dry housing appearance, no unusual noises heard during operation	
Front Differential Photos

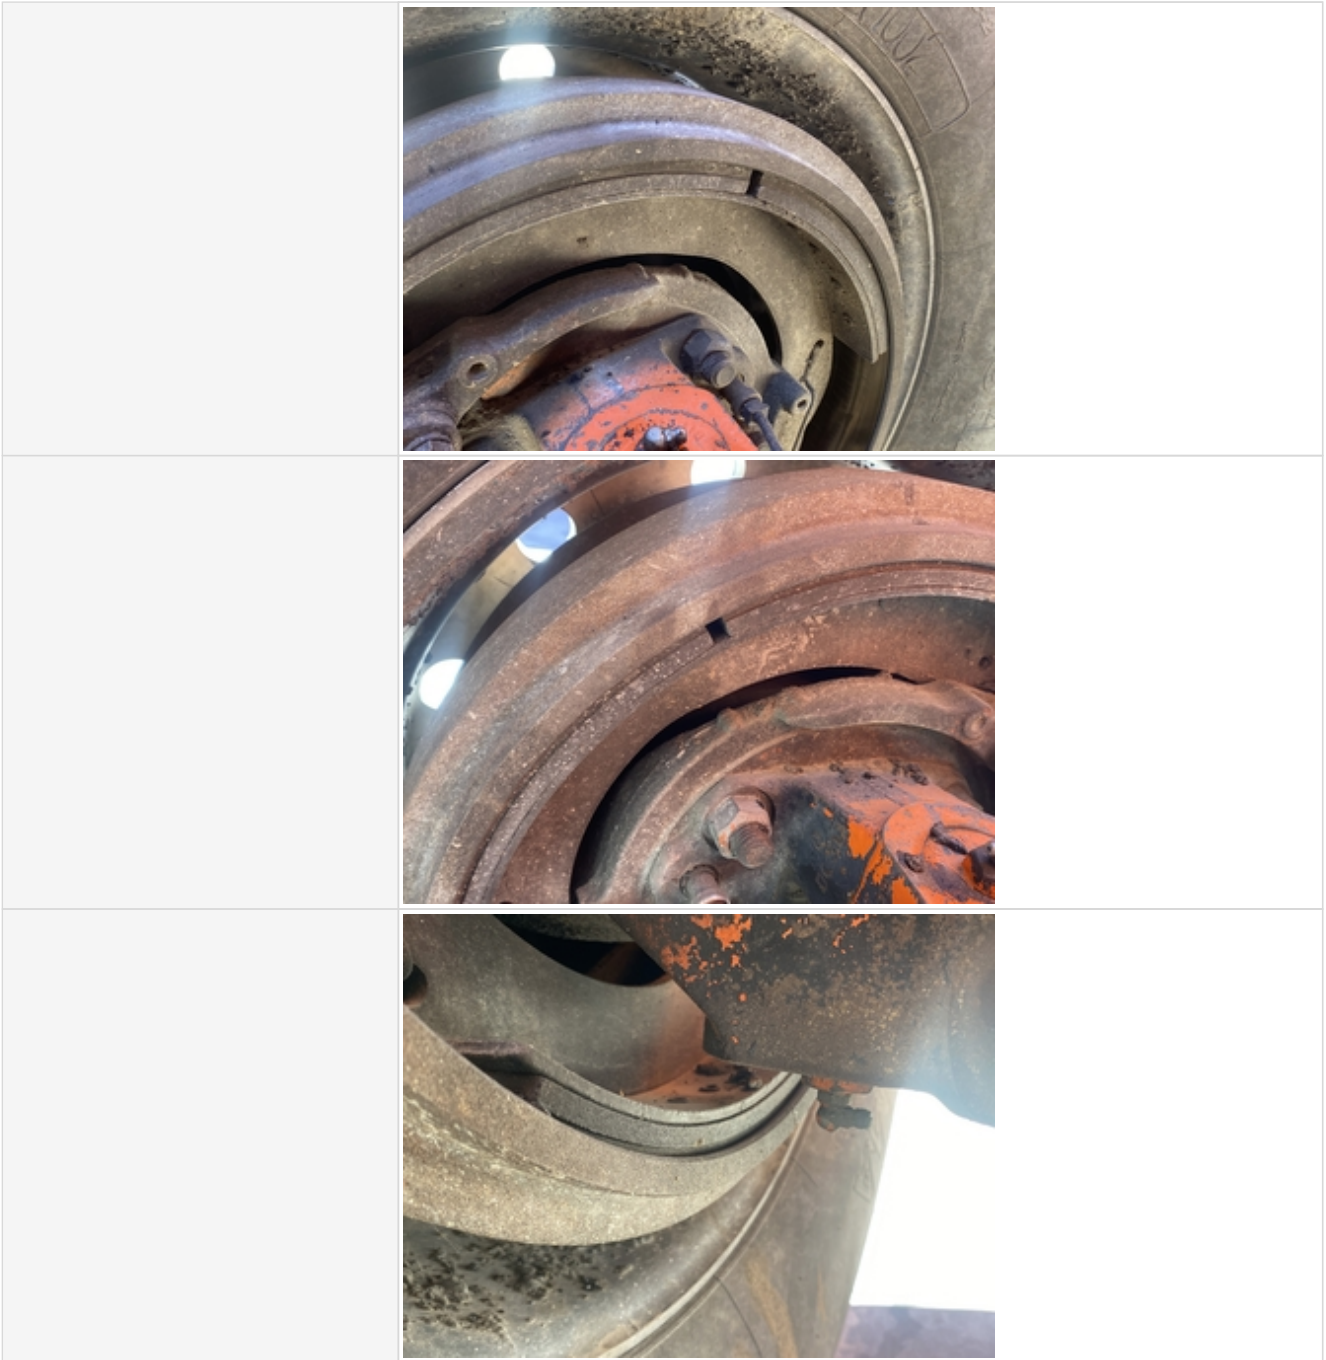
Brake Shoe Thickness	30%
Comments	3rd axle (rear) brakes shoes above 50% all others at 30% life left
Brake Shoe Photos

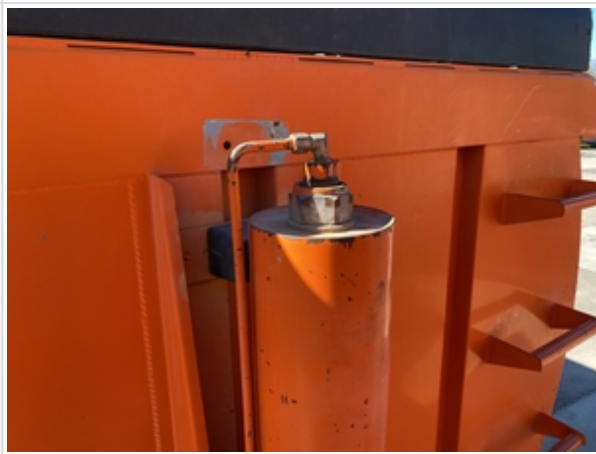
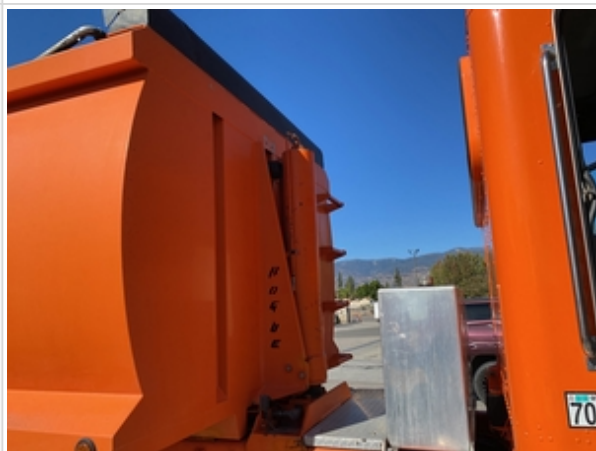
<p>Hydraulic Cylinders</p>	<p>3 - Normal Wear & Tear</p>
<p>Hydraulic Cylinder Photos</p>
