Inspection Report (On-Highway Dump Truck)

Year	2011
Make	Peterbilt
Model	367
Serial Number	1NPTLU0XXBD127979
Truck Odometer Reading	423,762
Previous Application (e.g., earth moving, mining, demolition, etc)	Asphalt Paving Construction

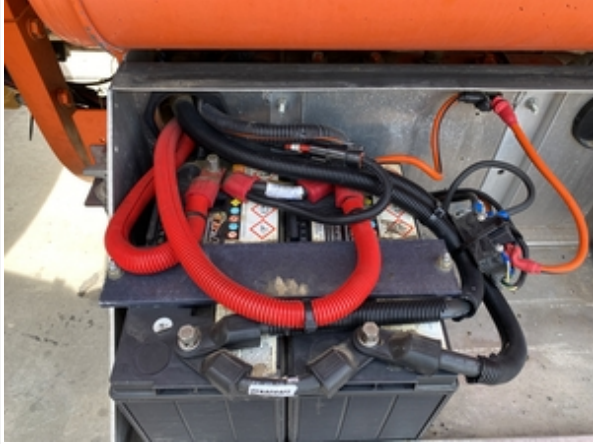
Engine Exhaust Color	Clear
Battery	2 - Above Average Wear
Battery Condition	Clean & dry appearance, tight connections, Needs charge or replacement, Other (see comments)
Comments	Had to jump start during inspection (May be old batteries or system draw)
Battery Condition Photos

What Needs Work	All rear tires and brake shoes will need to be replaced soon. Dump body drop down function, struggles and should be addressed for ease of functioning. Minor seepage seen from engine oil pan gasket and bell housing cover plate. Batteries may need to be replaced and/or charging system checked.
Date/Time	01-12-2023

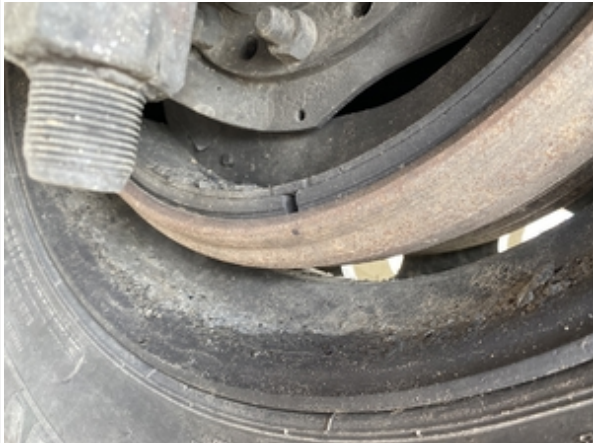
Brake Shoe Thickness	10%	
Comments	Rear brake shoes low and need to be replaced soon fronts above 90%	
Brake Shoe Photos

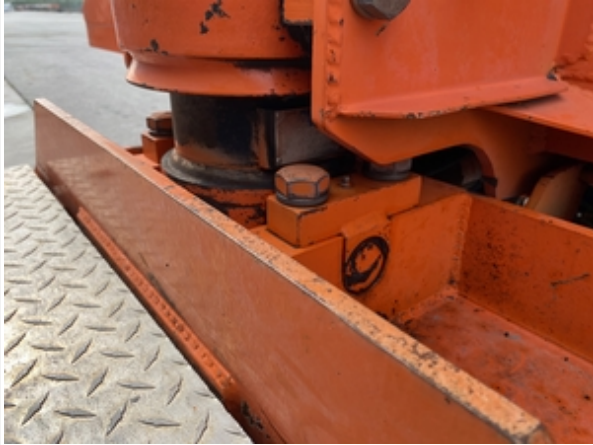
Hydraulic Function	3 - Normal Wear & Tear
Comments	Dump body lift cylinder works well when raised. When dump body cylinder telescopes in, it struggles a bit and requires the strong arm drop axles assistance for quicker response .
