Inspection Report (On-Highway Flatbed Truck)

Year	2014
Make	Trailking
Model	TK80HT-482
Serial Number	1TKA04825EM013367
Truck Odometer Reading	N/A
Current Inspection / State Cert / DOT	Inspected 9/2022 per 49 CFR, Part 396, FMCSR
Previous Application (e.g., earth moving, mining, demolition, etc)	EQUIPMENT RENTAL HAULER

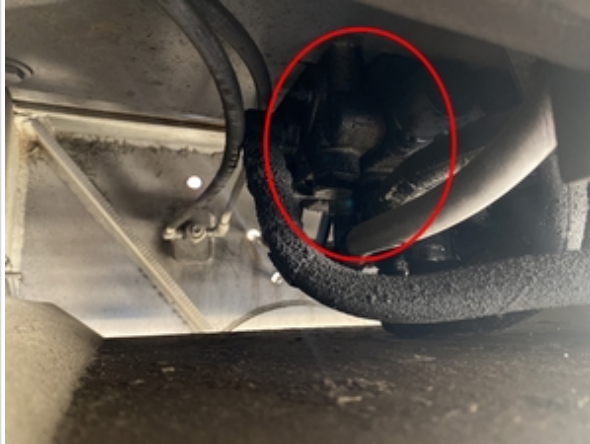
PTO Photos

This is a close-up photo of the hydraulic control valve used to power the rear hydraulic dovetail ramp. Small leakage observed from what could be worn hydraulic hoses.

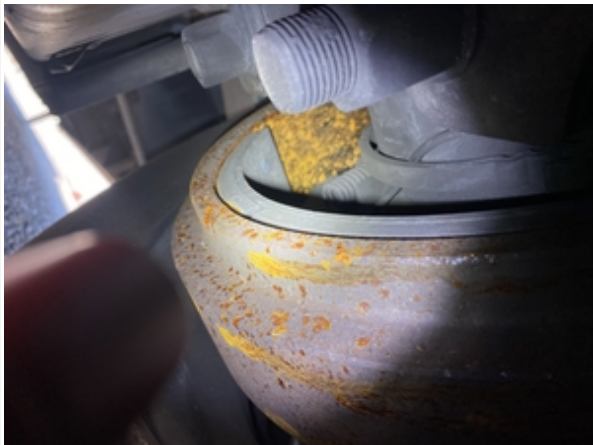
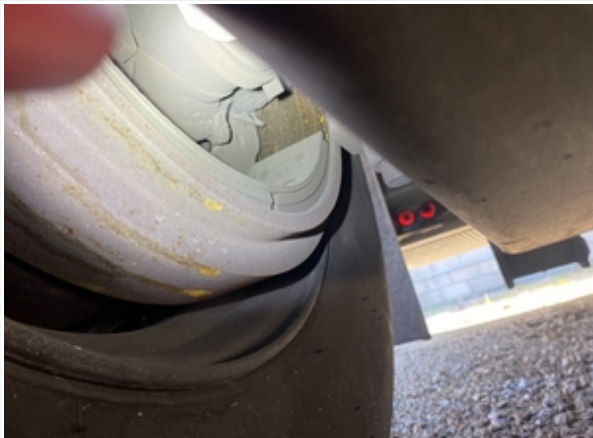
Differential	Check condition of the differential(s). Take photos and notes as relevant.	
Rear Differential	0	
Front Differential	0	
Brake Shoe Thickness	50%	
Comments	Front @40-50% Rear @80%	
Brake Shoe Photos

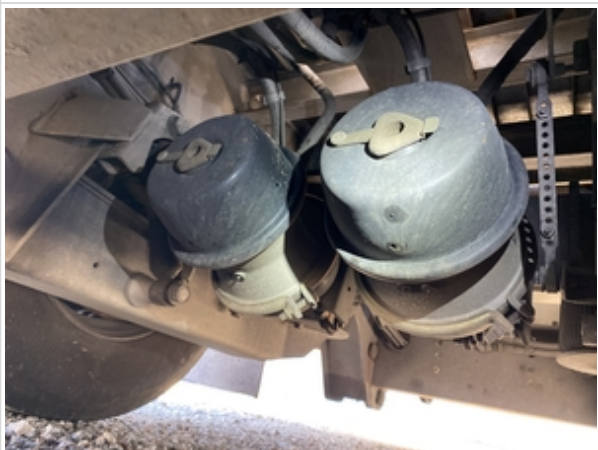
Air Brake System Leaks	N/A	
Air Brake Hose Condition	3 - Normal Wear & Tear	
Comments	Unable to test air system	
Air Brake System Photos

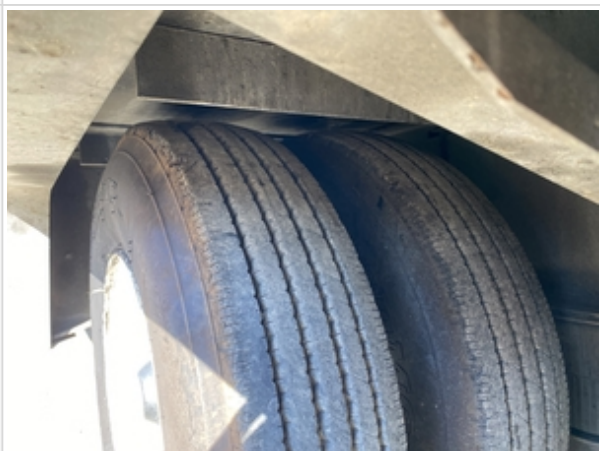
Wheel Seal Leaks	No	
Tire Brand	Sumitomo ST 727	
Tire Size	10R/17.5	
Front Left Tire - Ratio Remaining	70%	
Front Left Tire Photos

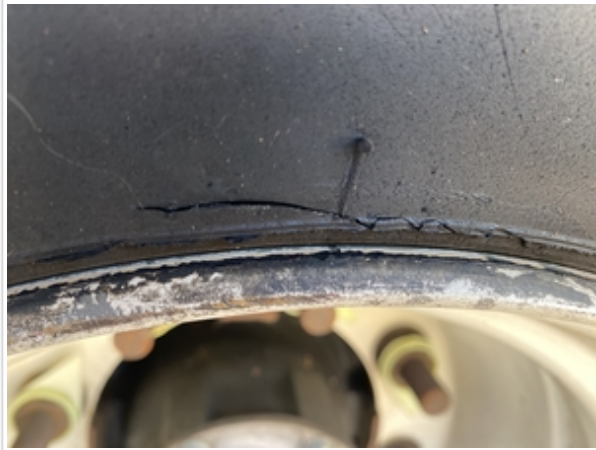
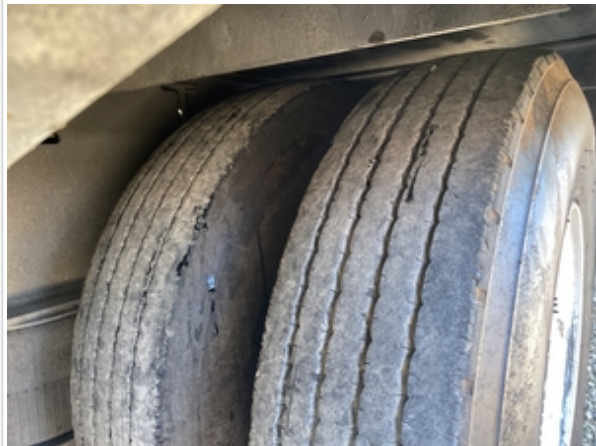
Front Right Tire - Ratio Remaining	10%
Front Right Tire Photos

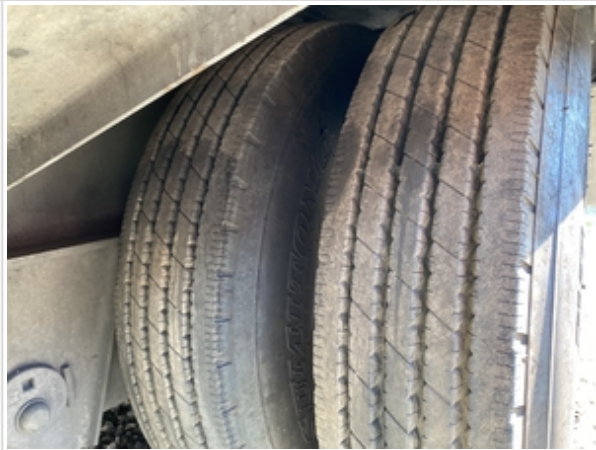
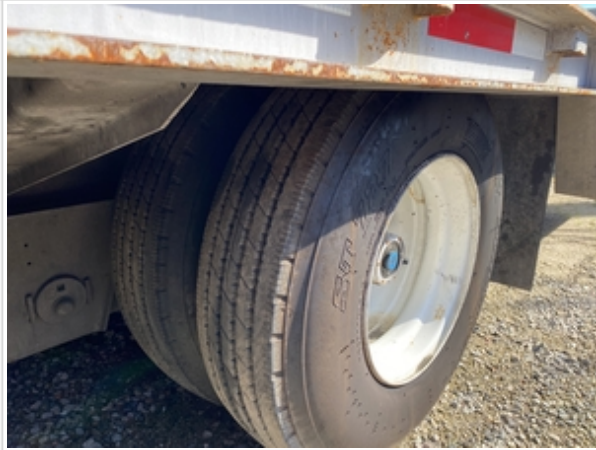
Rear Left Tire Photos

Rear Left Tire - Ratio Remaining	70%
