Inspection Report (Telehandler)

Year	2013
Make	SKYTRAK
Model	10054
Serial Number	0160055292
Hour Meter Reading	4,211 Hours
Previous Application (e.g., earth moving, mining, demolition, etc)	Equipment Rentals

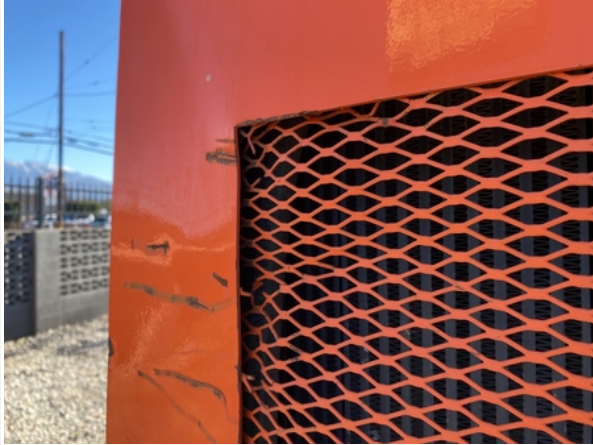
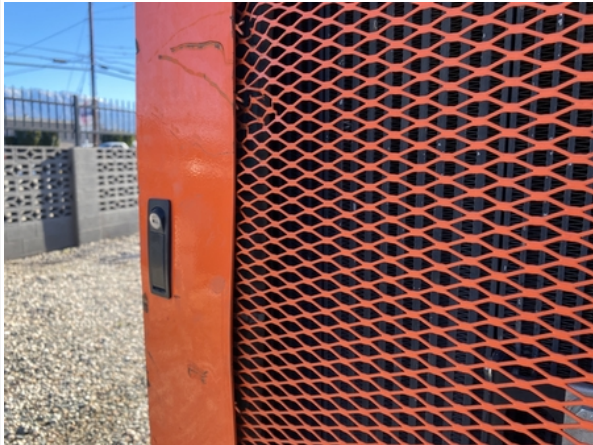
Body Panels	3 - Normal Wear & Tear
Body Panel Condition	No visible damage, good paint condition and panel fitment, Other (see comments)
Comments	Minor scuff marks all the way around, minor damage to rear door grill
Doors / Canopy Latches	3 - Normal Wear & Tear
Doors / Canopy Latches Condition	Other (see comments)
Comments	Rear door latch sticking (still locks closed, have to use small screwdriver to assist unlatching)
Steps / Ladders	3 - Normal Wear & Tear
Steps / Ladders Condition	Steps/ladders are fully intact and appear structurally sound
Handrails	3 - Normal Wear & Tear
Handrails Condition	Handrails are fully intact and appear structurally sound
Glass	0
Mirrors	3 - Normal Wear & Tear
Mirror Condition	Mirrors present and intact, no visible damage
Exterior Lights	3 - Normal Wear & Tear
Exterior Lights Condition	Other (see comments)
Comments	Bottom 2 front lights okay, other lights inoperable

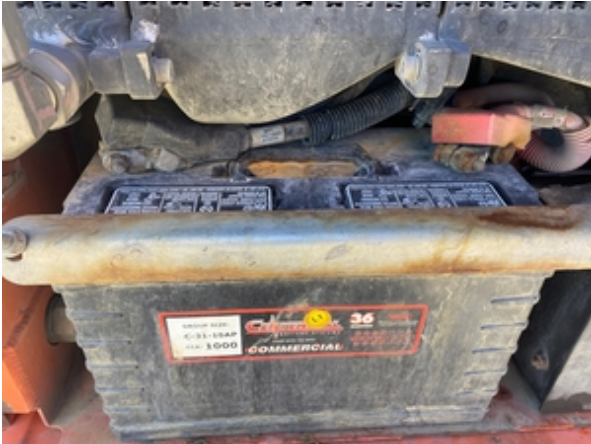
Battery	3 - Normal Wear & Tear
Battery Condition	Clean & dry appearance, tight connections, Dusty & dirty appearance
Battery Condition Photos

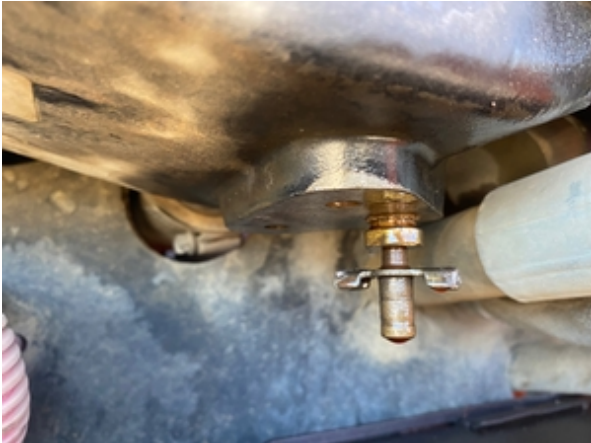
Radiator	2 - Above Average Wear
Radiator Condition	Radiator fins & components appear to be in good working order, no signs of damage or leaks, Other (see comments)
Comments	Possible leakage seen from fittings at radiator
Radiator Photos

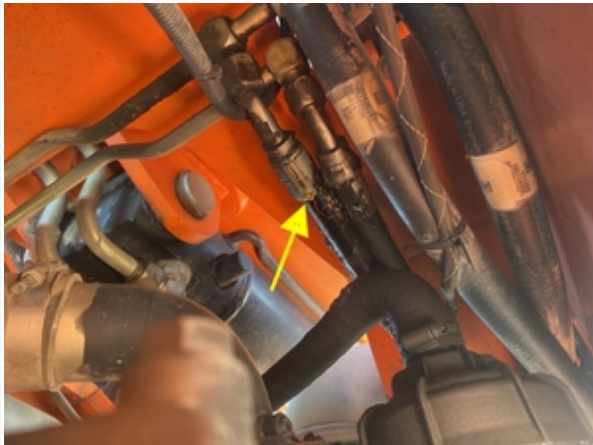
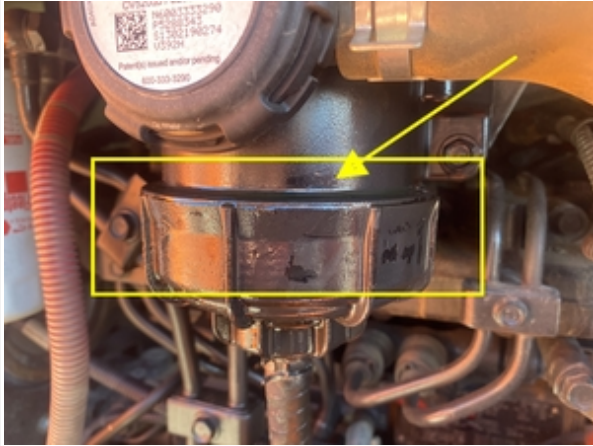
Coolant Color / Appearance	3 - Normal Wear & Tear
Coolant Color/Appearance Notes	Normal Translucent appearance, no visual signs of contamination
Oil Leaks	Yes
Oil Leak Notes	Other (see comments)
Comments	Oil leaks seen on engine coming from hydraulic hoses routed above engine, possible oil leak at radiator area
Oil Leak Photos

Oil Color / Appearance	3 - Normal Wear & Tear
Oil Color / Appearance Notes	Clean oil appearance, no signs of cross contamination, Appropriate oil level
Fuel Leaks	No
Requires DEF (Diesel Exhaust Fluid)	No
Overall Engine Appearance	Clean & dry
Overall Engine Comments	Engine service recommended (no date stamped on filters) Engine runs well and sounds good under load.

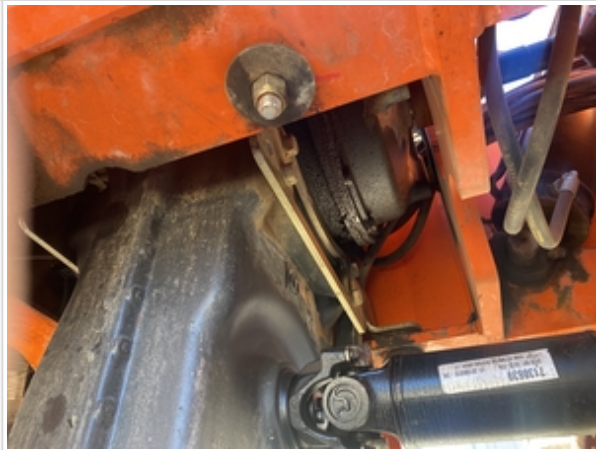
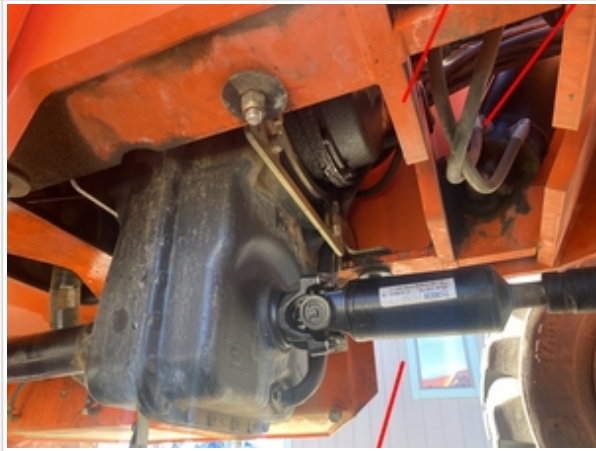
Transmission Photos

Hydrostatic Transmission?	No
Transmission Info (Make/Model/Speeds)	Powershift 4 Speed Forward 3 Speed Reverse
Transmission	3 - Normal Wear & Tear
Transmission Condition	Other (see comments), No unusual noises or vibrations
Comments	Residual oil buildup seen around Top Side of Transmission

Clutch	0
Shift Lever	3 - Normal Wear & Tear
Shift Lever Condition	Other Comments, Good forward and reverse function
Comments	Decals on shifter worn
Foot Brake	3 - Normal Wear & Tear
Foot Brake Condition	Poor braking performance
Comments	Brake Pedals require (hard depress) for brakes to activate
Inching Brake	0
Parking Brake	3 - Normal Wear & Tear
Parking Brake Condition	Good brake function
Overall Drivetrain Comments	Overall front and rear axle looked healthy, (externally) with no leaks or obvious issues observed. Transmission functions well in all gears forward and reverse. Suspension and steering seemed to work normal. Minor oil buildup observed at transmission. (Further inspection recommended to determine if it's hydraulic or transmission fluid seen during inspection).

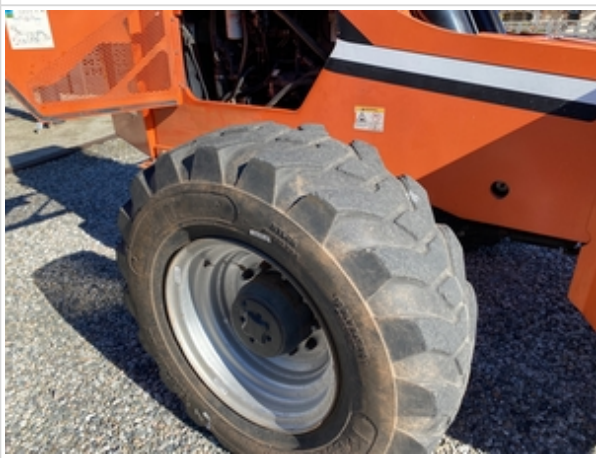
Wheels & Tires	3 - Normal Wear & Tear	
Comments	All 4 tires have similar wear/All 4 tires are foam filled	
Wheels & Tires Photos

Tire Brand	LoadMaster (Foam Filled)	
Tire Size	17.5-25	
Front Left Tire - Ratio Remaining	10%	
Rear Left Tire - Ratio Remaining	10%	
Front Right Tire - Ratio Remaining	10%

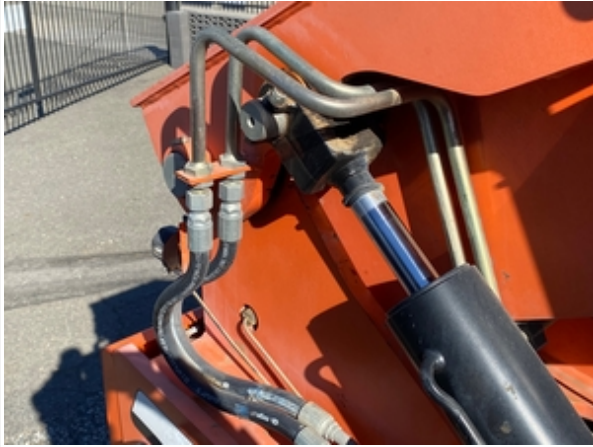
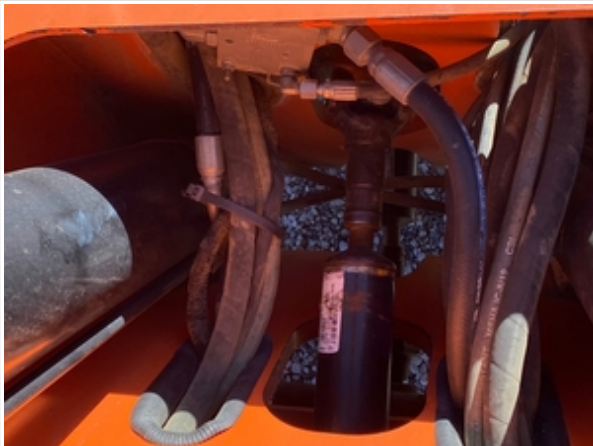
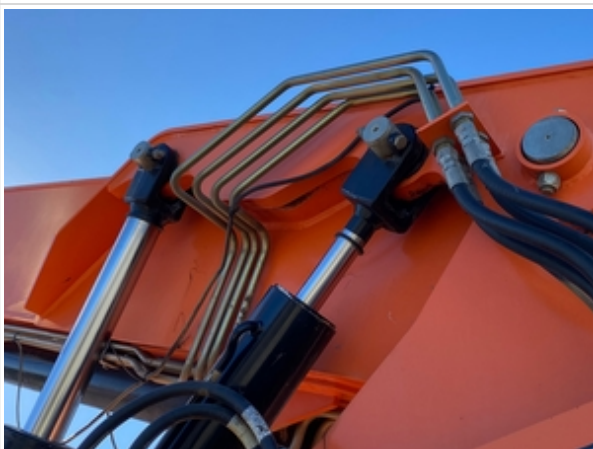
Appearance of Hydraulic Lines / Fittings	3 - Normal Wear & Tear
Hydraulic Lines / Fittings Condition	Hydraulic lines & fittings are clean and in good condition, Active leaks in hoses or fittings observed, Other (see comments)
Comments	Side to side bottom (Machine Leveling) hand control valve stiff
Appearance of Hydraulic Lines / Fittings Photos
