Inspection Report (On-Highway Flatbed Truck)

Year	2015
Make	Ford
Model	F-750
Serial Number	3FRXF7FE5FV005710
Truck Odometer Reading	168,613 Miles
Current Inspection / State Cert / DOT	Last Performed 04/2022
Previous Application (e.g., earth moving, mining, demolition, etc)	Compact Rental Equipment Hauler

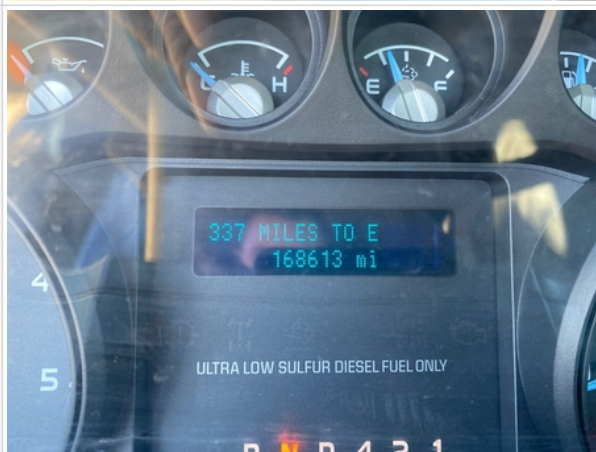
Odometer Activity	3 - Normal Wear & Tear
Odometer Condition	Odometer is working and in good condition
Controls/Switches/Gauges	3 - Normal Wear & Tear
Controls/Switches/Gauges Condition	All switches/gauges are in good condition and functioning
Brake System Type	Air Brakes
Air Brakes Build Correct Pressure	Yes
Clutch	0
Horn	3 - Normal Wear & Tear
Horn Condition	Horn is functioning as expected
Reverse Alarm / Backup Camera	3 - Normal Wear & Tear
Reverse Alarm / Backup Camera Condition	Other (see comments)
Comments	Back up camera installed and rear view mirror works as the monitor. (Did not observe monitor display turn on during inspection)
Heater & A/C	3 - Normal Wear & Tear
Heat & A/C Condition	Heater and A/C work as expected
Interior Lights	3 - Normal Wear & Tear
Interior Lights Condition	All interior lights are installed and functioning
Seats/Seat Belts	3 - Normal Wear & Tear
Seats/Seat Belt Condition	Seat(s) in good condition, no stains or tears in upholstery

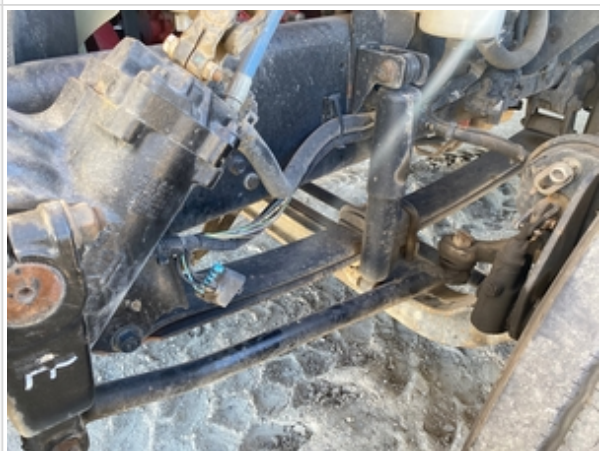
Frame	3 - Normal Wear & Tear	
Suspension	3 - Normal Wear & Tear	
Steer Axle Condition	3 - Normal Wear & Tear	
Steering Components	3 - Normal Wear & Tear	
Steering Component Photos

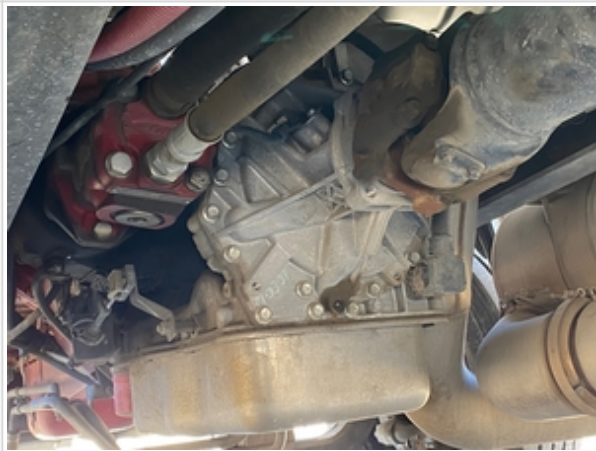
Transmission Info (Make/Model)	Allison Automatic 5 Speed
Transmission	3 - Normal Wear & Tear
Transmission Condition	No unusual noises or vibrations
Transmission Condition Photos

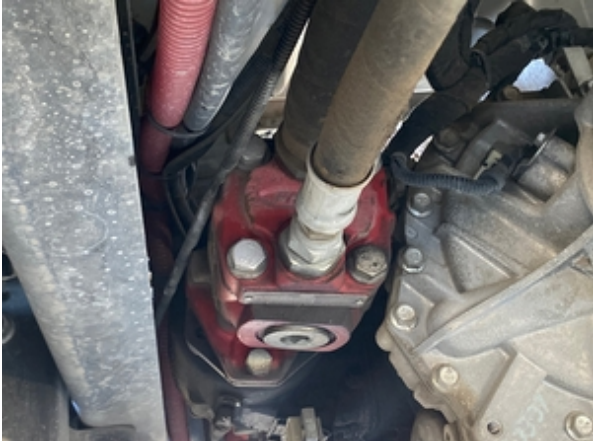
PTO Photos

PTO	3 - Normal Wear & Tear

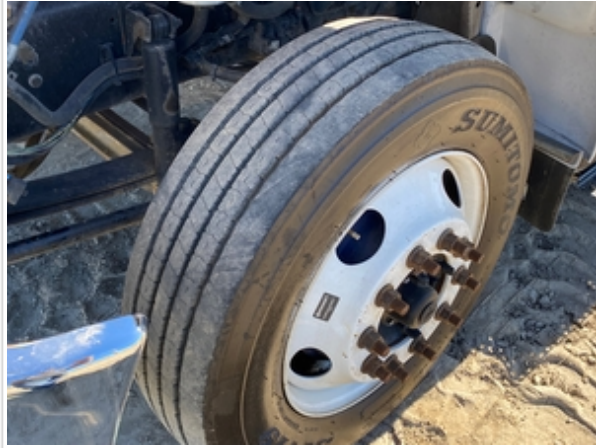
Wheels & Hub Condition	3	
Wheel Seal Leaks	No	
Tire Brand	Sumitomo	
Tire Size	275/70R/22.5	
Front Left Tire - Ratio Remaining	70%	
Front Left Tire Photos

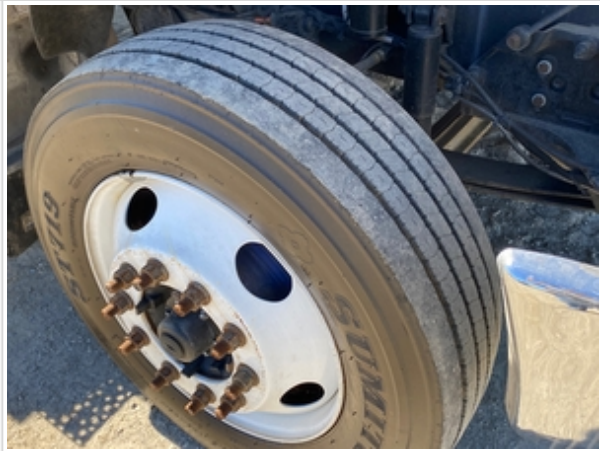
<p>Front Right Tire Photos</p>

Front Right Tire - Ratio Remaining	70%

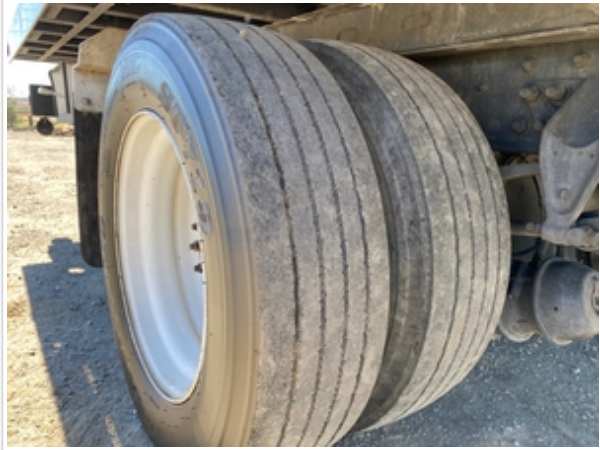
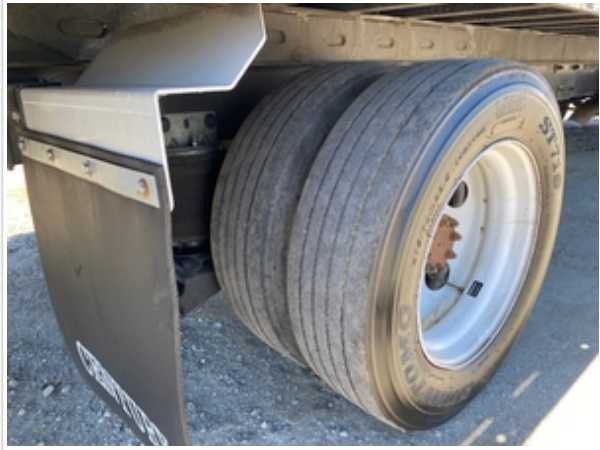
<p>Rear Right Tire - Ratio Remaining</p>	<p>10%</p>	
<p>Rear Right Tire Photos</p>

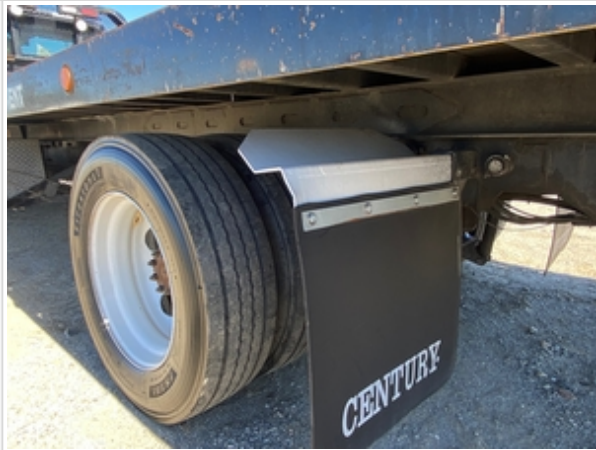
Rear Left Tire Photos

<p>Rear Left Tire - Ratio Remaining</p>	<p>30%</p>

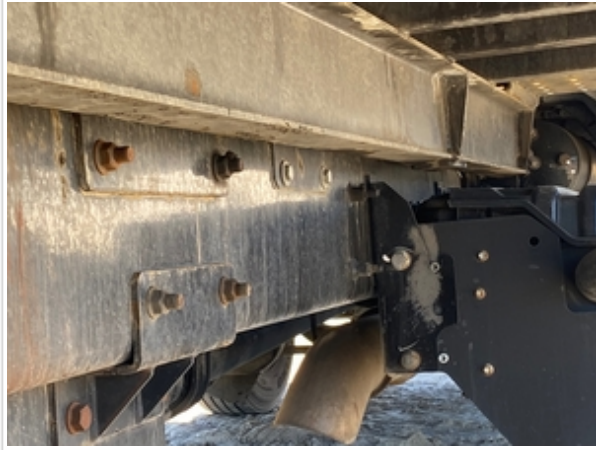
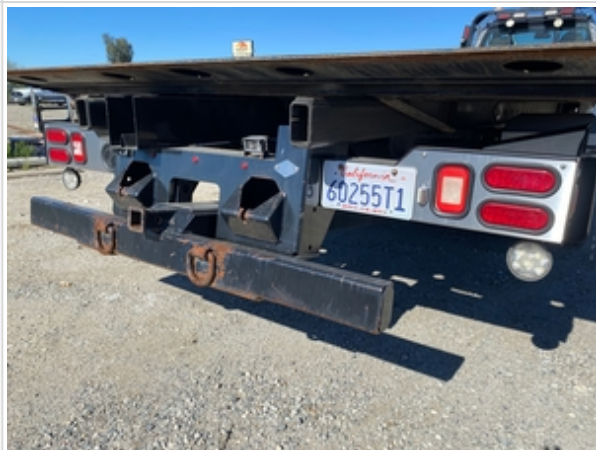
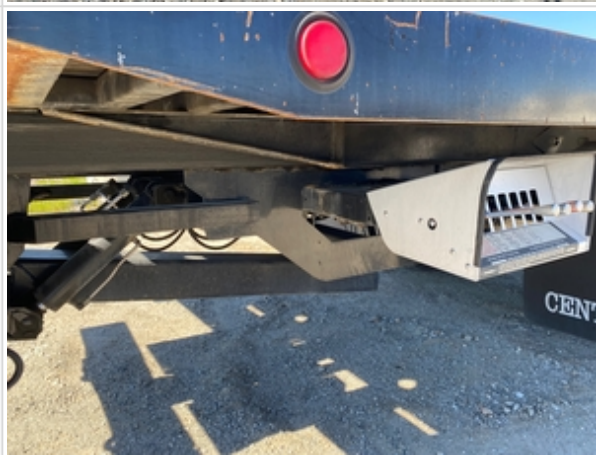
Tailgate Latch	0
Support Frame	3
Support Frame Photos
