Inspection Report (Telehandler)

| Make | SKYTRAK |
| Model | 10054 |
| Serial Number | 17806 |

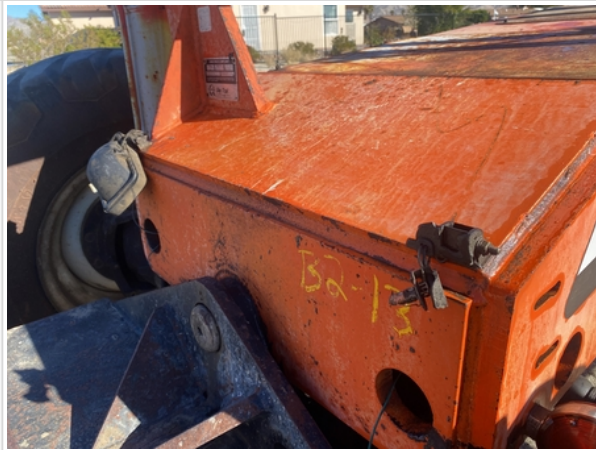
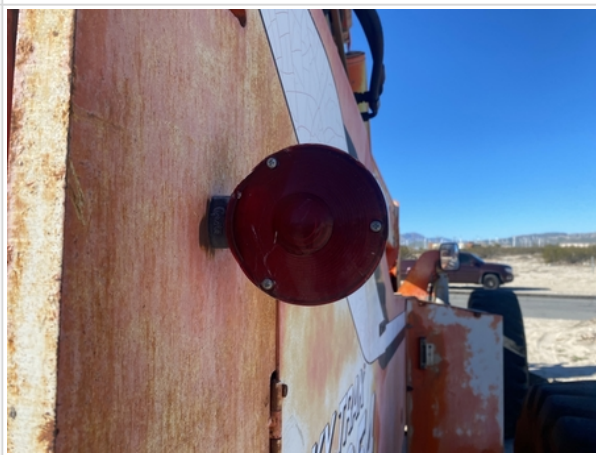
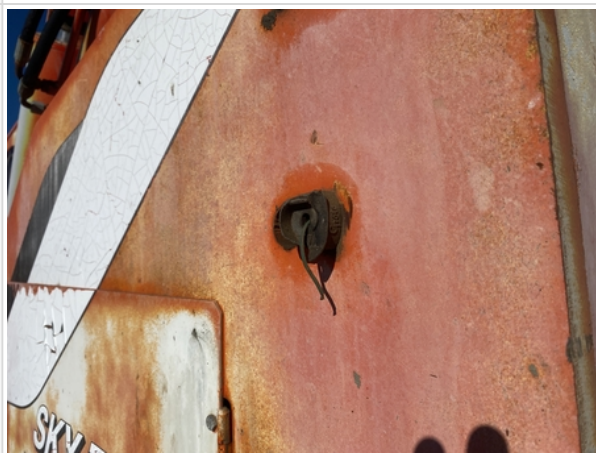
| <p>Exterior Lights Photos</p> | | |

| Exterior Lights | 2 - Above Average Wear |
| Exterior Lights Condition | Overall lighting system is non-operational |

| What Needs Work | Cosmetically, machine could use a paint job. Some hydraulic hoses showing signs of surface cracks and may need to be replaced soon. Tires may need to be replaced soon. Battery needs to be properly mounted. Minor active leak at main control valve. Hydraulic leak at front tilt cylinder hose fitting. Horn, Backup alarm And lights inoperable. |

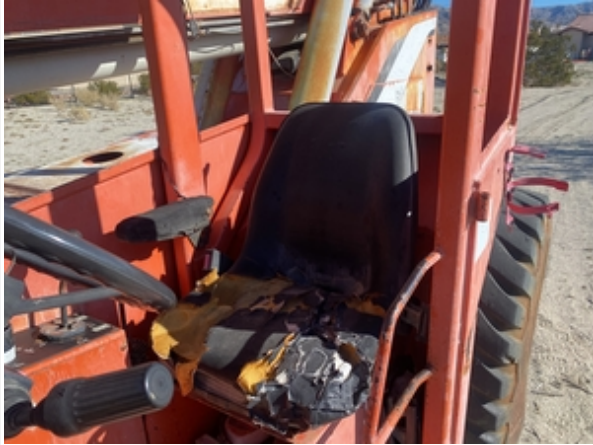
| Operator Seat Photos | |

| Operator Seat | 1 - Service Required |
| Operator Seat Condition | Seat(s) has major surface staining or tears |

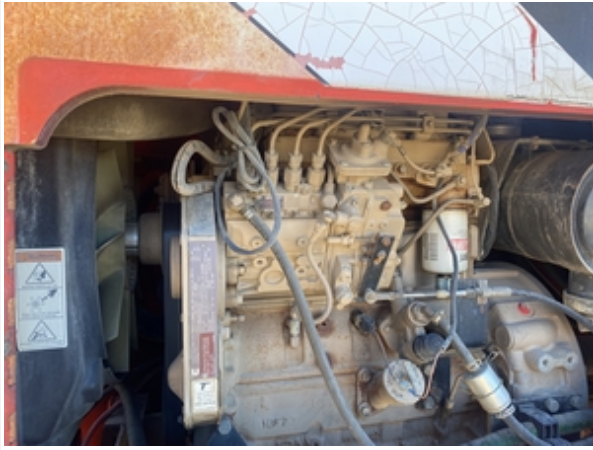
| Engine Photos | |

| Comments | Minor blowby observed at breather hose | |
| Comments | Negative Cable loose at Battery (causing intermittent no start) | |

| Comments | Negative cable loose hold down not installed |

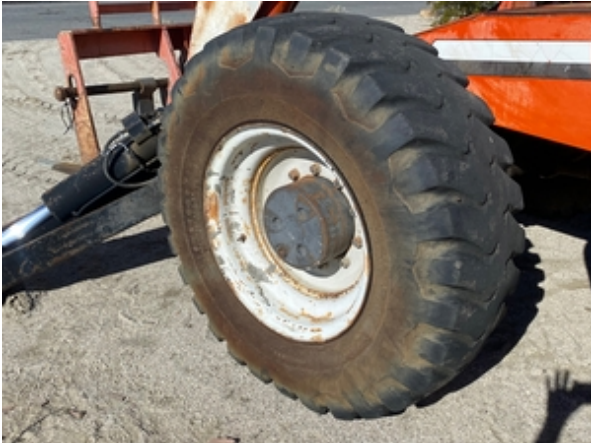
| Wheels & Tires Photos | | |

| Wheels & Tires | 2 - Above Average Wear | |
| Comments | Tires are Foam Filled | |

| Front Left Tire - Ratio Remaining | 10% |
| Rear Left Tire - Ratio Remaining | 10% |
| Front Right Tire - Ratio Remaining | 10% |
| Rear Right Tire - Ratio Remaining | 10% |

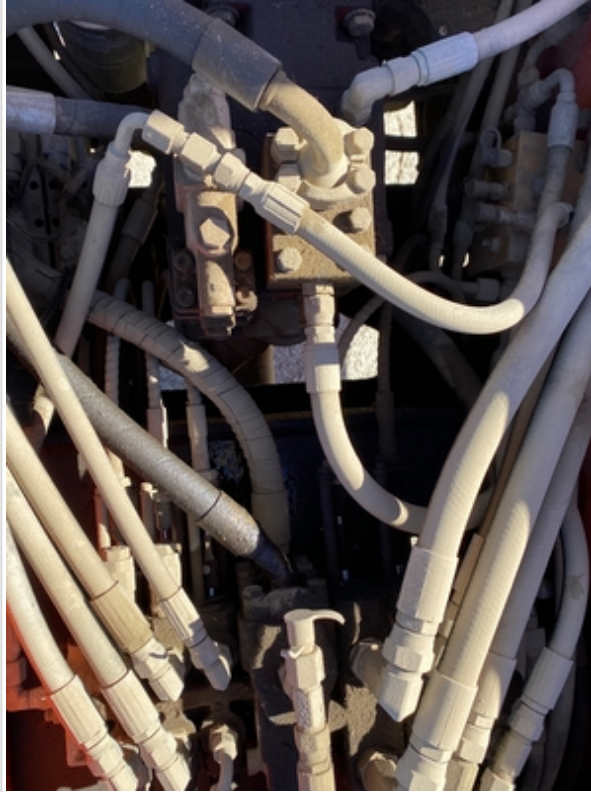
Appearance of Hydraulic Lines /
Fittings Photos

| Wet or Damp Hydraulic Lines / Fittings | Yes | |
| Hydraulic Lines / Fittings Condition | Hydraulic lines & fittings are clean and in good condition, Other (see comments) | |
| Comments | Most hydraulic hoses in good condition. Some showing signs of normal aged surface cracks | |

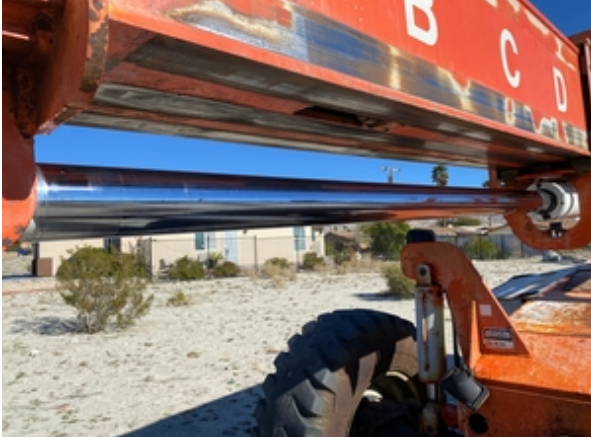
| Telescopic Boom Cylinders Photos | |

| Telescopic Boom Cylinders: Oil Leaks | Yes |
