Inspection Report (Compact Track Loader)

| Make | CAT |
| Model | 287C |
| Serial Number | MAS00561 |

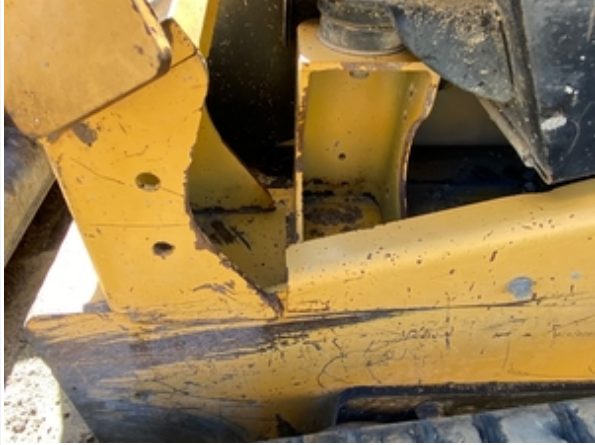
| Body Panels | 3 - Normal Wear & Tear | |
| Body Panel Condition | Large dents or cracks, Other (see comments) | |
| Comments | Rear engine door has small dent bottom left side, top of cab front edge panel slightly bent | |

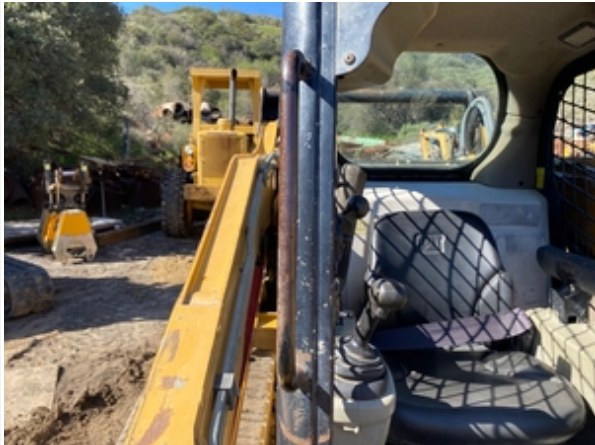
| Handrail Photos | | |

| Handrails | 3 - Normal Wear & Tear | |
| Handrails Condition | Bent or broken railings, Handrails are fully intact and appear structurally sound | |
| Comments | Front left side can handrail slightly bent in | |

| What Needs Work | Some Undercarriage idlers and bogies may need to be replaced soon. Cosmetic scuff marks and some dents observed. Front cab handrail bent in and travel alarm inoperable. Both lift cylinders leaking a bit and should be resealed. |

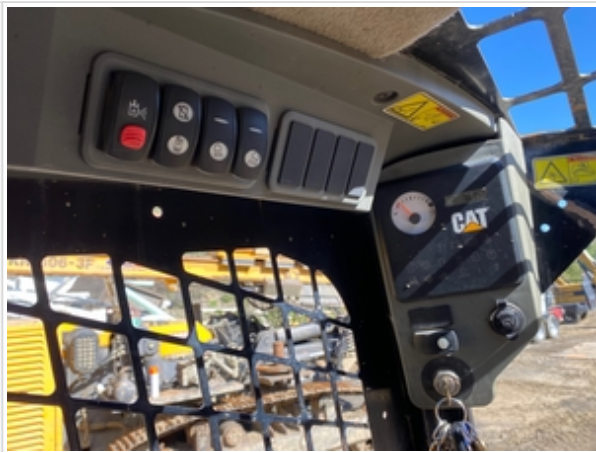
| Hour Meter Activity Photos | |

| Hour Meter Activity | 3 - Normal Wear & Tear | |
| Hour Meter Condition | Hour meter is functional and in good condition | |

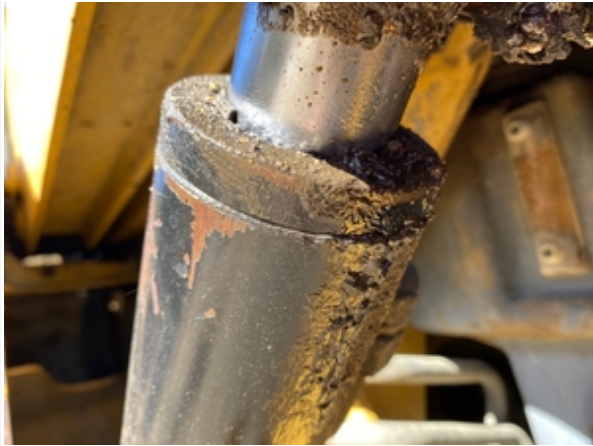
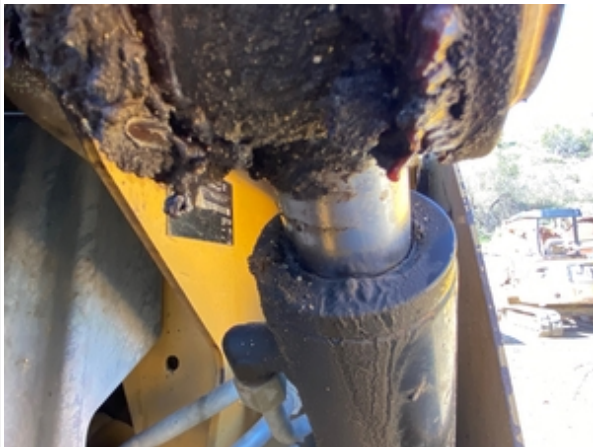
| Lift Cylinder & Mounting Pin Photos | |

| Lift Cylinder & Mounting Pin | 2 |
| Lift Cylinder: Oil Leaks | Yes |
| Comments | Both cylinders seeping out oil at rod seal |
