Inspection Report (Telehandler)

Year	2006
Make	Genie
Model	GTH-5519
Serial Number	14977
Hour Meter Reading	2,708
Previous Application (e.g., earth moving, mining, demolition, etc)	General Construction

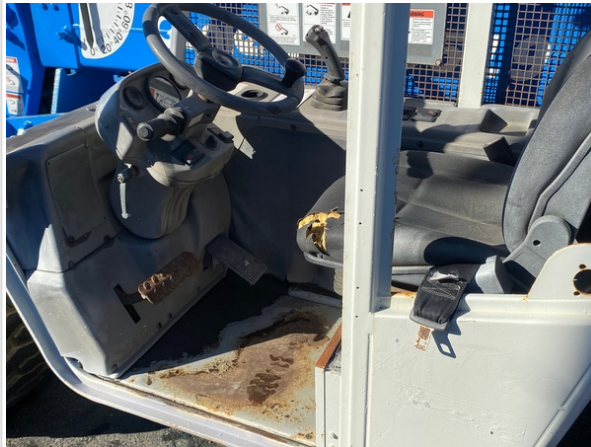
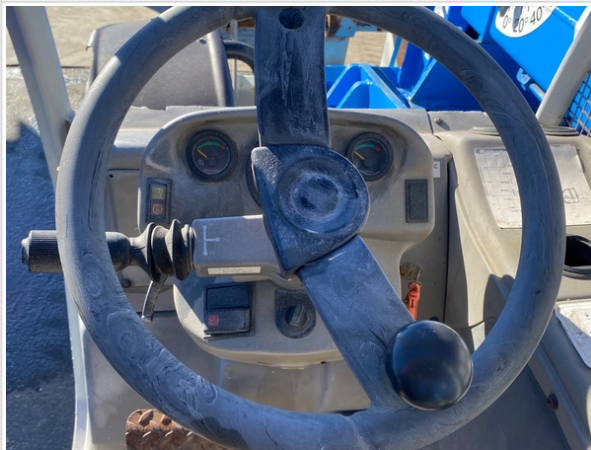
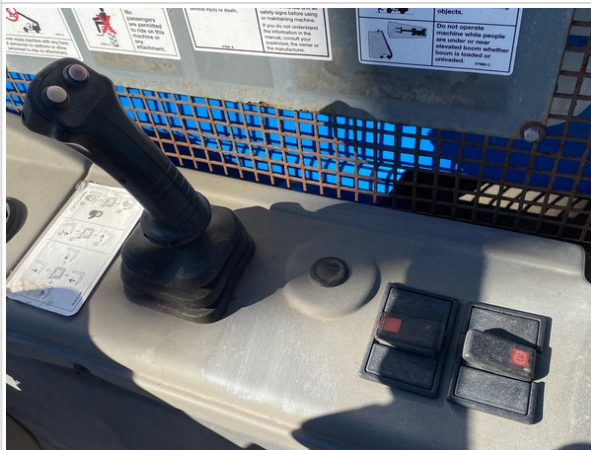
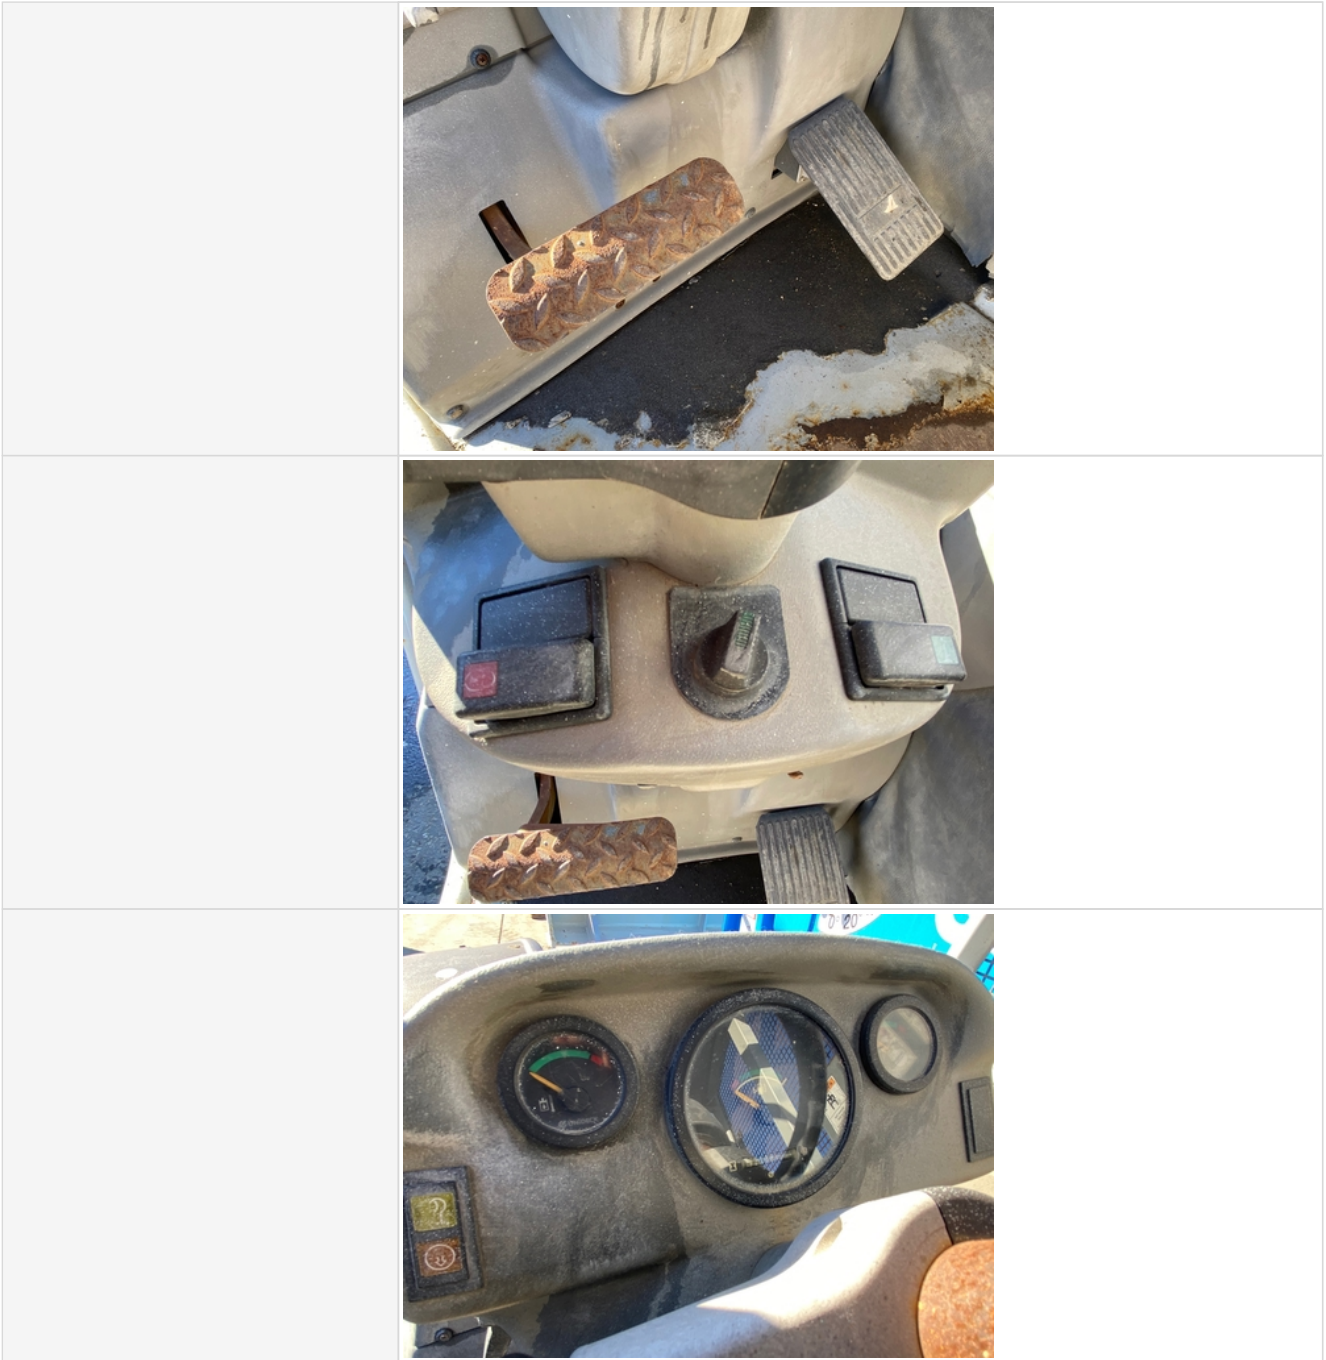
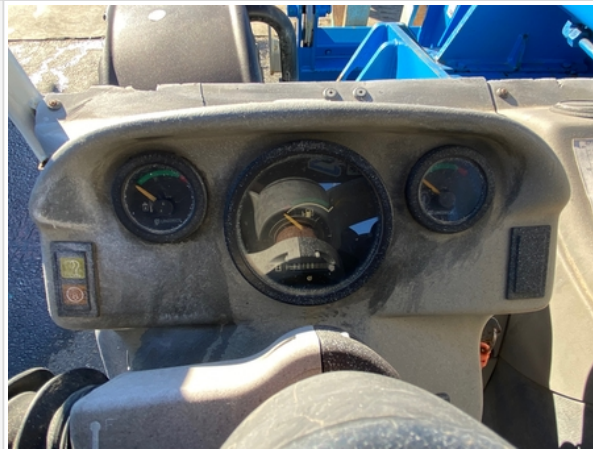
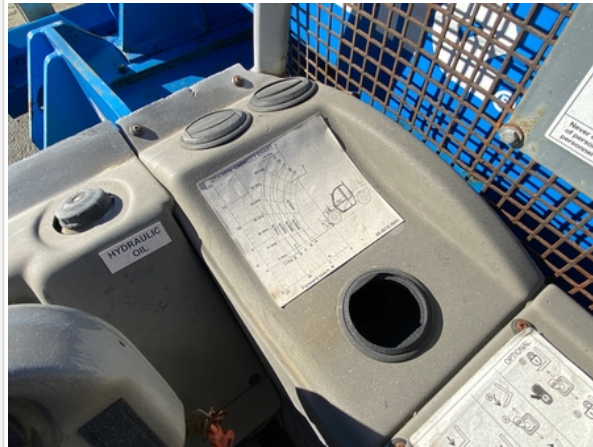
Operator Cabin Overall	3 - Normal Wear & Tear
Operator Cabin Overall Condition	Good cabin appearance, solid floors, panels, and ceiling, Minor cosmetic wear to cabin surfaces, floors, panels, and ceiling
Operator Seat	2 - Above Average Wear
Operator Seat Condition	Seat(s) in good condition, no stains or tears in upholstery, Seat(s) have minor surface staining or small tears
Cabin Lights	0
Safety Lock Out / Stop	3 - Normal Wear & Tear
Safety Lock Out / Stop Condition	Safety lock out device is present, in good condition, and functional
Controls & Switches	3 - Normal Wear & Tear
Controls & Switches Condition	All switches are installed and functional
Hour Meter Activity	3 - Normal Wear & Tear
Hour Meter Condition	Hour meter is functional and in good condition
Hour Meter Activity Photos

Exterior Rating	3 - Normal Wear & Tear
Interior Rating	3 - Normal Wear & Tear
Safety Rating	3 - Normal Wear & Tear
Quality Rating	3 - Normal Wear & Tear
Functionality Rating	3 - Normal, Operating as Expected
Overall Rating	3 - Normal Wear & Tear
What's Great About the Machine	Machine has low use hours for a 2006. Machine has been well kept and all functions operating well. No active leaks observed during the inspection. Tires are foam filled.
What Needs Work	Rear boom wear pads should be adjusted or replaced. Operator seat slightly worn.
Date/Time	02-06-2023

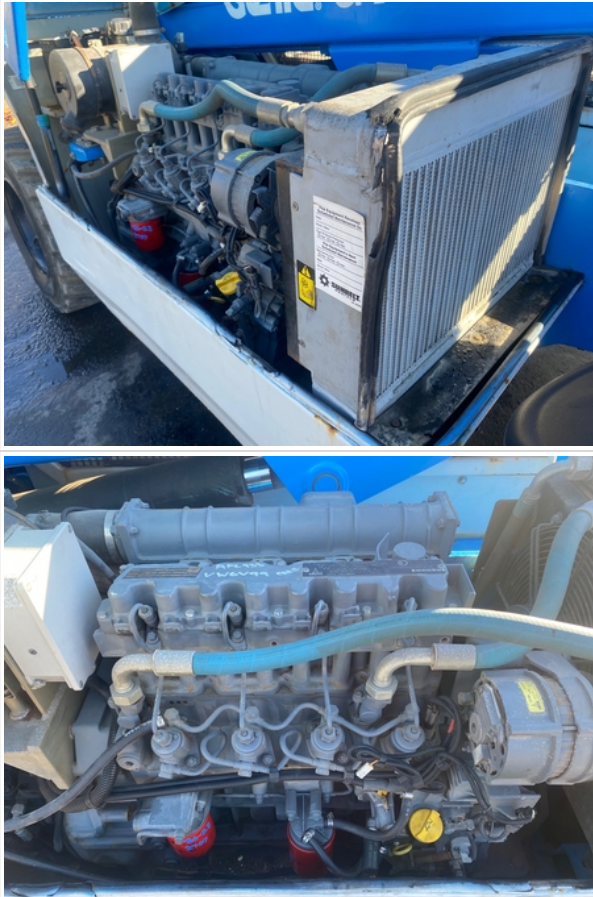
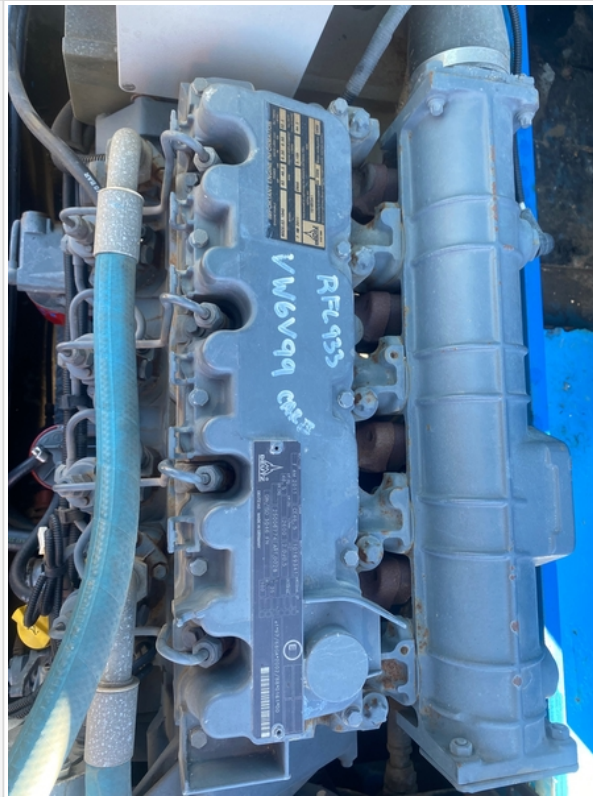
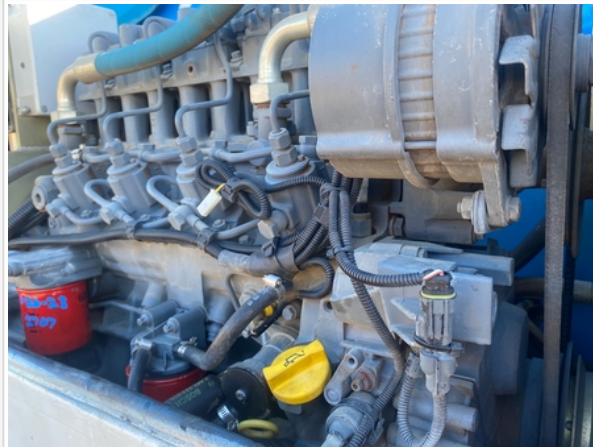
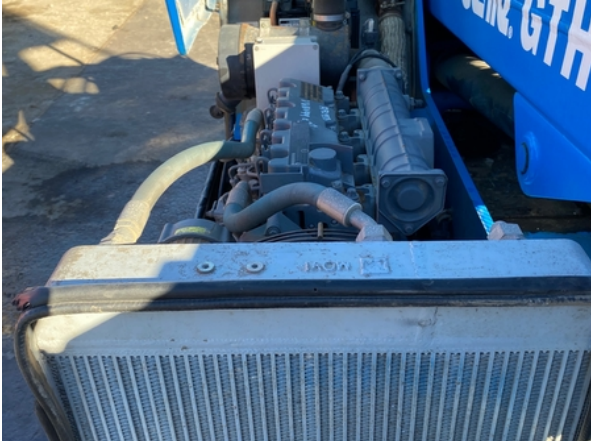
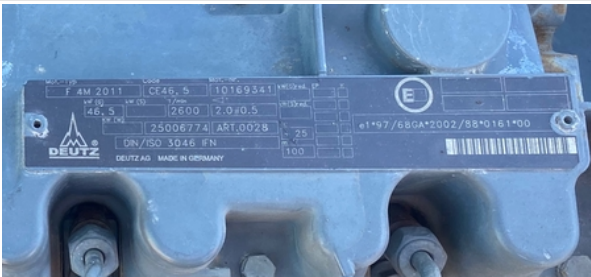
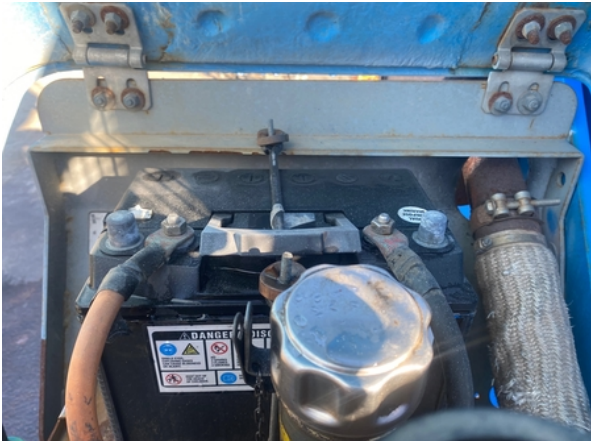
Blow-by (Visual Observation Check)	No
Unusual Noises (Upon Start-up, Idle, Shutdown)	No
Unusual Noise Notes	No unusual noises heard
Engine Smoke (Upon Start-up, Idle, Shutdown)	No
Engine Smoke Notes	No engine smoke issues observed
Engine Exhaust Color	Clear
Battery	3 - Normal Wear & Tear
Battery Condition	Clean & dry appearance, tight connections
Radiator	3 - Normal Wear & Tear

Radiator Condition	Radiator fins & components appear to be in good working order, no signs of damage or leaks
Belts	3 - Normal Wear & Tear
Belt Condition	Belts appear in good condition & alignment with proper tension
Hoses	3 - Normal Wear & Tear
Hose Condition	Firm, pliant hoses with no signs of wear or leaks
Water Pump	3 - Normal Wear & Tear
Water Pump Condition	No unusual pump noises heard
Cooling System Leaks	No
Coolant Color / Appearance	3 - Normal Wear & Tear
Coolant Color/Appearance Notes	Normal Translucent appearance, no visual signs of contamination
Oil Leaks	No
Oil Color / Appearance	3 - Normal Wear & Tear
Oil Color / Appearance Notes	Clean oil appearance, no signs of cross contamination, Appropriate oil level
Fuel Leaks	No
Requires DEF (Diesel Exhaust Fluid)	No
Overall Engine Appearance	Clean & dry
Overall Engine Comments	Engine In good condition. Fires right up, sounds healthy at idle and under load. Engine recently serviced.

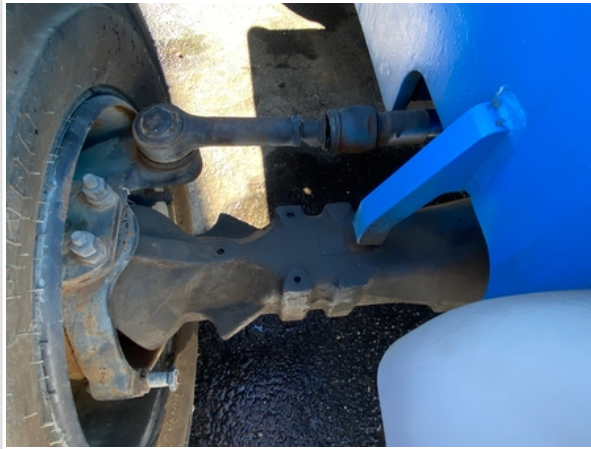
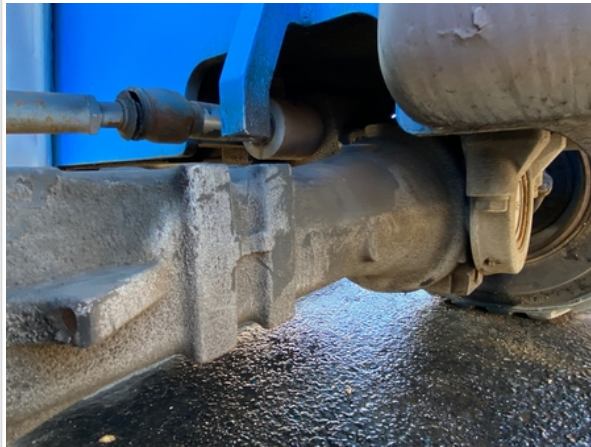
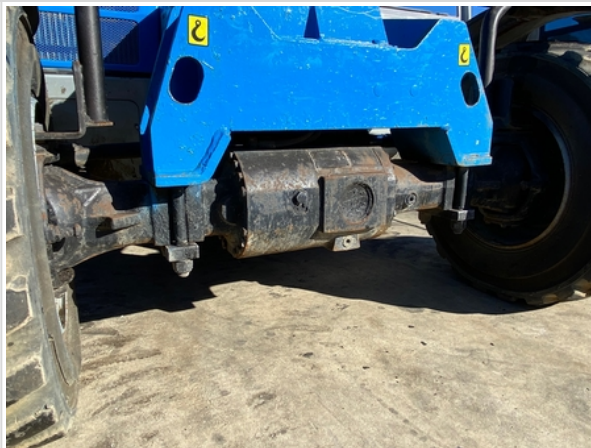
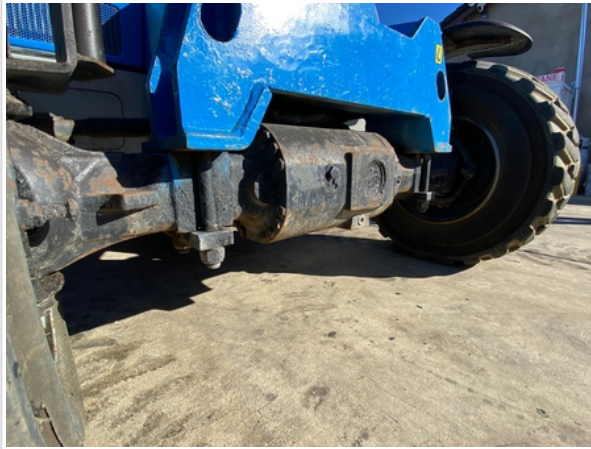
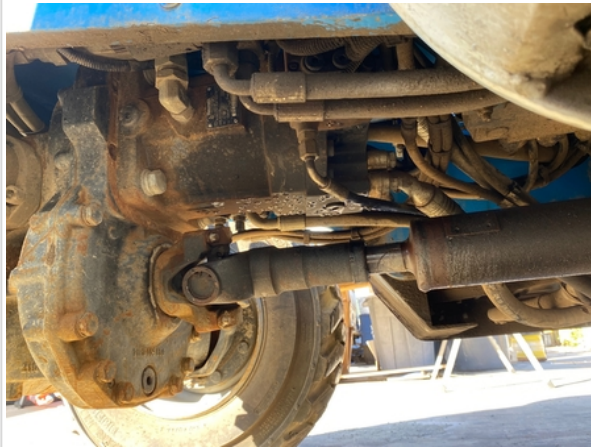
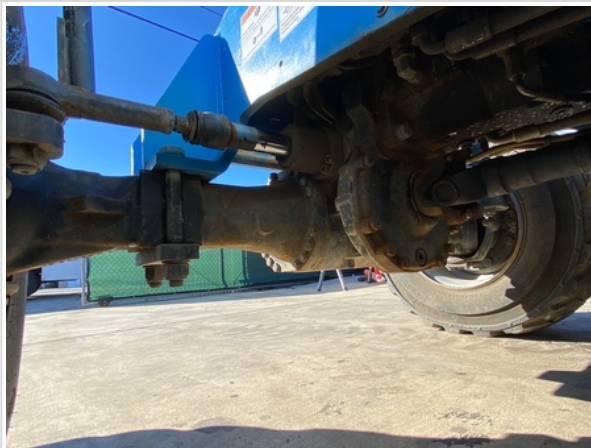
Hydrostatic Transmission?	Yes
2 Speed?	No
Hydrostatic Drive Configuration	Other (see comments)
Comments	Hydraulic Drive to 4x4 Transfer Case, 2 Axle Configuration
Drive Motors	0
Hydrostatic Parking Brake	3 - Normal Wear & Tear
Hydrostatic Parking Brake Condition	Good brake function
Overall Drivetrain Comments	Drivetrain in good looking condition with no active leaks observed during inspection.

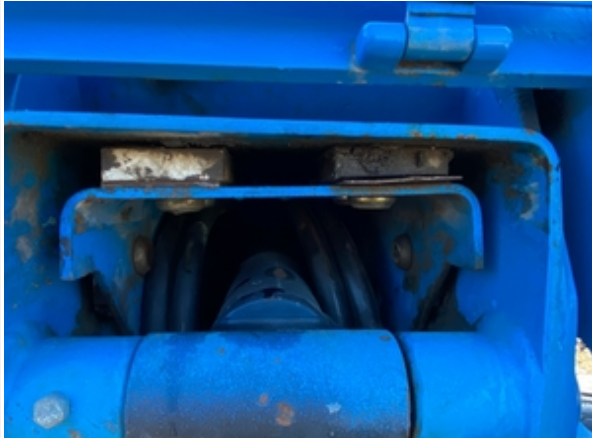
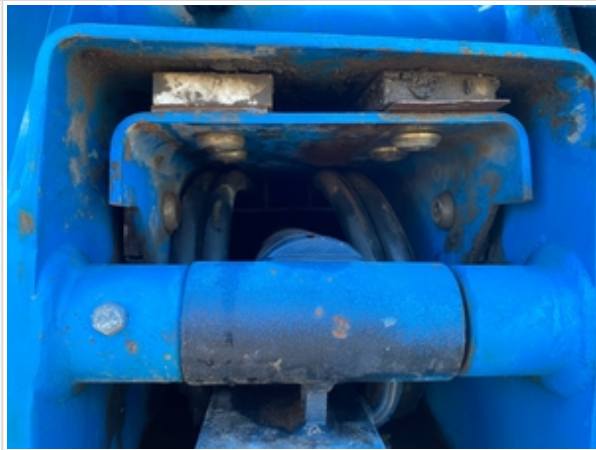
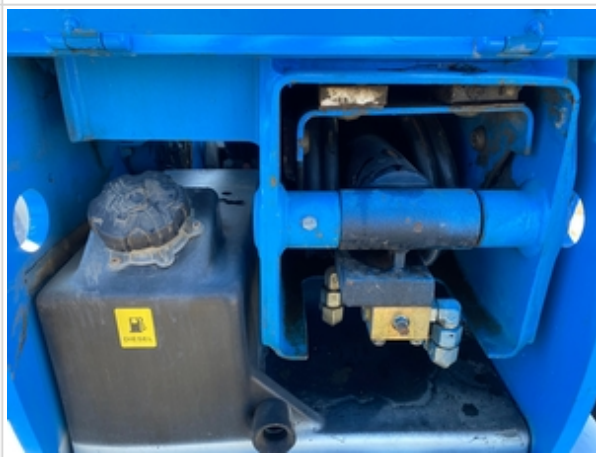
Chain / Tensioners	3 - Normal Wear & Tear	
Rollers & Guides	3 - Normal Wear & Tear	
Boom Wear Guides	2 - Above Average Wear	
Comments	Minor uneven wear at rear r/s of boom wear pads	
Boom Wear Guides Photos

Overall Chassis	3 - Normal Wear & Tear
Overall Chassis Comments	Chassis in good condition with only wear at rear pads observed as a minor wear item.

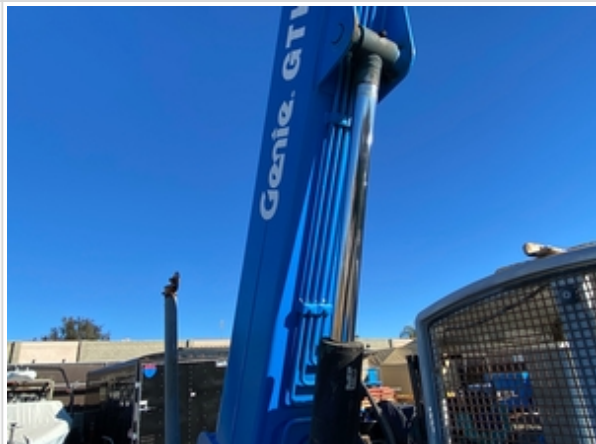
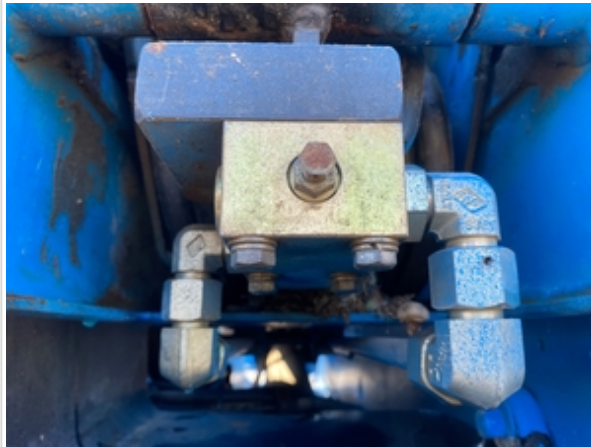
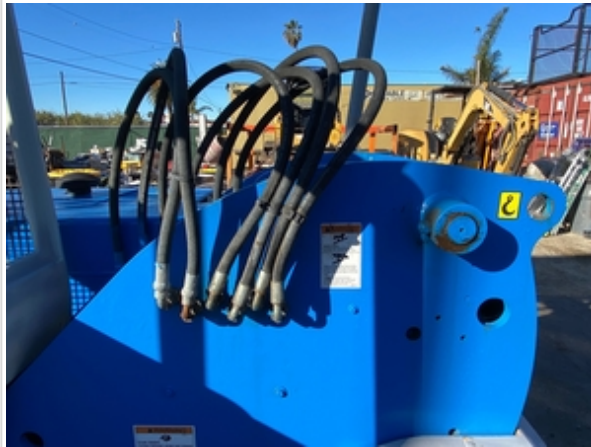
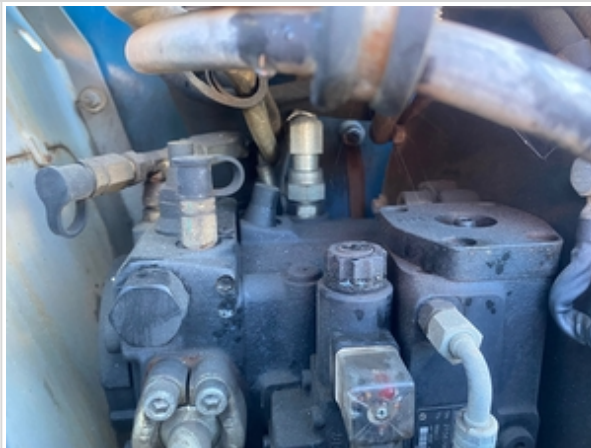
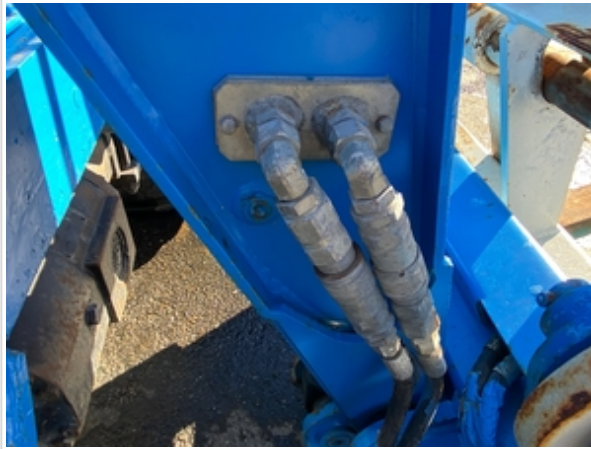
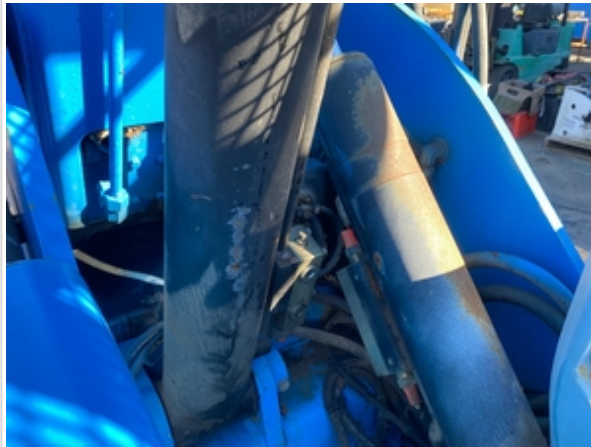
Wet or Damp Hydraulic Lines / Fittings	No
Appearance of Hydraulic Lines / Fittings	3 - Normal Wear & Tear
Hydraulic Lines / Fittings Condition	Hydraulic lines & fittings are clean and in good condition
Unusual Noises (Hydraulic Pump)	No
Hydraulic Pump Notes	No unusual noises heard during operation

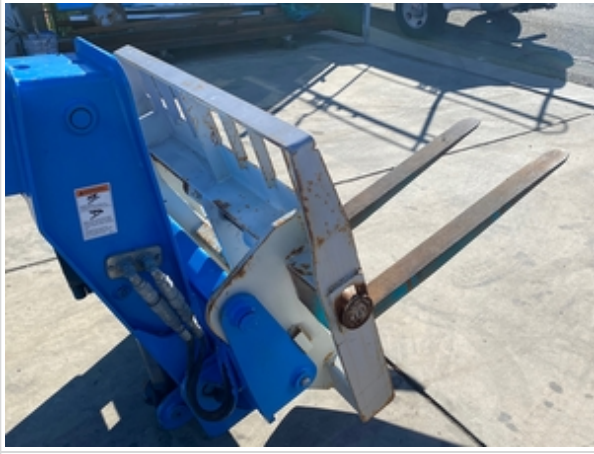
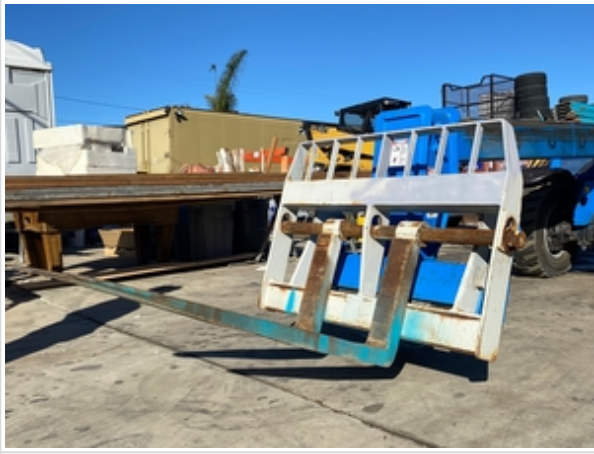
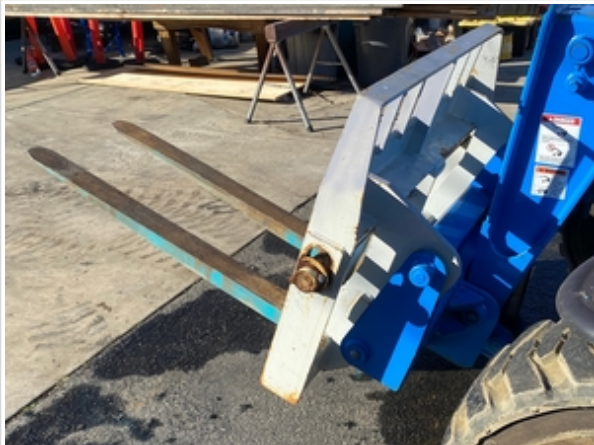
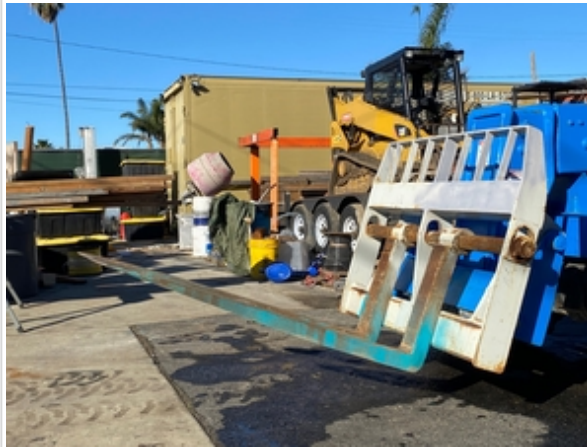
Forks / Work Tool Condition	3 - Normal Wear & Tear
Comments	L/S Fork Slightly Bent
Forks / Work Tool Photos
