Inspection Report (Wheel Loader)

Year	2011
Make	CAT
Model	938H
Serial Number	MJC01729
Hour Meter Reading	7,826
Previous Application (e.g., earth moving, mining, demolition, etc)	Erosion Control Construction

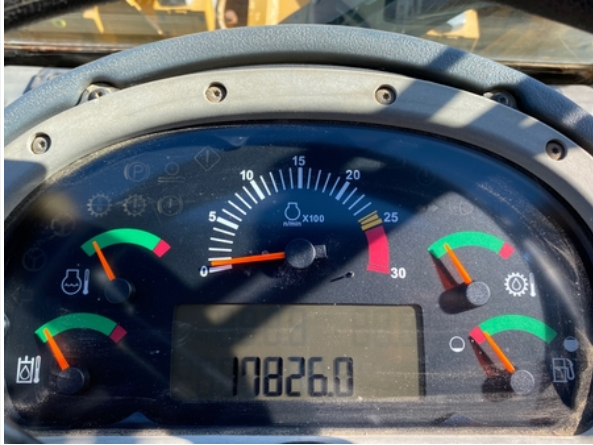
Hour Meter Activity Photos

Operator Cabin Overall	3 - Normal Wear & Tear
Operator Cabin Overall Condition	Good cabin appearance, solid floors, panels, and ceiling
Operator Seat	3 - Normal Wear & Tear
Operator Seat Condition	Seat(s) in good condition, no stains or tears in upholstery
Cabin Lights	3 - Normal Wear & Tear
Cabin Lights Condition	Cabin lights are installed with all light covers in place, bulbs are installed and working properly
Safety Lock Out / Stop	3 - Normal Wear & Tear
Safety Lock Out / Stop Condition	Safety lock out device is present, in good condition, and functional
Controls & Switches	3 - Normal Wear & Tear
Controls & Switches Condition	All switches are installed and functional
Hour Meter Activity	3 - Normal Wear & Tear
Hour Meter Condition	Hour meter is functional and in good condition

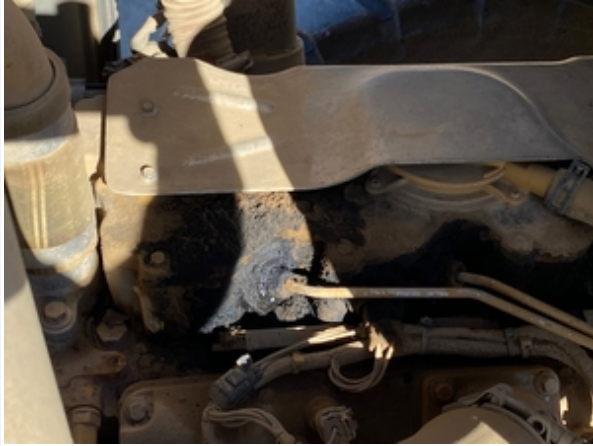
Water Pump	3 - Normal Wear & Tear
Water Pump Condition	No unusual pump noises heard
Cooling System Leaks	No
Coolant Color / Appearance	3 - Normal Wear & Tear
Coolant Color/Appearance Notes	Normal Translucent appearance, no visual signs of contamination
Oil Leaks	Yes
Oil Leak Notes	Wetness & discoloration observed, Other (see comments)
Oil Leak Photos

Oil Color / Appearance	3 - Normal Wear & Tear
Oil Color / Appearance Notes	Clean oil appearance, no signs of cross contamination, Appropriate oil level
Fuel Leaks	No
Requires DEF (Diesel Exhaust Fluid)	No
Overall Engine Appearance	Dusty & dry
Overall Engine Comments	Overall engine operated well under load and at idle. A few active leaks observed.

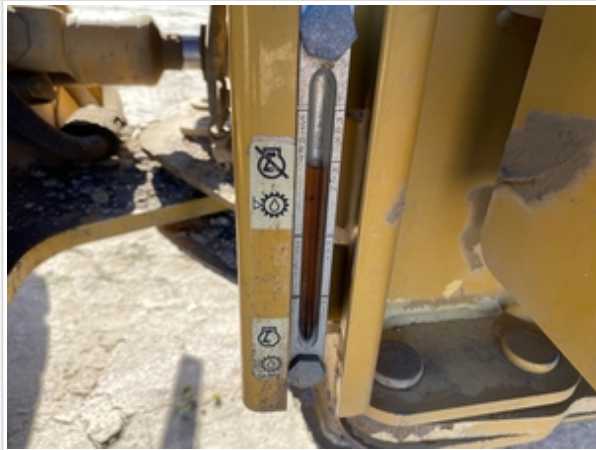
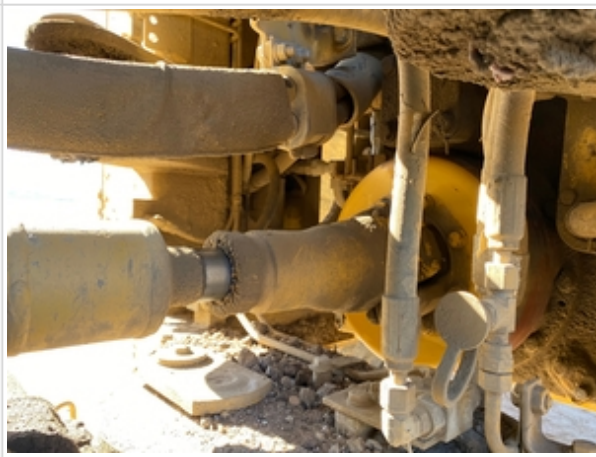
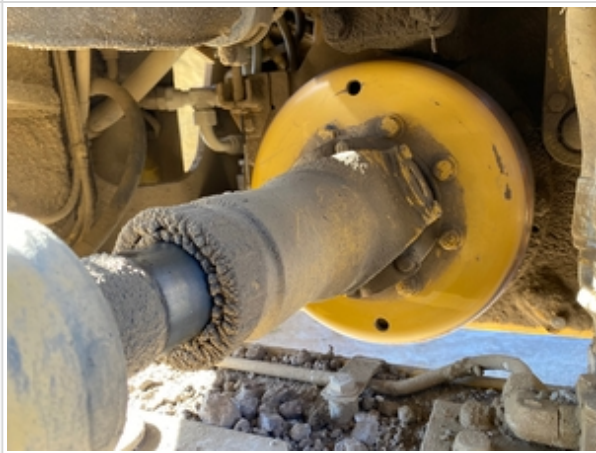
<p>Drivetrain Photos</p>

Hydrostatic Transmission?	No	
Transmission Info (Make/Model/Speeds)	Powershift 4 Speed	
Transmission	2 - Above Average Wear	
Transmission Condition	No unusual noises or vibrations, Other (see comments)	
Comments	Minor active leaks observed around transmission	
Clutch	0	
Shift Lever	3 - Normal Wear & Tear	
Shift Lever Condition	Good forward and reverse function	
Foot Brake	3 - Normal Wear & Tear	
Foot Brake Condition	Good brake function	
Inching Brake	3 - Normal Wear & Tear	
Inching Brake Condition	Good brake function	
Parking Brake	3 - Normal Wear & Tear	
Parking Brake Condition	Good brake function	
Overall Drivetrain Comments	Overall Drivetrain has good working appearance. Minor leaks observed at transmission. Operator worked machine through forward and reverse gears onsite and no abnormalities observed during the inspection.

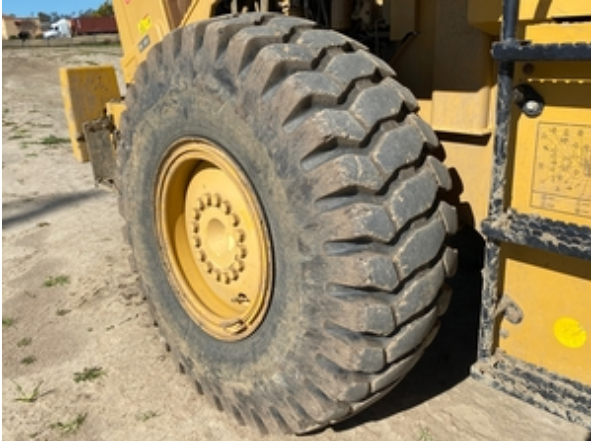
Rear Right Tire - Ratio Remaining	30%
Rear Right Tire Photos

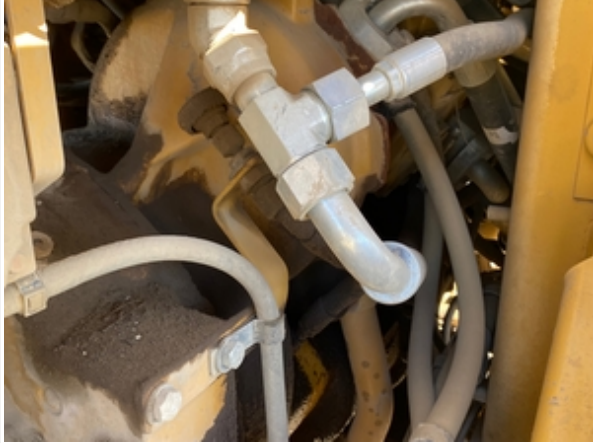
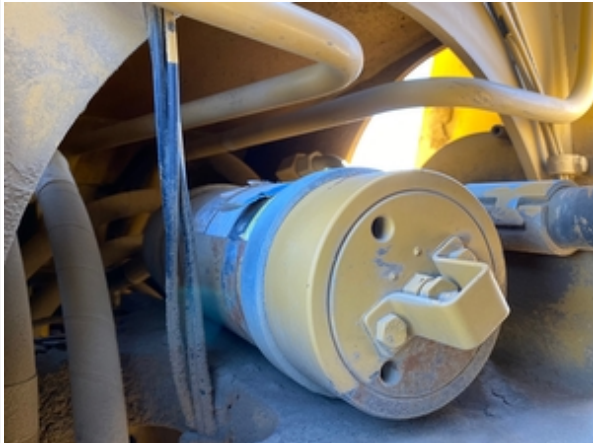
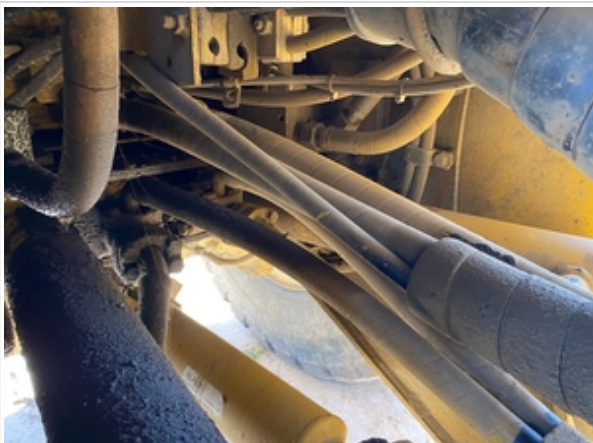
Wet or Damp Hydraulic Lines / Fittings	Yes
Appearance of Hydraulic Lines / Fittings	3 - Normal Wear & Tear
Hydraulic Lines / Fittings Condition	Hydraulic lines & fittings are clean and in good condition
Unusual Noises (Hydraulic Pump)	No
Hydraulic Pump Notes	No unusual noises heard during operation

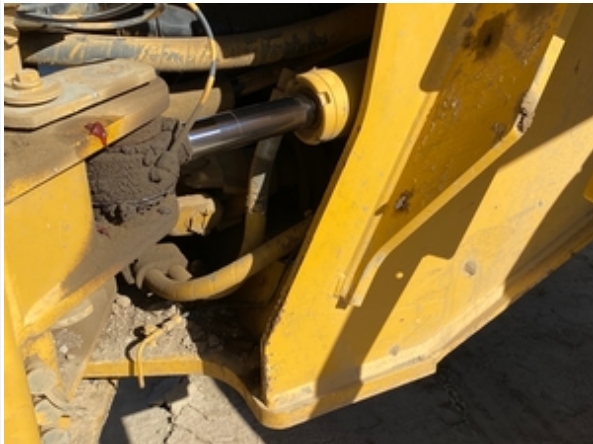
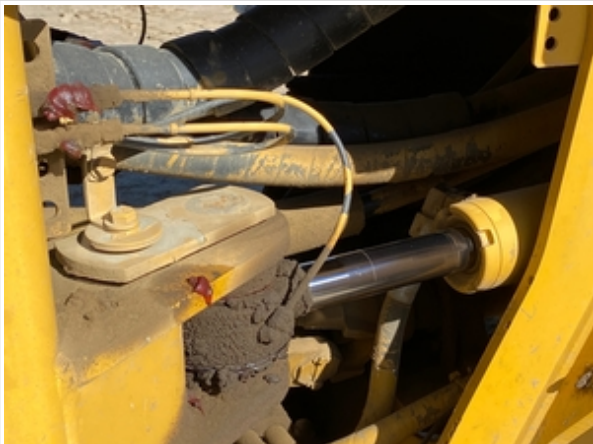
Steering Cylinder	Check the steering cylinder. Note any wear, pitting, discoloration, etc. Take photos.	
Steering Cylinder: Mounting Pin	3	
Steering Cylinder: Oil Leaks	Yes	
Comments	Minor seepage at left side steer rod seal	
Steering Cylinder Photos
