Inspection Report (Compact Track Loader)

Year	2015
Make	Bobcat
Model	T740
Serial Number	B3CA11018
Hour Meter Reading	2,281
Previous Application (e.g., earth moving, mining, demolition, etc)	Masonry General Construction

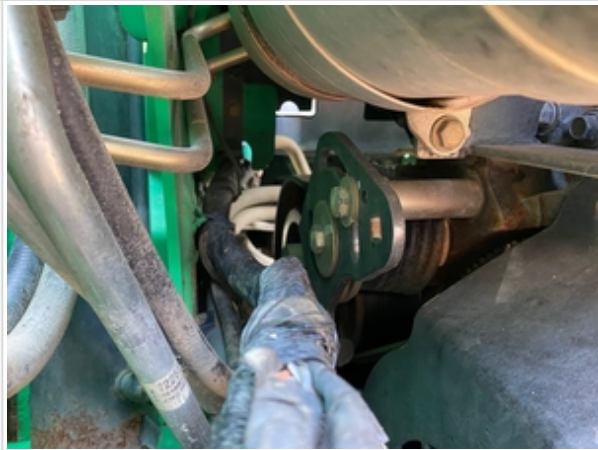
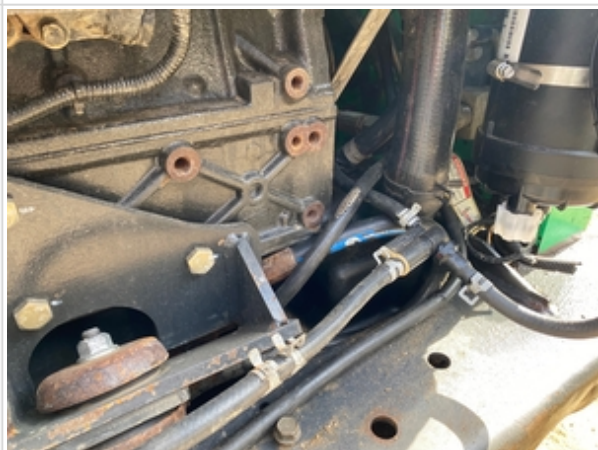
Blow-by (Visual Observation Check)	No	
Unusual Noises (Upon Start-up, Idle, Shutdown)	Yes	
Unusual Noise Notes	No unusual noises heard, Other (see comments)	
Comments	Starter solenoid not engaging (intermittently) causing starter motor to spin and not turnover engine	
Engine Smoke (Upon Start-up, Idle, Shutdown)	No	
Engine Smoke Notes	No engine smoke issues observed	
Engine Exhaust Color	Clear	
Battery	3 - Normal Wear & Tear	
Battery Condition	Like new, recently replaced	
Radiator	3 - Normal Wear & Tear	
Radiator Condition	Radiator fins & components appear to be in good working order, no signs of damage or leaks	
Belts	3 - Normal Wear & Tear	
Belt Condition	Belts appear in good condition & alignment with proper tension	
Hoses	3 - Normal Wear & Tear

Hose Condition	Firm, pliant hoses with no signs of wear or leaks
Water Pump	3 - Normal Wear & Tear
Water Pump Condition	No unusual pump noises heard
Cooling System Leaks	No
Coolant Color / Appearance	3 - Normal Wear & Tear
Coolant Color/Appearance Notes	Normal Translucent appearance, no visual signs of contamination
Oil Leaks	No
Oil Color / Appearance	3 - Normal Wear & Tear
Oil Color / Appearance Notes	Clean oil appearance, no signs of cross contamination, Appropriate oil level
Fuel Leaks	No
Requires DEF (Diesel Exhaust Fluid)	No
Overall Engine Appearance	Clean & dry
Overall Engine Comments	Engine sounds healthy at idle and under load. No leaks observed and engine appearance in well maintained condition. Only small issue is starter starting to fail intermittently and will not engage to turn engine.

Overall Assessment	
Exterior Rating	3 - Normal Wear & Tear
Interior Rating	3 - Normal Wear & Tear
Safety Rating	3 - Normal Wear & Tear
Quality Rating	3 - Normal Wear & Tear
Functionality Rating	3 - Normal, Operating as Expected
Overall Rating	3 - Normal Wear & Tear
What's Great About the Machine	This compact track loader is in well maintained condition all the way around. No major active leaks observed and machine operating normal. The tracks are like new with over 80% of track tread left.
What Needs Work	Starter needs to be further inspected but may be as simple as replacing it.
Date/Time	02-16-2023

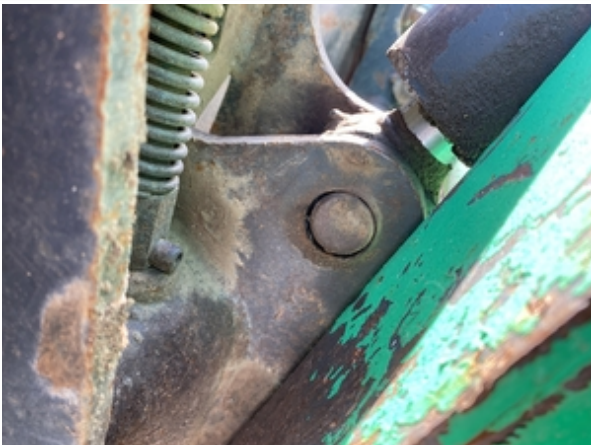
Frame	3 - Normal Wear & Tear
Stance	3 - Normal Wear & Tear
Lift Arm	3 - Normal Wear & Tear
Chassis to Arm Pins	3 - Normal Wear & Tear
Quick Coupler	3 - Normal Wear & Tear
Quick Coupler to Arms Pins	2 - Above Average Wear
Comments	Minor wear at bucket cylinder to quick coupler pin bores
Quick Coupler to Arms Pins Photos

Overall Chassis	3 - Normal Wear & Tear
Overall Chassis Comments	Overall chassis in good condition with Normal wear observed throughout the implements. Some excess play seen in front bucket coupler to cylinder pins.

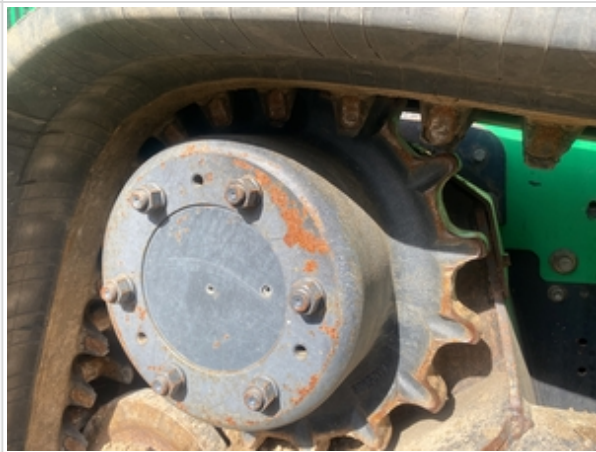
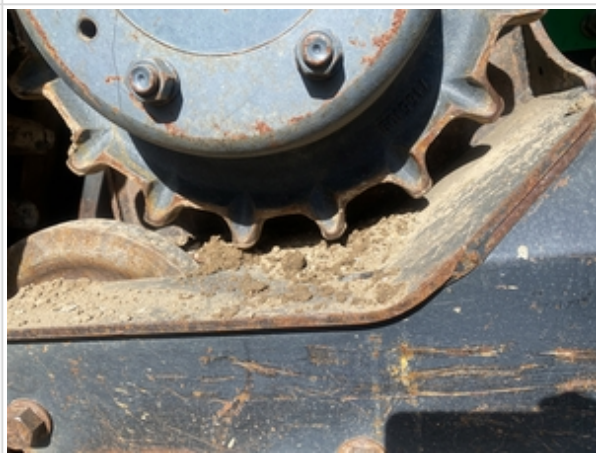
Sprockets	3 - Normal Wear & Tear	
Comments	Normal wear on sprocket for the hours	
Sprockets Photos

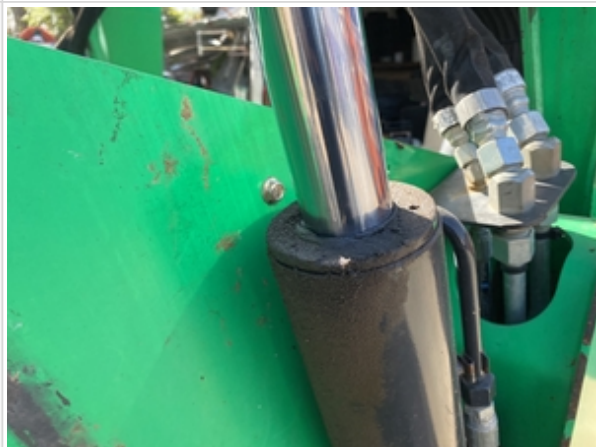
Lift Cylinder	Check the lift cylinder. Note any wear, pitting, discoloration, etc. Take photos.
Lift Cylinder & Mounting Pin	3
Lift Cylinder: Oil Leaks	Yes
Comments	Both lift cylinders showing signs of minor leakage at rod seals
Lift Cylinder & Mounting Pin Photos

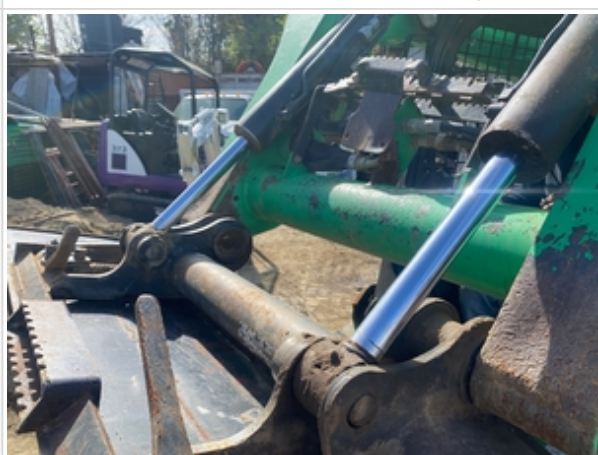
Bucket Cylinder	Check the bucket cylinder. Note any wear, pitting, discoloration, etc. Take photos.	
Bucket Cylinder & Mounting Pin	3	
Bucket Cylinder: Oil Leaks	No	
Comments	No active leaks observed, left side bucket cylinder has signs of seepage buildup	
Bucket Cylinder & Mounting Pin Photos

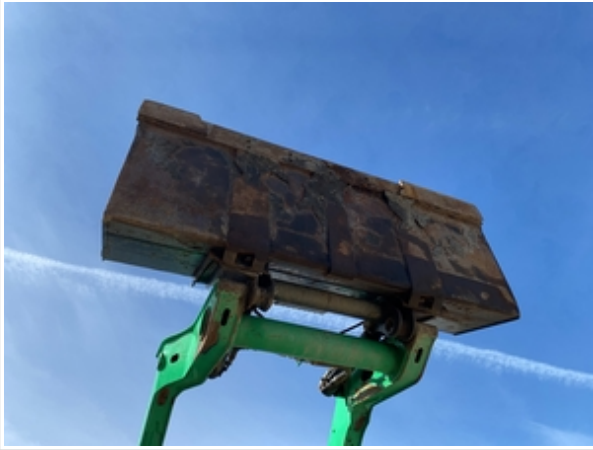
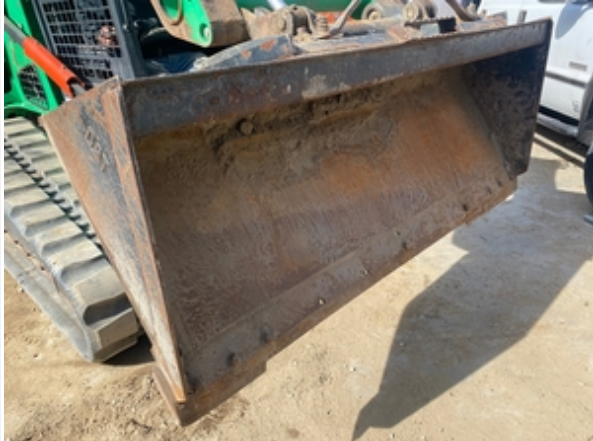
Bucket	3 - Normal Wear & Tear
Comments	Bucket slightly worn more in bottom front center area
Bucket Photos

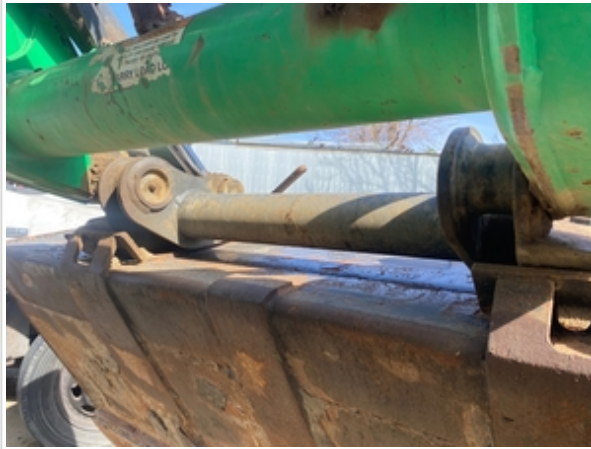
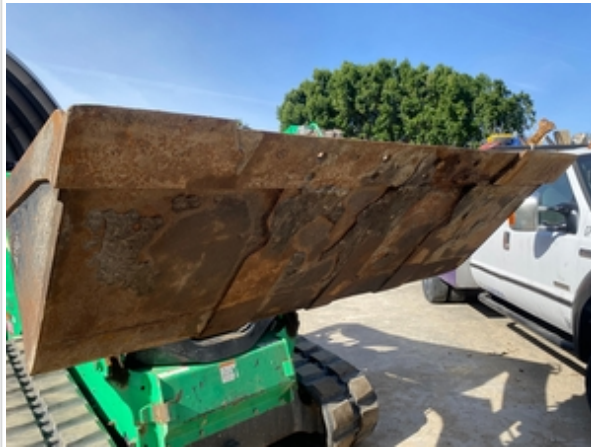
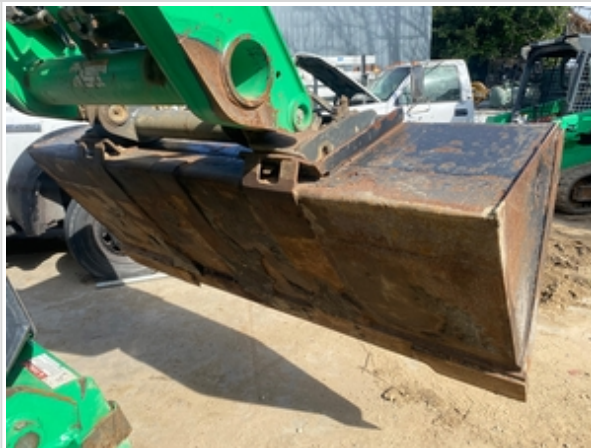
Bucket Edge / Deflectors	3 - Normal Wear & Tear
Comments	Cutting edge broken at center and should be replaced
