Inspection Report (Compact Track Loader)

Year	2016
Make	Bobcat
Model	T550
Serial Number	AJZV15768
Hour Meter Reading	2,366
Previous Application (e.g., earth moving, mining, demolition, etc)	masonry general construction

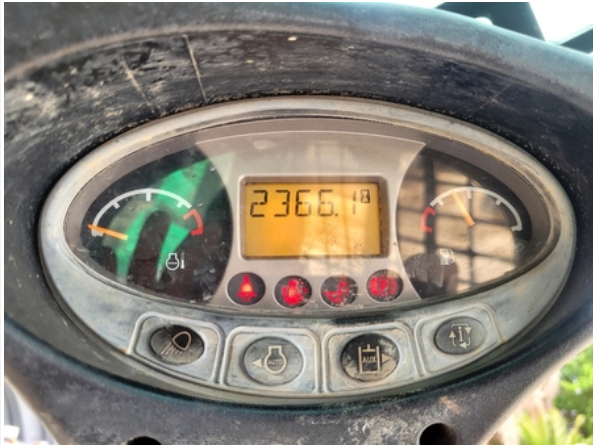
Controls & Switches	3 - Normal Wear & Tear
Controls & Switches Condition	All switches are installed and functional
Hour Meter Activity	3 - Normal Wear & Tear
Hour Meter Condition	Hour meter is functional and in good condition
Hour Meter Activity Photos

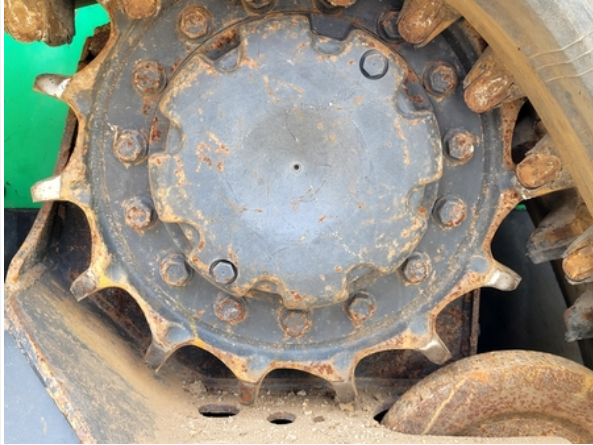
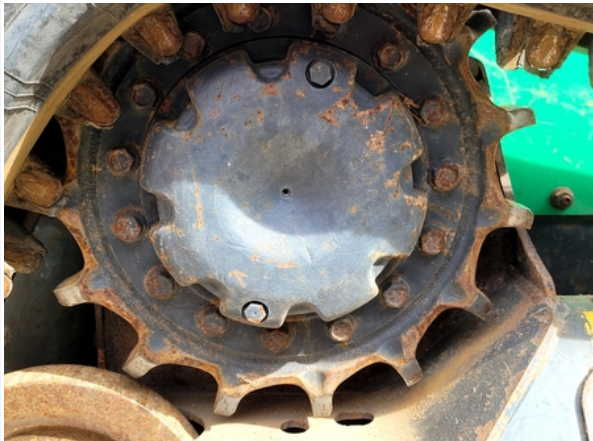
Hydrostatic Transmission?	Yes
2 Speed?	Yes
Hydrostatic Drive Configuration	Split Transmission
Drive Motors	2 - Above Average Wear
Hydrostatic Parking Brake	3 - Normal Wear & Tear
Hydrostatic Parking Brake Condition	Good brake function
Overall Drivetrain Comments	Overall drivetrain in solid condition. Tracks about 50 to 60% of life left.

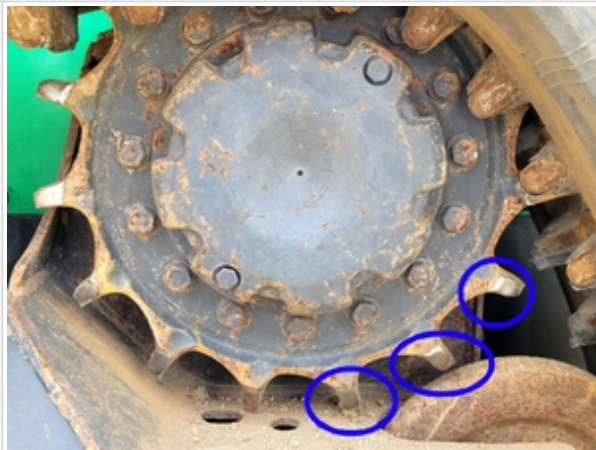
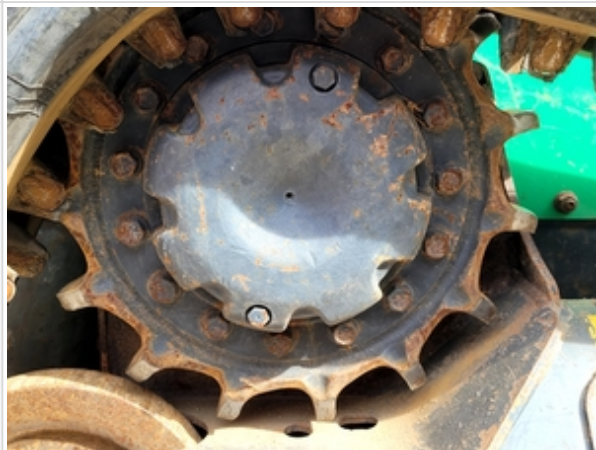
Sprockets	3 - Normal Wear & Tear
Comments	sprockets worn down in relation to hours worked (noticeable where sprockets meet drive lugs on tracks)
Sprockets Photos

<p data-bbox="531 931 1129 976">sprockets will need to be replaced soon for optimal performance</p>

Overall Assessment	
Exterior Rating	3 - Normal Wear & Tear
Interior Rating	3 - Normal Wear & Tear
Safety Rating	3 - Normal Wear & Tear
Quality Rating	3 - Normal Wear & Tear
Functionality Rating	3 - Normal, Operating as Expected
Overall Rating	3 - Normal Wear & Tear
What's Great About the Machine	All core functions work great and machine is well maintained inside and out.
What Needs Work	Some cylinders need to be resealed soon. Sprockets segments need to be replaced soon.
Date/Time	02-16-2023

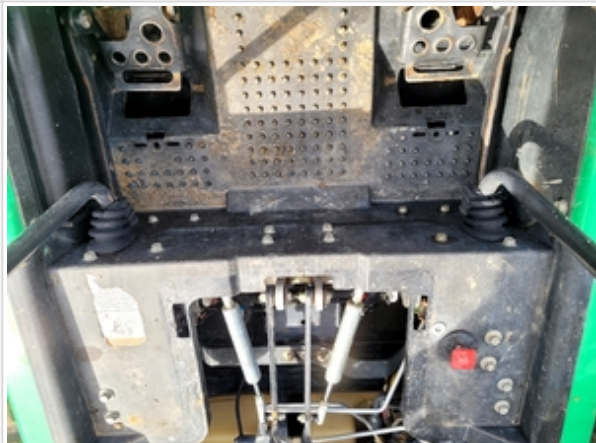
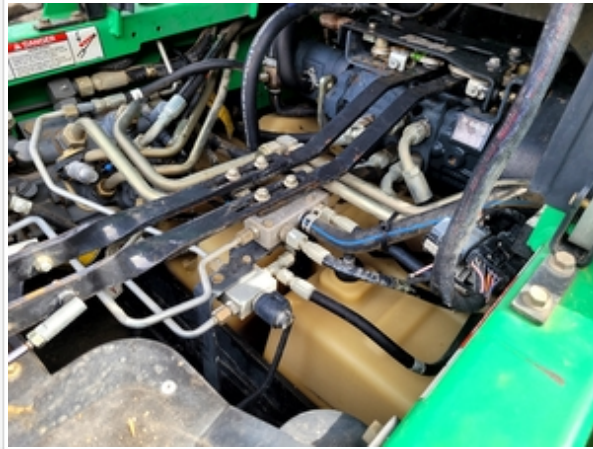
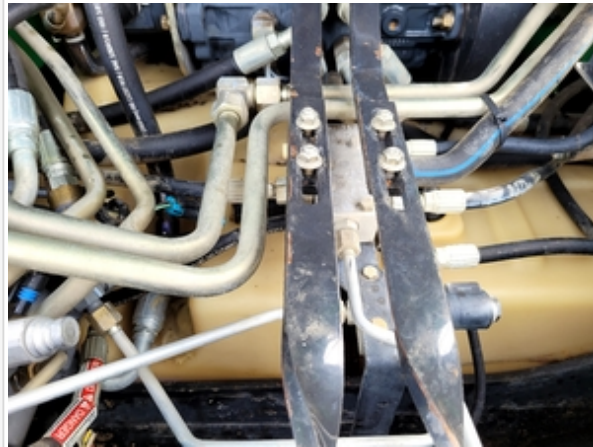
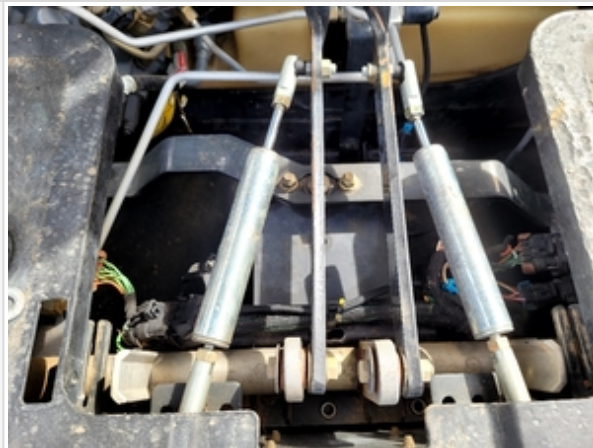
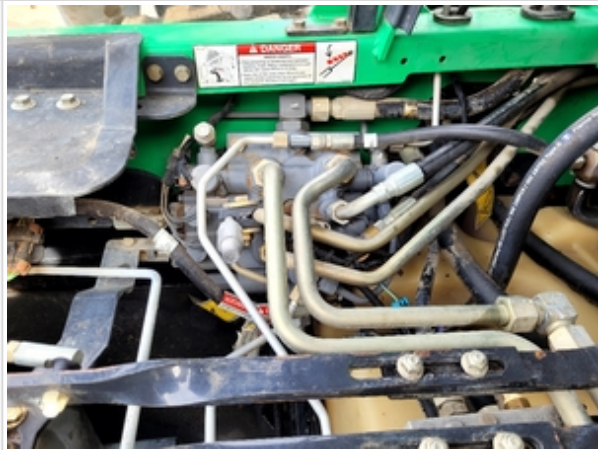
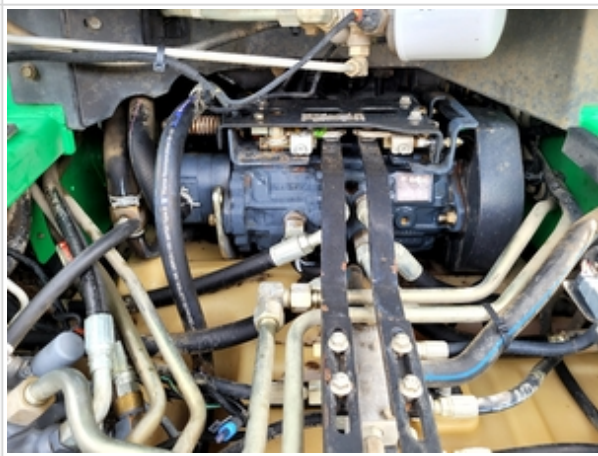
Wet or Damp Hydraulic Lines / Fittings	No	
Appearance of Hydraulic Lines / Fittings	3 - Normal Wear & Tear	
Hydraulic Lines / Fittings Condition	Hydraulic lines & fittings are clean and in good condition	
Unusual Noises (Hydraulic Pump)	No	
Hydraulic Pump Notes	No unusual noises heard during operation	
Comments	Hydraulics are In solid condition with no active leaks seen.

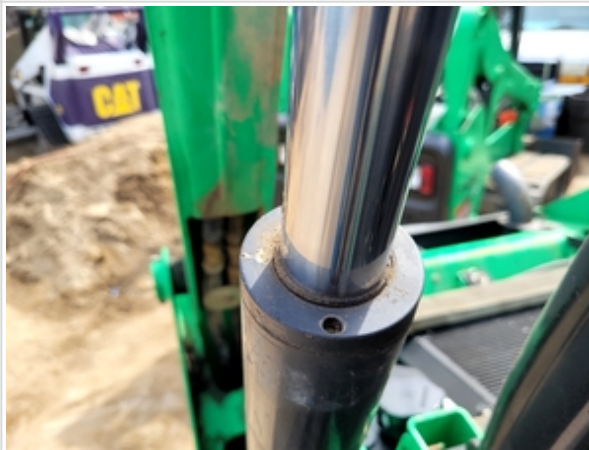
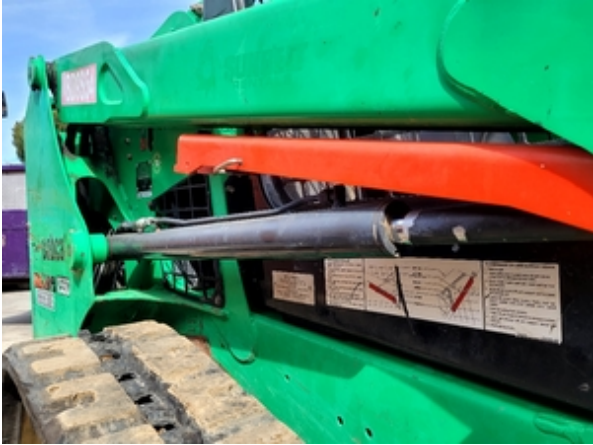
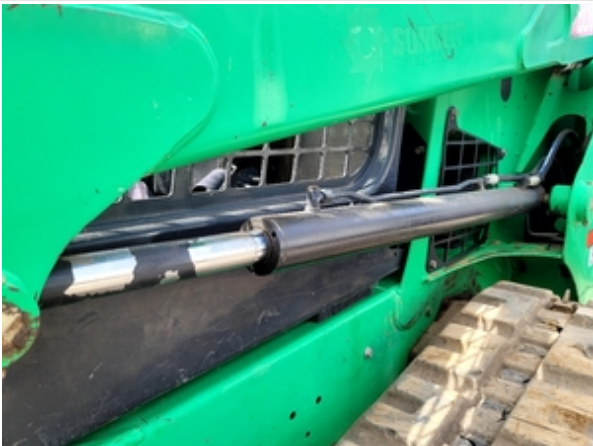
Lift Cylinder & Mounting Pin
Photos

Lift Cylinder	Check the lift cylinder. Note any wear, pitting, discoloration, etc. Take photos.	
Lift Cylinder & Mounting Pin	3	
Lift Cylinder: Oil Leaks	Yes	
Comments	left side cylinder leaking at rid seal

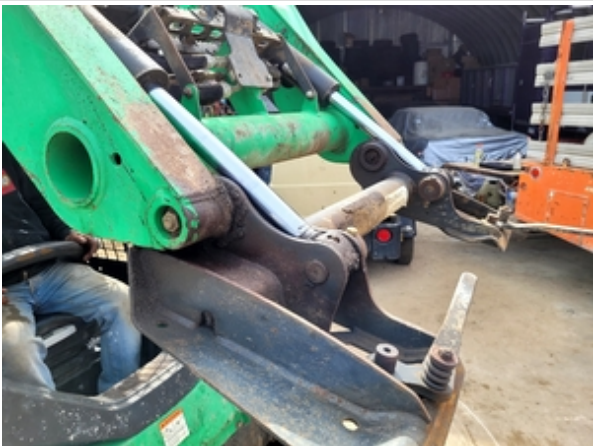
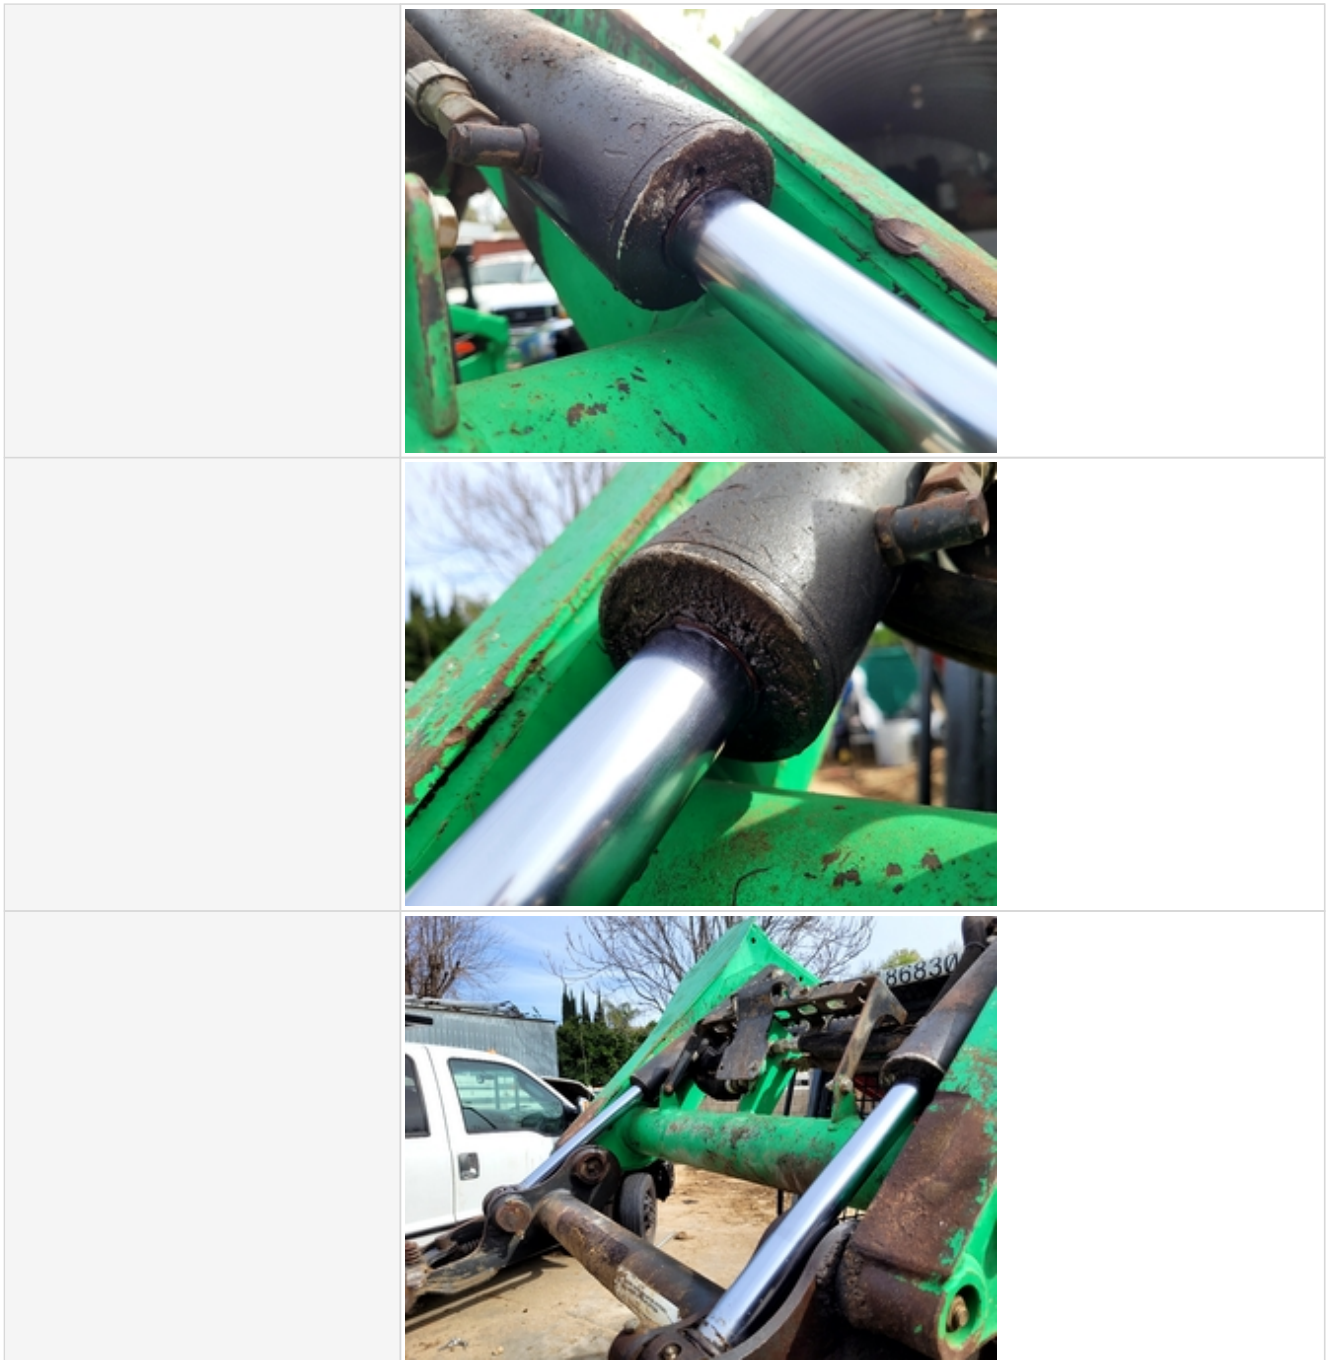
Bucket Cylinder	Check the bucket cylinder. Note any wear, pitting, discoloration, etc. Take photos.	
Bucket Cylinder & Mounting Pin	3	
Bucket Cylinder: Oil Leaks	No	
Comments	bucket cylinders not leaking but showing signs of seepage at rod seals	
Bucket Cylinder & Mounting Pin Photos
