Inspection Report (Skid Steer)

Year	2017
Make	CAT
Model	236D
Serial Number	BGZ02819
Hour Meter Reading	842 Hours
Previous Application (e.g., earth moving, mining, demolition, etc)	Masonry General Construction

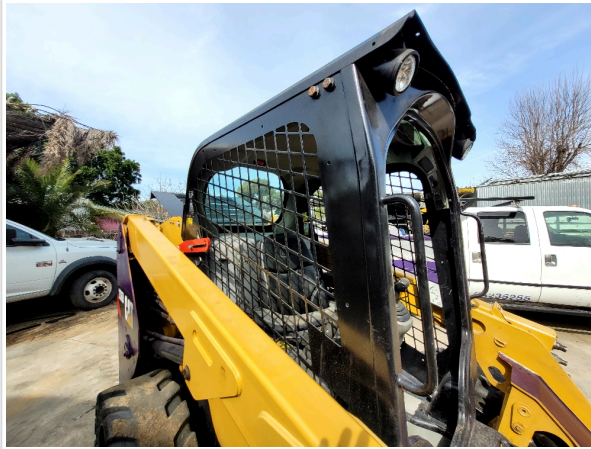
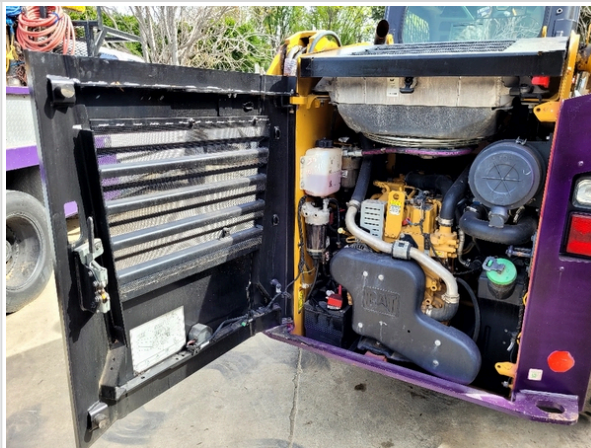
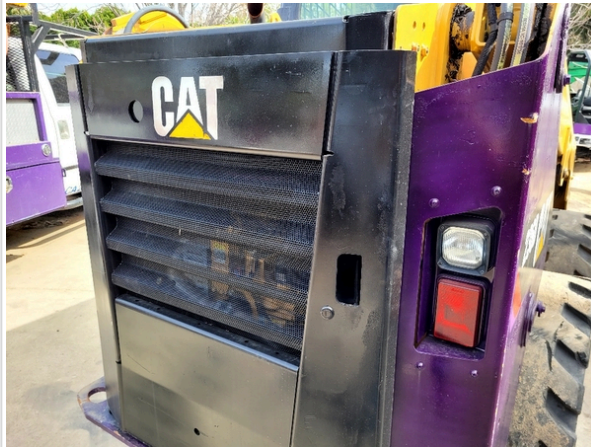
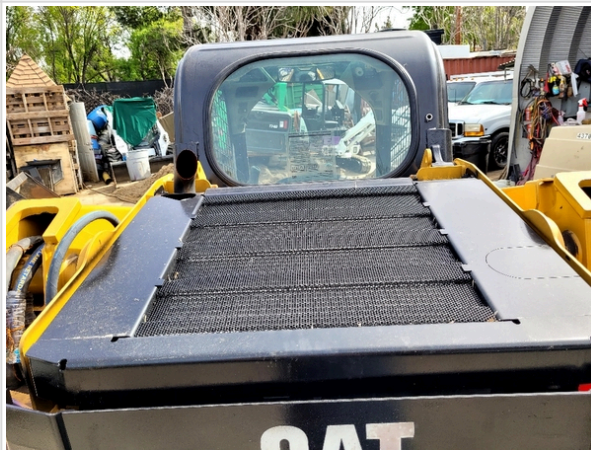
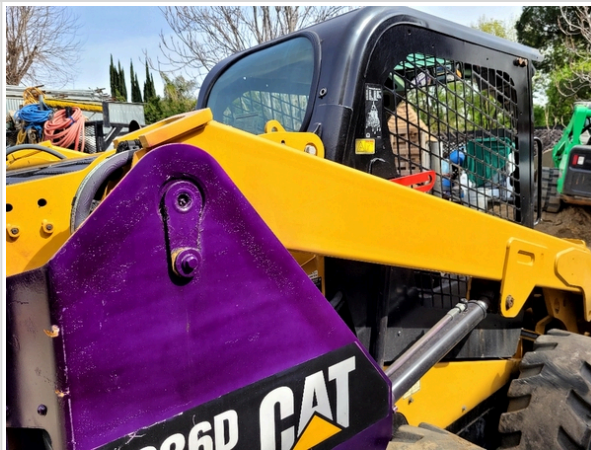
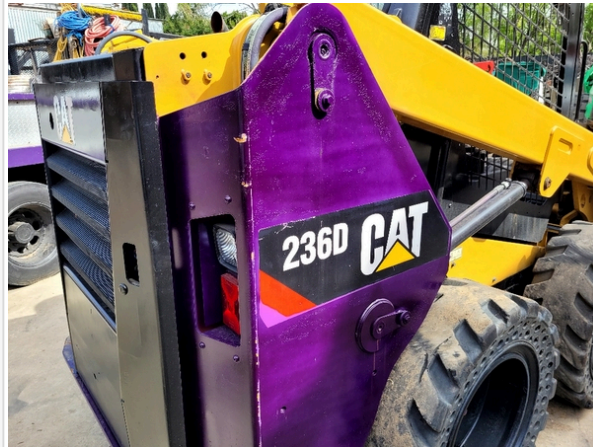
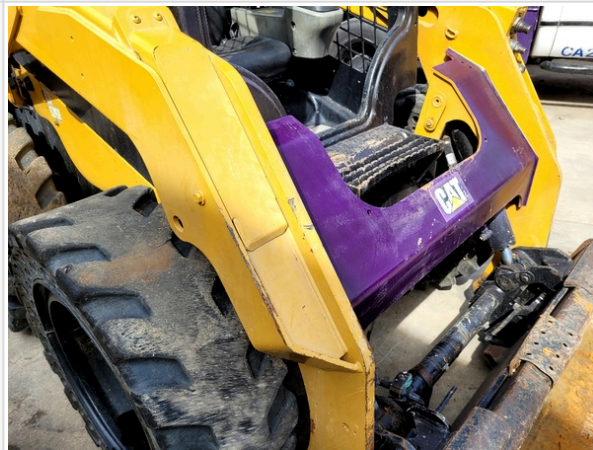
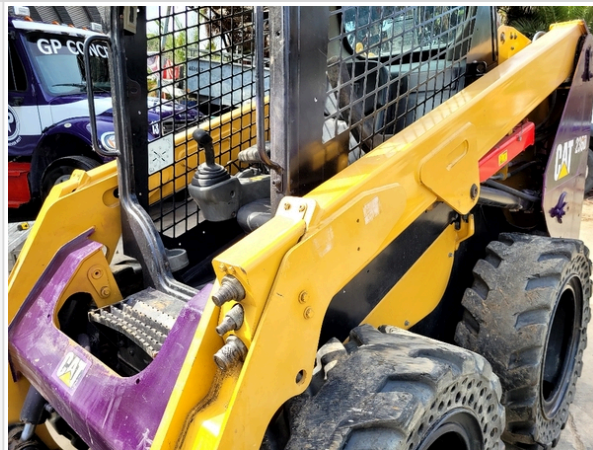
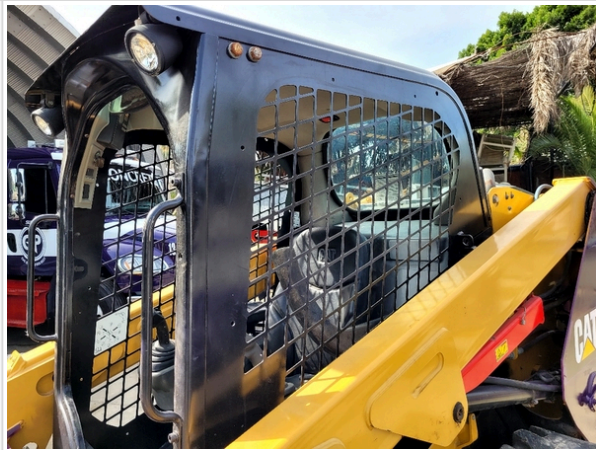
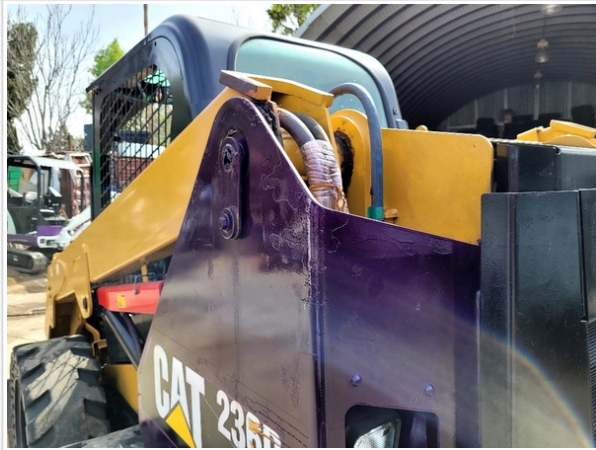
Close-up Exterior Photos

Body Panels	3 - Normal Wear & Tear
Body Panel Condition	No visible damage, good paint condition and panel fitment
Doors / Canopy Latches	3 - Normal Wear & Tear
Doors / Canopy Latches Condition	No visible damage
Steps / Ladders	3 - Normal Wear & Tear
Steps / Ladders Condition	Steps/ladders are fully intact and appear structurally sound
Handrails	3 - Normal Wear & Tear
Handrails Condition	Handrails are fully intact and appear structurally sound
Glass	3 - Normal Wear & Tear
Glass Condition	Glass intact, no visible damage
Mirrors	3 - Normal Wear & Tear
Mirror Condition	Mirrors present and intact, no visible damage
Exterior Lights	3 - Normal Wear & Tear
Exterior Lights Condition	No visible damage, lighting system is operational

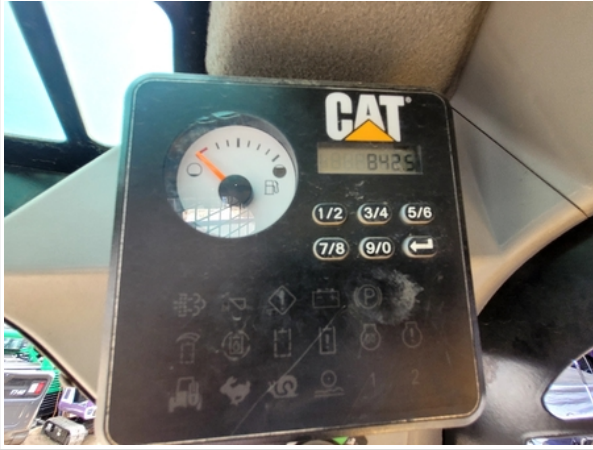
Safety Lock Out / Stop Condition	Safety lock out device is present, in good condition, and functional
Controls & Switches	3 - Normal Wear & Tear
Controls & Switches Condition	All switches are installed and functional
Hour Meter Activity	3 - Normal Wear & Tear
Hour Meter Condition	Hour meter is functional and in good condition
Hour Meter Activity Photos

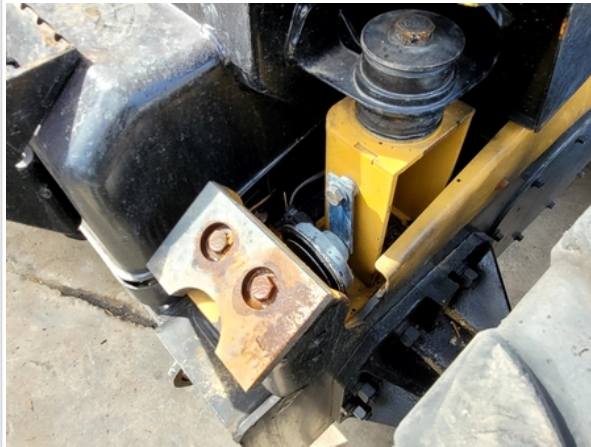
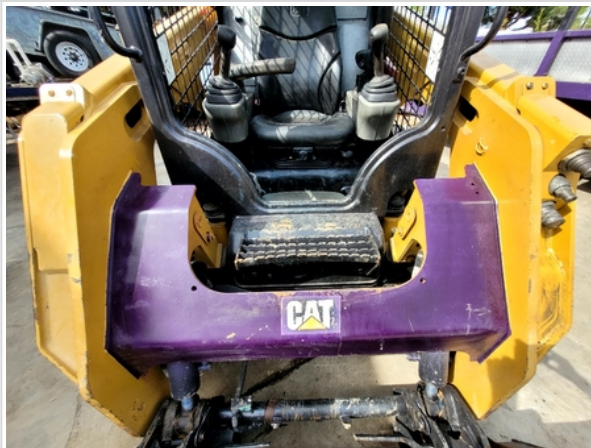
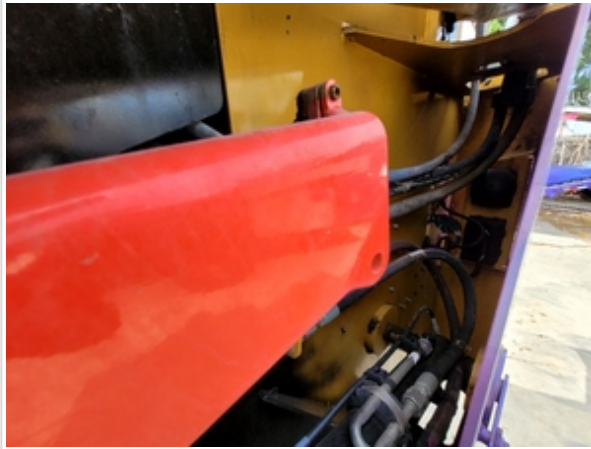
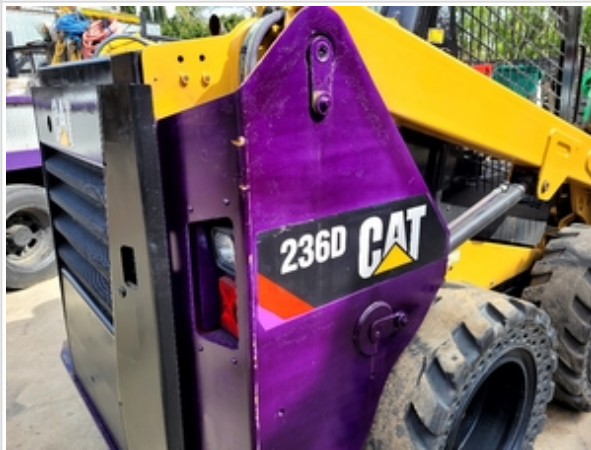
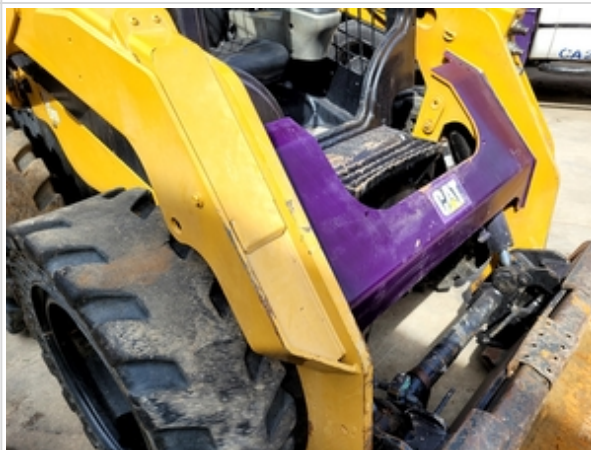
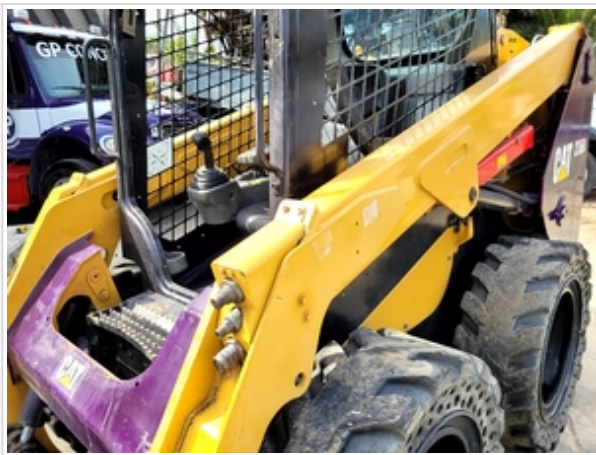
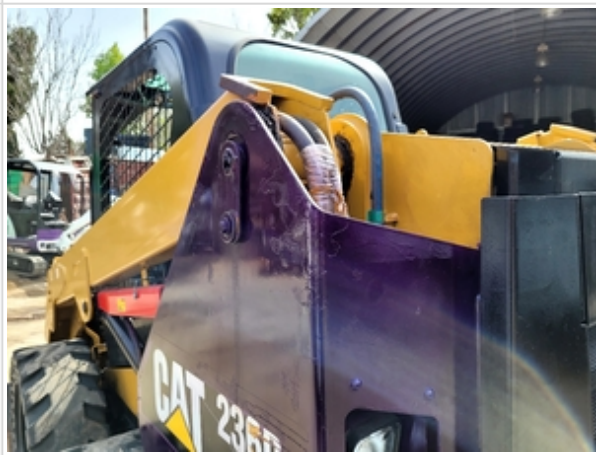
Frame Photos

Frame	3 - Normal Wear & Tear
-------	------------------------

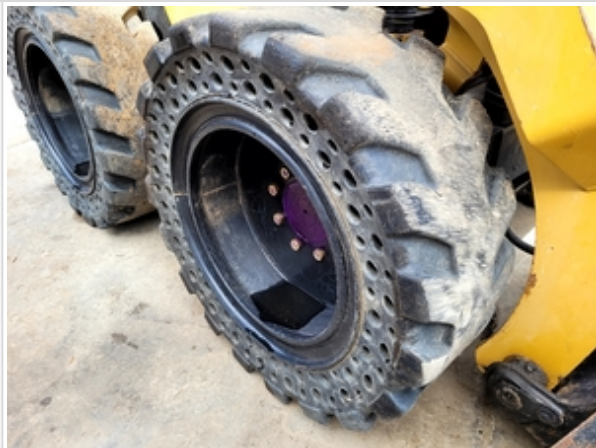
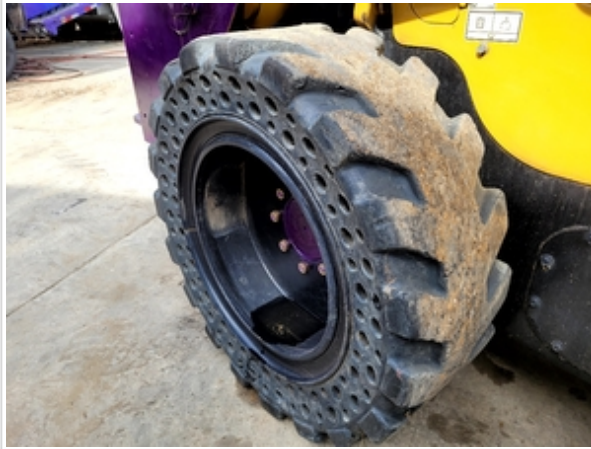
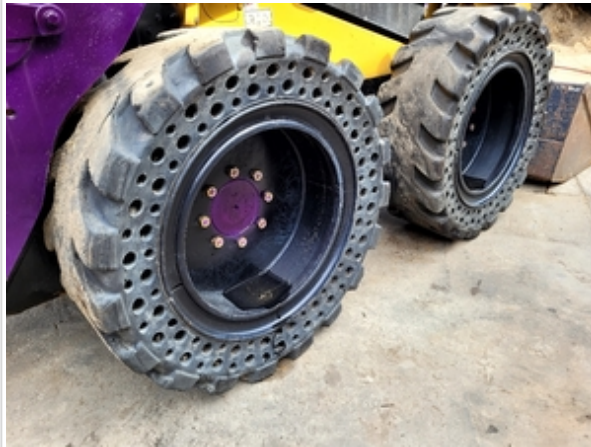
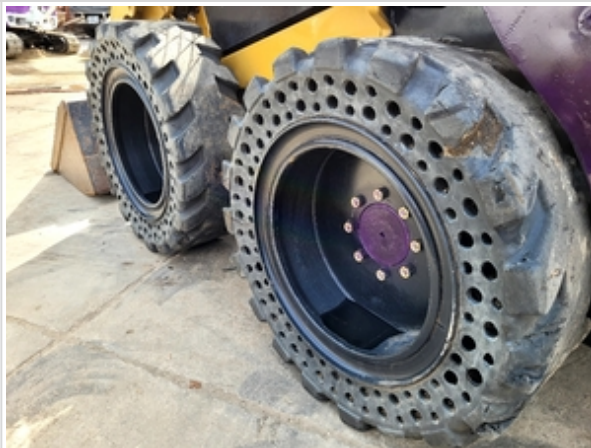
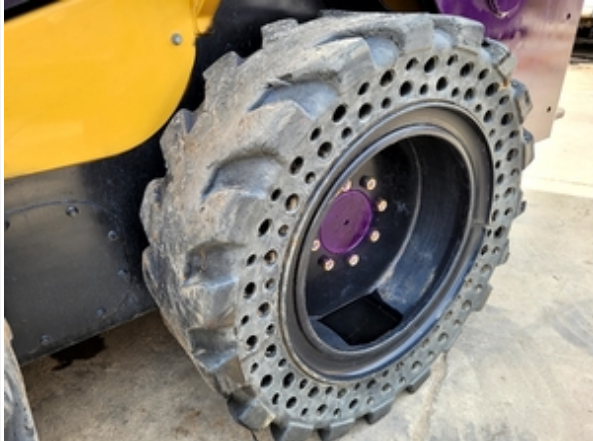
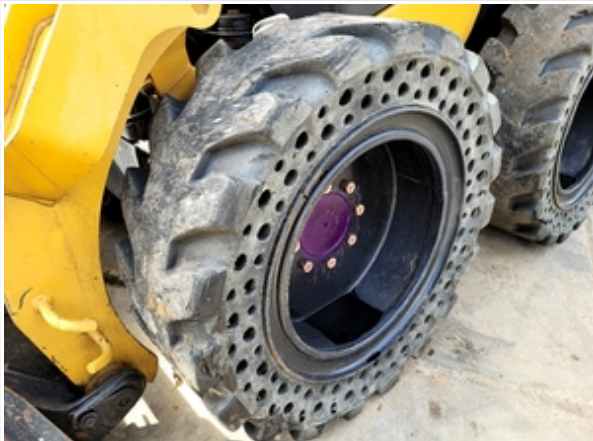
Stance	3 - Normal Wear & Tear	
Wheels & Tires	3 - Normal Wear & Tear	
Comments	Tires are solid rubber	
Wheels & Tires Photos

Tire Brand	N/A
Tire Size	N/A
Front Left Tire - Ratio Remaining	30%
Rear Left Tire - Ratio Remaining	30%
Front Right Tire - Ratio Remaining	30%
Rear Right Tire - Ratio Remaining	30%
Lift Arm	3 - Normal Wear & Tear
Lift Arm Photos

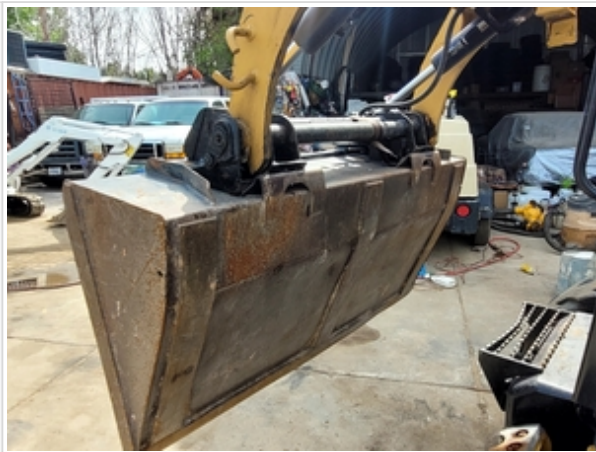
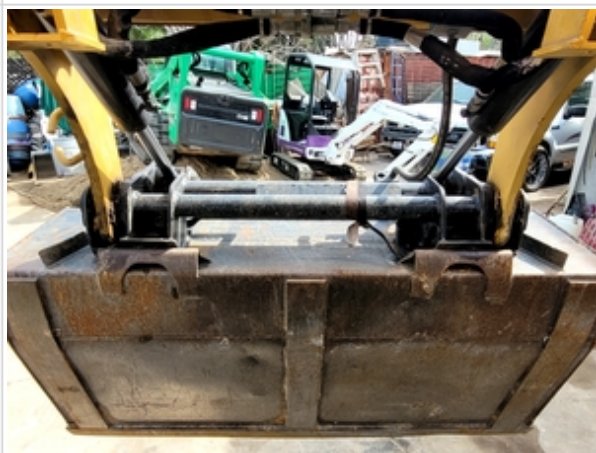
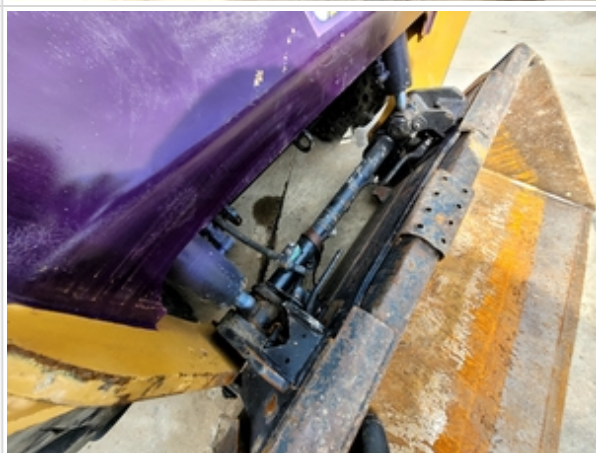
Quick Coupler Photos

Quick Coupler to Arms Pins	3 - Normal Wear & Tear
Overall Chassis	3 - Normal Wear & Tear
Overall Chassis Comments	Overall Chassis in good shape and no obvious issues observed during the inspection.

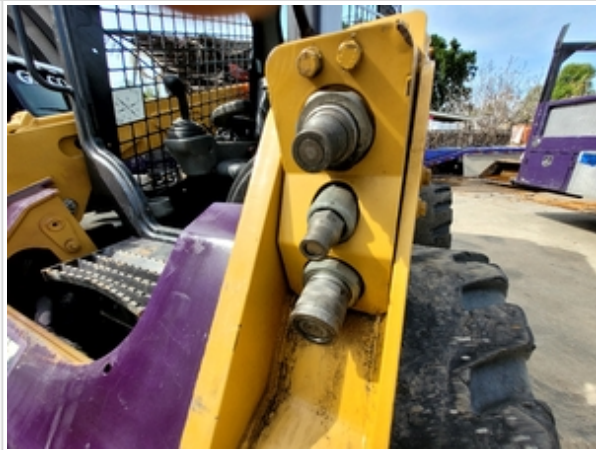
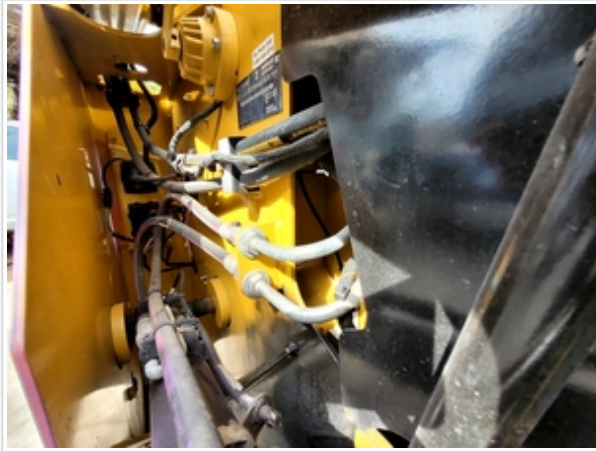
Hydraulic System Photos

Wet or Damp Hydraulic Lines / Fittings	No
Appearance of Hydraulic Lines / Fittings	3 - Normal Wear & Tear
Hydraulic Lines / Fittings Condition	Hydraulic lines & fittings are clean and in good condition
Unusual Noises (Hydraulic Pump)	No
Hydraulic Pump Notes	No unusual noises heard during operation

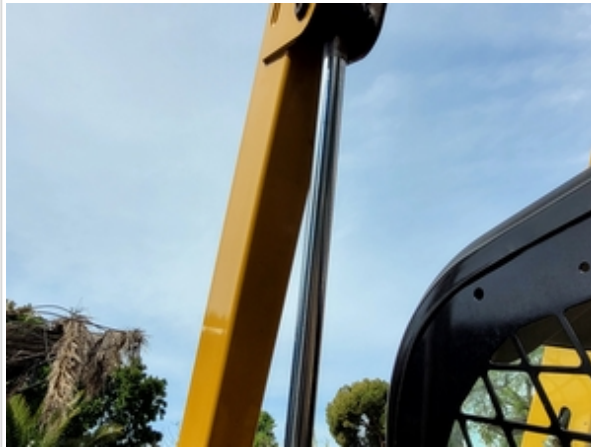
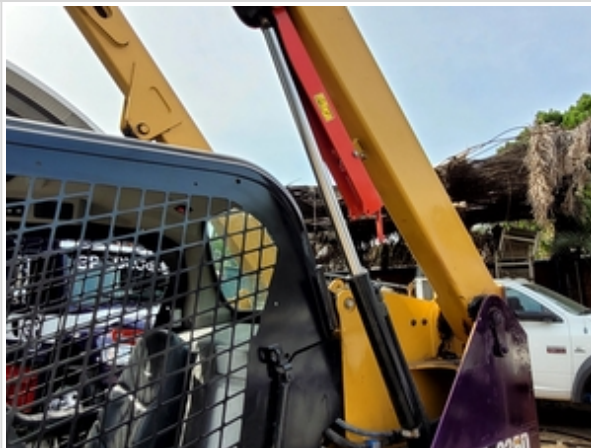
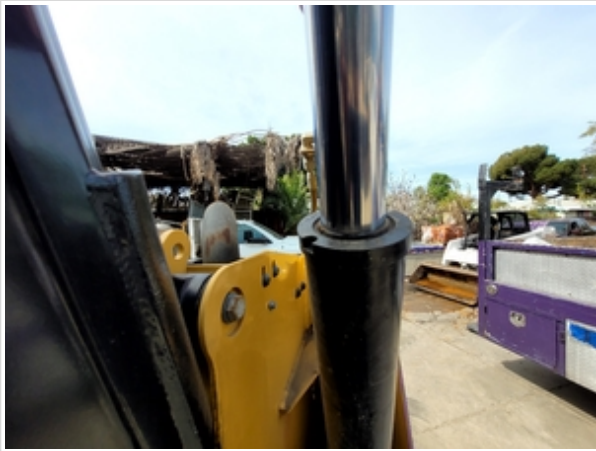
Lift Cylinder Photos

Lift Cylinder	Check the lift cylinder. Note any wear, pitting, discoloration, etc. Take photos.
Lift Cylinder: Mounting Pin	3
Lift Cylinder: Oil Leaks	No

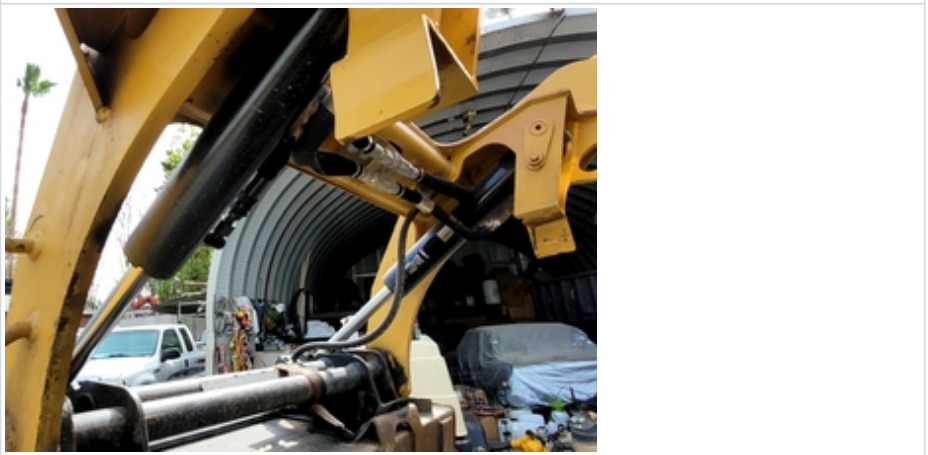
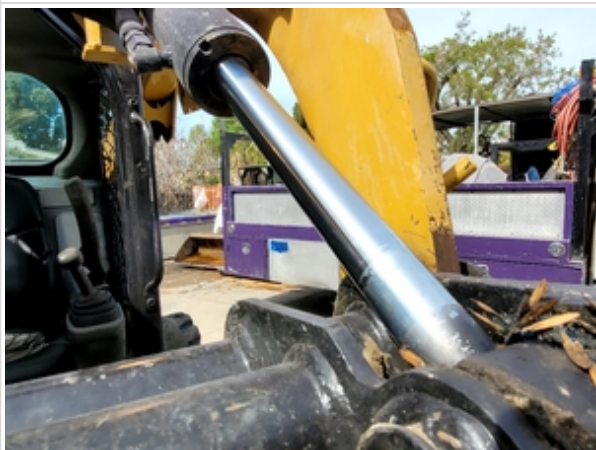
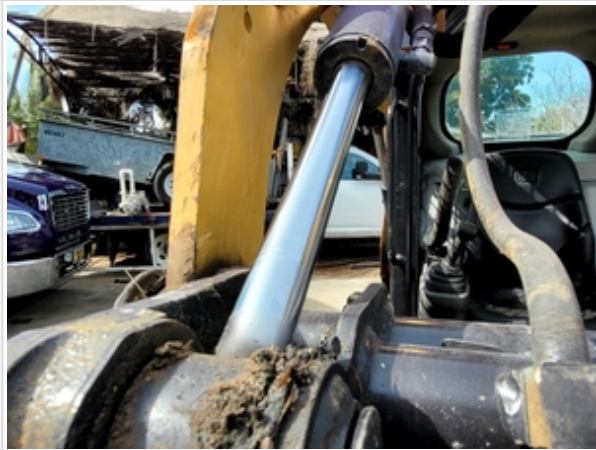
Bucket Cylinder	Check the bucket cylinder. Note any wear, pitting, discoloration, etc. Take photos.	
Bucket Cylinder: Mounting Pin	3	
Bucket Cylinder: Oil Leaks	No	
Bucket Cylinder Photos

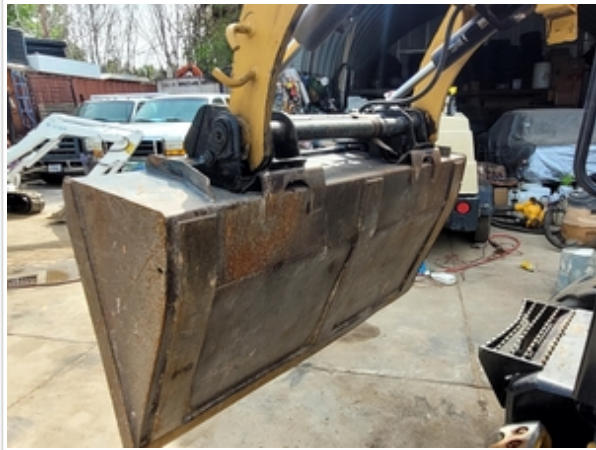
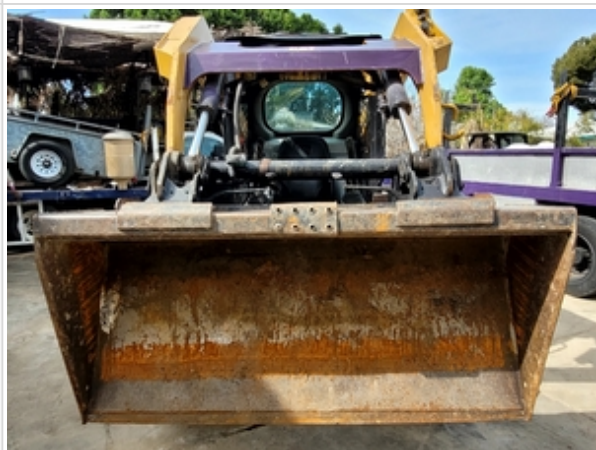
Bucket Condition	3 - Normal Wear & Tear
Comments	Bucket does not have bolt-on cutting edge
Bucket Photos
