Inspection Report (Vibratory Compactor)

Year	2017
Make	Wacker
Model	RTSC3
Serial Number	4630202290
Hour Meter Reading	539.8 Hours
Previous Application (e.g., earth moving, mining, demolition, etc)	Masonry General Construction

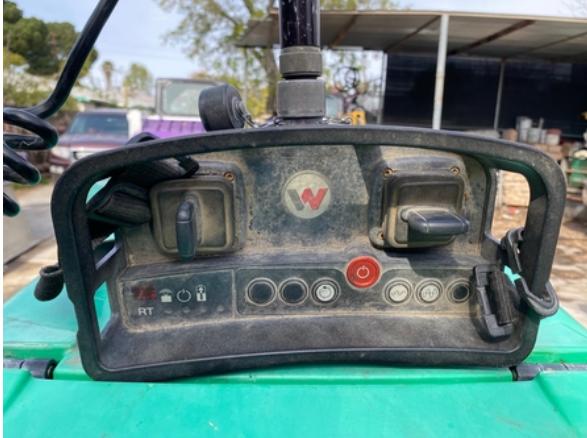
Controls & Switches Photos

Operator Cabin Overall	3 - Normal Wear & Tear
Operator Cabin Overall Condition	Good cabin appearance, solid floors, panels, and ceiling
Operator Seat	0
Cabin Lights	0
Safety Lock Out / Stop	3 - Normal Wear & Tear
Safety Lock Out / Stop Condition	Safety lock out device is present, in good condition, and functional
Controls & Switches	3 - Normal Wear & Tear
Controls & Switches Condition	All switches are installed and functional

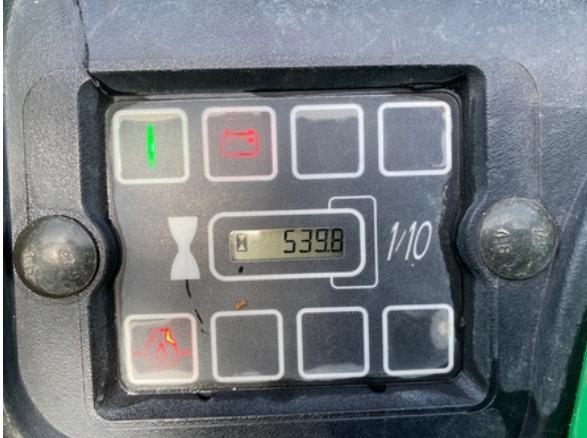
Hour Meter Activity	3 - Normal Wear & Tear
Hour Meter Condition	Hour meter is functional and in good condition
Hour Meter Activity Photos

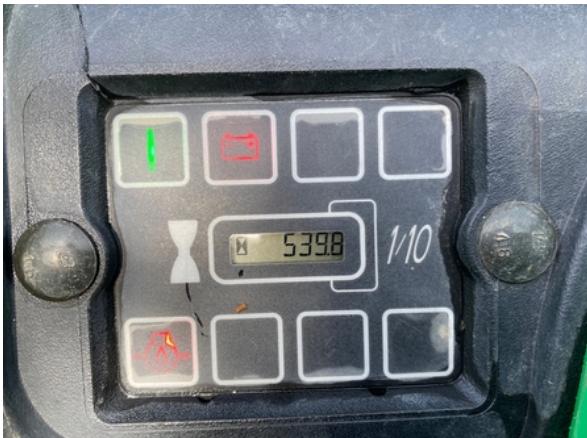
Other Gauge Activity	3 - Normal Wear & Tear
Other Gauge Condition	All cockpit gauges are functional and in good condition
Other Gauge Activity Photos

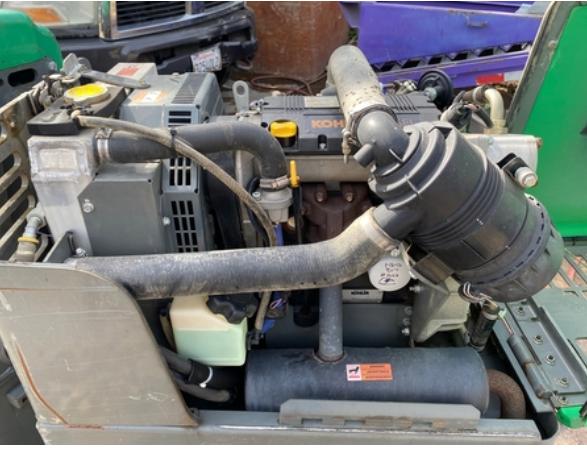
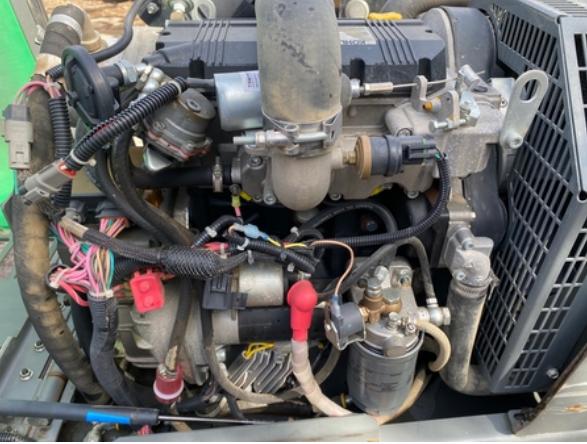
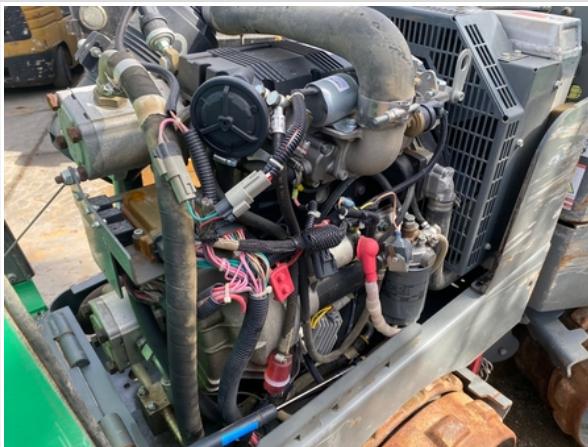
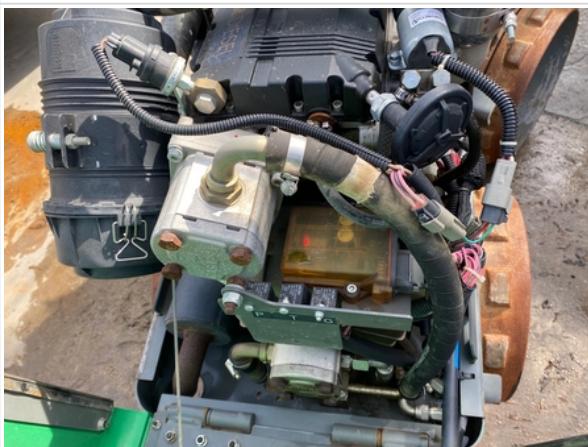
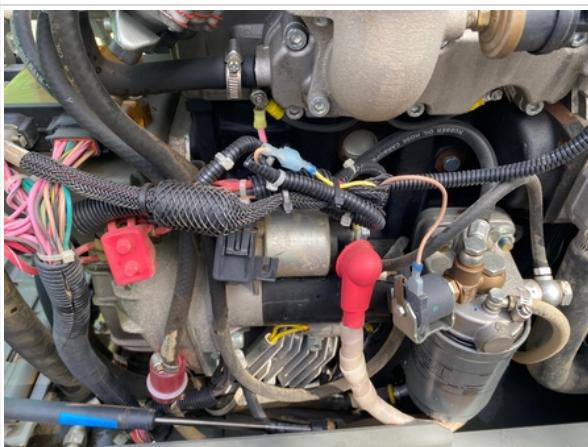
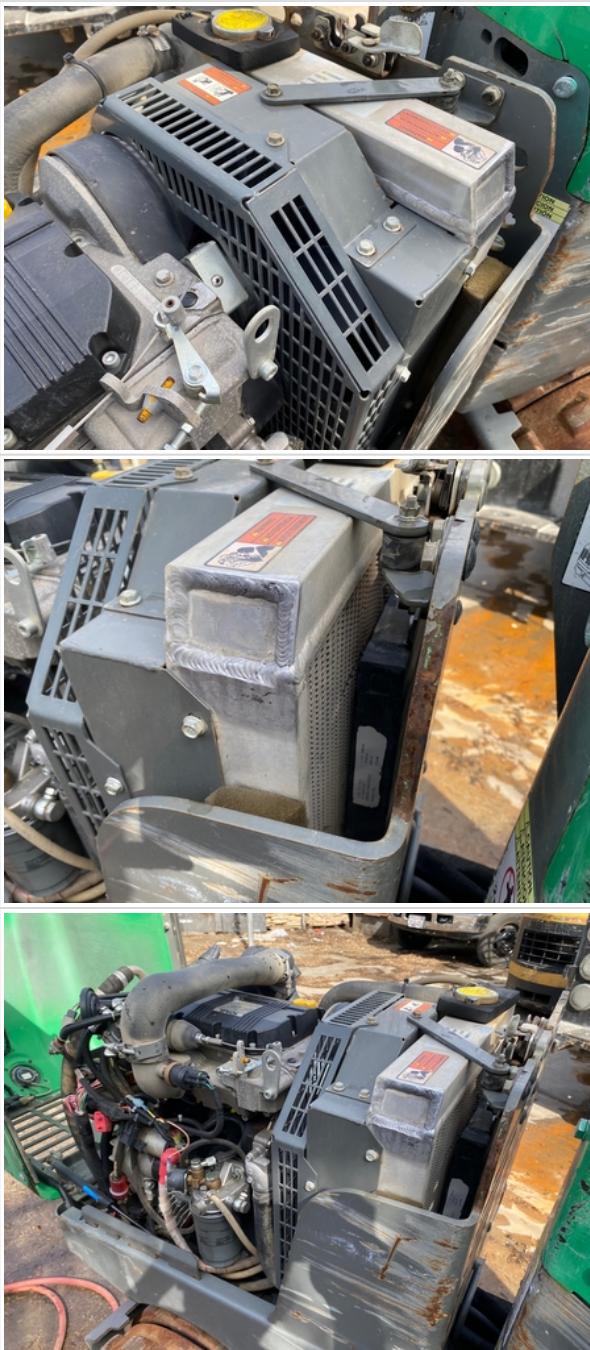
Overall Engine Comments	Engine and engine compartment in clean shape. Engine runs well and sounds healthy under load and at idle. No active leaks observed.

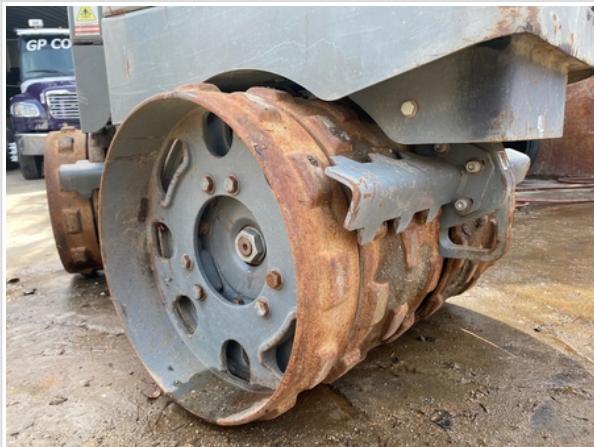
Hydrostatic Transmission?	Yes
2 Speed?	No
Hydrostatic Drive Configuration	Split Transmission
Drive Motors	2 - Above Average Wear
Hydrostatic Parking Brake	3 - Normal Wear & Tear
Hydrostatic Parking Brake Condition	Good brake function
Overall Drivetrain Comments	Machine travels normally in forward and reverse. Unit steering well.

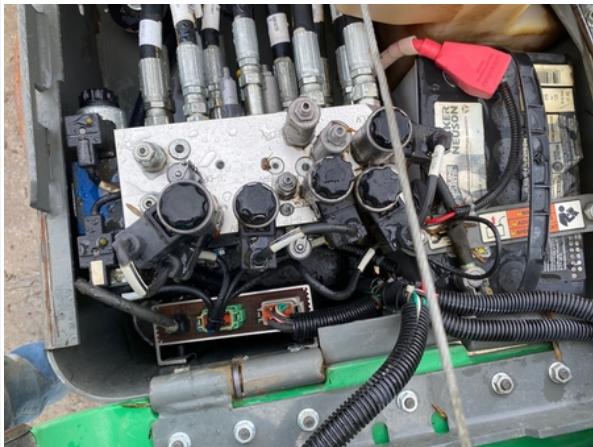
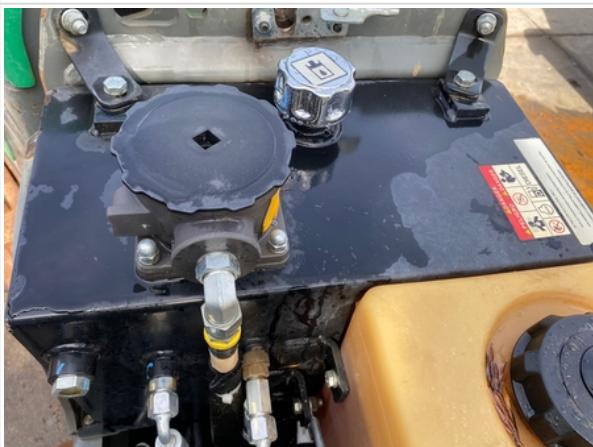
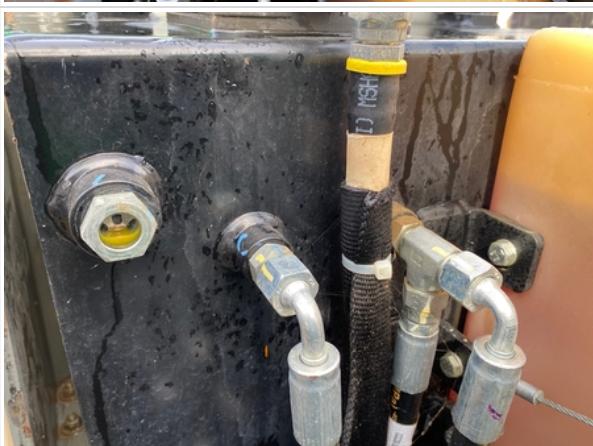
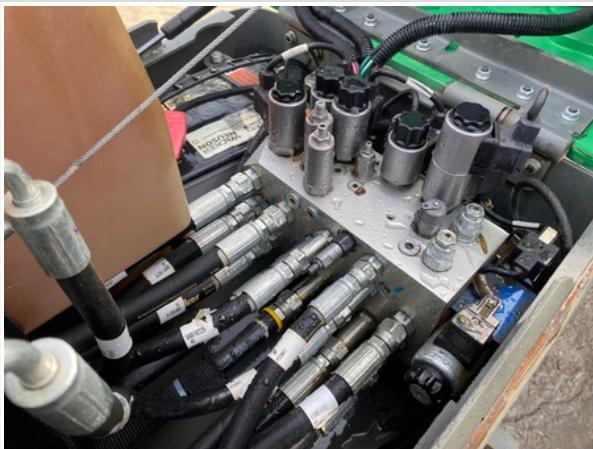
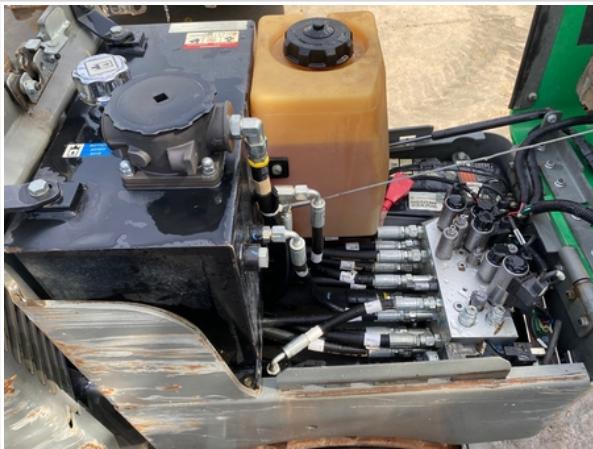
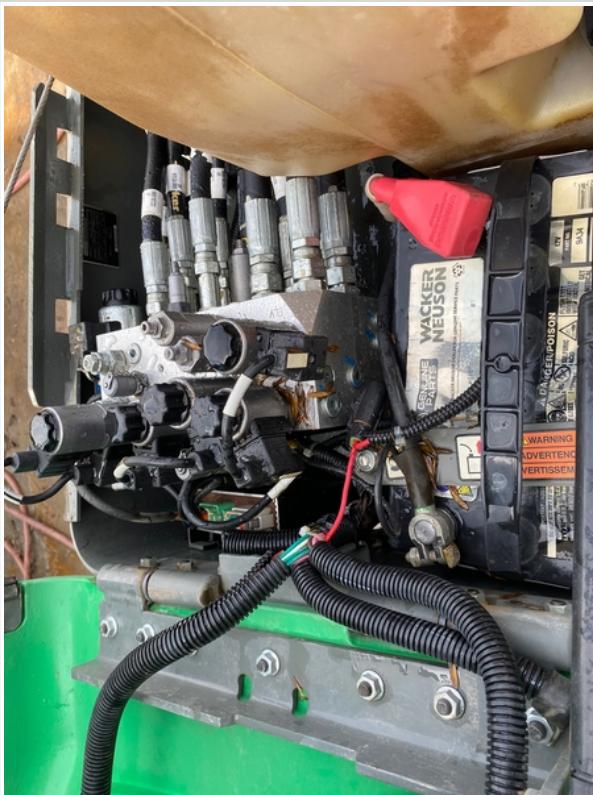
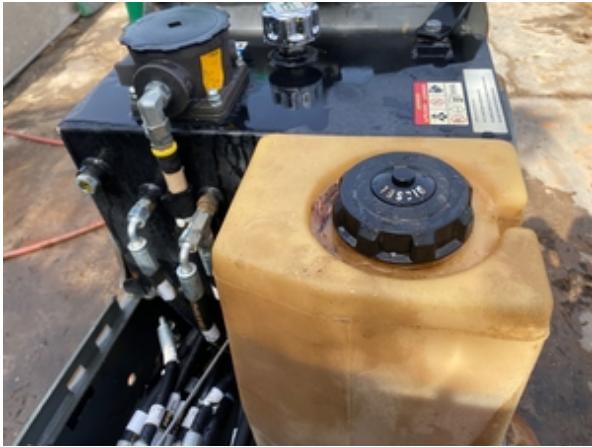
Hydraulic System Photos

Wet or Damp Hydraulic Lines / Fittings	No
Appearance of Hydraulic Lines / Fittings	3 - Normal Wear & Tear
Hydraulic Lines / Fittings Condition	Hydraulic lines & fittings are clean and in good condition
Unusual Noises (Hydraulic Pump)	No
Hydraulic Pump Notes	No unusual noises heard during operation
Comments	Hydraulics have good appearance with no active leaks observed during operation.

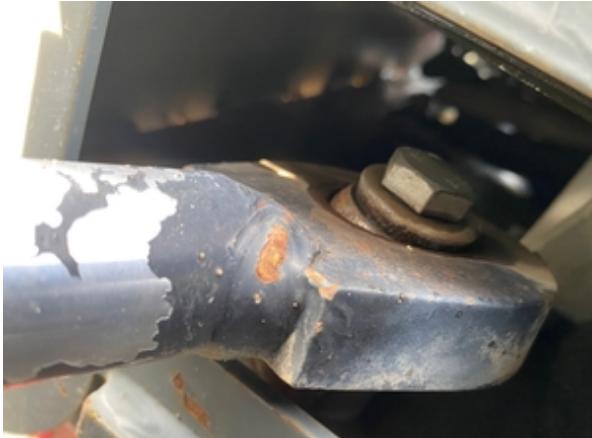
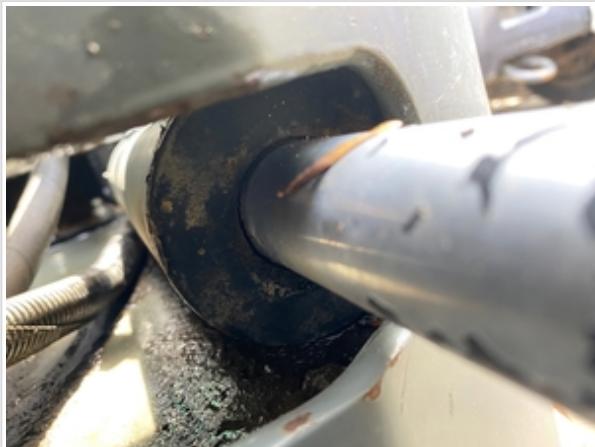
Steering Cylinders	Check the steering cylinder. Note any wear, pitting, discoloration, etc. Take photos.
Steering Cylinders: Mounting Pin	3
Steering Cylinders: Oil Leaks	Yes
Comments	Signs of minor seepage buildup seen at rod seal
Steering Cylinders Photos

Exterior Rating	3 - Normal Wear & Tear
Interior Rating	3 - Normal Wear & Tear
Safety Rating	3 - Normal Wear & Tear
Quality Rating	3 - Normal Wear & Tear
Functionality Rating	3 - Normal, Operating as Expected
Overall Rating	3 - Normal Wear & Tear
What's Great About the Machine	Machine has low hours and main core items operating great. No active leaks seen and machine has plenty of life left.
What Needs Work	Cosmetic scuff marks observed all around. Steer cylinder may need to be resealed soon.
Date/Time	02-17-2023
