## Inspection Report (Skid Steer)

Year	2016
Make	Bobcat
Model	S450
Serial Number	AUVB12760
Hour Meter Reading	1,148 Hrs.
Previous Application (e.g., earth moving, mining, demolition, etc)	Masonry General Construction

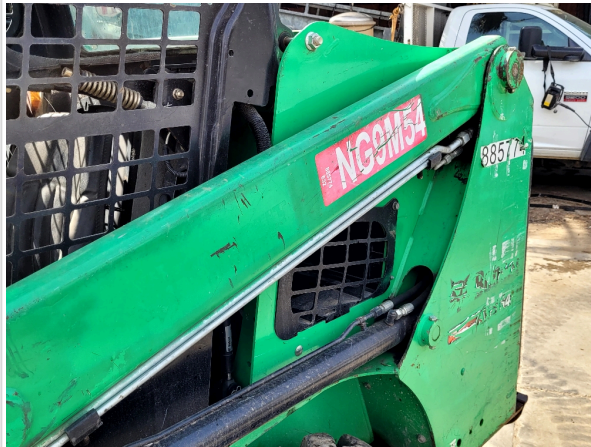
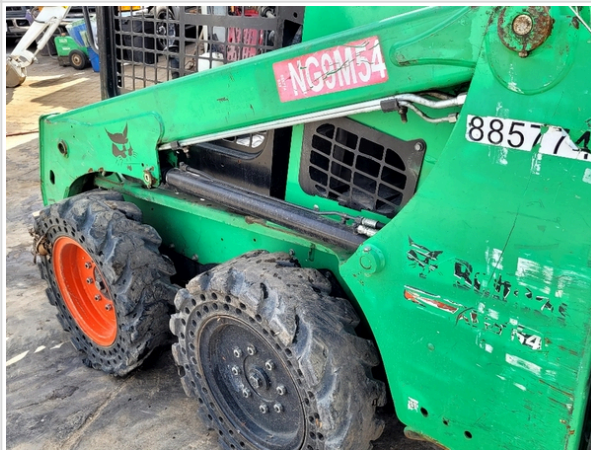
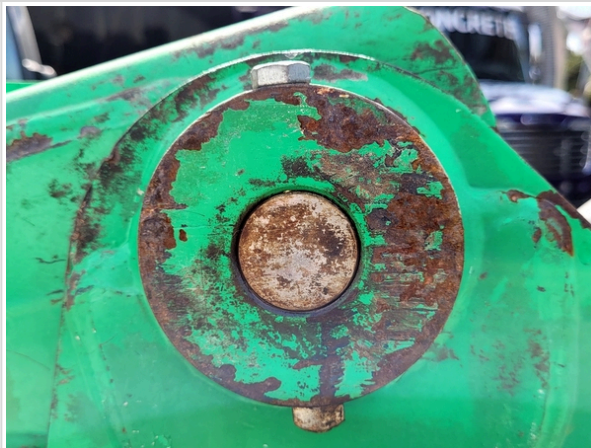
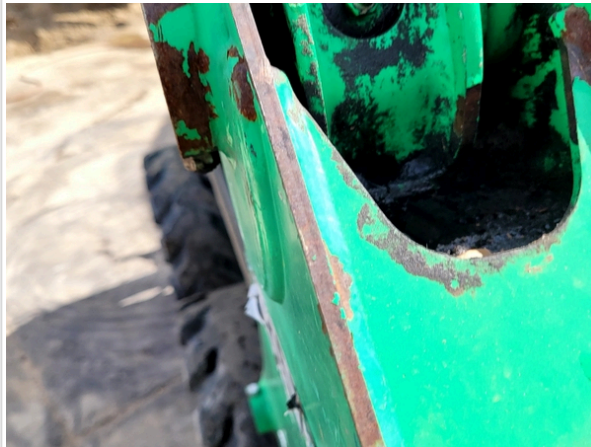
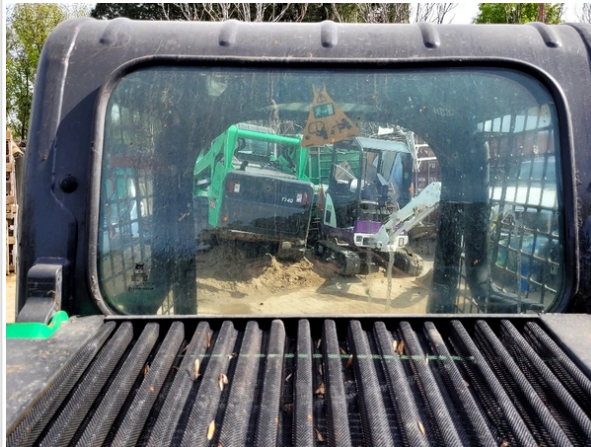
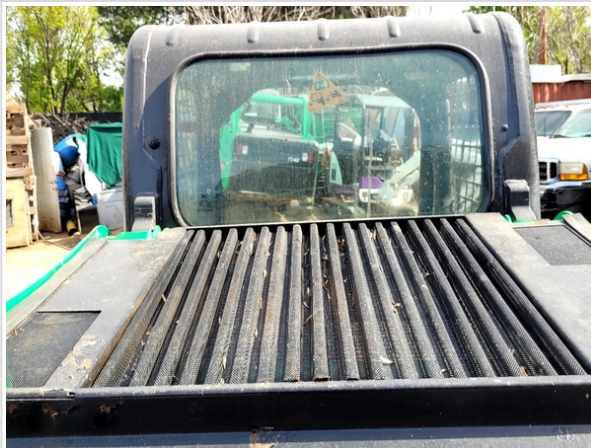
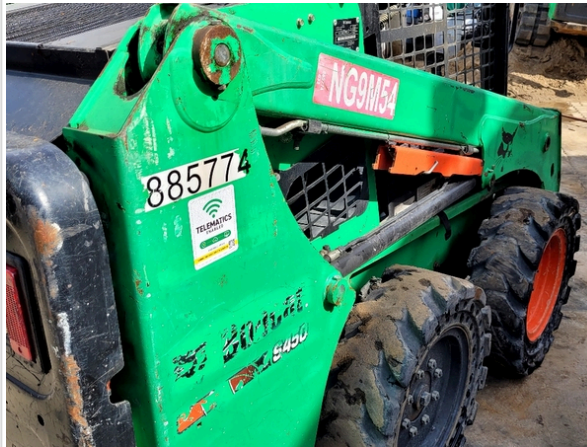
### Close-up Exterior Photos

<b>Body Panels</b>	3 - Normal Wear & Tear
<b>Body Panel Condition</b>	No visible damage, good paint condition and panel fitment
<b>Doors / Canopy Latches</b>	3 - Normal Wear & Tear
<b>Doors / Canopy Latches Condition</b>	No visible damage
<b>Steps / Ladders</b>	3 - Normal Wear & Tear
<b>Steps / Ladders Condition</b>	Steps/ladders are fully intact and appear structurally sound
<b>Handrails</b>	3 - Normal Wear & Tear
<b>Handrails Condition</b>	Handrails are fully intact and appear structurally sound
<b>Glass</b>	3 - Normal Wear & Tear
<b>Glass Condition</b>	Glass intact, no visible damage
<b>Mirrors</b>	3 - Normal Wear & Tear
<b>Mirror Condition</b>	Mirrors present and intact, no visible damage
<b>Exterior Lights</b>	3 - Normal Wear & Tear
<b>Exterior Lights Condition</b>	No visible damage, lighting system is operational

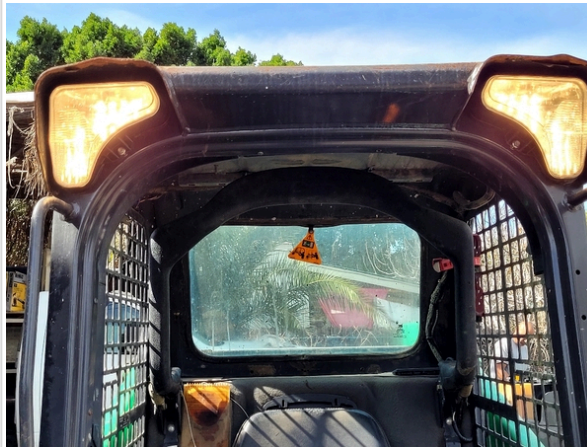
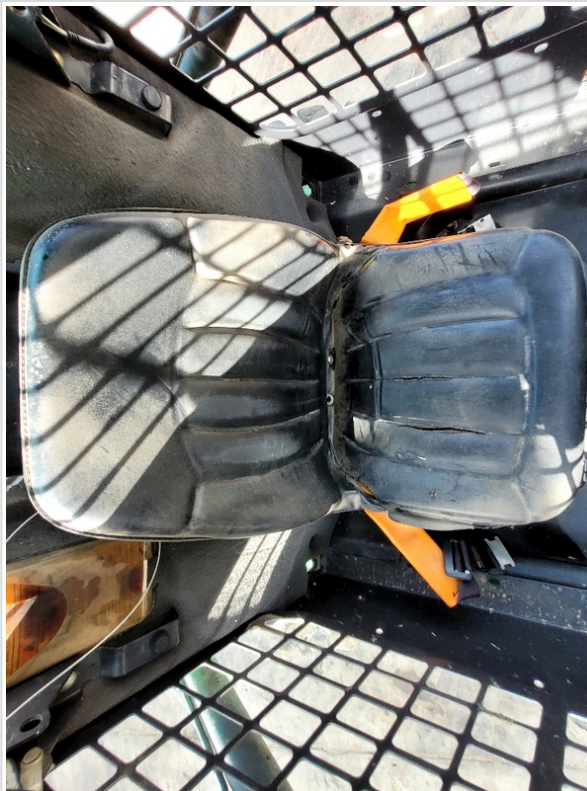
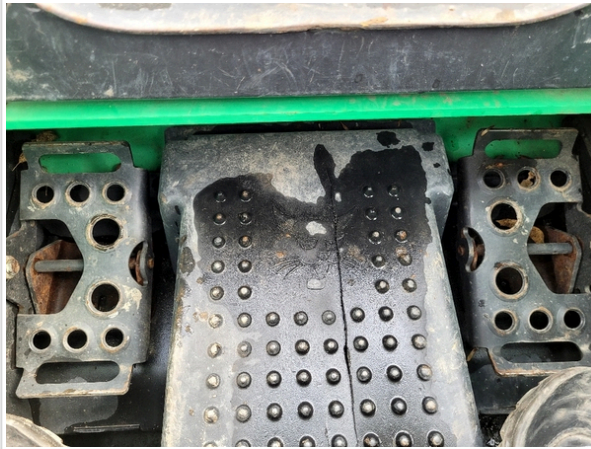
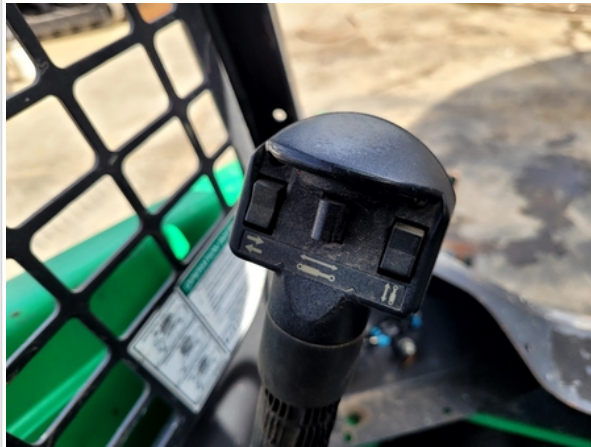
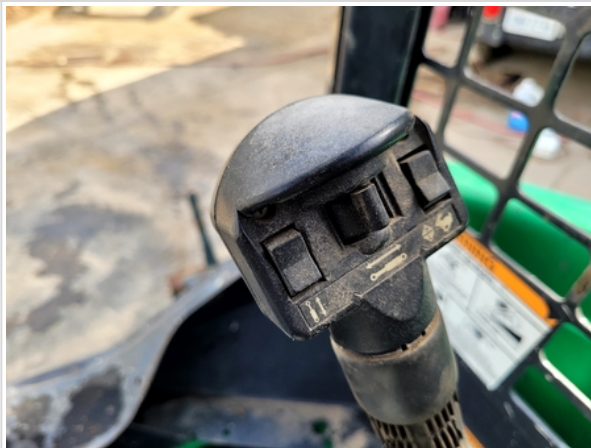
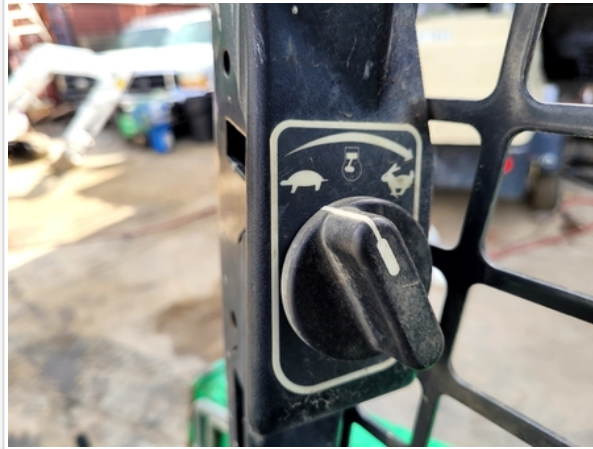
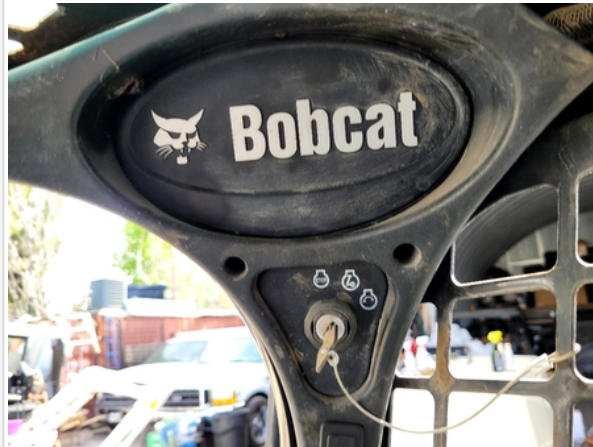
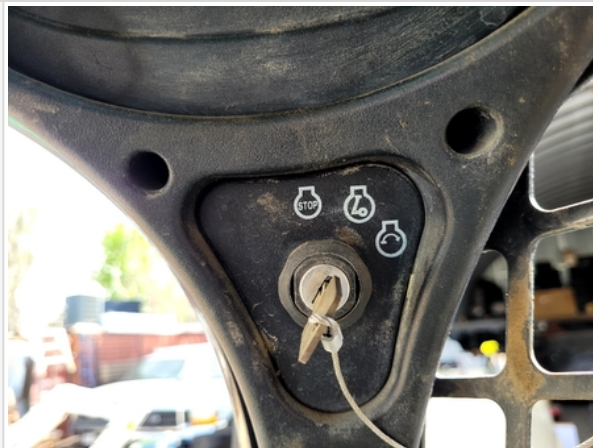
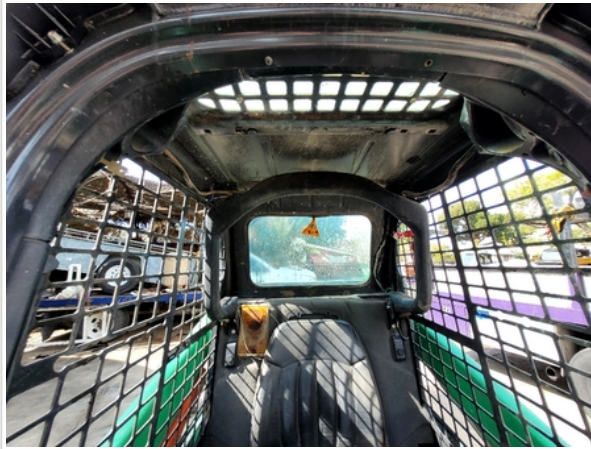
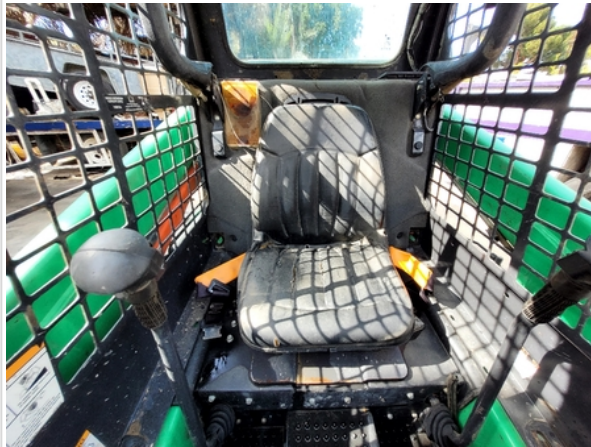
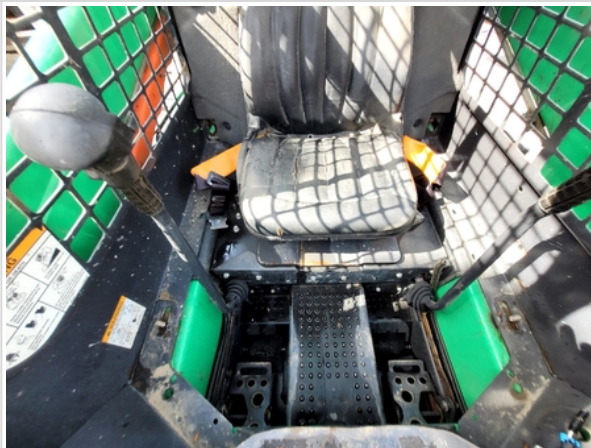
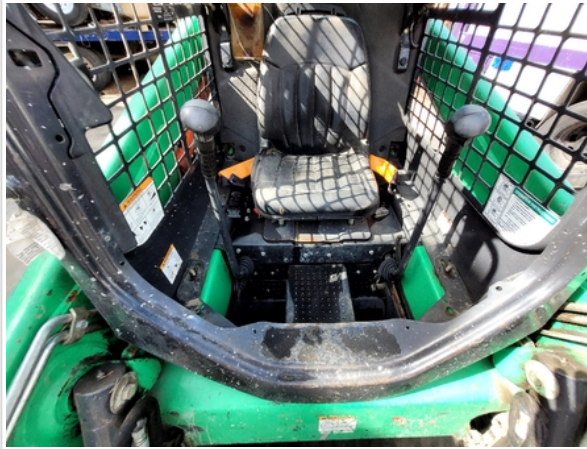
Operator Cabin Photos

Operator Cabin Overall	3 - Normal Wear & Tear
Operator Cabin Overall Condition	Good cabin appearance, solid floors, panels, and ceiling
Operator Seat	3 - Normal Wear & Tear
Operator Seat Condition	Seat(s) have minor surface staining or small tears
Cabin Lights	3 - Normal Wear & Tear
Cabin Lights Condition	Cabin lights are installed with all light covers in place, bulbs are installed and working properly
Safety Lock Out / Stop	3 - Normal Wear & Tear
Safety Lock Out / Stop Condition	Safety lock out device is present, in good condition, and functional
Controls & Switches	3 - Normal Wear & Tear
Controls & Switches Condition	All switches are installed and functional
Hour Meter Activity	3 - Normal Wear & Tear
Hour Meter Condition	Hour meter is functional and in good condition
Other Gauge Activity	3 - Normal Wear & Tear
Other Gauge Condition	All cockpit gauges are functional and in good condition
Heater & A/C	0

Travel Alarm	2 - Above Average Wear
Travel Alarm Condition	System is configured but not operating correctly
Comments	Travel alarm inoperable
Horn	3 - Normal Wear & Tear
Horn Condition	Horn is installed and functioning as expected
Backup Camera	0

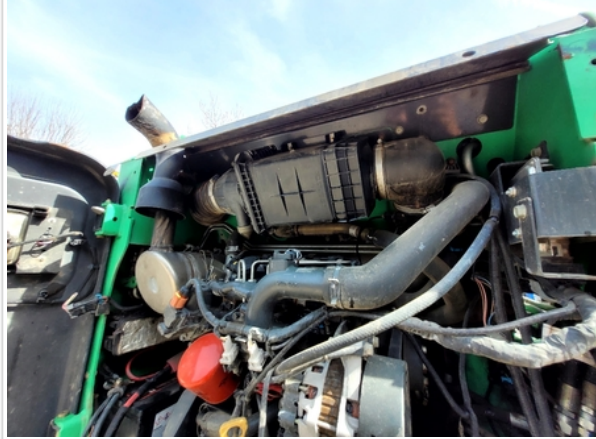
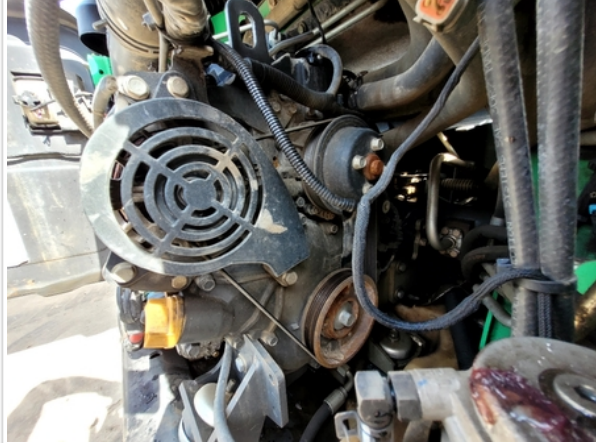
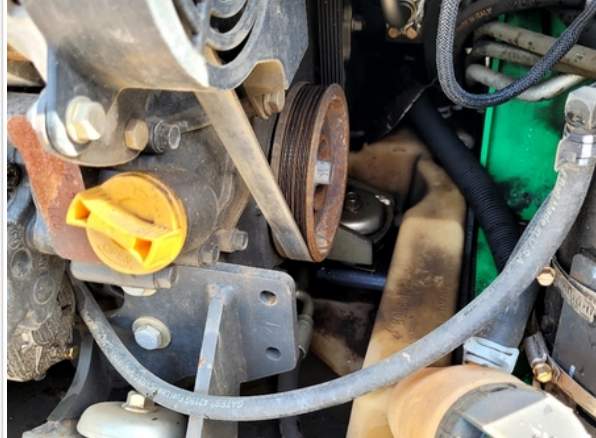
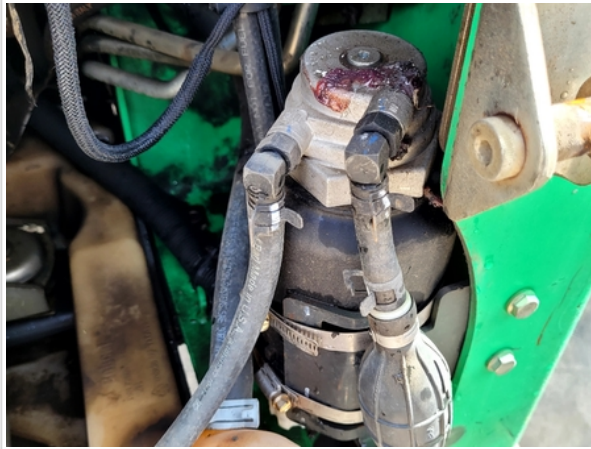
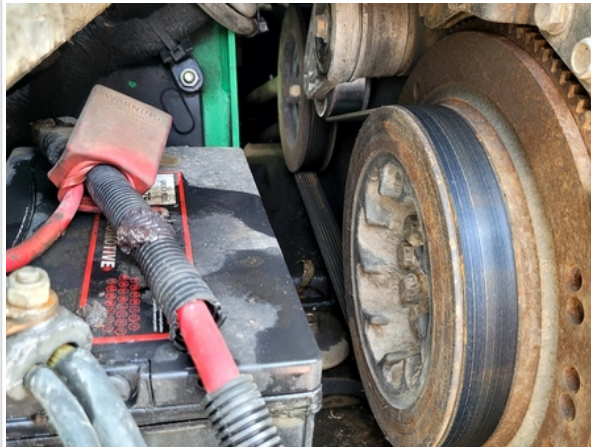
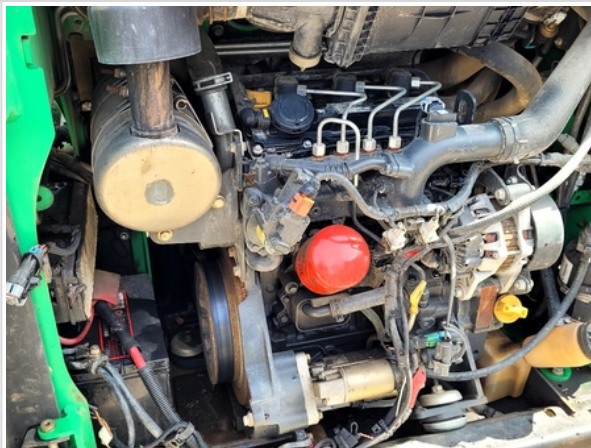
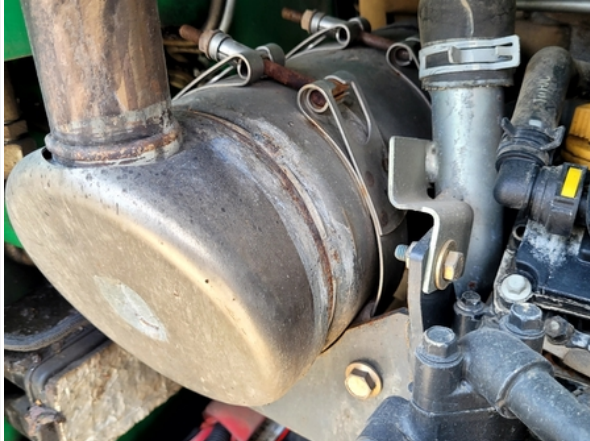
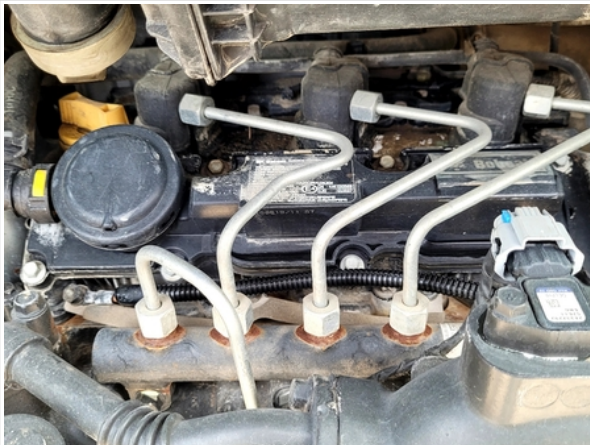
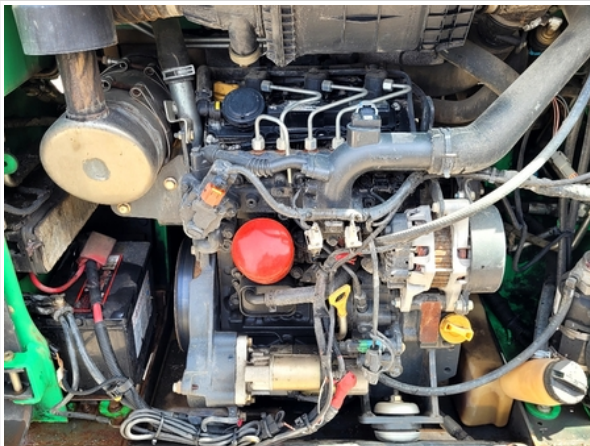
<b>Blow-by (Visual Observation Check)</b>	No	
<b>Unusual Noises (Upon Start-up, Idle, Shutdown)</b>	No	
<b>Unusual Noise Notes</b>	No unusual noises heard	
<b>Engine Smoke (Upon Start-up, Idle, Shutdown)</b>	No	
<b>Engine Smoke Notes</b>	No engine smoke issues observed	
<b>Engine Exhaust Color</b>	Clear

Battery	3 - Normal Wear & Tear
Battery Condition	Like new, recently replaced, Other (see comments)
Comments	battery hold down missing
Radiator	3 - Normal Wear & Tear
Radiator Condition	Radiator fins & components appear to be in good working order, no signs of damage or leaks
Belts	3 - Normal Wear & Tear
Belt Condition	Belts appear in good condition & alignment with proper tension
Hoses	3 - Normal Wear & Tear
Hose Condition	Firm, pliant hoses with no signs of wear or leaks
Water Pump	3 - Normal Wear & Tear
Water Pump Condition	No unusual pump noises heard
Cooling System Leaks	No
Coolant Color / Appearance	3 - Normal Wear & Tear
Coolant Color/Appearance Notes	Normal Translucent appearance, no visual signs of contamination
Oil Leaks	No
Oil Color / Appearance	3 - Normal Wear & Tear
Oil Color / Appearance Notes	Clean oil appearance, no signs of cross contamination, Appropriate oil level
Fuel Leaks	No
Requires DEF (Diesel Exhaust Fluid)	No

Overall Engine Appearance	Clean & dry
Overall Engine Comments	Overall engine in good shape and runs well under load. No active leaks observed during the inspection.

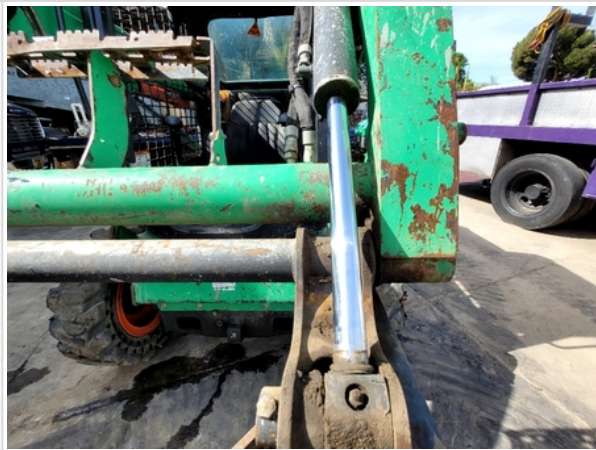
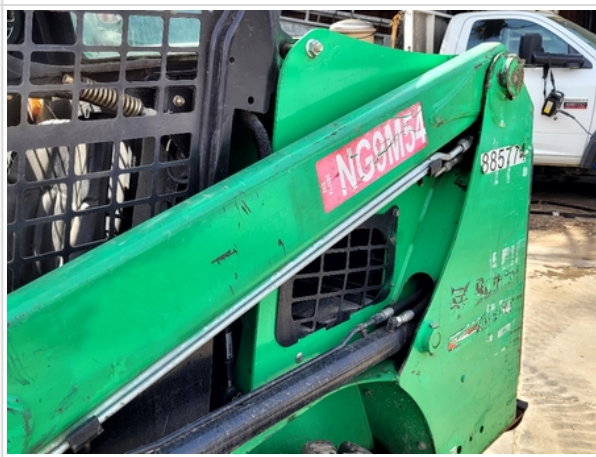
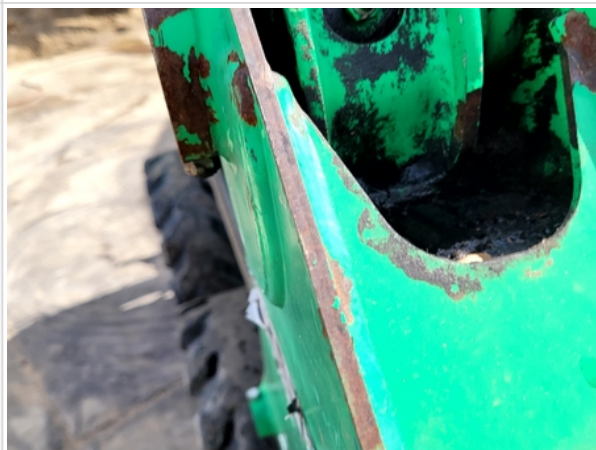
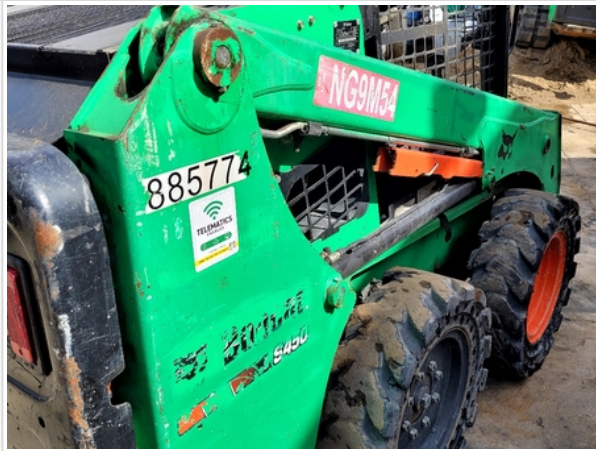
<p>Frame</p>	<p>3 - Normal Wear &amp; Tear</p>
<p>Frame Photos</p>

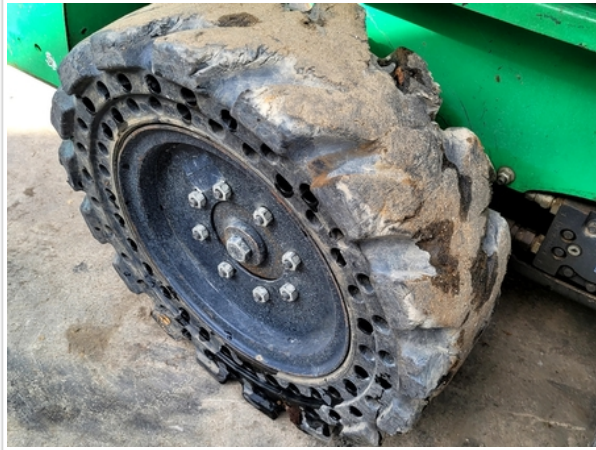
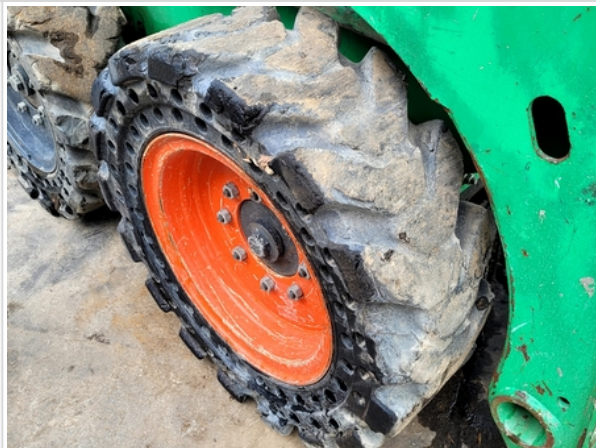
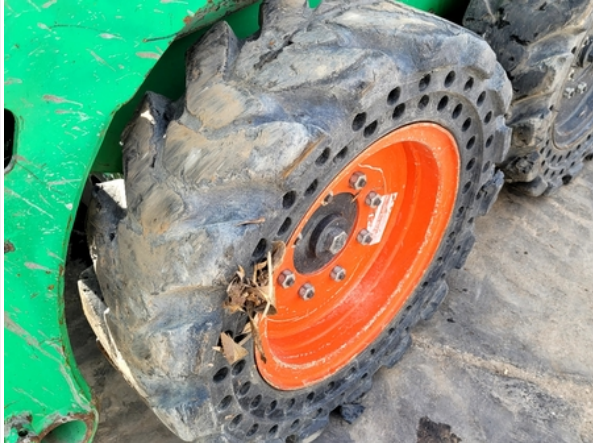
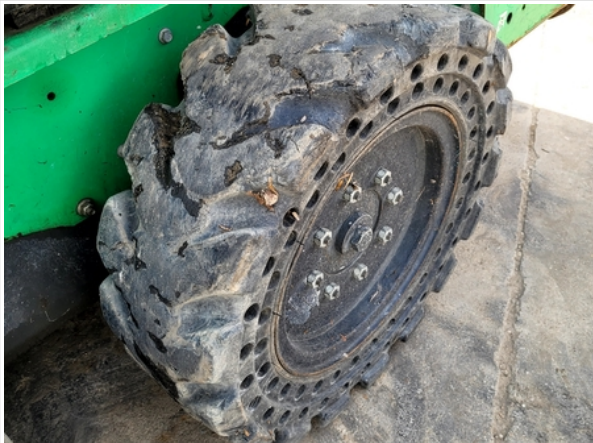
<p><b>Stance</b></p>	<p>3 - Normal Wear &amp; Tear</p>	
<p><b>Wheels &amp; Tires</b></p>	<p>3 - Normal Wear &amp; Tear</p>	
<p><b>Comments</b></p>	<p>Wheels Solid Rubber</p>	
<p><b>Wheels &amp; Tires Photos</b></p>

Tire Brand	N/A
Tire Size	N/A
Front Left Tire - Ratio Remaining	10%
Rear Left Tire - Ratio Remaining	10%
Front Right Tire - Ratio Remaining	10%
Rear Right Tire - Ratio Remaining	10%
Lift Arm	3 - Normal Wear & Tear
Lift Arm Photos

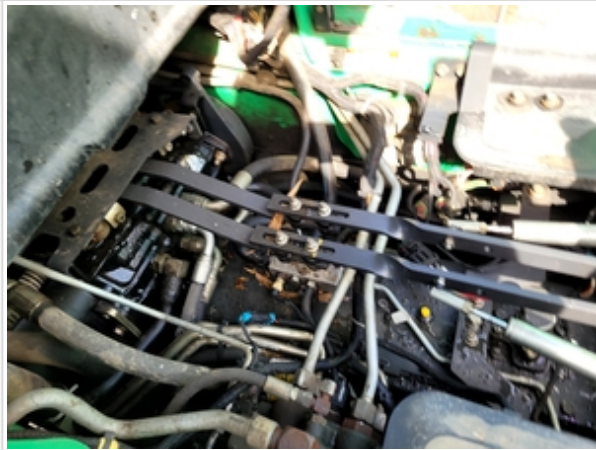
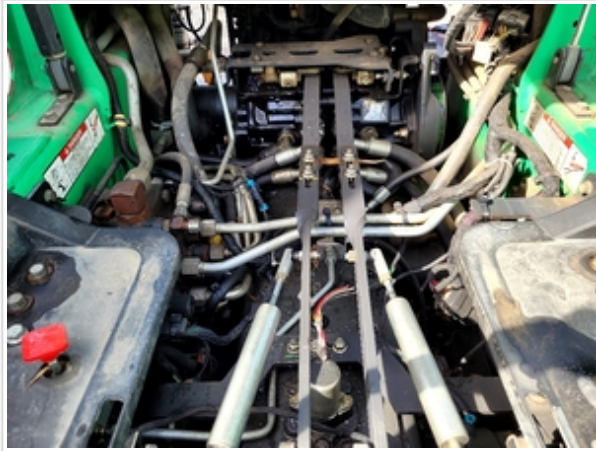
Hydraulic System Photos

Wet or Damp Hydraulic Lines / Fittings	No
Appearance of Hydraulic Lines / Fittings	3 - Normal Wear & Tear
Hydraulic Lines / Fittings Condition	Hydraulic lines & fittings are clean and in good condition
Unusual Noises (Hydraulic Pump)	No
Hydraulic Pump Notes	No unusual noises heard during operation, Other unusual sounds (see comments)
Comments	minor seepage seen at r/s top of hydraulic pump

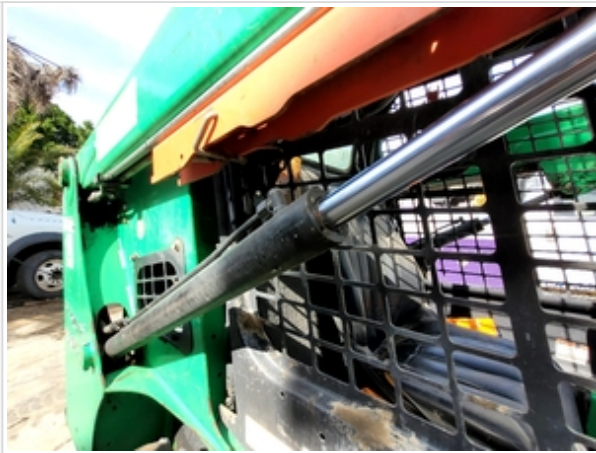
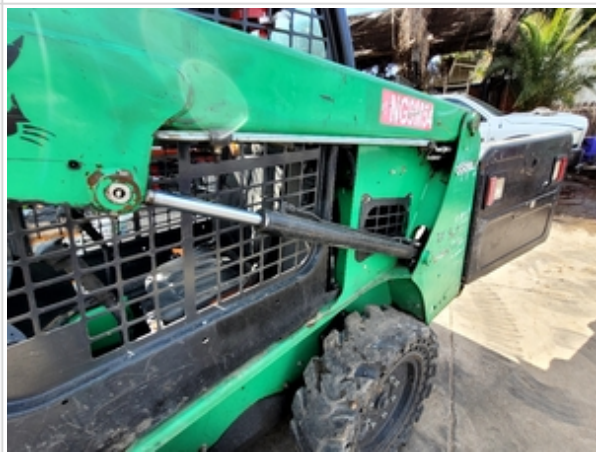
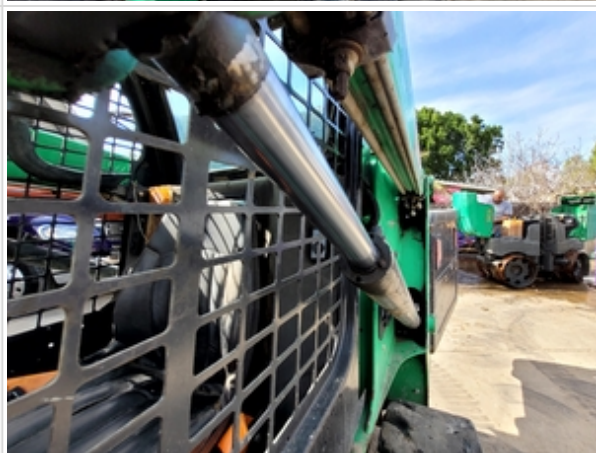
Lift Cylinder Photos

Lift Cylinder	Check the lift cylinder. Note any wear, pitting, discoloration, etc. Take photos.
Lift Cylinder: Mounting Pin	3
Lift Cylinder: Oil Leaks	No

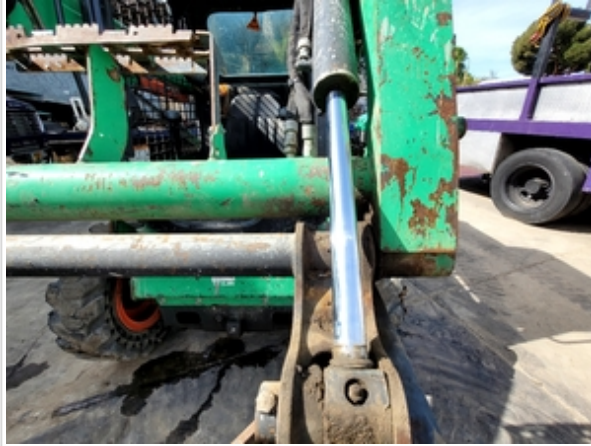
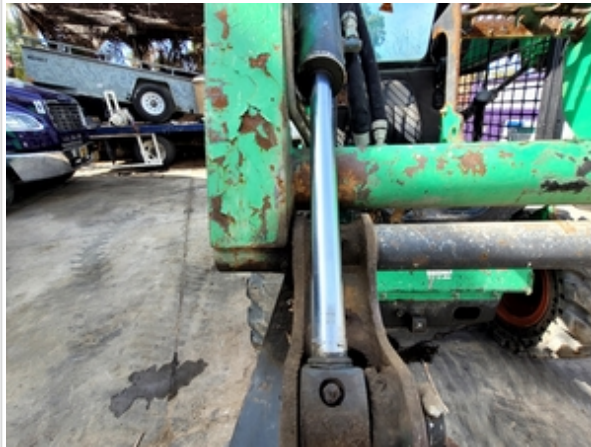
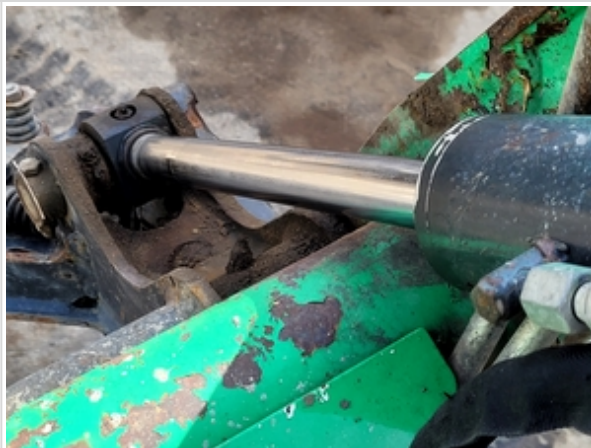
Bucket Cylinder Photos

<b>Bucket Cylinder</b>	Check the bucket cylinder. Note any wear, pitting, discoloration, etc. Take photos.
<b>Bucket Cylinder: Mounting Pin</b>	3
<b>Bucket Cylinder: Oil Leaks</b>	No
