Inspection Report (Material Handler)

Year	2019
Make	Sennebogen
Model	718E
Serial Number	718.0.2072
Hour Meter Reading	655 Hrs.
Previous Application (e.g., earth moving, mining, demolition, etc)	General Tree Services

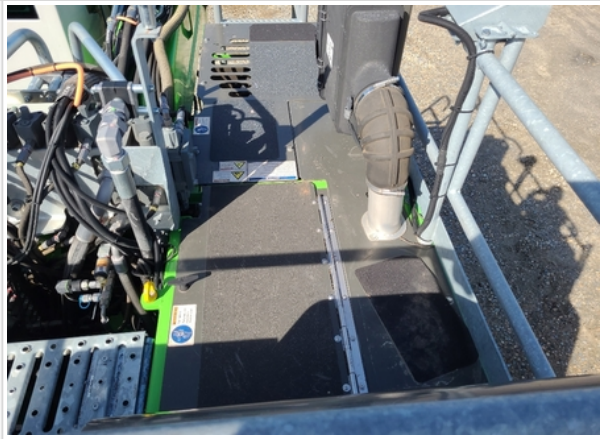
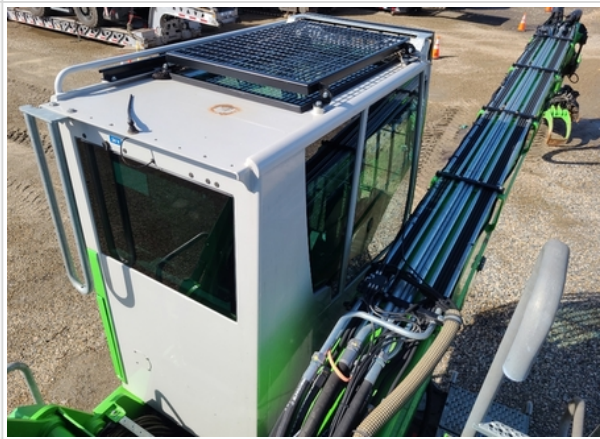
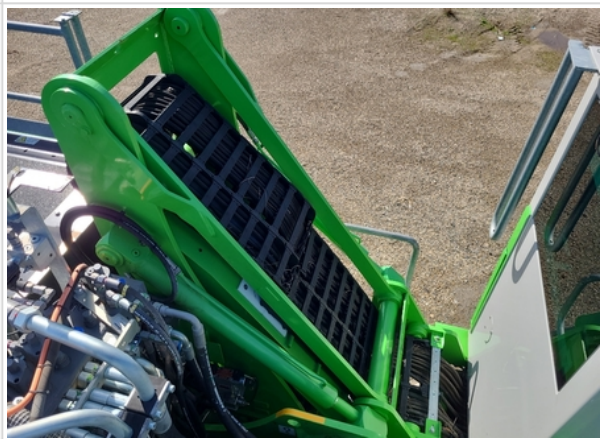
Body Panels	4 - Like New, Recently Replaced	
Body Panel Condition	No visible damage, good paint condition and panel fitment	
Doors / Canopy Latches	4 - Like New, Recently Replaced	
Doors / Canopy Latches Condition	No visible damage	
Steps / Ladders	4 - Like New, Recently Replaced	
Steps / Ladders Condition	Steps/ladders are fully intact and appear structurally sound	
Handrails	3 - Normal Wear & Tear	
Handrails Condition	Handrails are fully intact and appear structurally sound, Bent or broken railings, Other (see comments)

Comments	Front R/S Cab handrail slightly bent inwards.
Glass	4 - Like New, Recently Replaced
Glass Condition	Glass intact, no visible damage
Mirrors	4 - Like New, Recently Replaced
Mirror Condition	Mirrors present and intact, no visible damage
Exterior Lights	4 - Like New, Recently Replaced
Exterior Lights Condition	No visible damage, lighting system is operational

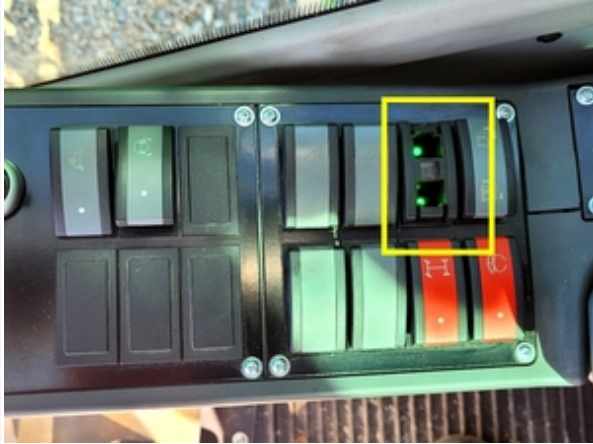
Safety Lock Out / Stop Condition	Safety lock out device is present, in good condition, and functional
Controls & Switches	4 - Like New, Recently Replaced
Controls & Switches Condition	All switches are installed and functional, Switches have good functionality, minor cosmetic damage observed
Comments	Cab up/down control switch on r/s console area missing top cover and lights exposed. Switch works, simply cosmetic issue.
Controls & Switches Photos

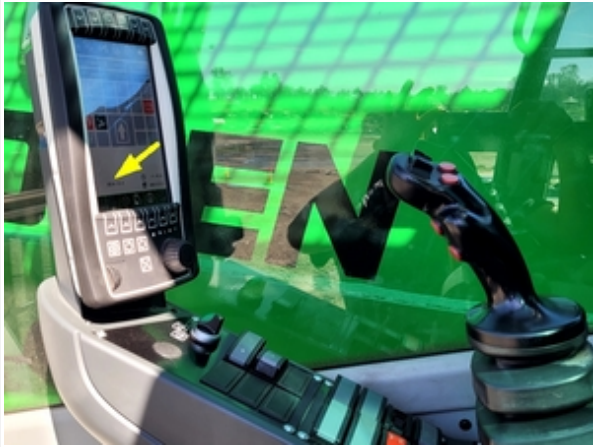
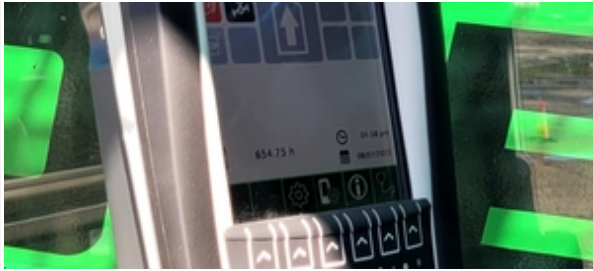
Hour Meter Activity	4 - Like New, Recently Replaced
Hour Meter Condition	Hour meter is functional and in good condition
Hour Meter Activity Photos

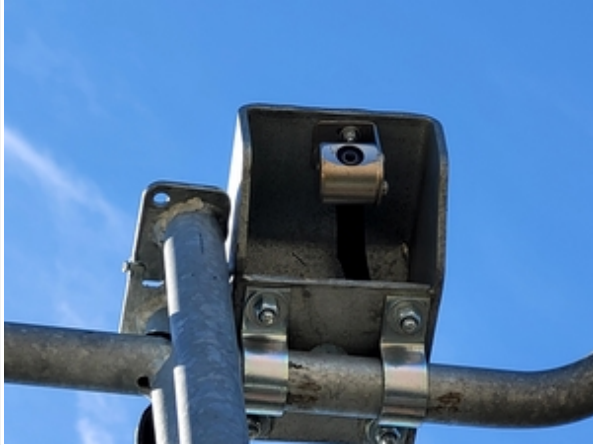
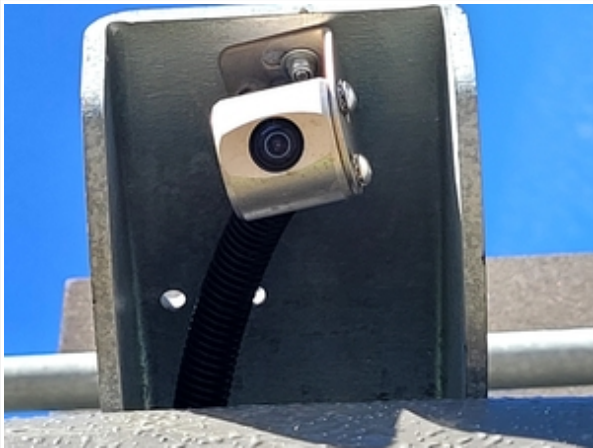
Travel Alarm	4 - Like New, Recently Replaced
Travel Alarm Condition	Travel alarm is installed and functioning as expected
Horn	4 - Like New, Recently Replaced
Horn Condition	Horn is installed and functioning as expected
Backup Camera	4 - Like New, Recently Replaced
Backup Camera Condition	Back up camera is installed and functioning as expected, Other (see comments)
Comments	Additional R/S Camera installed above engine compartment
Backup Camera Photos

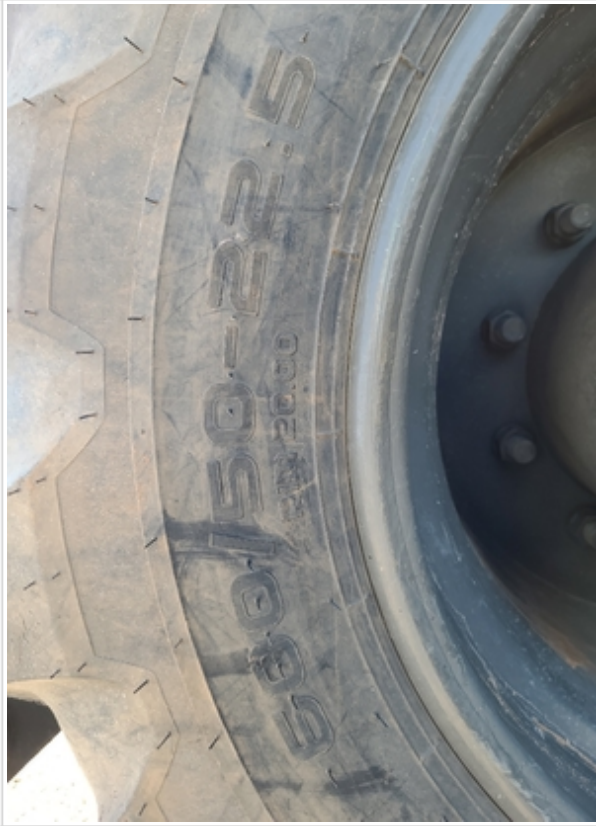
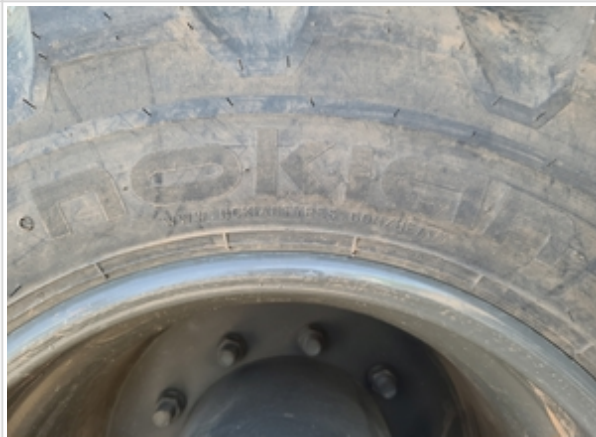
Wheels & Hub Condition	4
Comments	Tires are above 90%
Wheels & Hub Photos

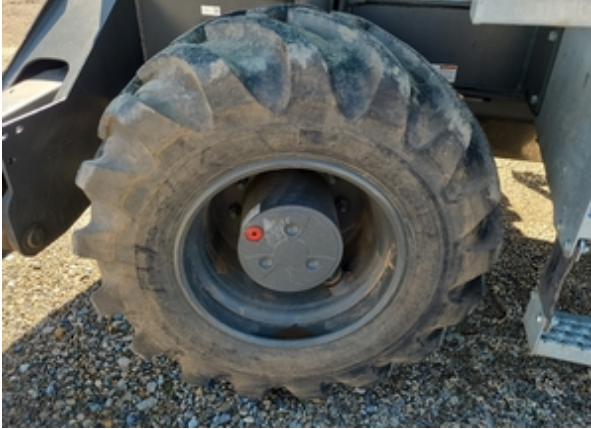
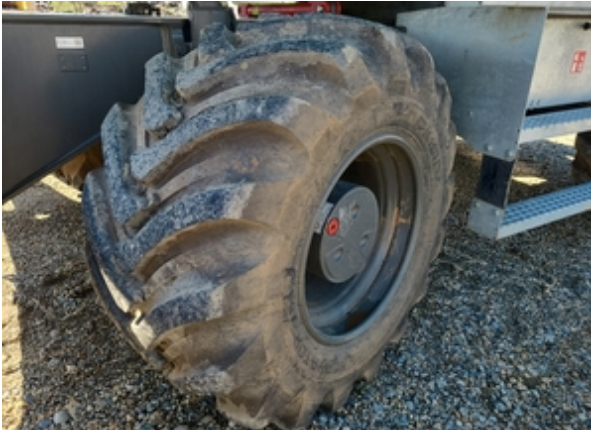
Wheel Seal Leaks	No	
Tire Brand	Nokian	
Tire Size	600/50-22.5	
Front Left Tire - Ratio Remaining	90%	
Front Left Tire Photos

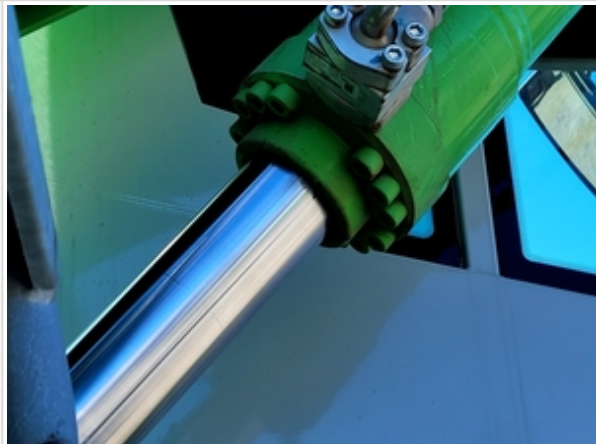
Boom Cylinder: Mounting Pins	4 - Like New, Recently Replaced
Boom Cylinder: Oil Leaks	No
Boom Cylinder Photos

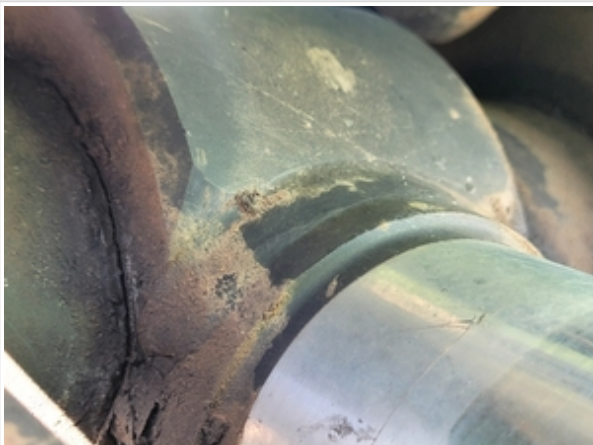
Stick Cylinder: Mounting Pins	4 - Like New, Recently Replaced	
Stick Cylinder: Oil Leaks	No	
Stick Cylinder Photos

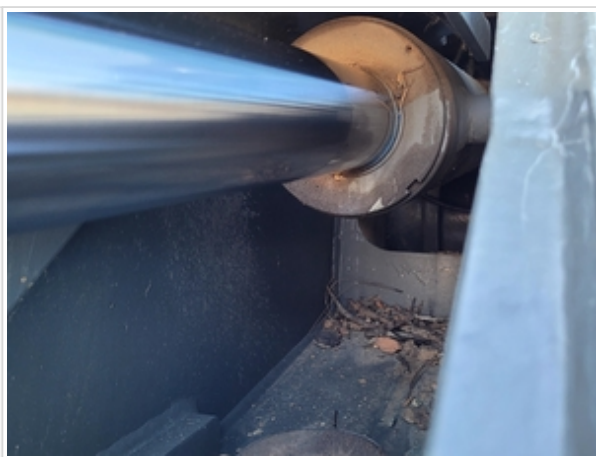
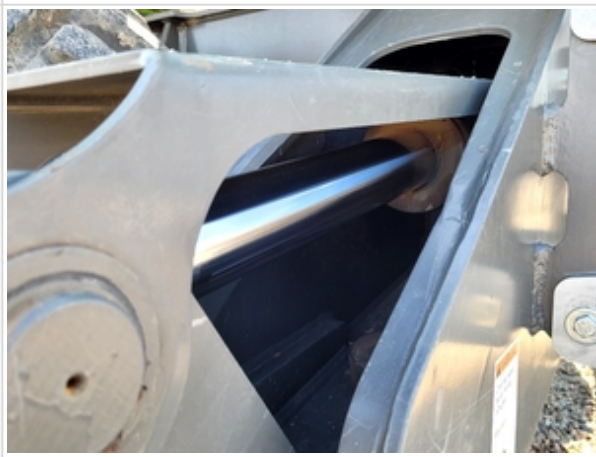
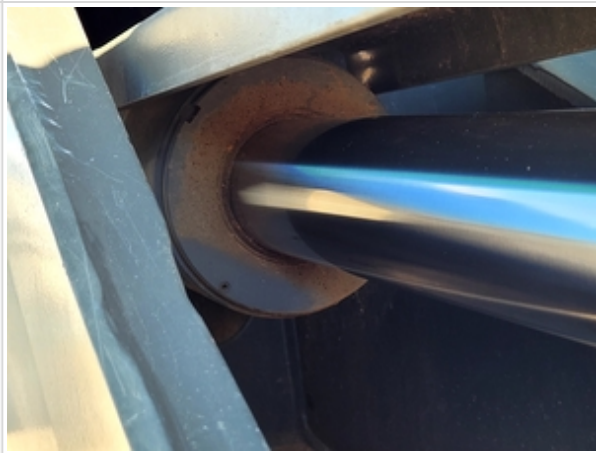
<p>Outrigger Cylinder(s) Photos</p>

Outrigger Cylinder(s): Mounting Pins	4 - Like New, Recently Replaced
Outrigger Cylinder(s): Oil Leaks	No
