## Inspection Report (Material Handler)

Year	2019
Make	Sennebogen
Model	718E
Serial Number	718.0.2074
Hour Meter Reading	547 Hrs.
Previous Application (e.g., earth moving, mining, demolition, etc)	General Tree Services

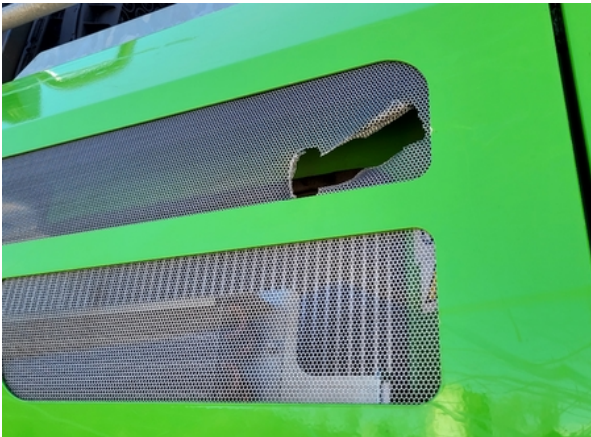
<b>Body Panels</b>	3 - Normal Wear & Tear
<b>Body Panel Condition</b>	Other (see comments)
<b>Comments</b>	Small damage on R/S engine enclosure door. Scuff marks all around exterior panels.
<b>Body Panels Photos</b>

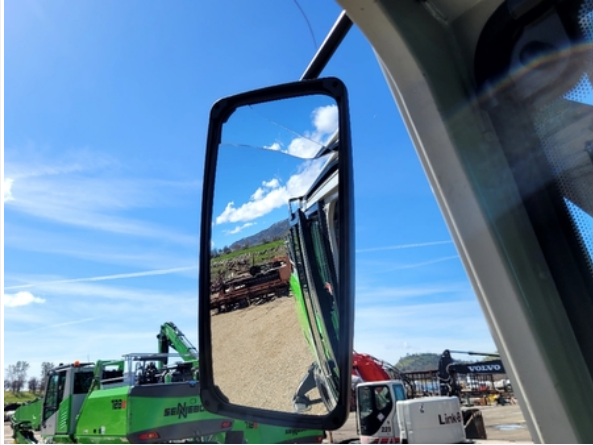
Handrails	4 - Like New, Recently Replaced
Handrails Condition	Handrails are fully intact and appear structurally sound
Glass	4 - Like New, Recently Replaced
Glass Condition	Glass intact, no visible damage
Mirrors	2 - Above Average Wear
Mirror Condition	Minor chips or cracks observed
Comments	Exterior Cab Mirror Cracked
Mirrors Photos

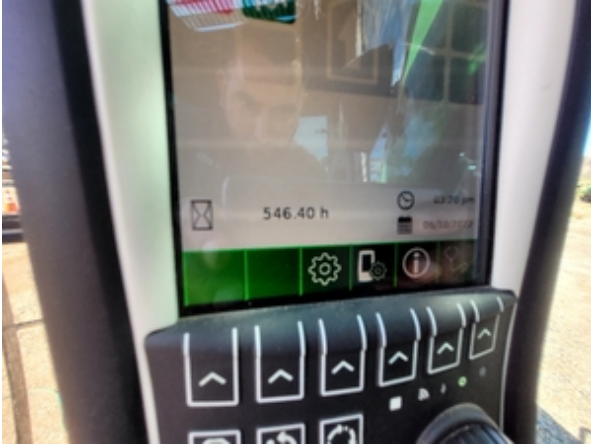
Hour Meter Activity Photos

<b>Controls &amp; Switches Photos</b>	 
<b>Hour Meter Activity</b>	4 - Like New, Recently Replaced
<b>Hour Meter Condition</b>	Hour meter is functional and in good condition

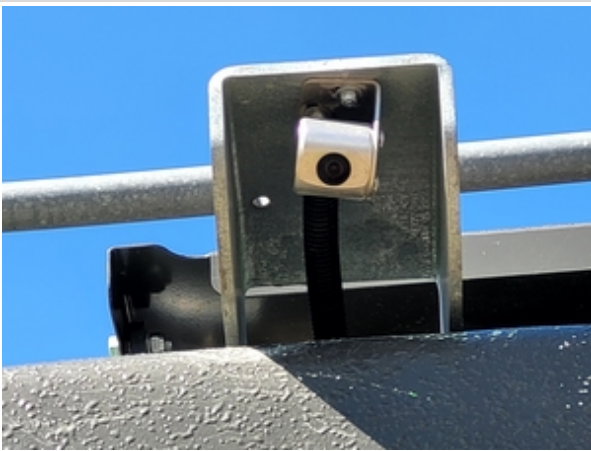
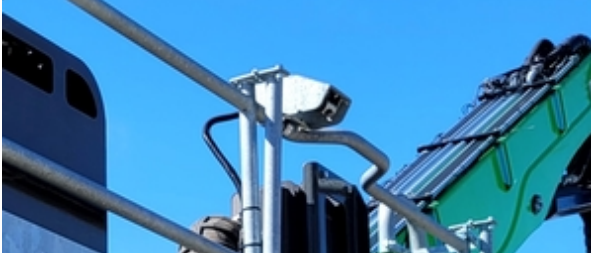
Other Gauge Activity	4 - Like New, Recently Replaced
Other Gauge Condition	All cockpit gauges are functional and in good condition
Heater & A/C	4 - Like New, Recently Replaced
Heater & A/C Condition	Heater and A/C work as expected
Travel Alarm	4 - Like New, Recently Replaced
Travel Alarm Condition	Travel alarm is installed and functioning as expected
Horn	4 - Like New, Recently Replaced
Horn Condition	Horn is installed and functioning as expected
Backup Camera	4 - Like New, Recently Replaced
Backup Camera Condition	Back up camera is installed and functioning as expected, Other (see comments)
Comments	Machine equipped with Rear and R/S Cameras
Backup Camera Photos

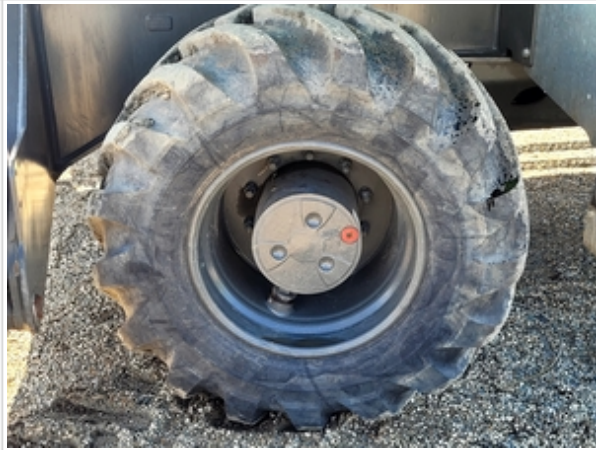
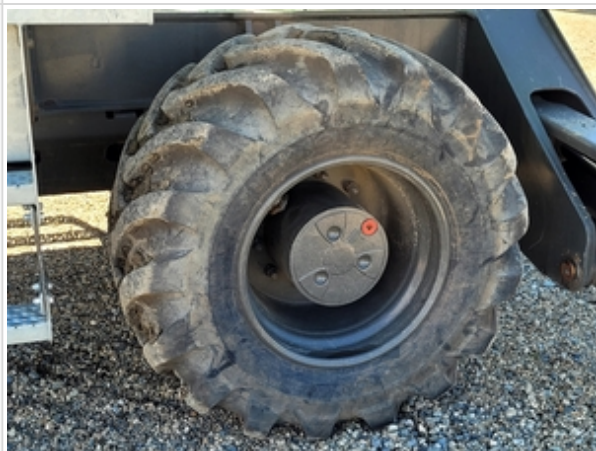
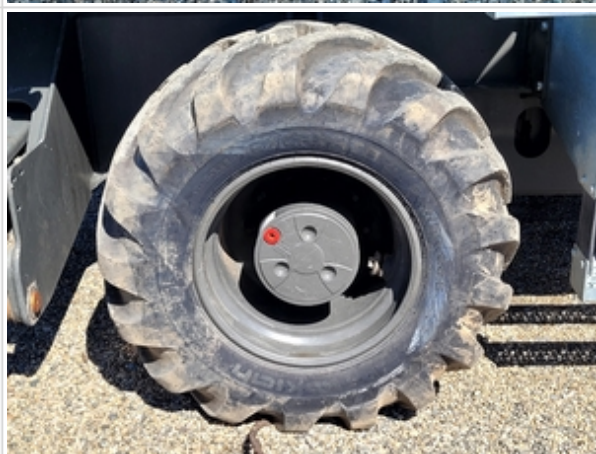
Wheels & Hub Condition	4
Comments	Tires may be water filled and have above 90%
Wheels & Hub Photos

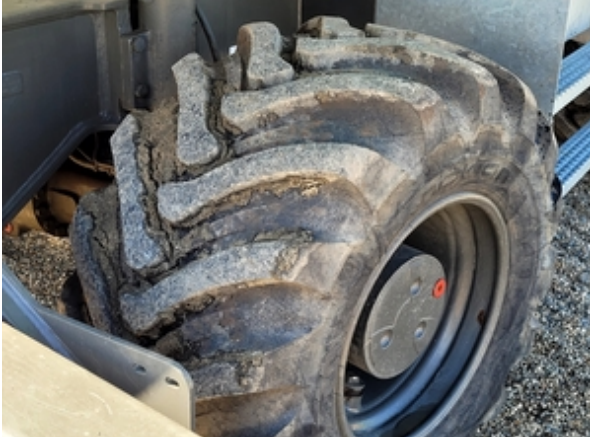
Wheel Seal Leaks	No	
Tire Brand	Nokia	
Tire Size	600/50-22.5	
Front Left Tire - Ratio Remaining	90%	
Front Left Tire Photos

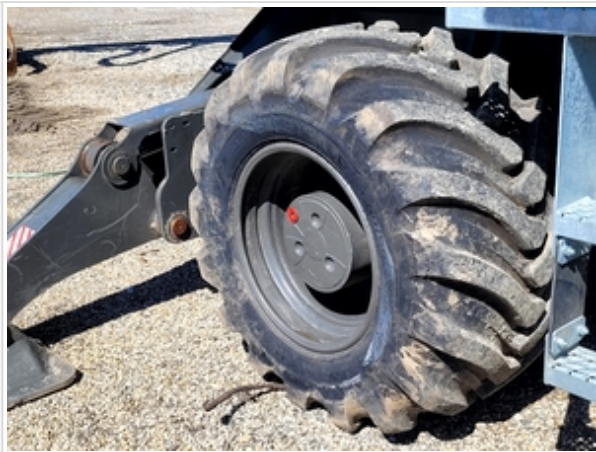
Rear Right Tire Photos

Rear Right Tire - Ratio Remaining	90%

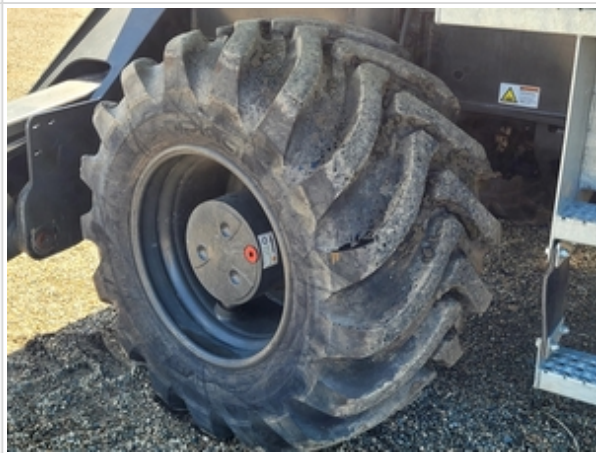
Rear Left Tire - Ratio Remaining	90%
Rear Left Tire Photos

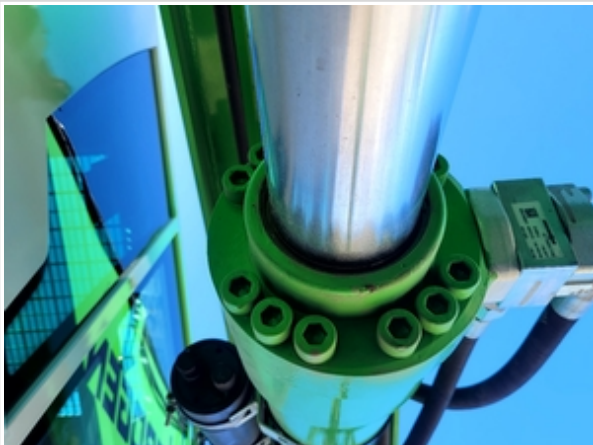
Boom Cylinder Photos	 
----------------------	---

Boom Cylinder: Mounting Pins	4 - Like New, Recently Replaced
------------------------------	---------------------------------

Boom Cylinder: Oil Leaks	No
--------------------------	----

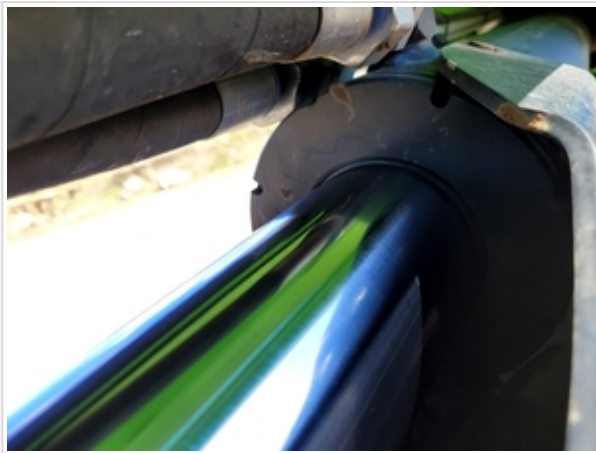
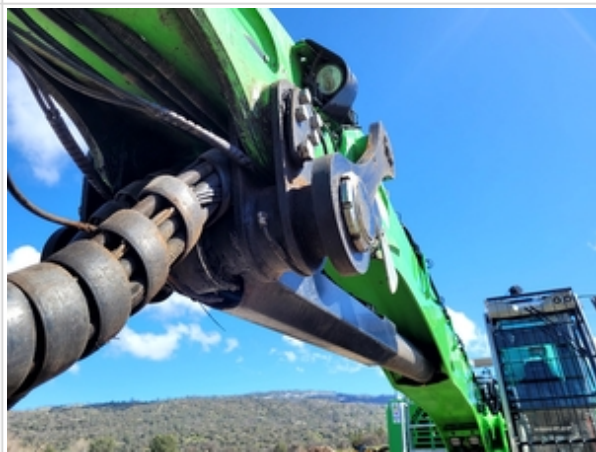
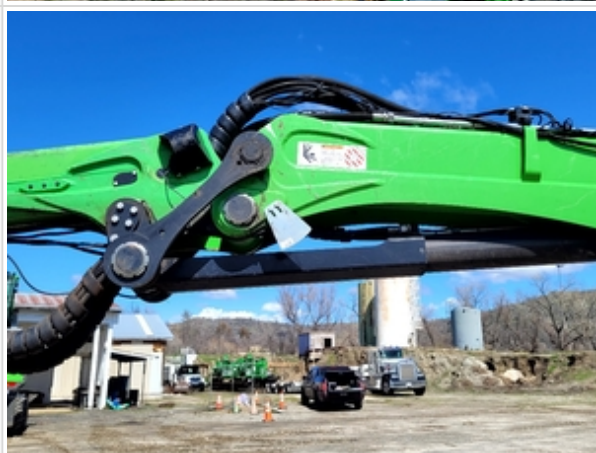
Stick Cylinder Photos

Stick Cylinder: Mounting Pins	4 - Like New, Recently Replaced
-------------------------------	---------------------------------

Stick Cylinder: Oil Leaks	No
---------------------------	----
