Inspection Report (Material Handler)

Year	2017
Make	Sennebogen
Model	825M
Serial Number	825.0.2446
Hour Meter Reading	10,882
Previous Application (e.g., earth moving, mining, demolition, etc)	Scrap Yard Work

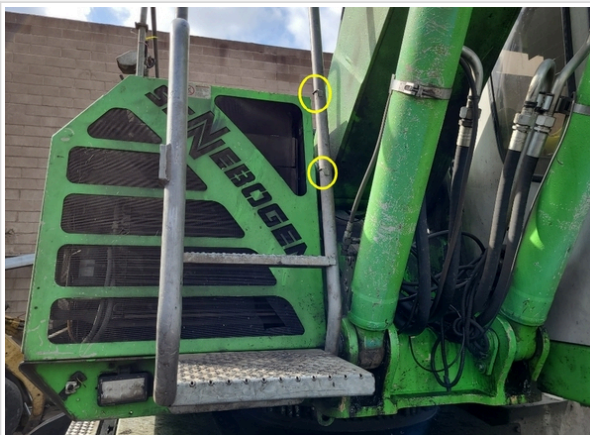
Steps Broken Off

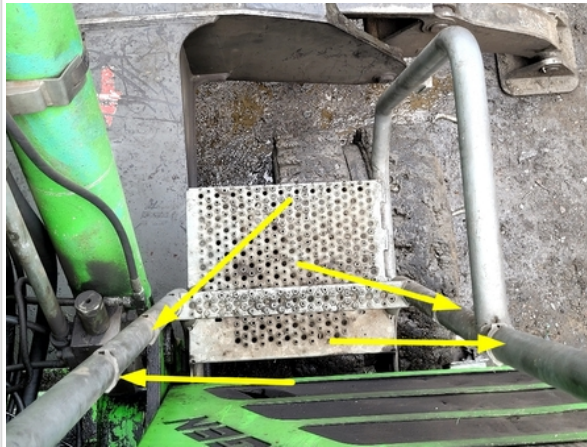
Steps Missing

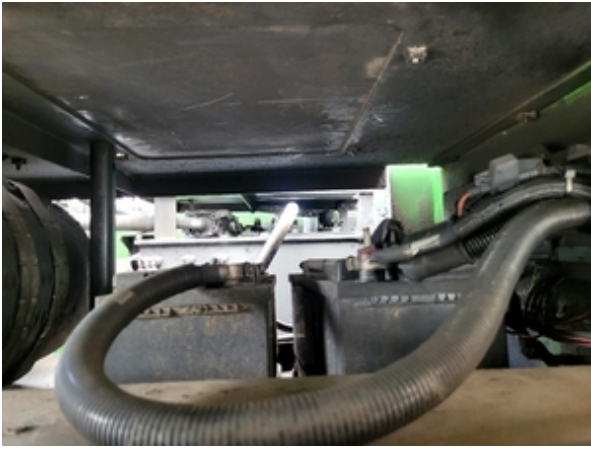
Blow-by (Visual Observation Check)	No
Unusual Noises (Upon Start-up, Idle, Shutdown)	No
Unusual Noise Notes	No unusual noises heard
Engine Smoke (Upon Start-up, Idle, Shutdown)	No
Engine Smoke Notes	No engine smoke issues observed
Engine Exhaust Color	Clear
Battery	3 - Normal Wear & Tear
Battery Condition	Other (see comments), Dusty & dirty appearance
Comments	Batteries missing hold down bracket

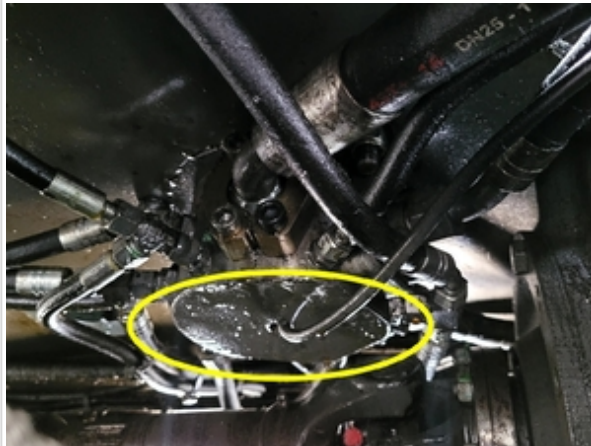
Hydraulics Under Cab

The circled area has minor hydraulic oil buildup. Minor active leak present at swivel.

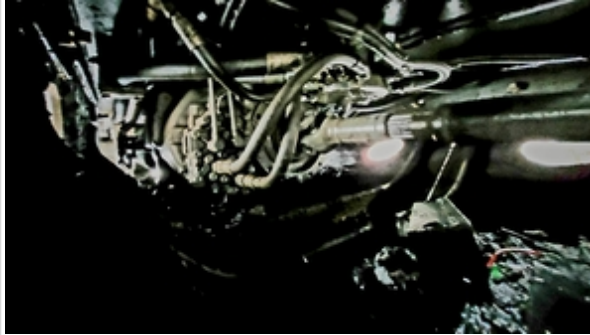
Hydrostatics Pump main area, beneath center of machine has minor oil buildup on surface of bottom machine guards.

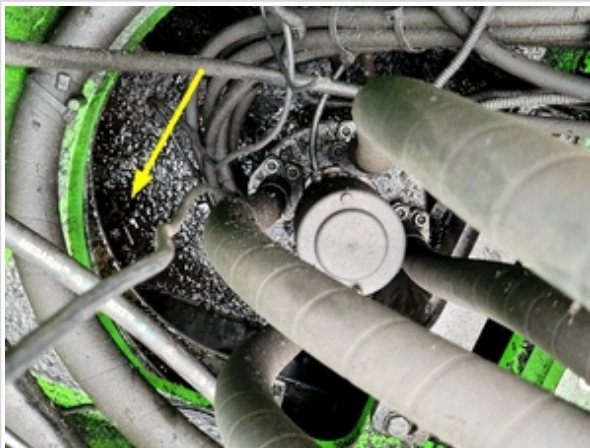
Bottom of Main control valve

Hyd. Oil buildup seen at pointed area. Active leak in the area may be present.

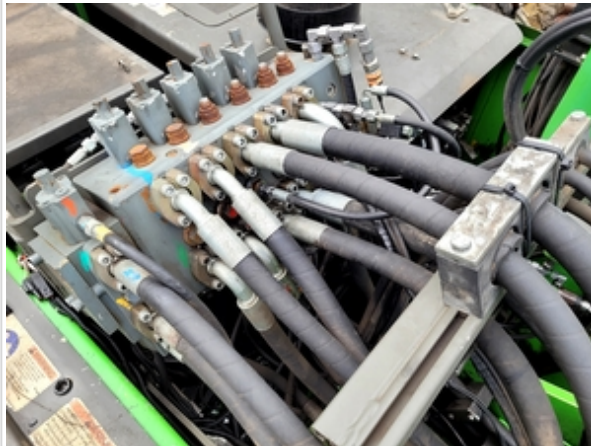
Main control valve is leak free and hoses to it are in good shape.

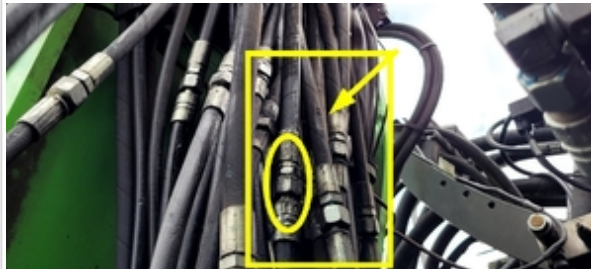
Circled area slightly leaking and pointed area shows hose surface rubbing

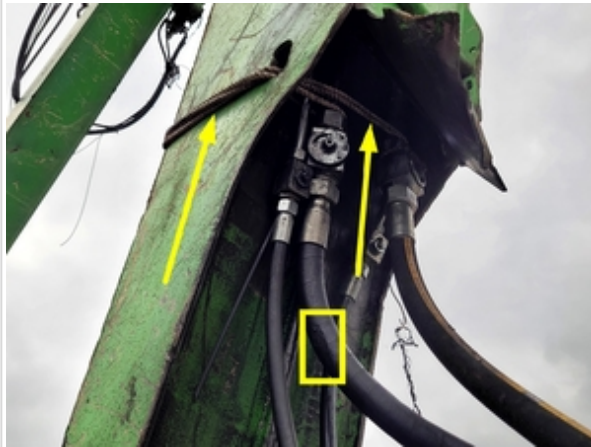
Main Auxiliary Hose brackets missing and minor seepage seen. Small surface damage observed.

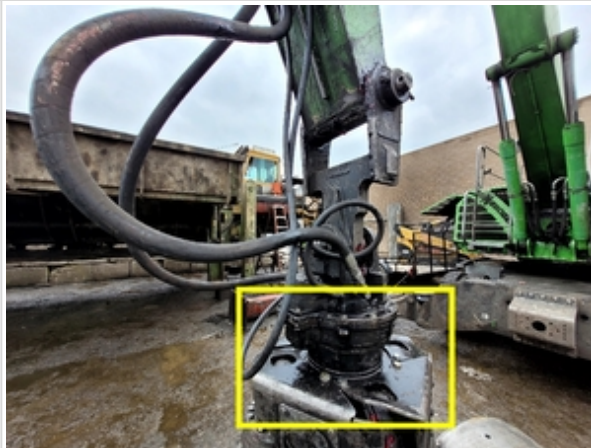
Surface wet of residual hydraulic oil

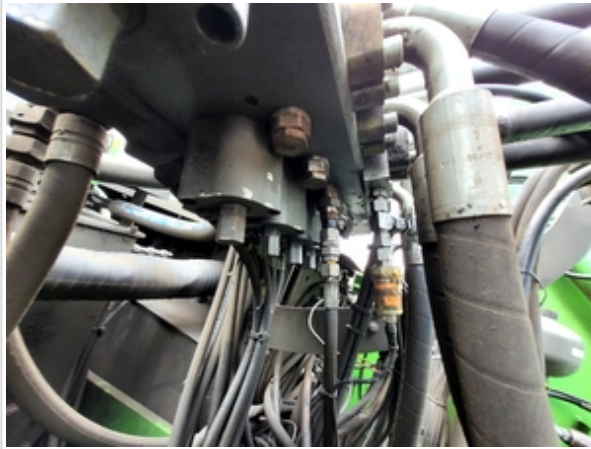
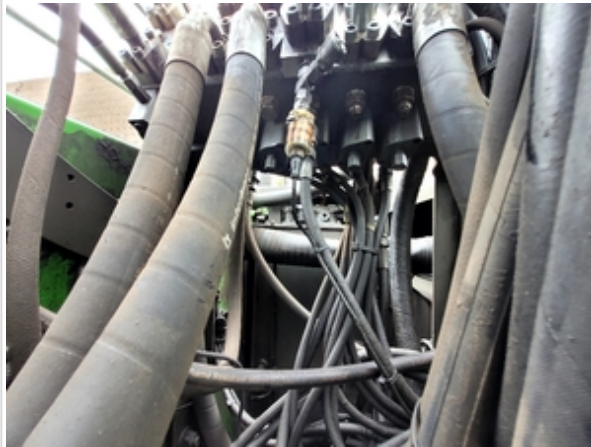
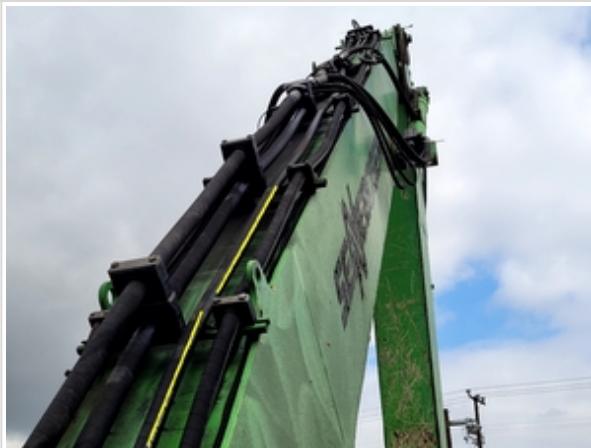
Highlighted Hose missing mounting brackets

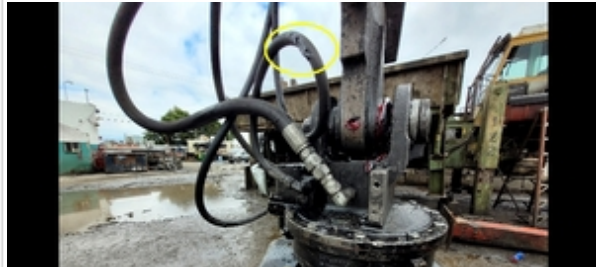
<p>Damaged Grapple Hyd. Hoses</p>
Unusual Noises (Hydraulic Pump)	No
Hydraulic Pump Notes	No unusual noises heard during operation
Swing Motor	3 - Normal Wear & Tear
Hydraulic Swivel Center	3 - Normal Wear & Tear
