Inspection Report (On-Highway Truck Cab + Chassis)

Year	2012
Make	Kenworth
Model	T800
Serial Number	1XKDDP9X4CJ335277
Truck Odometer Reading	321,622
Current Inspection / State Cert / DOT	DOT Annual Inspection Performed 10/2022 per accordance with 49CFR, Part 396, FMCSR
Previous Application (e.g., earth moving, mining, demolition, etc)	Equipment Rental Hauler

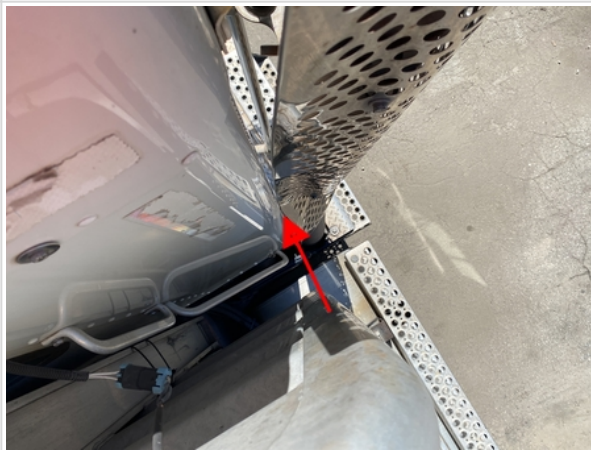
Exhaust shield damaged and pressed up against cab

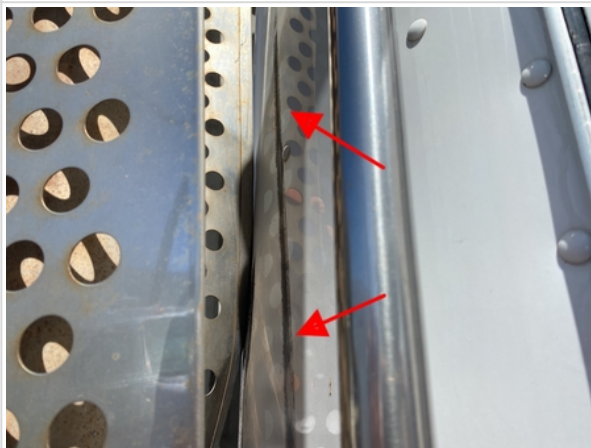
Minor scuff mark from exhaust shield damage

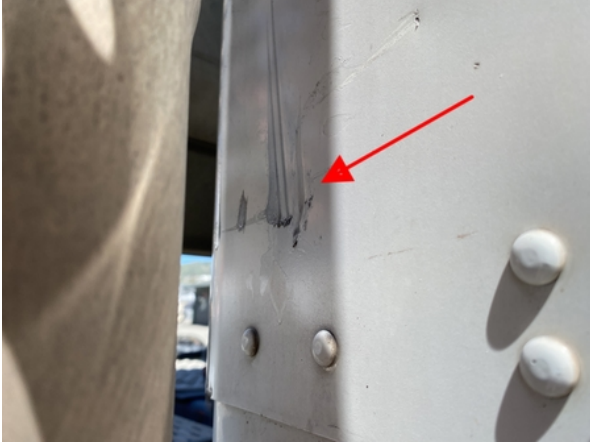
Minor damage part of exhaust shield impact	
Body Panels	3 - Normal Wear & Tear	
Body Panel Condition	No visible damage, good paint condition and panel fitment, Other (see comments)	
Comments	Only observed one area behind Exhaust Stack with minor damage.	
Doors / Canopy Latches	3 - Normal Wear & Tear	
Doors / Canopy Latches Condition	No visible damage	
Steps / Ladders	3 - Normal Wear & Tear	
Steps / Ladders Condition	Steps/ladders are fully intact and appear structurally sound	
Handrails	3 - Normal Wear & Tear	
Handrails Condition	Handrails are fully intact and appear structurally sound	
Glass	3 - Normal Wear & Tear	
Glass Condition	Glass intact, no visible damage	
Mirrors	3 - Normal Wear & Tear	
Mirror Condition	Mirrors present and intact, no visible damage, Other (see comments)	
Comments	Electric mirror adjustable control function inoperable on driver side and partially inoperable for passenger side.

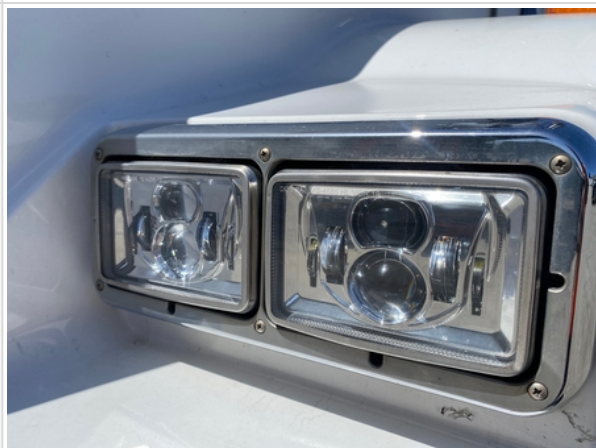
Exterior Lights	4 - Like New, Recently Replaced	
Exterior Lights Condition	Other (see comments), No visible damage, lighting system is operational	
Comments	Fault code active for fog lights but tractor does not have fog lights installed	
Exterior Lights Photos

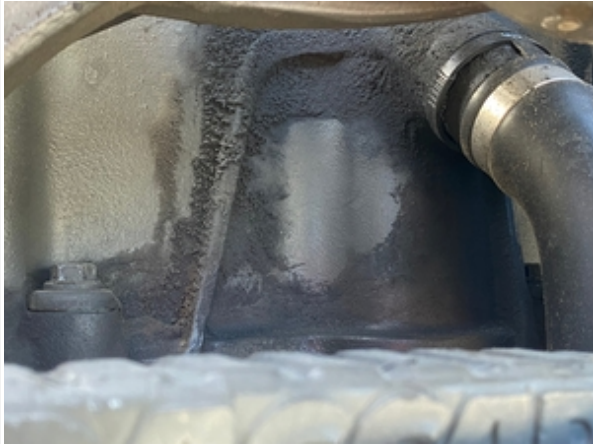
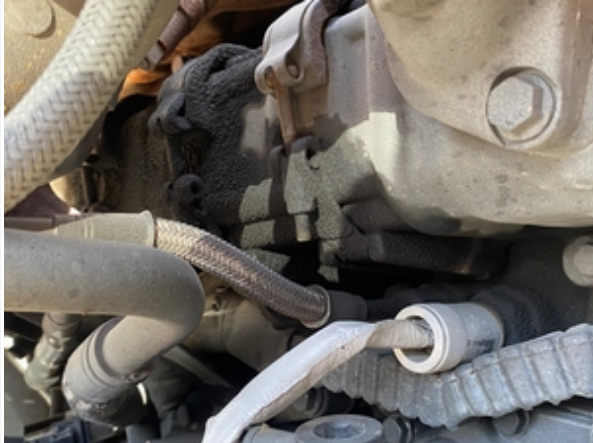
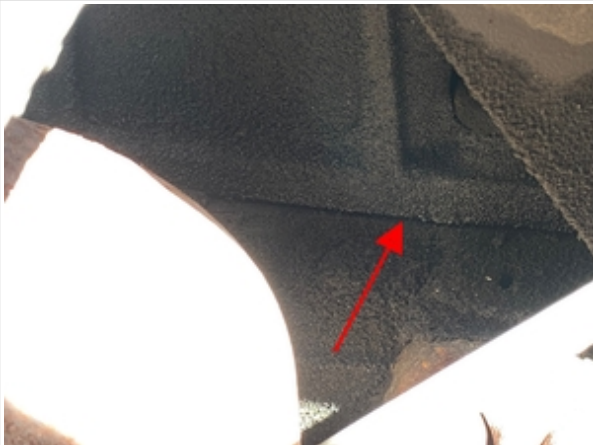
Oil Leak Photos

Battery	3 - Normal Wear & Tear
Battery Condition	Clean & dry appearance, tight connections
Radiator	3 - Normal Wear & Tear
Radiator Condition	Radiator fins & components appear to be in good working order, no signs of damage or leaks
Belts	3 - Normal Wear & Tear
Belt Condition	Belts appear in good condition & alignment with proper tension
Hoses	3 - Normal Wear & Tear
Hose Condition	Firm, pliant hoses with no signs of wear or leaks
Water Pump	3 - Normal Wear & Tear
Water Pump Condition	No unusual pump noises heard, Other (see comments)
Comments	Water pump looks like it's been recently replaced
Cooling System Leaks	No
Coolant Color / Appearance	3 - Normal Wear & Tear
Coolant Color/Appearance Notes	Normal Translucent appearance, no visual signs of contamination
Oil Leaks	Yes
Oil Leak Notes	Other (see comments), Wetness & discoloration observed
Comments	Valve cover gasket showing signs of minor leakage and hoses/tubes to valve cover also showing signs of oil seepage

<p>Valve cover leakage area</p>
Oil Color / Appearance	3 - Normal Wear & Tear
Oil Color / Appearance Notes	Clean oil appearance, no signs of cross contamination, Appropriate oil level
Fuel Leaks	No
Requires DEF (Diesel Exhaust Fluid)	Yes
DEF Tank	3 - Normal Wear & Tear
DEF Tank Condition	Area around DEF tank cap is clean, fluid is clear & appears free of contaminants
Overall Engine Appearance	Clean & dry
Overall Engine Comments	Overall engine has been well taken care of. Some components such as water pump have been replaced and engine sounds healthy under load.
