Inspection Report (Mini Excavator)

Year	2019
Make	Kubota
Model	KX033-4
Serial Number	KBCK0334PK3G13787
Hour Meter Reading	1,088 Hrs.
Previous Application (e.g., earth moving, mining, demolition, etc)	Equipment Rental

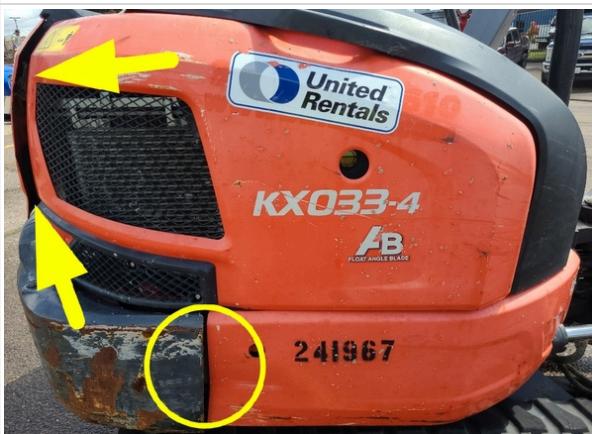
Engine Compartment Door misaligned but still closes and opens with no major issues.

Gaps from minor damages and misalignment highlighted

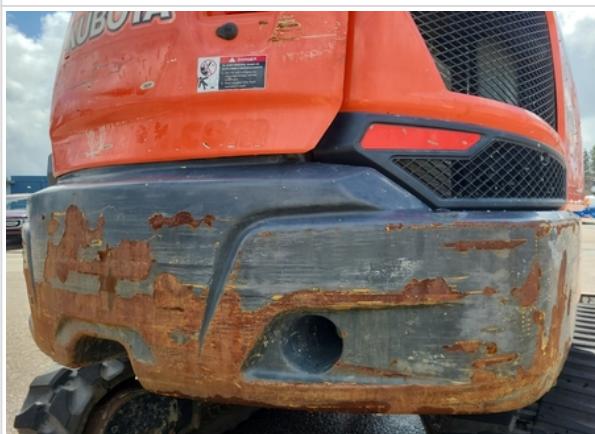
small dent present

Normal wear and tear scuff marks and minor surface rust observed on counter weight

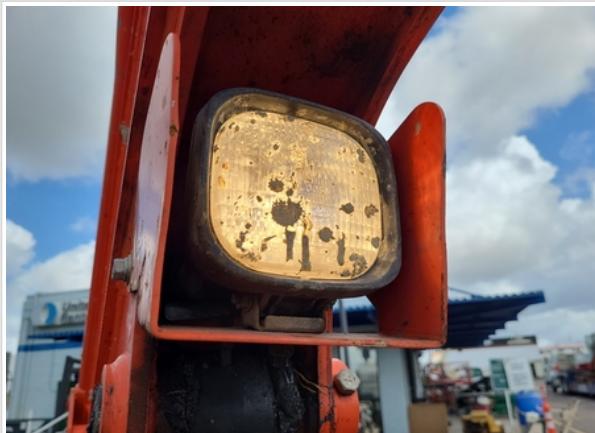
Body Panels	3 - Normal Wear & Tear
Body Panel Condition	Some panel misalignment observed, Visible chipped paint or dents, Areas of surface rust observed, Other (see comments)
Comments	Mostly minor cosmetic damage observed
Doors / Canopy Latches	3 - Normal Wear & Tear
Steps / Ladders	0
Handrails	3 - Normal Wear & Tear
Handrails Condition	Handrails are fully intact and appear structurally sound
Glass	0
Mirrors	0
Exterior Lights	3 - Normal Wear & Tear
Exterior Lights Condition	No visible damage, lighting system is operational

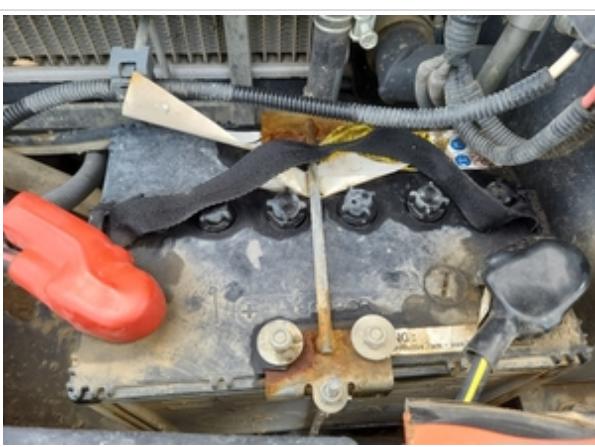
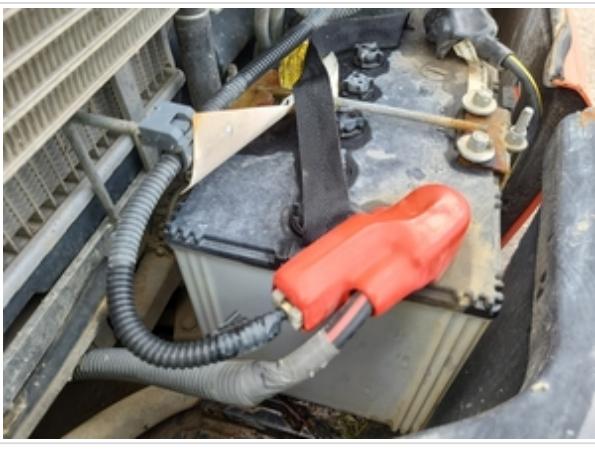
Battery Condition Photos

Blow-by (Visual Observation Check)	N/A
Unusual Noises (Upon Start-up, Idle, Shutdown)	No
Unusual Noise Notes	No unusual noises heard
Engine Smoke (Upon Start-up, Idle, Shutdown)	No
Engine Smoke Notes	No engine smoke issues observed
Engine Exhaust Color	Clear
Battery	3 - Normal Wear & Tear
Battery Condition	Dusty & dirty appearance, Clean & dry appearance, tight connections

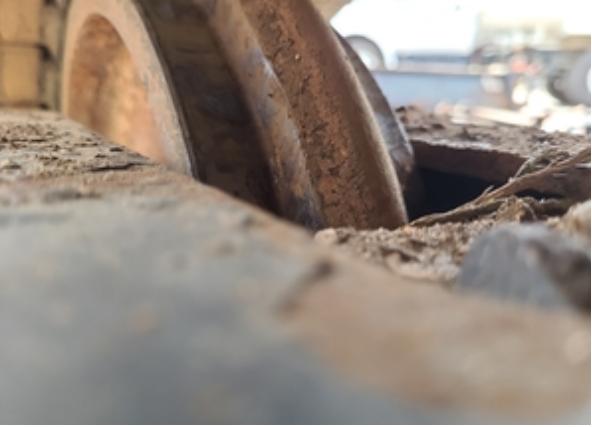
A close-up photograph of a rear idler wheel, showing significant rust and wear on the metal frame.

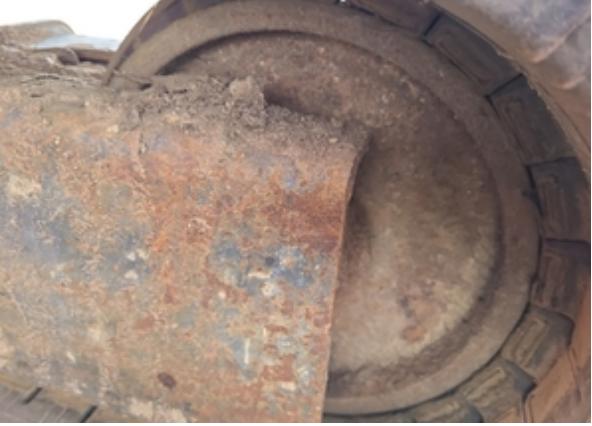
A close-up photograph of a track roller, showing significant rust and wear on the metal frame.
Rear Idlers	0
Track Rollers	3 - Normal Wear & Tear
Track Rollers Photos

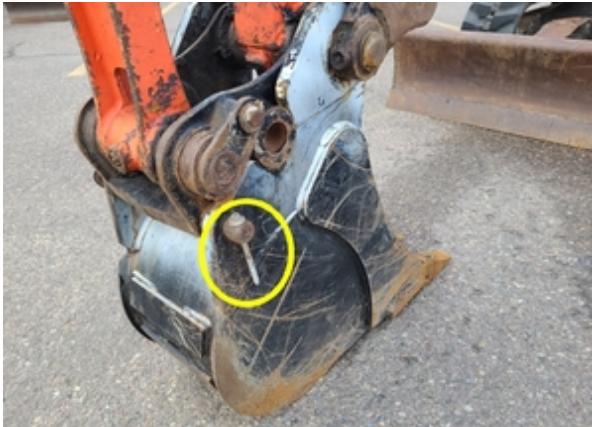
Bucket Condition	3 - Normal Wear & Tear
Comments	Bucket pin has improper retaining hardware
Bucket Photos	A photograph of a mini excavator's bucket, showing the metal digging edge and the hydraulic arm it is attached to. The bucket is positioned on a paved surface.

Pin retainer missing nut or should be replaced	
Bucket Hose & Fittings	3 - Normal Wear & Tear

What's Great About the Machine	Machine has well maintained appearance and no active leaks observed. Machine is equipped with lift and angle Tilt for front blade. Machine also has a hydraulic thumb with a 12" bucket in great condition. Low hours on this Machine and plenty of work life left.
What Needs Work	Cosmetic damage all around the main body of the machine. Bucket coupler pin retainer should be repaired.
Date/Time	03-30-2023
