Inspection Report (Skip Loader)

Year	2006
Make	John Deere
Model	210 LE
Serial Number	T0210LE885081
Hour Meter Reading	4,488 Hrs.
Previous Application (e.g., earth moving, mining, demolition, etc)	Water Treatment General Construction

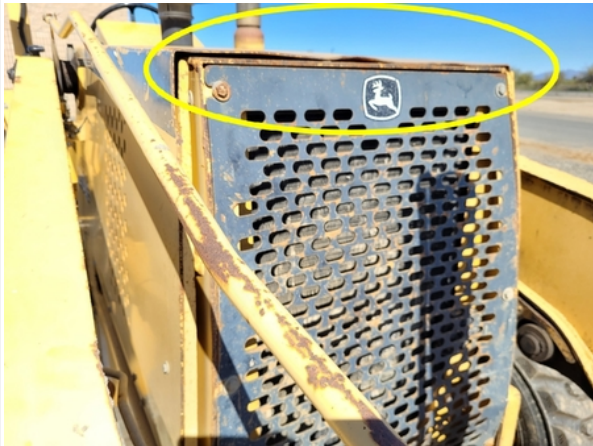
Body Panels Photos

Body Panels	3 - Normal Wear & Tear	
Body Panel Condition	Some panel misalignment observed, Other (see comments), Visible chipped paint or dents	
Comments	Minor cosmetic front hood damage @ front center area

Minor cosmetic damage
Doors / Canopy Latches	3 - Normal Wear & Tear
Doors / Canopy Latches Condition	No visible damage
Steps / Ladders	3 - Normal Wear & Tear
Steps / Ladders Condition	Steps/ladders are fully intact and appear structurally sound
Handrails	0
Glass	0
Mirrors	3 - Normal Wear & Tear
Mirror Condition	Mirrors present and intact, no visible damage
Exterior Lights	3 - Normal Wear & Tear
Exterior Lights Condition	No visible damage, lighting system is operational

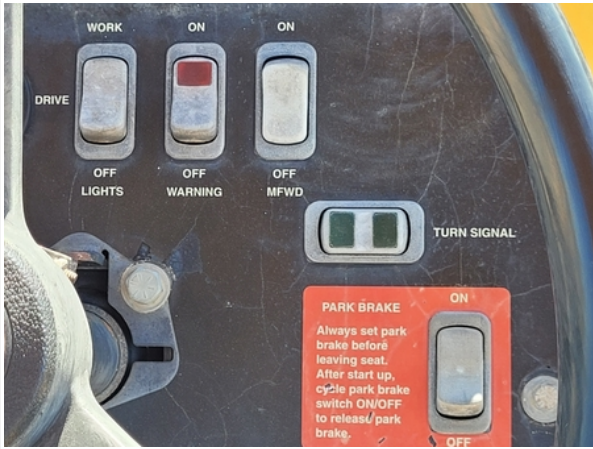
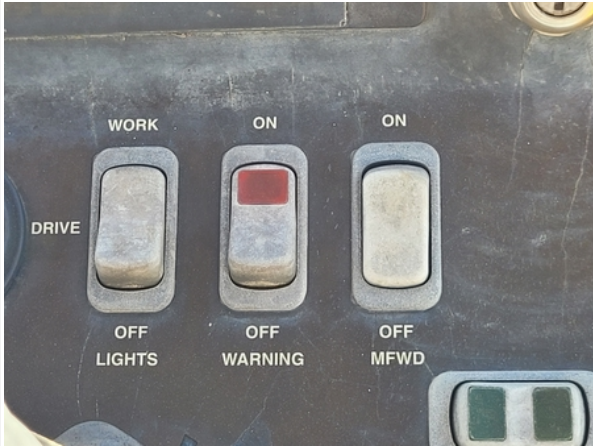
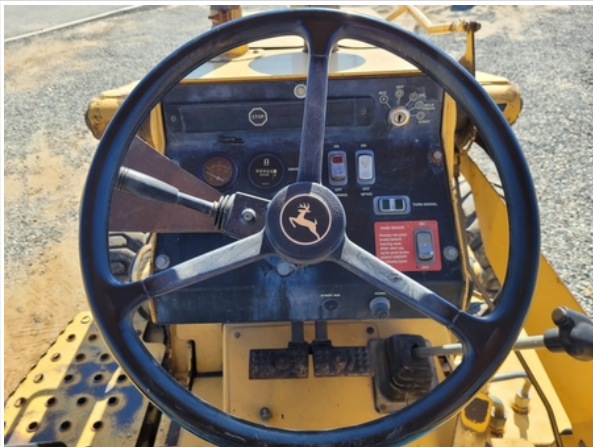
Controls & Switches	3 - Normal Wear & Tear
Controls & Switches Condition	One or more switches are inoperative or missing, Other (see comments), Switches have good functionality, minor cosmetic damage observed
Comments	Horn Switch Inoperable, Horn inop or disconnected. Front bucket control lever linkage loose at control valve
Controls & Switches Photos

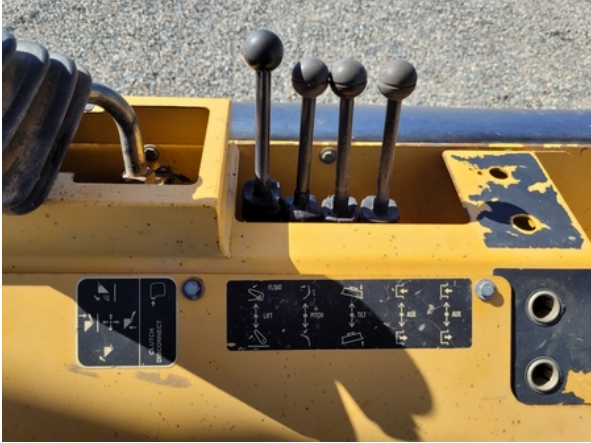
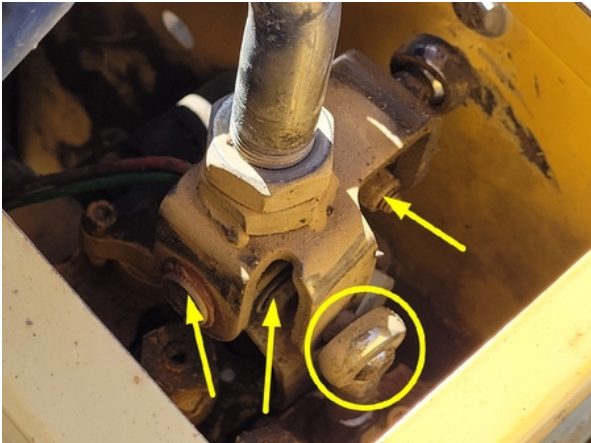
<p>Front bucket control linkage highlighted, should be further inspected to address excess play</p>
Hour Meter Activity	3 - Normal Wear & Tear
Hour Meter Condition	Hour meter is functional and in good condition
Hour Meter Activity Photos

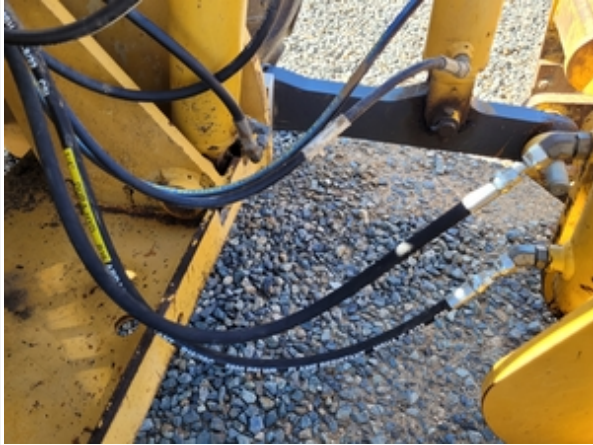
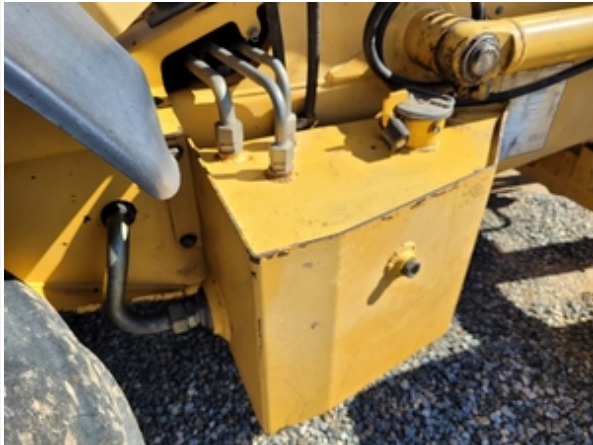
Wet or Damp Hydraulic Lines / Fittings	Yes	
Appearance of Hydraulic Lines / Fittings	3 - Normal Wear & Tear	
Hydraulic Lines / Fittings Condition	Hydraulic lines & fittings are clean and in good condition, Other (see comments)	
Comments	Small leak observed at rear Gannon (Box) control valve	
Unusual Noises (Hydraulic Pump)	No	
Hydraulic Pump Notes	No unusual noises heard during operation	
Comments	Hydraulics operating well with main functions.

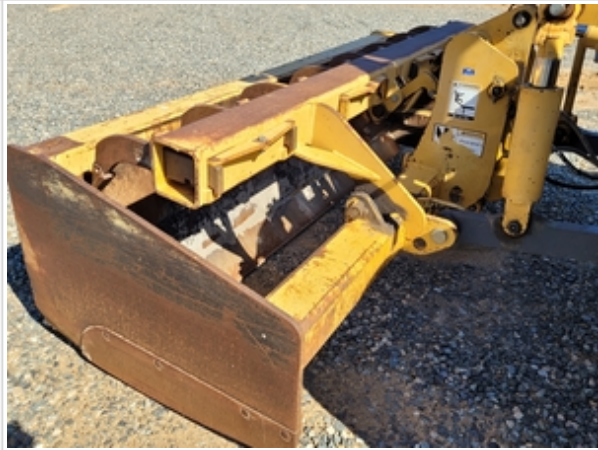
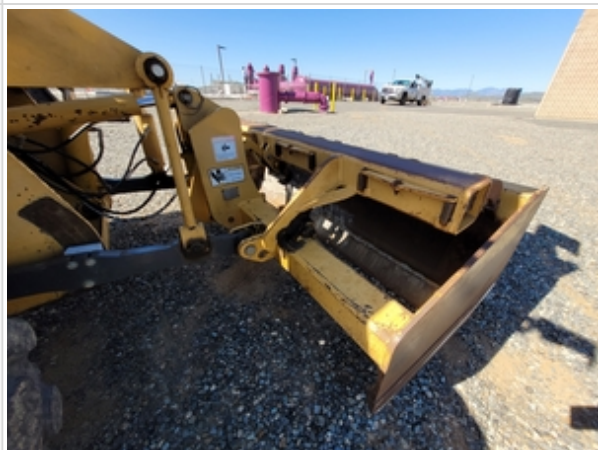
Box	3 - Normal Wear & Tear	
Comments	1 Scarifier Tip missing, Cutting edges okay, Side cutters worn	
Box Photos
