## Inspection Report (Generator)

Year	2002
Make	300kW Kohler Generator (Enclosed Portable Trailer)
Model	30OREOZD-RT
Serial Number	O749039
Hour Meter Reading	3,870 Hrs.
Previous Application (e.g., earth moving, mining, demolition, etc)	N/A

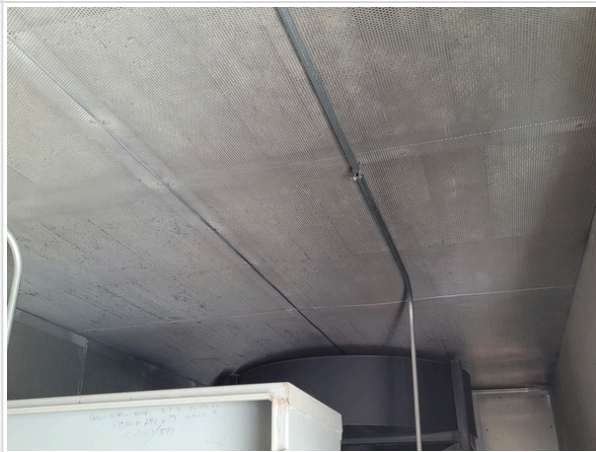
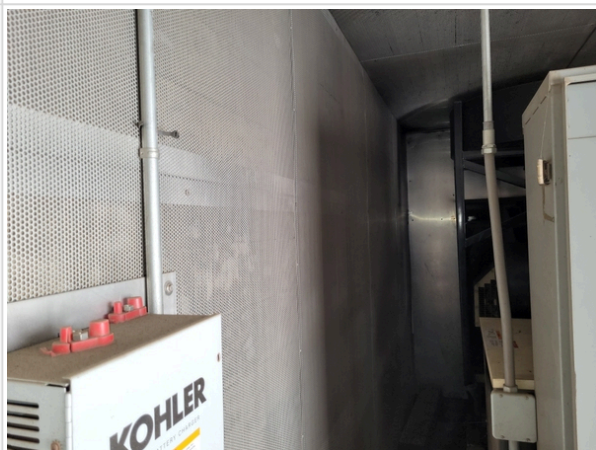
<b>Body Panels</b>	3 - Normal Wear & Tear	
<b>Body Panel Condition</b>	No visible damage, good paint condition and panel fitment, Other (see comments)	
<b>Body Panels Photos</b>

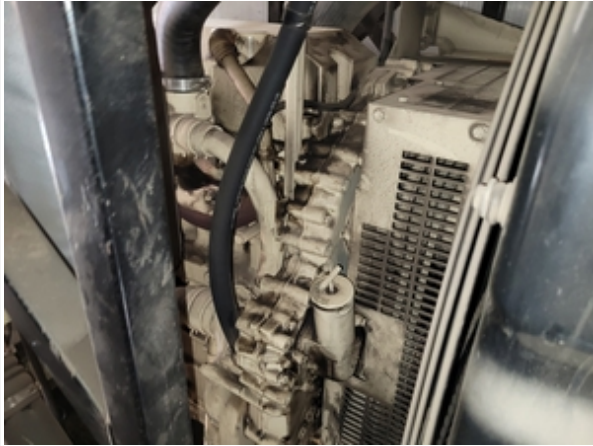
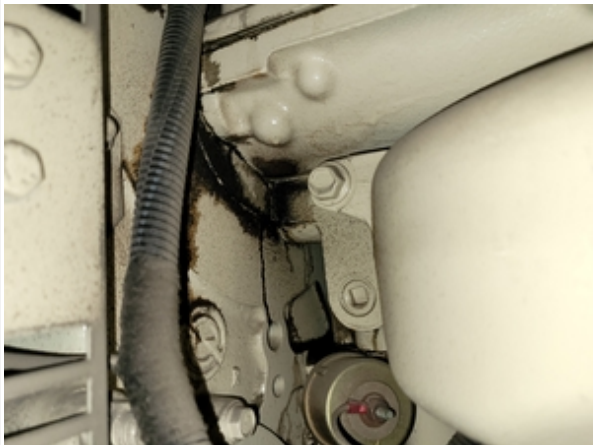
Belt Condition	Other (see comments)
Comments	Belts looked okay but fan shields obstructed clear view
Hoses	3 - Normal Wear & Tear
Hose Condition	Firm, pliant hoses with no signs of wear or leaks
Water Pump	3 - Normal Wear & Tear
Water Pump Condition	No unusual pump noises heard
Cooling System Leaks	No
Coolant Color / Appearance	3 - Normal Wear & Tear
Coolant Color/Appearance Notes	Normal Translucent appearance, no visual signs of contamination
Oil Leaks	Yes
Oil Leak Notes	Wetness & discoloration observed, Other (see comments)
Comments	Signs of active oil leaks seen at both sides of front engine cover and also around valve cover gasket
Oil Leak Photos

Overall Engine Comments	Signs of possible front engine oil leak seen. Oil pressure sensor not displaying on monitor panel.
-------------------------	--

Exterior Rating	3 - Normal Wear & Tear
Interior Rating	3 - Normal Wear & Tear
Safety Rating	3 - Normal Wear & Tear
Quality Rating	3 - Normal Wear & Tear
Functionality Rating	3 - Normal, Operating as Expected
Overall Rating	3 - Normal Wear & Tear
What's Great About the Machine	Generator trailer in good condition inside and out. Engine and generator had a good working appearance.
What Needs Work	Engine oil pressure not reading on monitor display. Possible engine oil leak at front of engine and valve cover. Tires should be replaced based on age and sidewall cracks.
Date/Time	04-07-2023

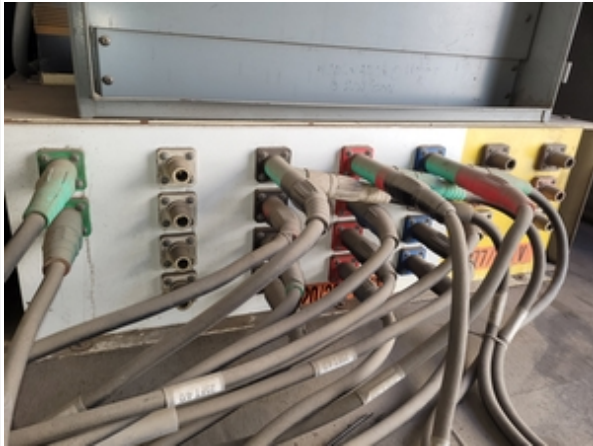
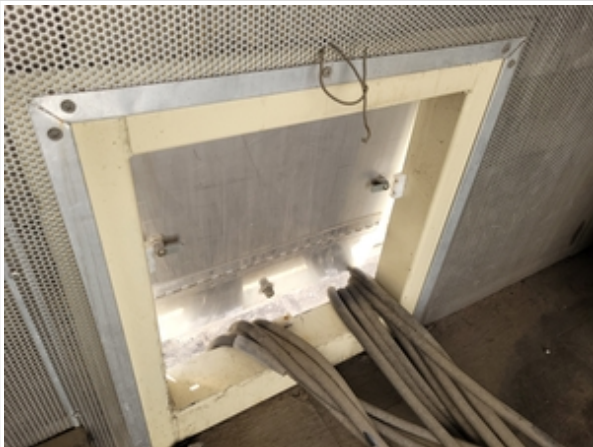
Cables & Fittings	3 - Normal Wear & Tear
Comments	Power supply cables NOT included
Cables & Fittings Photos

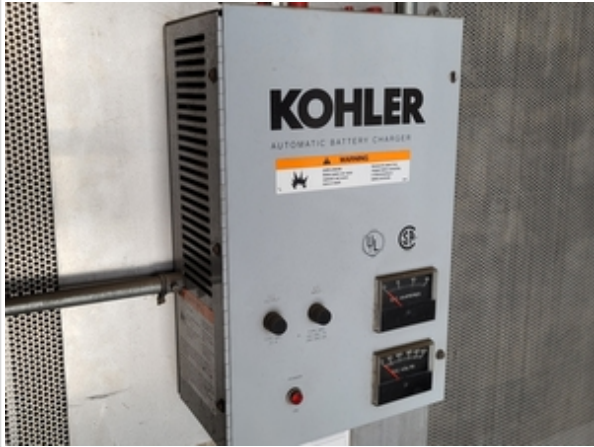
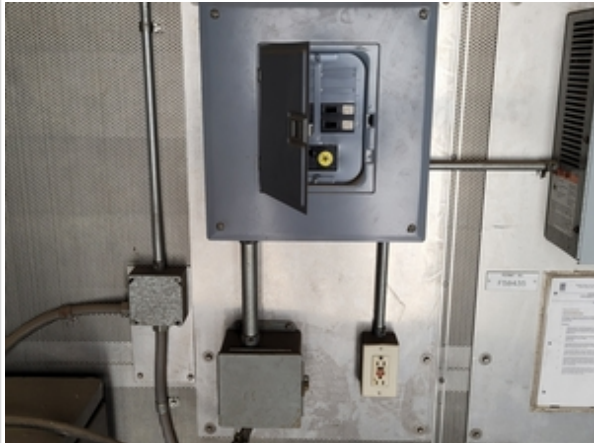
Controls & Switches	3 - Normal Wear & Tear
Comments	Start/Stop Timer added by owner next to start panel. Voltage regulator knob missing
Controls & Switches Photos

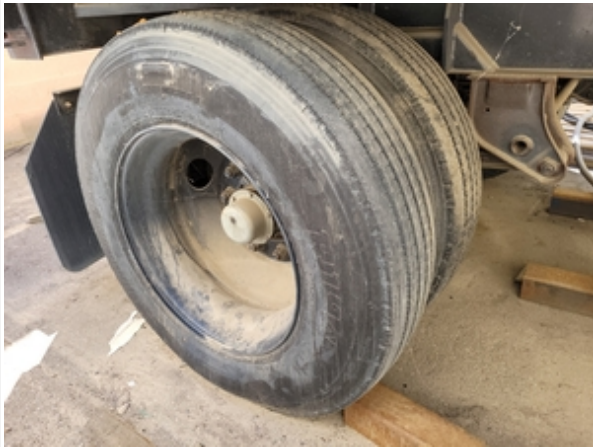
Wheels & Hub Condition	3 - Normal Wear & Tear
Loose Lugs	No
Tire Brand	Bridgestone
Tire Size	295/75R/22.5
Rear Right Tire - Ratio Remaining	10%
Rear Right Tire Photos

Overall Trailer Condition	3 - Normal Wear & Tear
Overall Trailer Comments	Front Square Tubing Stands added for stability and need to be removed for transport. Tires old and have sidewall cracks. Unable to test trailer for proper operation in regards to lights, air and breakaway system. DOT inspection recommended.
Fuel Tank Condition	3 - Normal Wear & Tear
Comments	800 Gallon tank mounted inside rear side of trailer
Fuel Tank Photos

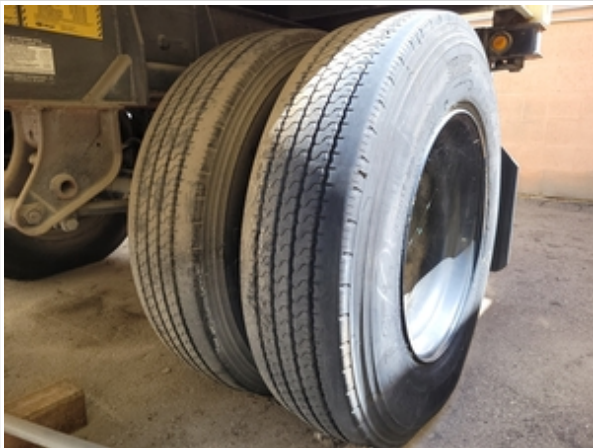
Rear Left Tire - Ratio Remaining	10%
Rear Left Tire Photos

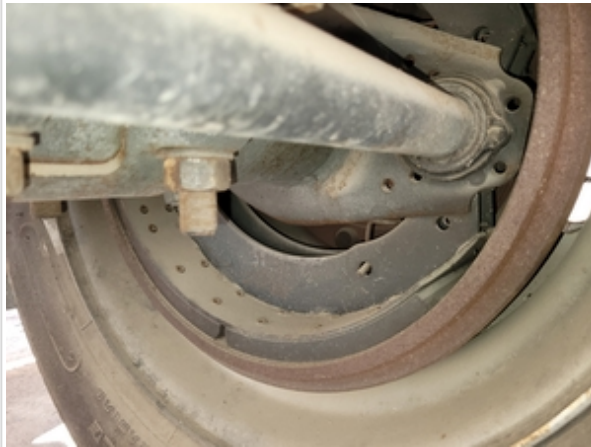
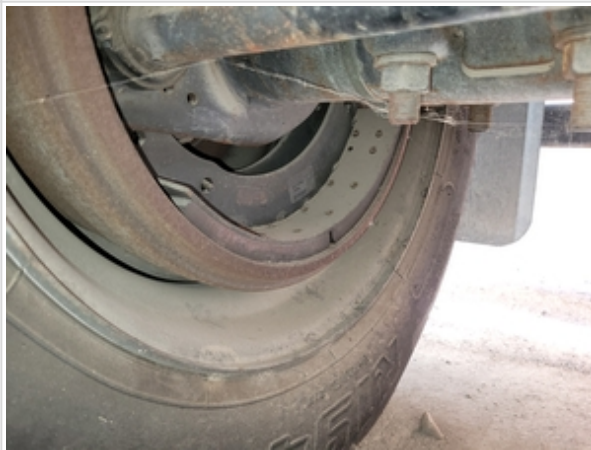
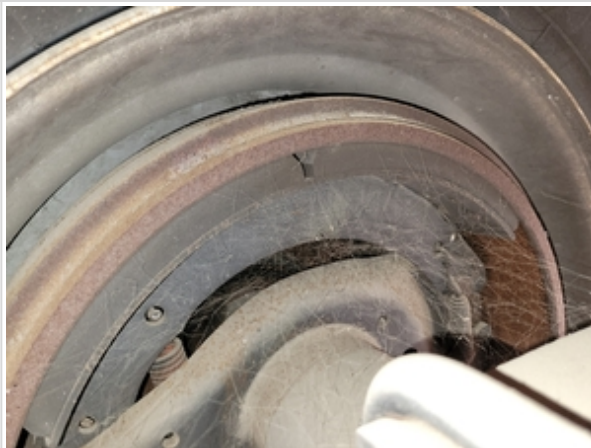
Brake Type	Air Brakes
Brake Controller	No
Air Brake System Leaks	N/A
Air Lines Condition (Between Trailers, Gladhands, Rubbers)	3 - Normal Wear & Tear
Brake Shoe Thickness	70%
