Inspection Report (Generator)

Year	2008
Make	L3 OFNW8
Model	MEP-805B
Serial Number	HX36952
Hour Meter Reading	840 Hrs.
Previous Application (e.g., earth moving, mining, demolition, etc)	U.S.A. Military Generator

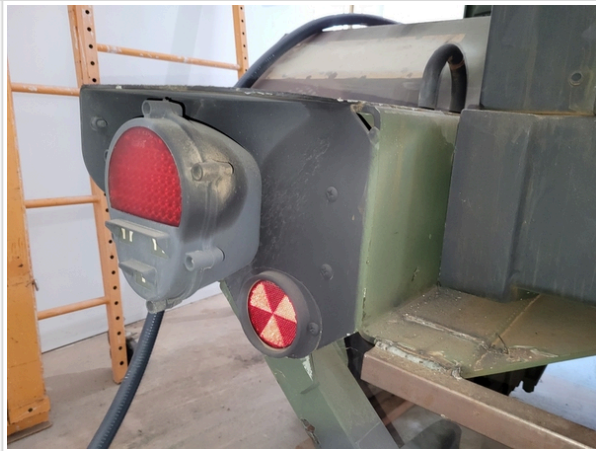
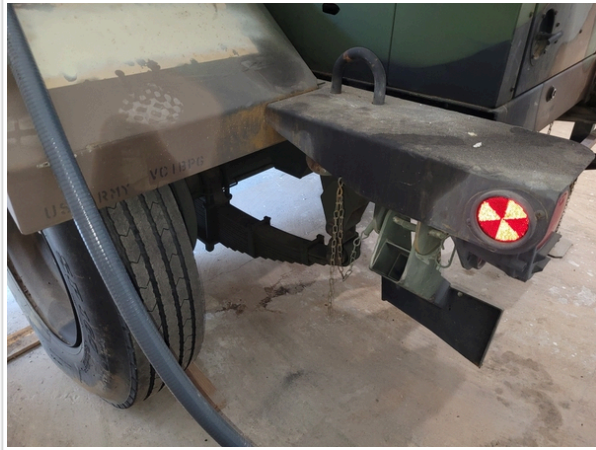
Body Panels	3 - Normal Wear & Tear
Body Panel Condition	No visible damage, good paint condition and panel fitment
Doors / Canopy Latches	3 - Normal Wear & Tear
Doors / Canopy Latches Condition	No visible damage
Steps / Ladders	0
Handrails	0
Glass	0
Mirrors	0
Exterior Lights	3 - Normal Wear & Tear
Exterior Lights Condition	Other (see comments)
Comments	Unable to test during inspection. Light fixtures had good appearance.

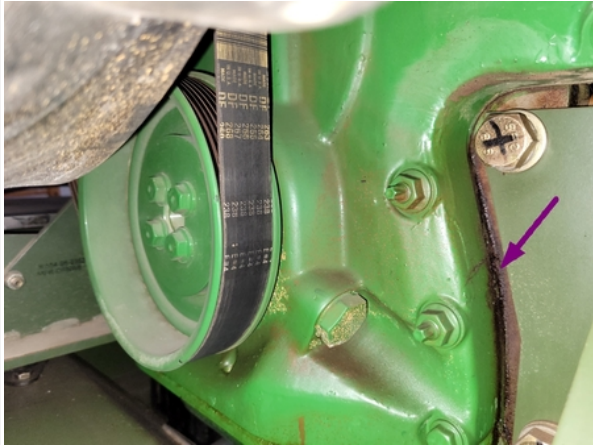
Water Pump	3 - Normal Wear & Tear
Water Pump Condition	No unusual pump noises heard
Cooling System Leaks	No
Coolant Color / Appearance	3 - Normal Wear & Tear
Coolant Color/Appearance Notes	Normal Translucent appearance, no visual signs of contamination
Oil Leaks	Yes
Oil Leak Notes	Dried oil seepages seen, Other (see comments)
Comments	Minor seepage leak seen at front engine area
Oil Leak Photos

Overall Assessment	
Exterior Rating	3 - Normal Wear & Tear
Interior Rating	3 - Normal Wear & Tear
Safety Rating	3 - Normal Wear & Tear
Quality Rating	3 - Normal Wear & Tear
Functionality Rating	3 - Normal, Operating as Expected
Overall Rating	3 - Normal Wear & Tear
What's Great About the Machine	John Deere engine in solid shape and generator working well. Trailer also in good condition and tires are like new. Generator has clean, well maintained appearance, inside and out.
What Needs Work	Minor oil leak at front of engine. DOT Inspection recommended.
Date/Time	04-07-2023

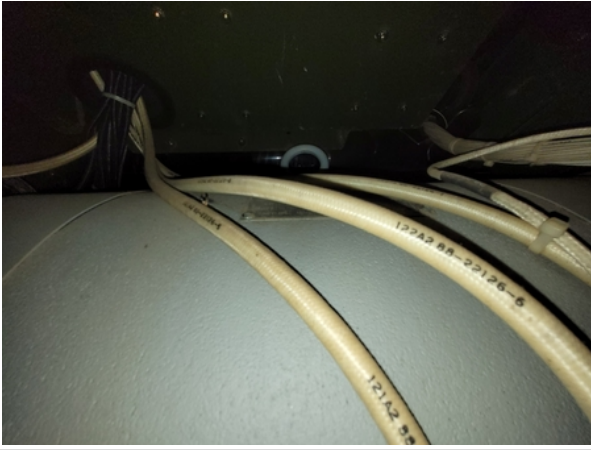
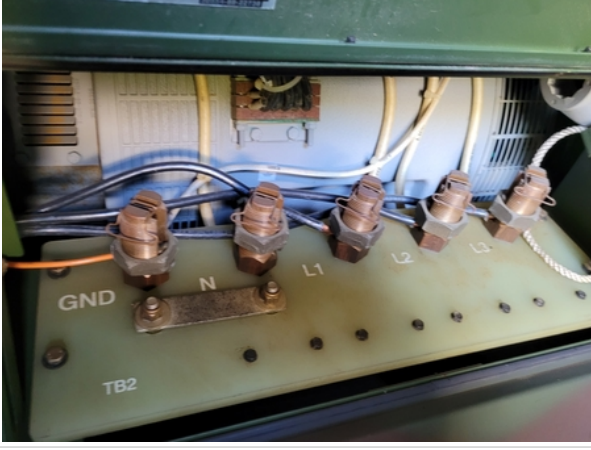
Cables & Fittings	3 - Normal Wear & Tear	
Cables & Fittings Photos

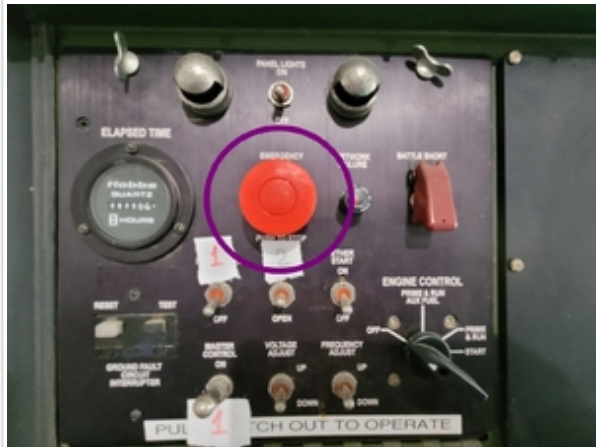
Disconnect Switch	3 - Normal Wear & Tear
Disconnect Switch Photos

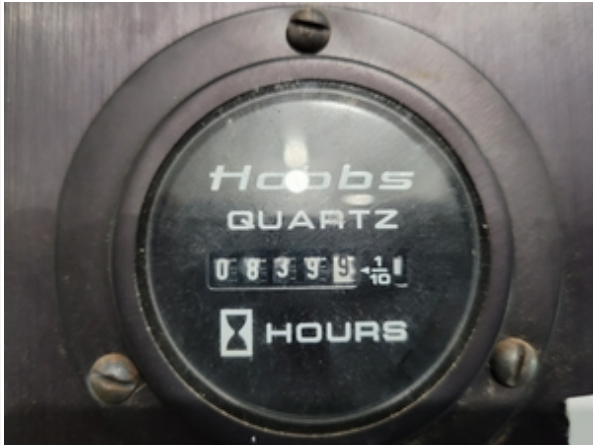
Hour Meter	3 - Normal Wear & Tear
Hour Meter Photos

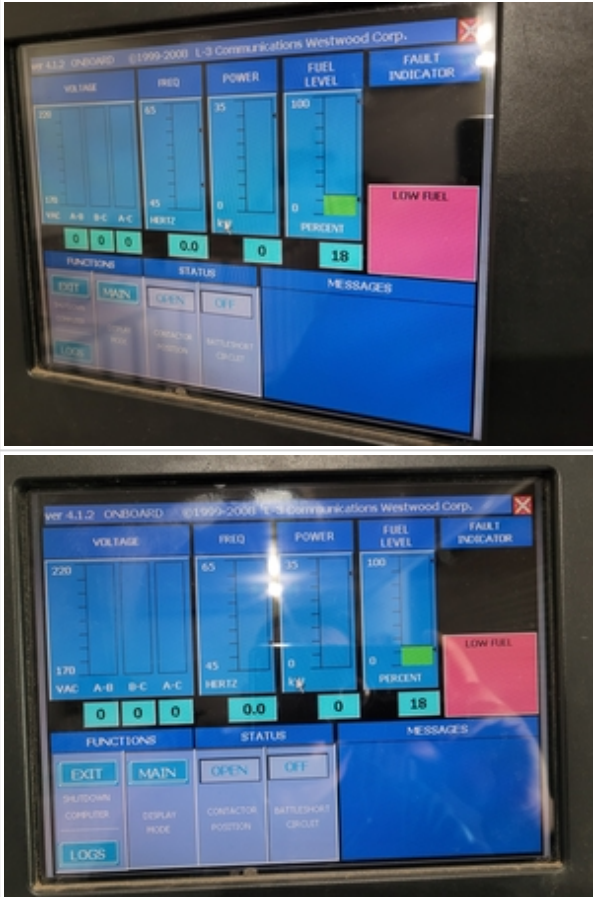
RPM Display	3 - Normal Wear & Tear
Volt Display	3 - Normal Wear & Tear
Pressure Display	3 - Normal Wear & Tear
Menu Display	3 - Normal Wear & Tear
Menu Display Photos

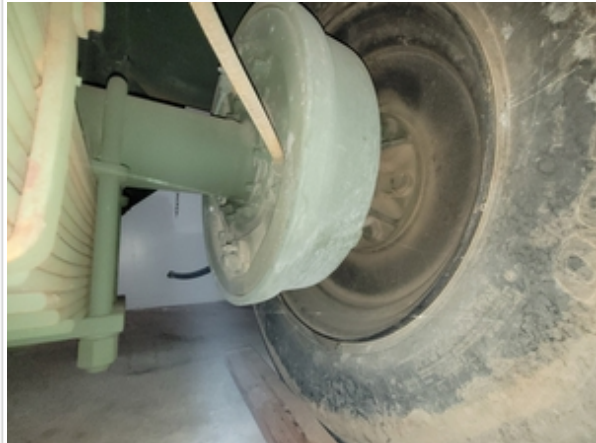
Brake Type	Air Brakes, Other (see comments)	
Comments	Air/Mechanical, brake chamber to mechanical cable to brake drums	
Air Brake System Leaks	N/A	
Air Lines Condition (Between Trailers, Gladhands, Rubbers)	3 - Normal Wear & Tear	
Brake Shoe Thickness	70%	
Comments	Drum brakes covered, Estimated percentage based on hours and years	
Brake Shoe Photos

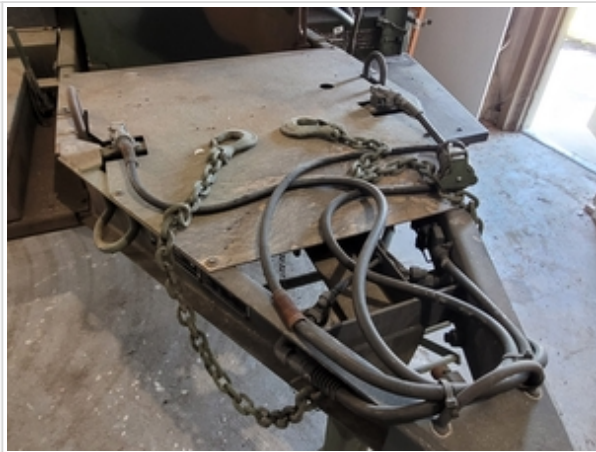
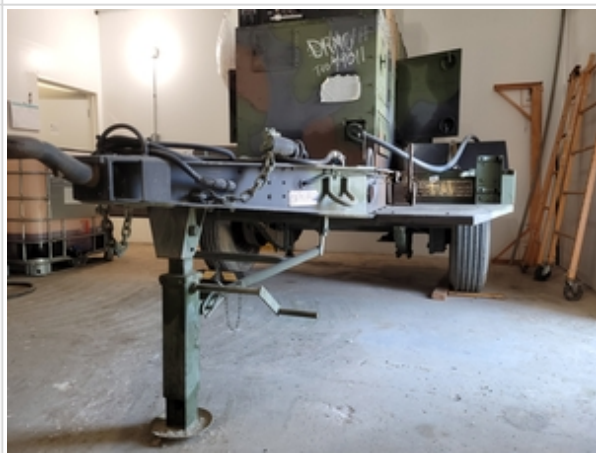
Emergency Brake/Break-Away Photos

<p>Emergency Brake/Break-Away</p>	<p>3 - Normal Wear & Tear</p>
