Inspection Report (On-Highway Truck Cab + Chassis)

Year	2013
Make	Chevrolet
Model	2500HD
Serial Number	1GC2CXCG8DZ289731
Truck Odometer Reading	195,618
Previous Application (e.g., earth moving, mining, demolition, etc)	Equipment Rental

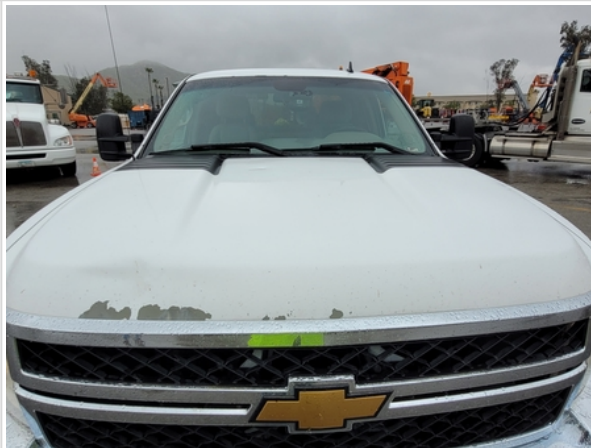
Small Chrome Film Peeling Off

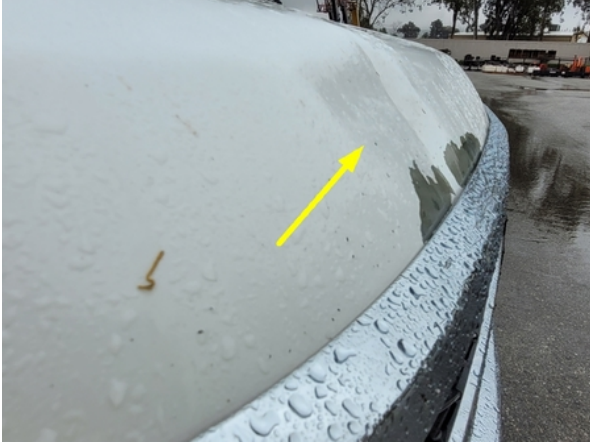
Small dent at pointed area

Small Dent at Pointed Area	
Body Panels	3 - Normal Wear & Tear	
Body Panel Condition	Visible chipped paint or dents	
Doors / Canopy Latches	3 - Normal Wear & Tear	
Doors / Canopy Latches Condition	No visible damage	
Steps / Ladders	3 - Normal Wear & Tear	
Steps / Ladders Condition	Steps/ladders are fully intact and appear structurally sound	
Handrails	3 - Normal Wear & Tear	
Handrails Condition	Handrails are fully intact and appear structurally sound	
Glass	3 - Normal Wear & Tear	
Glass Condition	Glass intact, no visible damage	
Mirrors	3 - Normal Wear & Tear	
Mirror Condition	Mirrors present and intact, no visible damage, Other (see comments)	
Comments	Driver Side Mirror may have an electric motor problem (Mirror adjustment hesitation observed)	
Exterior Lights	3 - Normal Wear & Tear	
Exterior Lights Condition	No visible damage, lighting system is operational

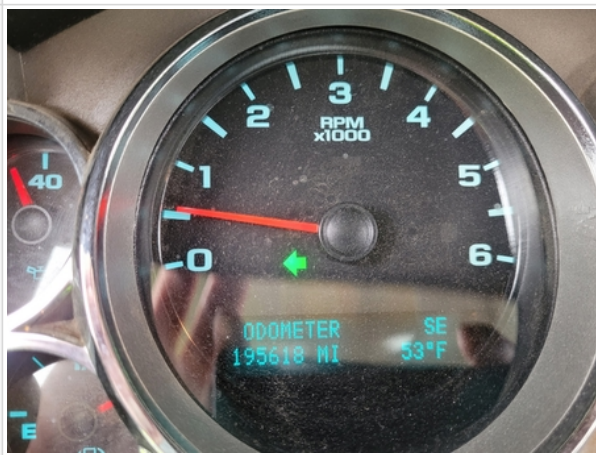
<p> RPM x1000 ODOMETER 195618 MI SE 53°F </p>
<p>Cab Interior Photos</p>

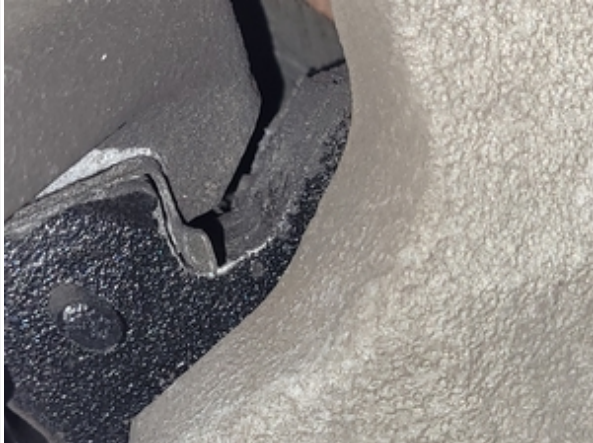
Frame	3 - Normal Wear & Tear	
Suspension	3 - Normal Wear & Tear	
Comments	Rear shocks oil seepage observed and should be replaced for optimal performance.	
Steer Axle Condition	3 - Normal Wear & Tear	
Steering Components	3 - Normal Wear & Tear	
Steering Component Photos
