Inspection Report (On-Highway Lube Truck)

Year	2012
Make	Ford
Model	F750
Serial Number	3FRNF7FA9CV417953
Truck Odometer Reading	9,282 Miles
Current Inspection / State Cert / DOT	Performed 2/2023 In accordance with 49 CFR, Part 396, FMCSR
Previous Application (e.g., earth moving, mining, demolition, etc)	Equipment Rental

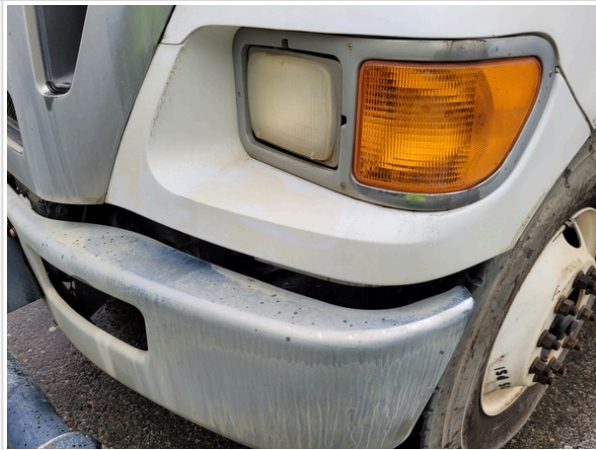
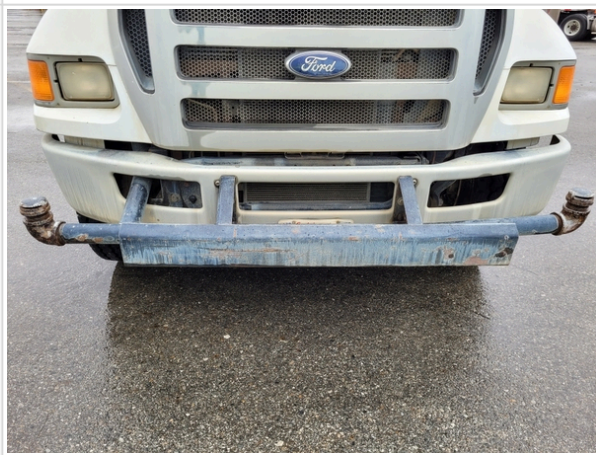
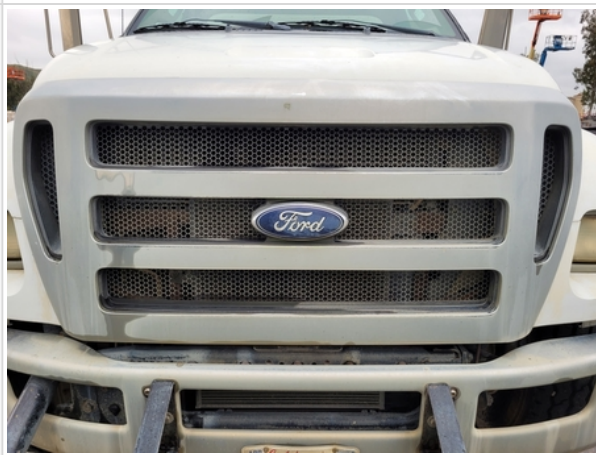
Body Panels	3 - Normal Wear & Tear
Body Panel Condition	No visible damage, good paint condition and panel fitment, Other (see comments)
Comments	Minor scuff marks on hood and minor chrome damage at front grill
Doors / Canopy Latches	3 - Normal Wear & Tear
Doors / Canopy Latches Condition	No visible damage
Steps / Ladders	3 - Normal Wear & Tear
Steps / Ladders Condition	Steps/ladders are fully intact and appear structurally sound, Other (see comments)

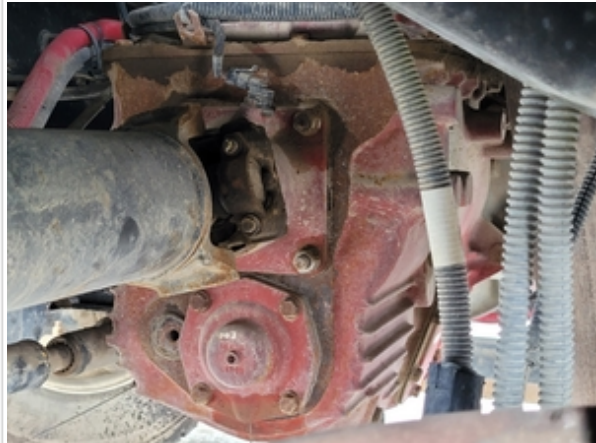
Transmission Info (Make/Model)	Manual 6 Speed
Transmission	2 - Above Average Wear
Transmission Condition	Grinding, clunking or whining sounds heard, Other (see comments)
Comments	High pitched abnormal sound heard while engaged into gears & during operation
Transmission Condition Photos

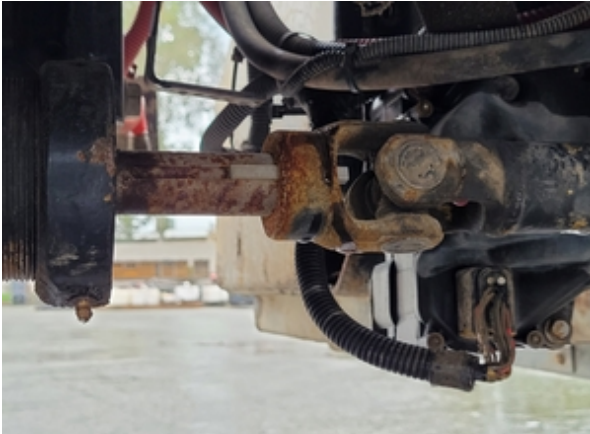
PTO	1 - Service Required	
Comments	PTO sounds like it's engaging but driveshaft to water pump not turning	
PTO Photos

Truck Hydraulics	Check the condition of the vehicle's hydraulic system
Hydraulic PTO	No
PTO Condition	2
Comments	Issue between PTO connection to outputshaft
Unusual Noises Heard	Yes
Comments	Noise seems to be related to PTO issue
Leaks Found	N/A
Hydraulic Hoses & Fittings	3
Comments	Visually okay (unable to test with water PSI)

Exterior Rating	3 - Normal Wear & Tear
Interior Rating	3 - Normal Wear & Tear
Safety Rating	3 - Normal Wear & Tear
Quality Rating	3 - Normal Wear & Tear
Functionality Rating	2 - Operable, but Diagnosis Needed
Overall Rating	3 - Normal Wear & Tear
What's Great About the Machine	Water truck is well equipped with a Valew spray system and has additional suction plumbing built in. Rear water hose reel also installed. The F750 has a durable, well maintained Cummins engine and no active leaks observed. The tires have good amount of tread left and the brakes are like new.
What Needs Work	Transmission should be further inspected for abnormal noise. The PTO system not working properly. Unable to test water truck system. Engine cranked longer than expected after sitting for a while without being started. Further diagnosis recommended to determine issue.
Any Additional Info from the Seller?	PTO system will be further inspected to determine issue.

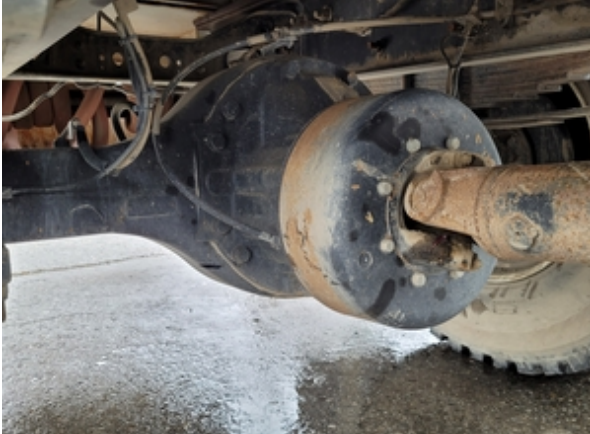
Differential	Check condition of the differential(s). Take photos and notes as relevant.	
Rear Differential	3 - Normal Wear & Tear	
Rear Differential Condition	Dry housing appearance, no unusual noises heard during operation	
Rear Differential Photos

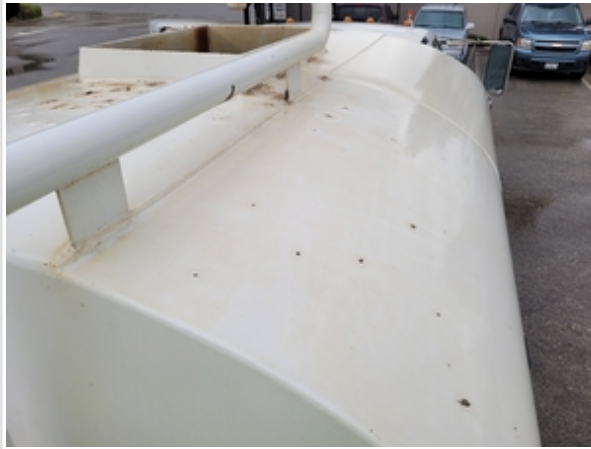
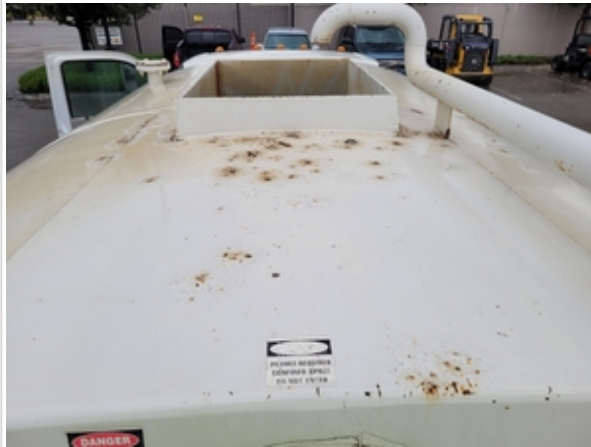
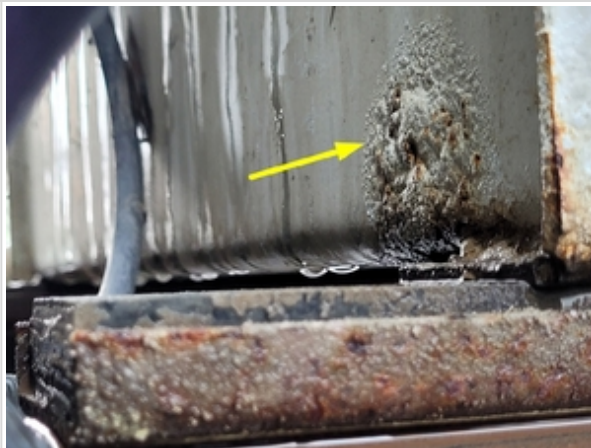
Oil & Fluid Reservoirs	Check the condition of the vehicle's hydraulic system
Number of Tanks	1
Pumps Installed on Tanks	Yes
Number of Pumps	1
Tank Configuration (Contents, Capacities)	Valew 2,000 Gal. Water Tank with 5 sprayers and suction plumbing. Rear hose reel installed. Spray system is manually/cable operated.
Exterior Tank(s) Condition	3
Comments	Some small areas of rust buildup observed

Rust on front lower side of water tank (Behind left side of Cab)

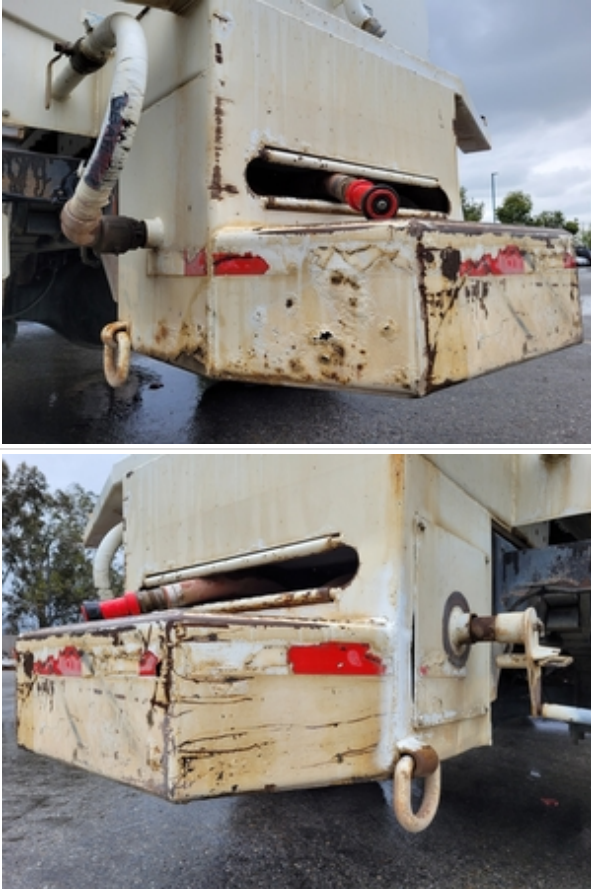
PTO Driveshaft	
Pump(s) Functionality	1	
Comments	Unable to test spray system due to PTO issue	
Grease Pump Installed	N/A	
Hose Reels & Nozzles	3	
Comments	Rear manual hose reel installed in custom storage compartment behind tank with 1&1/2" hose	
Hose Reels & Nozzles Photos

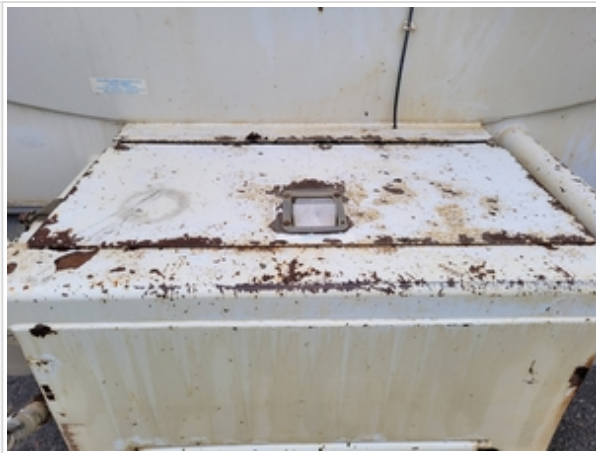
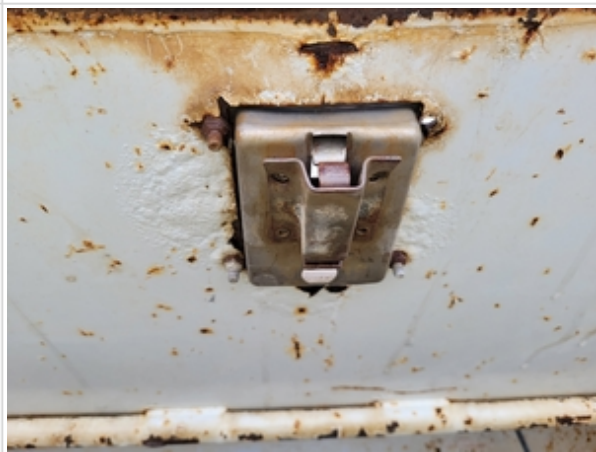
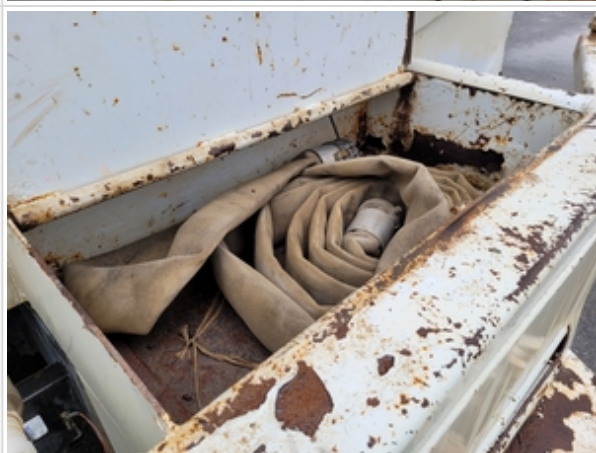
Storage	Check the condition of all storage cabinets (interior & exterior), latches, locks, hinges, and slide out features if applicable.
Toolboxes & Cabinets	3
Comments	Rear storage box has minor surface rust and Lid Handle, Latch not working properly
