Inspection Report (On-Highway Dump Truck)

Year	2015
Make	Ford
Model	F550
Serial Number	FDUF5GTOFEB04931
Truck Odometer Reading	70,633
Current Inspection / State Cert / DOT	Performed 3/2023
Previous Application (e.g., earth moving, mining, demolition, etc)	Equipment Rental

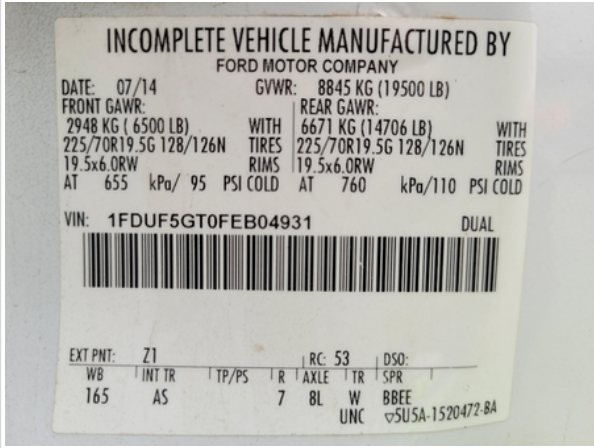
VIN/Serial Number Plate Photo

<p>INCOMPLETE VEHICLE MANUFACTURED BY FORD MOTOR COMPANY</p> <p>DATE: 07/14 GVWR: 8845 KG (19500 LB)</p> <p>FRONT GAWR: 2948 KG (6500 LB) WITH 6671 KG (14706 LB) WITH 225/70R19.5G 128/126N TIRES 225/70R19.5G 128/126N TIRES 19.5x6.0RW RIMS 19.5x6.0RW RIMS AT 655 kPa/ 95 PSI COLD AT 760 kPa/110 PSI COLD</p> <p>VIN: 1FDUF5GT0FEB04931 DUAL</p> <p>EXT PNT: Z1 RC: 53 DSO: WB INT TR TP/PS R AXLE TR SPR 165 AS 7 8L W BBEE UNC 5U5A-1520472-BA</p>
Odometer Photo

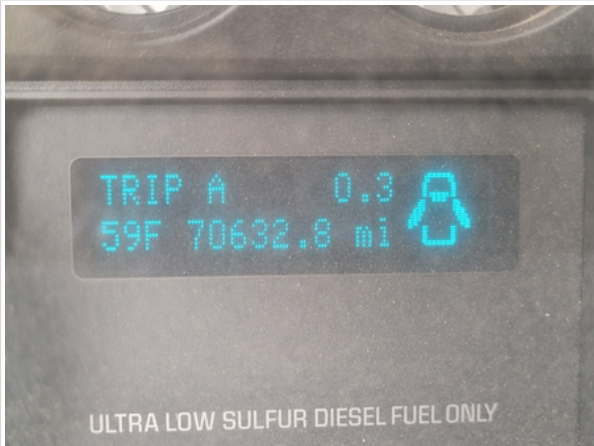
<p>TRIP A 0.3 59F 70632.8 mi</p> <p>ULTRA LOW SULFUR DIESEL FUEL ONLY</p>

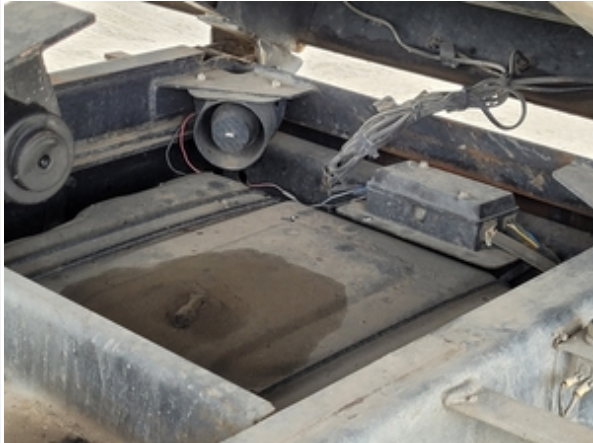
<p>Top of Fuel Tank, Horn, Backup Alarm and Electrical junction box</p>

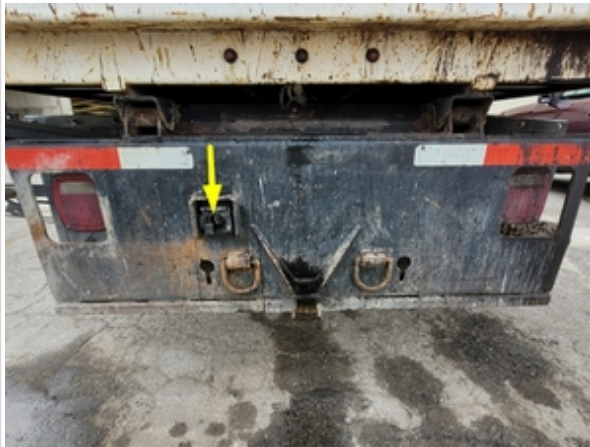
Trailer Connection Cover Broken

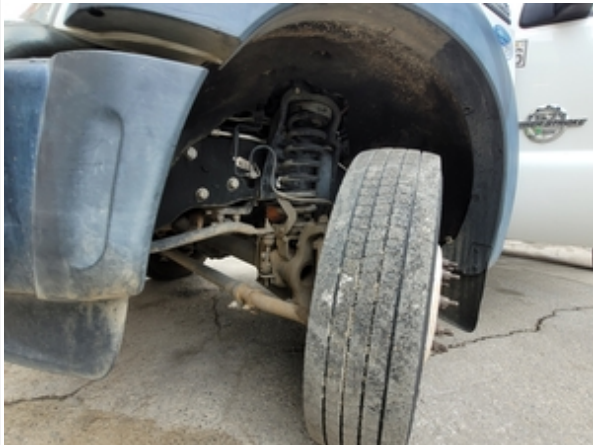
Wheels & Hub Condition	3
Wheel Seal Leaks	No
Tire Brand	Front & Rear - Falken
Tire Size	225/70R/19.5
Front Left Tire - Ratio Remaining	10%
Front Left Tire Photos

Exterior Rating	3 - Normal Wear & Tear
Interior Rating	3 - Normal Wear & Tear
Safety Rating	3 - Normal Wear & Tear
Quality Rating	3 - Normal Wear & Tear
Functionality Rating	3 - Normal, Operating as Expected
Overall Rating	3 - Normal Wear & Tear
What's Great About the Machine	Truck has well maintained appearance and dump truck hydraulics working well. No active leaks observed.
What Needs Work	Mirror adjustment control motor hesitation observed on driver side. Tires need to be replaced soon. Rear brakes getting low.
Date/Time	04-14-2023

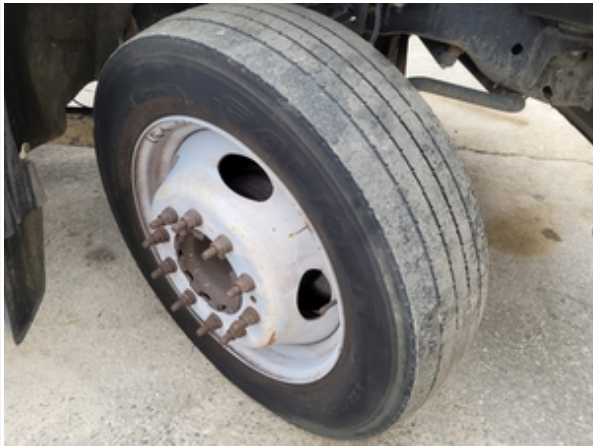
Front Right Tire - Ratio Remaining	10%
Front Right Tire Photos

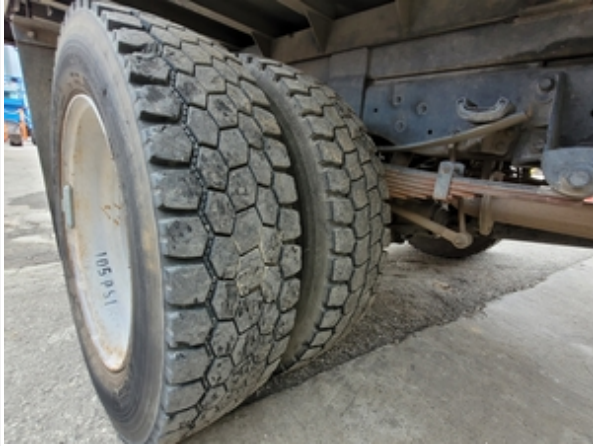
Rear Right Tire - Ratio Remaining	30%

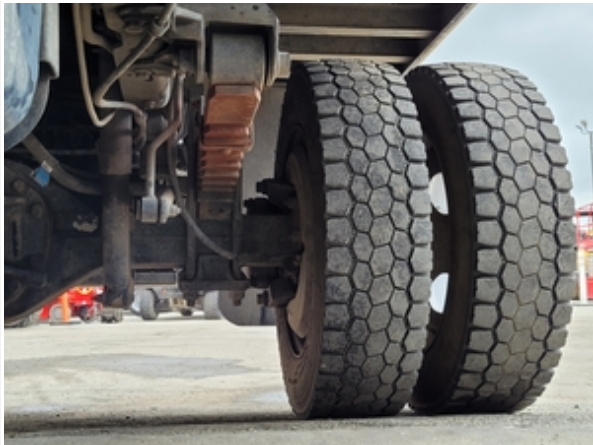
Rear Left Tire - Ratio Remaining	30%	
Rear Left Tire Photos
