Inspection Report (Backhoe Loader)

| Make | CAT |
| Model | 420F |
| Serial Number | SKR00900 |

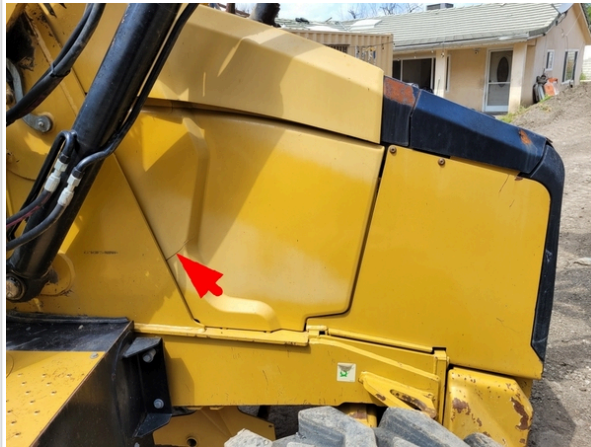
Fiberglass crack

| Comments | Right side engine panel has small crack, Front Top Side of hood has dent. Minor scuff marks all around |

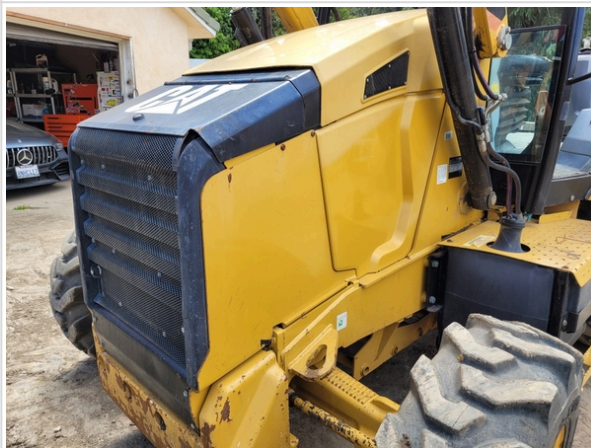
Top hood dented

| What Needs Work | A few possible seepage (not active leaks) may eventually become leaks @ brake pedal valve and steer cylinder. Minor cosmetic damage on hood. Seat is torn and should be replaced soon for operator comfort. Rear tires will need to be replaced soon. |

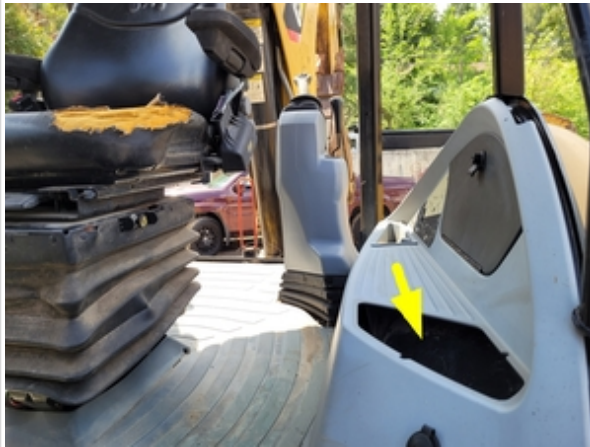
Cover missing

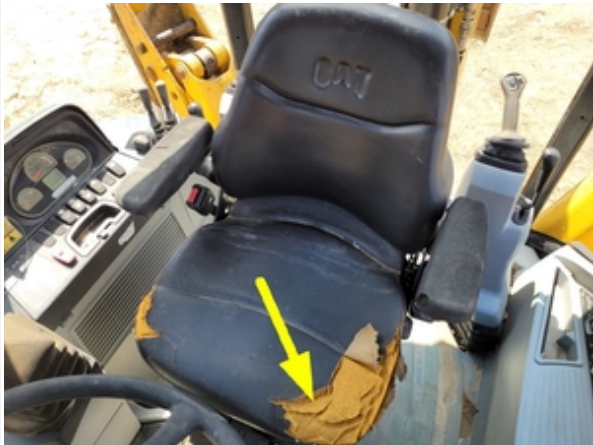
| Operator Seat Photos | | |

| Operator Seat Condition | Seat(s) has major surface staining or tears, Seat belt secures properly | |
| | Seat Torn | |

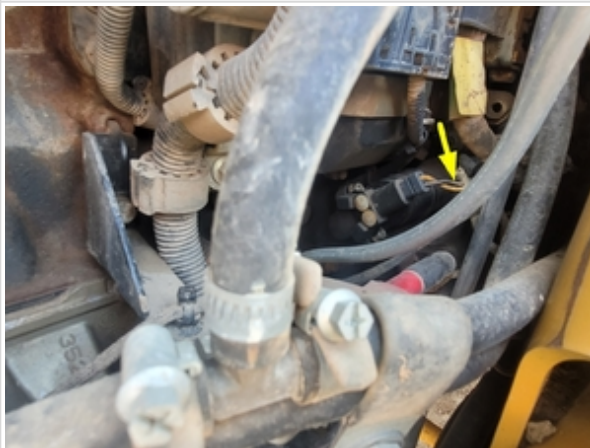
Engine sensor wiring damaged

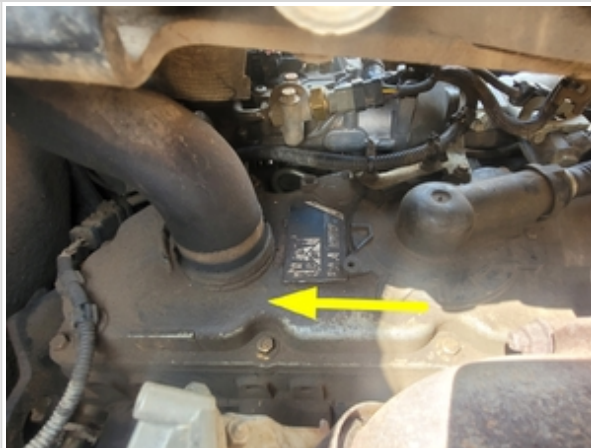
Residual oil buildup on valve cover. No active leak seen

| Overall Engine Comments | Engine in good shape and no active leaks observed. Top of valve cover has some residual oil/dirt buildup and should be further inspected for possible engine oil seepage or leak. |

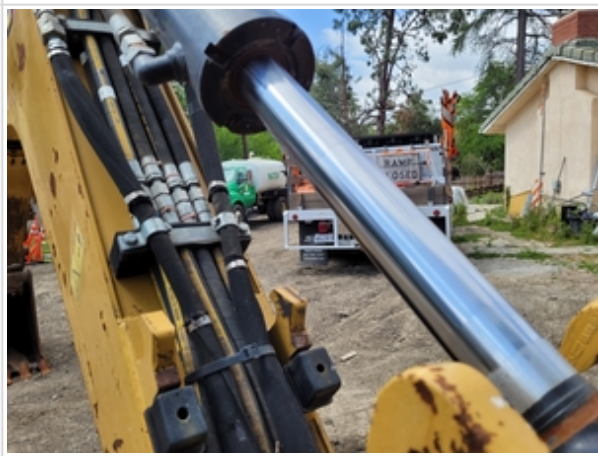
Hydraulic hose damaged (Not leaking)

| Comments | A few hydraulic hoses have surface damage | |

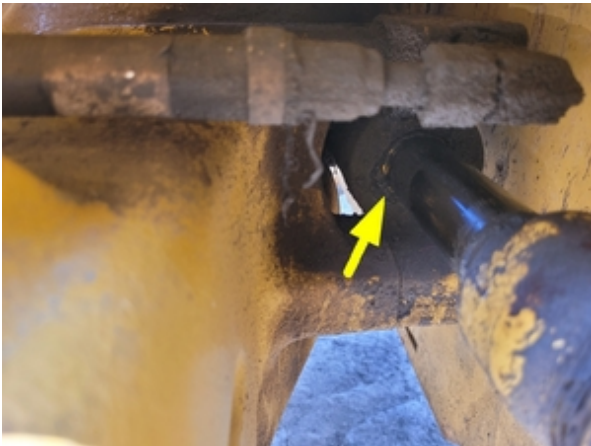
| Steering Cylinder Photos | | |

| Comments | Right side steer cylinder has minor oil/dirt buildup around rod seal. Further inspection recommended to determine if minor leak exist | |
