Inspection Report (Bulldozer)

Year	2008
Make	John Deere
Model	850JR
Serial Number	T0850JR160387
Hour Meter Reading	8,298 Hrs.
Previous Application (e.g., earth moving, mining, demolition, etc)	General Construction

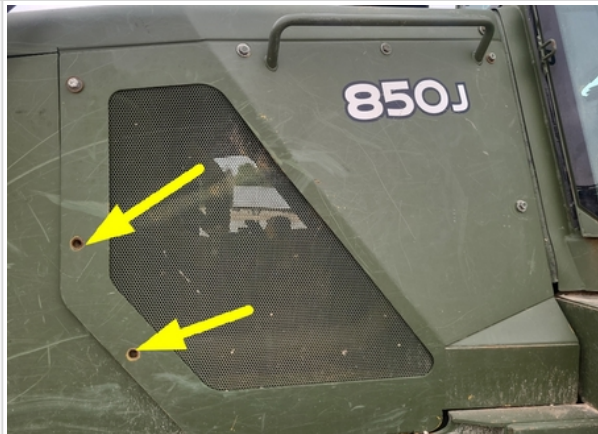
Body Panels	3 - Normal Wear & Tear
Body Panel Condition	No visible damage, good paint condition and panel fitment, Other (see comments)
Comments	Left side engine panel missing hardware

<p>850J</p> <p>Missing Hardware</p>

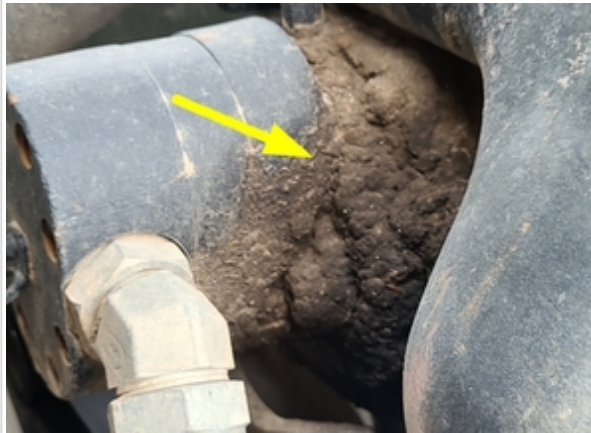
Minor engine oil leak at mounted seal

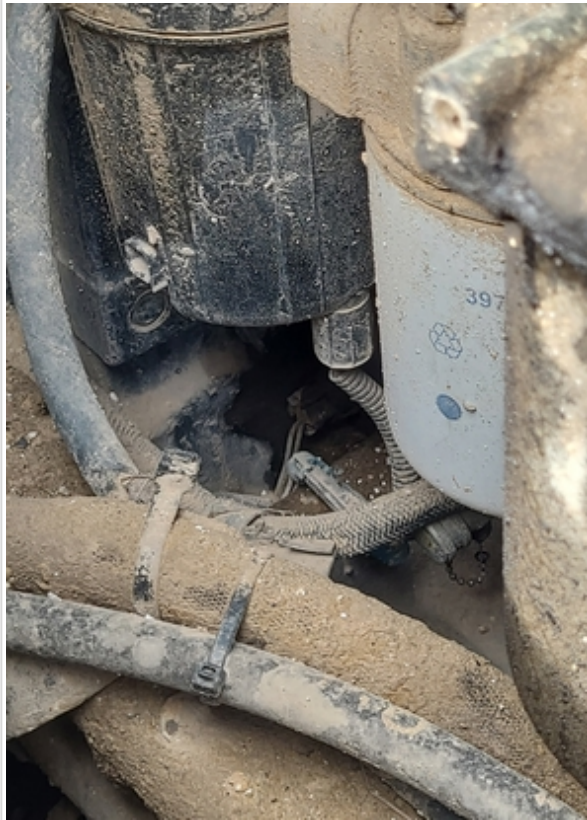
Blow-by (Visual Observation Check)	Yes
Comments	Excessive blowby seen at engine breather hose
Unusual Noises (Upon Start-up, Idle, Shutdown)	No
Unusual Noise Notes	No unusual noises heard
Engine Smoke (Upon Start-up, Idle, Shutdown)	No
Engine Smoke Notes	No engine smoke issues observed
Engine Exhaust Color	Clear
Battery	2 - Above Average Wear
Battery Condition	Clean & dry appearance, tight connections, Needs charge or replacement
Comments	Batteries were low on charge during initial inspection
Radiator	3 - Normal Wear & Tear
Radiator Condition	Radiator fins & components appear to be in good working order, no signs of damage or leaks
Belts	3 - Normal Wear & Tear
Belt Condition	Belts appear in good condition & alignment with proper tension
Hoses	3 - Normal Wear & Tear
Hose Condition	Firm, pliant hoses with no signs of wear or leaks

Overall Functional Test Comments	Breather Hose shown is engine blowby
Operating Video	Click to Download
Additional Video	Click to Download
Additional Video	Click to Download

Water Pump	3 - Normal Wear & Tear
Water Pump Condition	No unusual pump noises heard
Cooling System Leaks	No
Coolant Color / Appearance	3 - Normal Wear & Tear
Coolant Color/Appearance Notes	Normal Translucent appearance, no visual signs of contamination
Oil Leaks	Yes
Oil Leak Notes	Wetness & discoloration observed, Other (see comments)
Comments	Minor oil leaks seen at right side of engine
Oil Color / Appearance	3 - Normal Wear & Tear
Oil Color / Appearance Notes	Clean oil appearance, no signs of cross contamination, Appropriate oil level
Fuel Leaks	No
Equipped with DPF (Diesel Particulate Filter)	No
Requires DEF (Diesel Exhaust Fluid)	No
Overall Engine Appearance	Dusty & dry
Overall Engine Comments	Excessive blowby observed and further Engine Diag. Recommended.

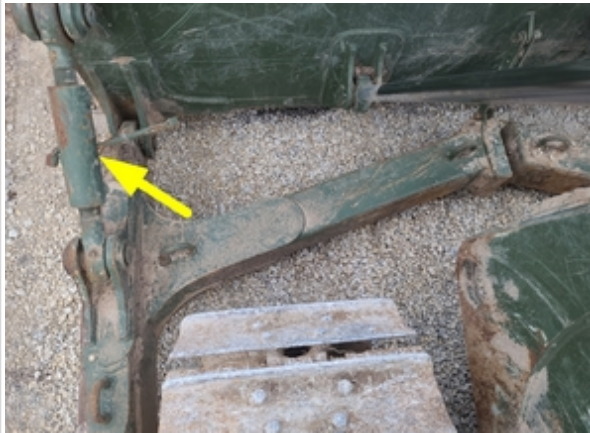
Push Arm / C-Frame Condition	2 - Above Average Wear
Comments	Bushing/Bearing that connects to front blade worn and have improper mounting pins

Left side blade bracket has improper retaining hardware

Recommend further inspection at all blade to arm connections for excess play.

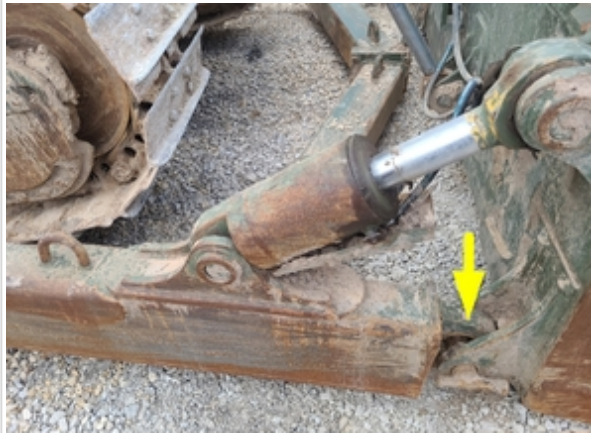
Right side arm retaining pin incorrect and bearing missing

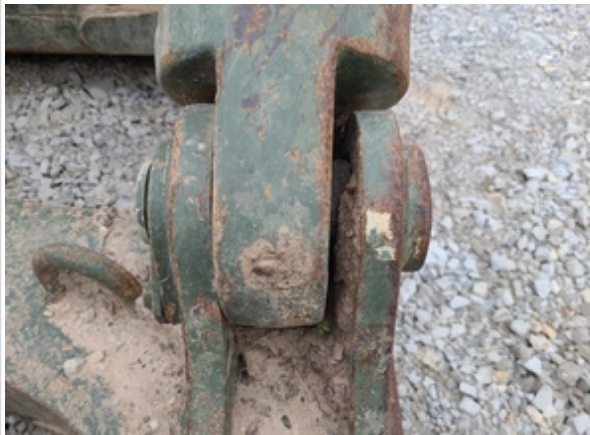
R/S Arm Bearing missing

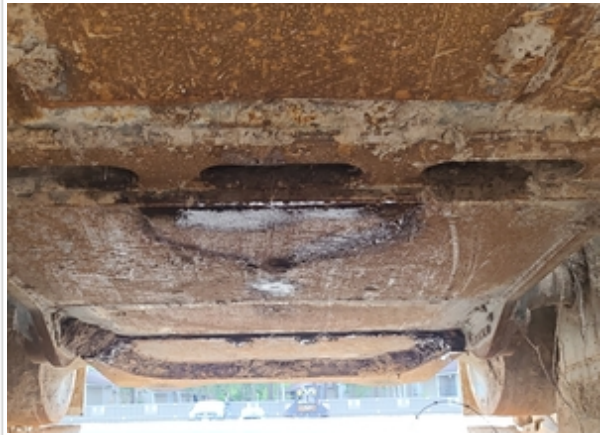
Overall Chassis	Oil leaking out of belly pan from center of machine.	
Overall Chassis Comments	3 - Normal Wear & Tear Overall Main Frame in good shape, but Blade push arm bores and bushings worn and should be further inspected.

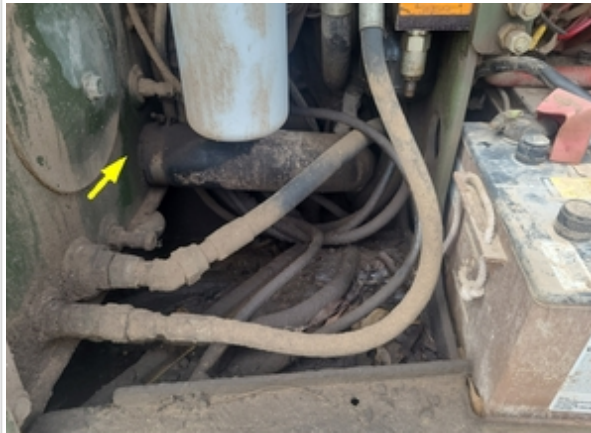
Possible small leak at hydraulic hose

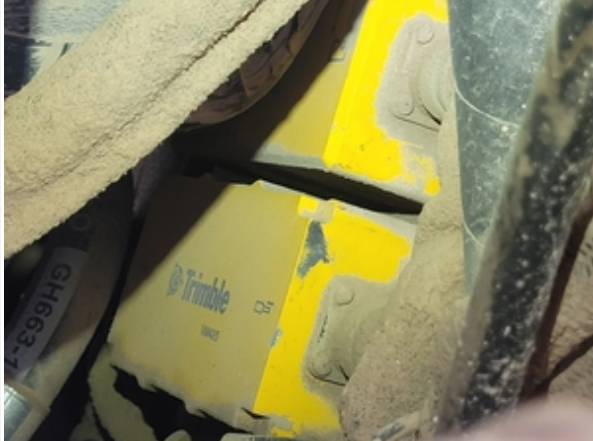
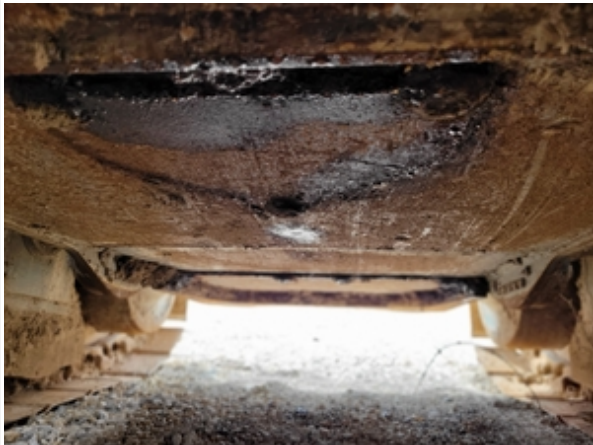
<p>Active Oil leak seen dripping from bottom belly pan. May be Engine or Hydraulic Oil. Further inspection recommended.</p>
Wet or Damp Hydraulic Lines / Fittings	Yes
Appearance of Hydraulic Lines / Fittings	3 - Normal Wear & Tear
Hydraulic Lines / Fittings Condition	Other (see comments)
Comments	Signs of hydraulic leaks observed around right side of Cab hydraulic filter area and beneath bellypans
Unusual Noises (Hydraulic Pump)	No
Hydraulic Pump Notes	No unusual noises heard during operation
Comments	Pumps and drive motors underneath cab not inspected. Visually unaware of conditions of hydraulic system underneath cab.

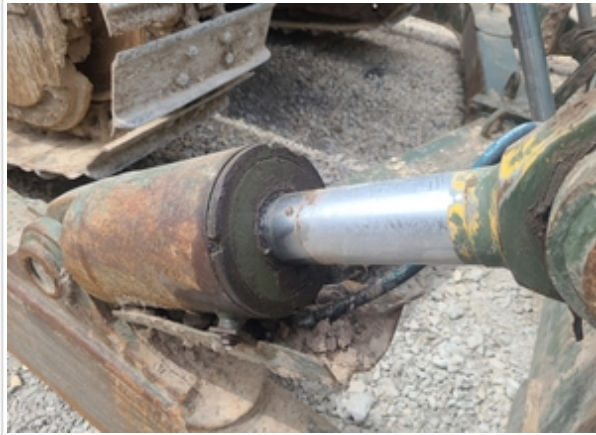
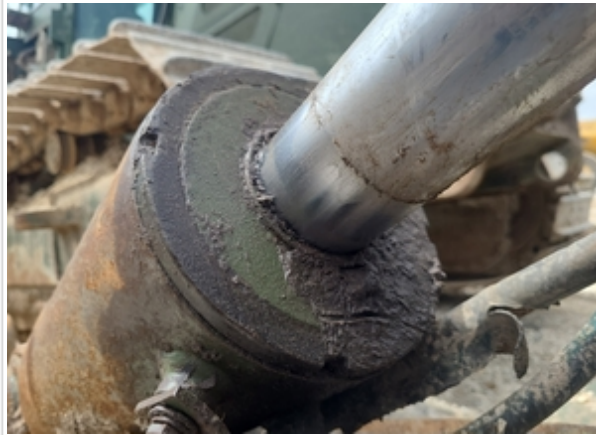
Tilt Cylinder	Check the tilt cylinder. Note any wear, pitting, discoloration, etc. Take photos.
Tilt Cylinder: Mounting Pin	3
Tilt Cylinder: Oil Leaks	Yes
Comments	Active leak seen at rod seal
