Inspection Report (Bulldozer)

Year	2013
Make	CAT
Model	D6T
Serial Number	ZJB01163
Hour Meter Reading	12,207 Hrs.
Previous Application (e.g., earth moving, mining, demolition, etc)	General Construction

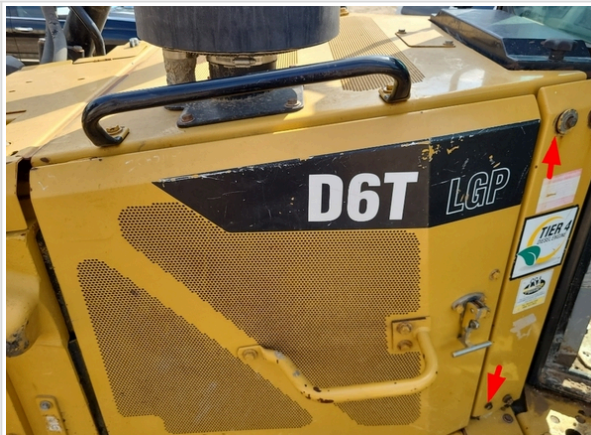
Hardware slightly loose

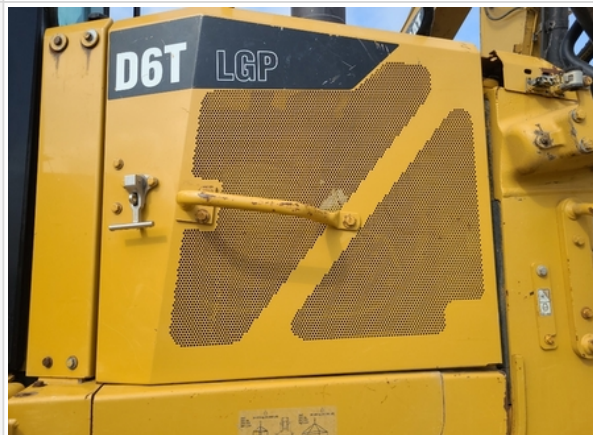
Front Grill Damaged

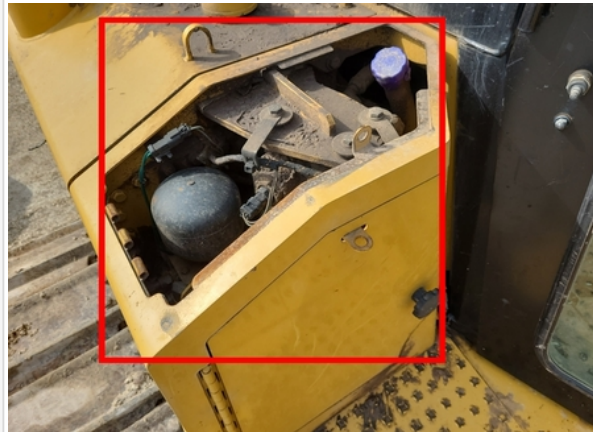
Top cover missing

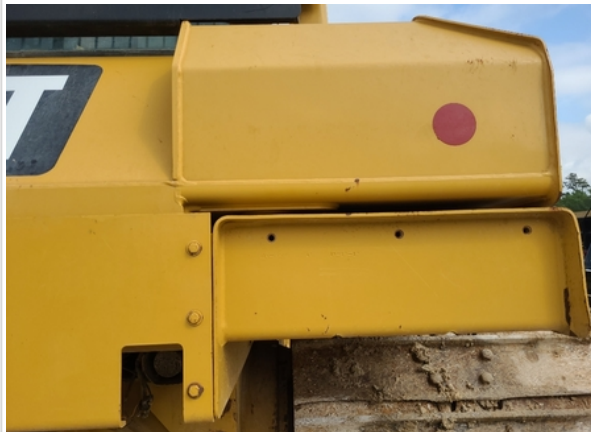
Hardware Missing

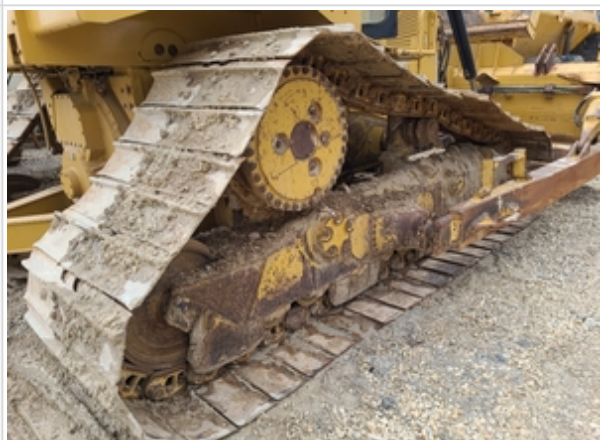
Undercarriage Overall Condition	3 - Normal Wear & Tear	
Comments	Tracks are 36" wide. Track pads, idlers and rollers below 50% of wear left and will need to be replaced soon.	
Undercarriage Overall Photos

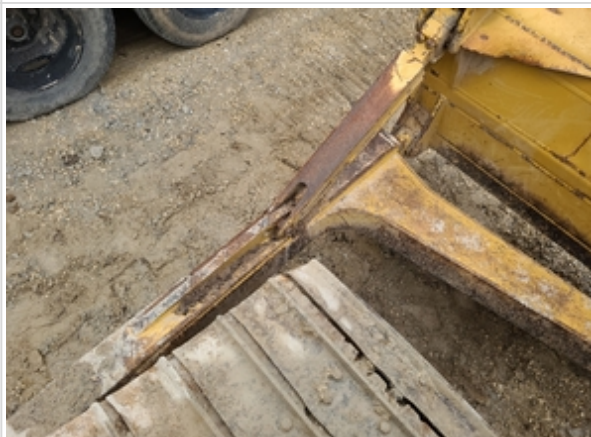
Connection Worn

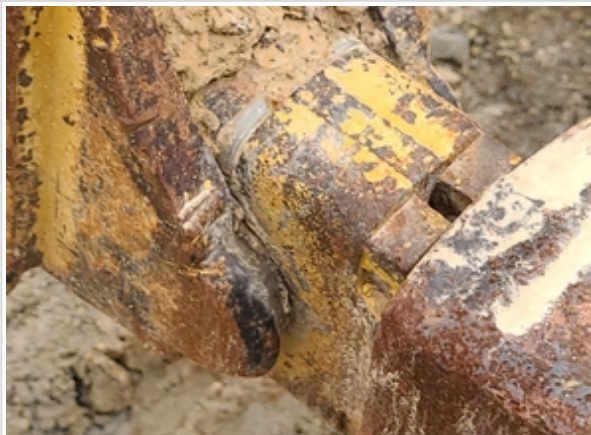
Bushings, bores, & pins should be further inspected for proper repair procedures. Excess play observed during the inspection.

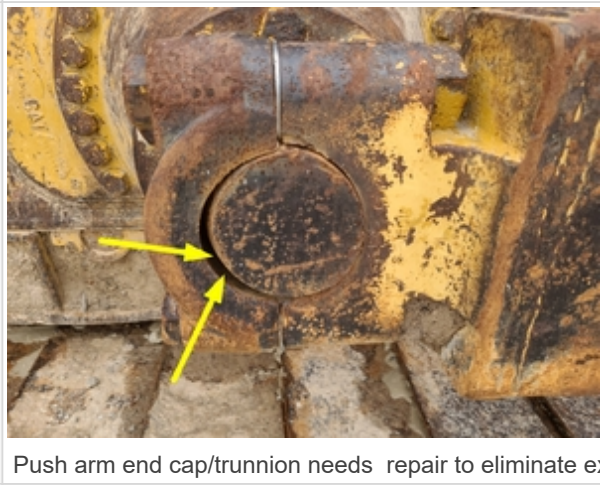
<p>Push arm end cap/trunnion needs repair to eliminate excess play.</p>

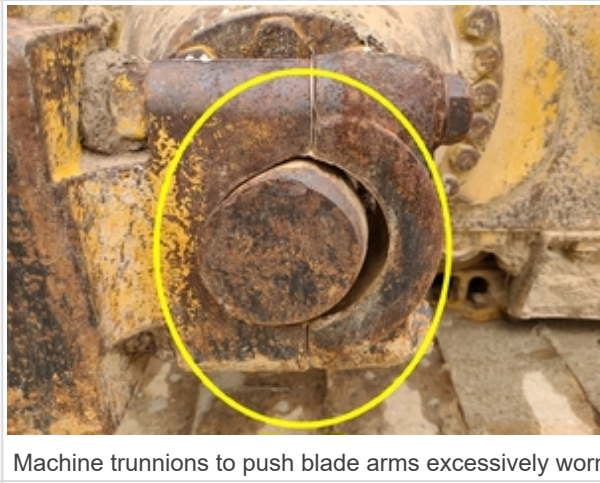
<p>Machine trunnions to push blade arms excessively worn and should be replaced.</p>
<p>Push Arm Pivot / C-Frame Trunnions Condition</p>	<p>2 - Above Average Wear</p>	
<p>Comments</p>	<p>Trunnion connections worn</p>

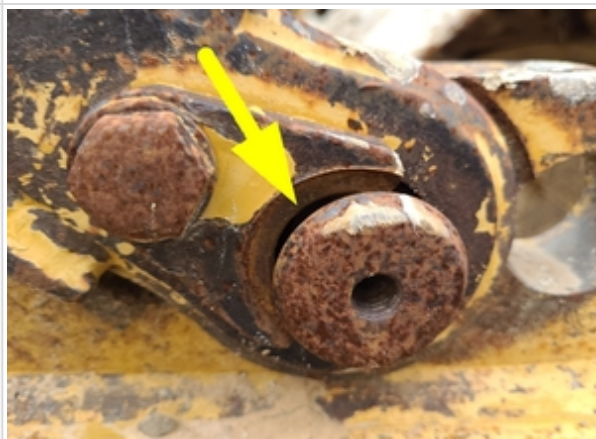
<p>Left Side Bore Worn</p>

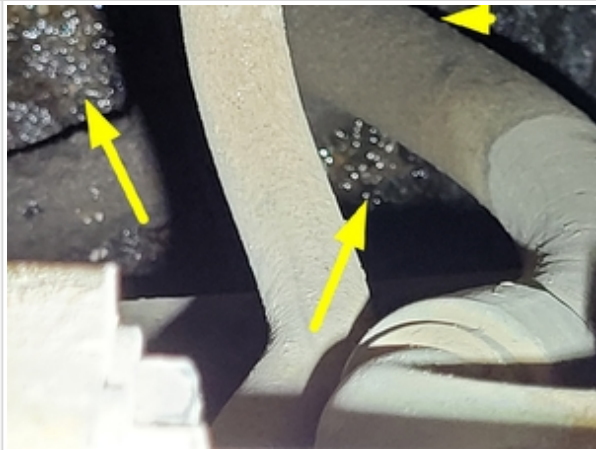
<p>Oil buildup seen at bottom of machine underneath hydraulic pumps</p>
Wet or Damp Hydraulic Lines / Fittings	No
Appearance of Hydraulic Lines / Fittings	3 - Normal Wear & Tear
Hydraulic Lines / Fittings Condition	Hydraulic lines & fittings are clean and in good condition
Unusual Noises (Hydraulic Pump)	No
Hydraulic Pump Notes	No unusual noises heard during operation
