Year	2022
Make	Bobcat
Model	E35i
Serial Number	B57911419
Hour Meter Reading	140 Hrs.
Previous Application (e.g., earth moving, mining, demolition, etc)	Landscape / Tree Services

Inspection Report (Mini Excavator)

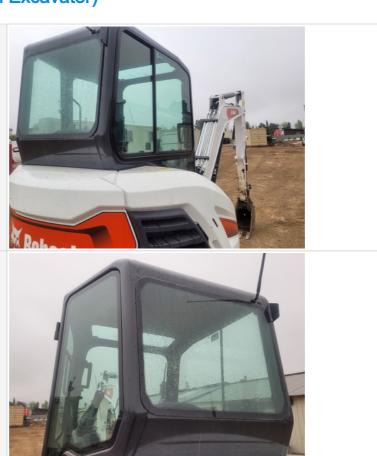
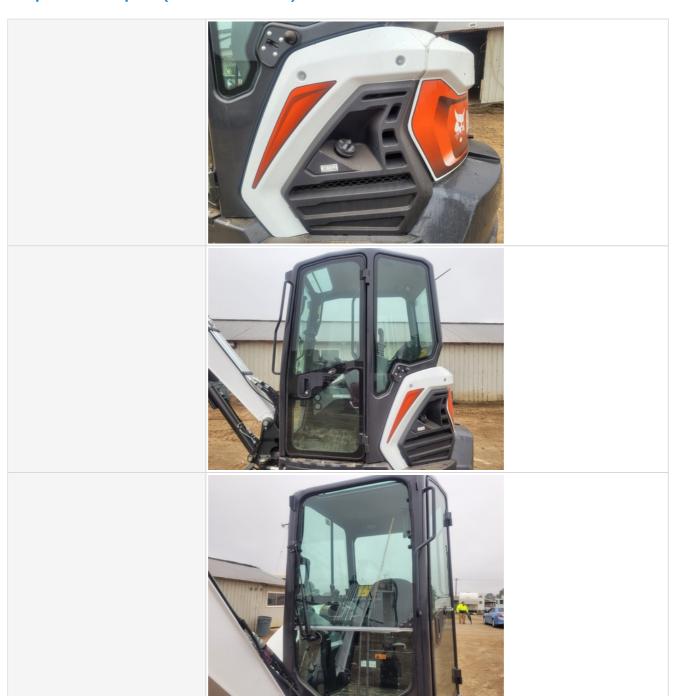
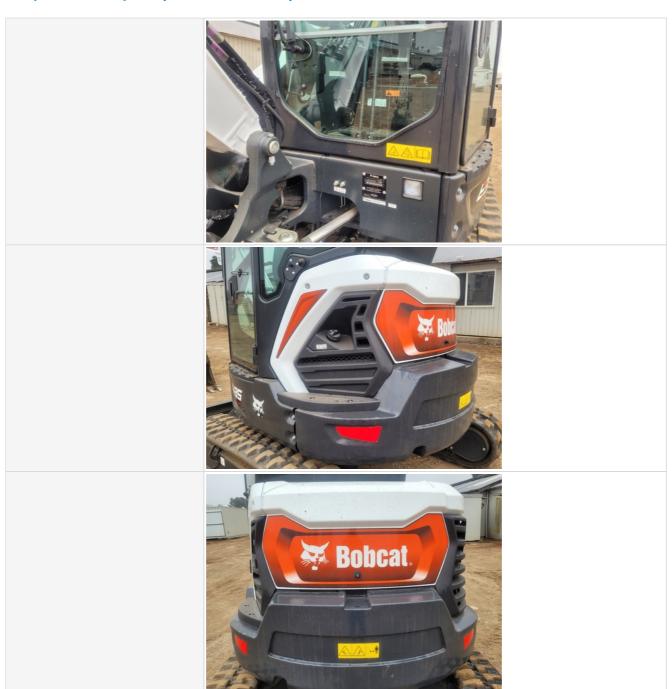
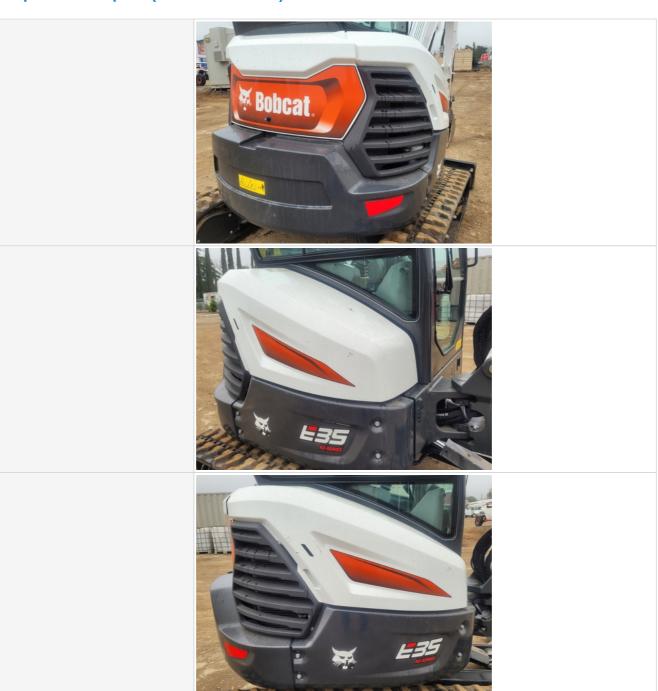
Close-up Exterior Photos

Body Panels	4 - Like New, Recently Replaced
Body Panel Condition	No visible damage, good paint condition and panel fitment
Doors / Canopy Latches	4 - Like New, Recently Replaced
Doors / Canopy Latches Condition	No visible damage
Steps / Ladders	4 - Like New, Recently Replaced
Steps / Ladders Condition	Steps/ladders are fully intact and appear structurally sound
Handrails	4 - Like New, Recently Replaced
Handrails Condition	Handrails are fully intact and appear structurally sound
Glass	4 - Like New, Recently Replaced
Glass Condition	Glass intact, no visible damage
Mirrors	4 - Like New, Recently Replaced
Mirror Condition	Mirrors present and intact, no visible damage
Exterior Lights	4 - Like New, Recently Replaced
Exterior Lights Condition	No visible damage, lighting system is operational

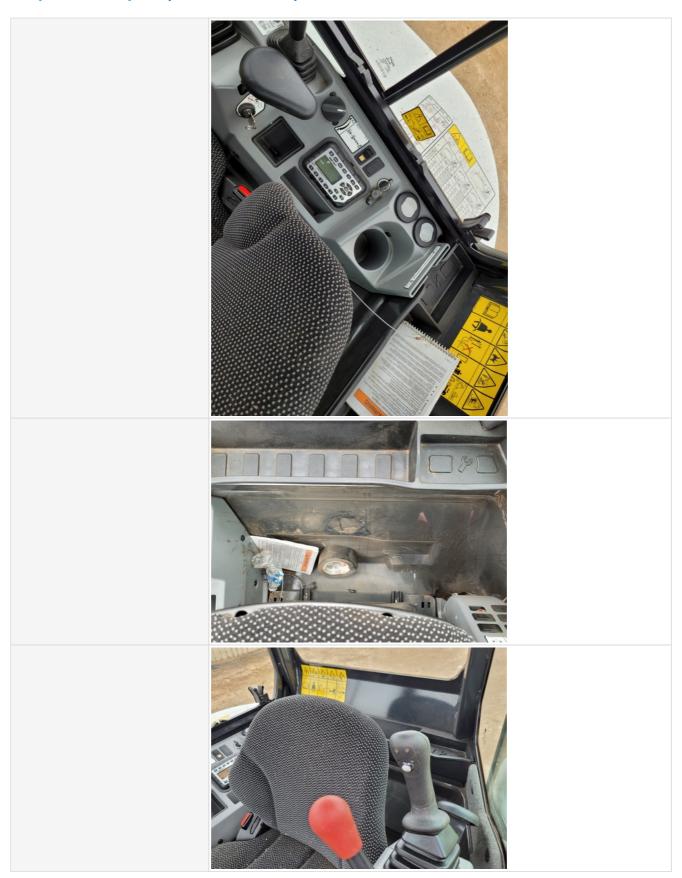
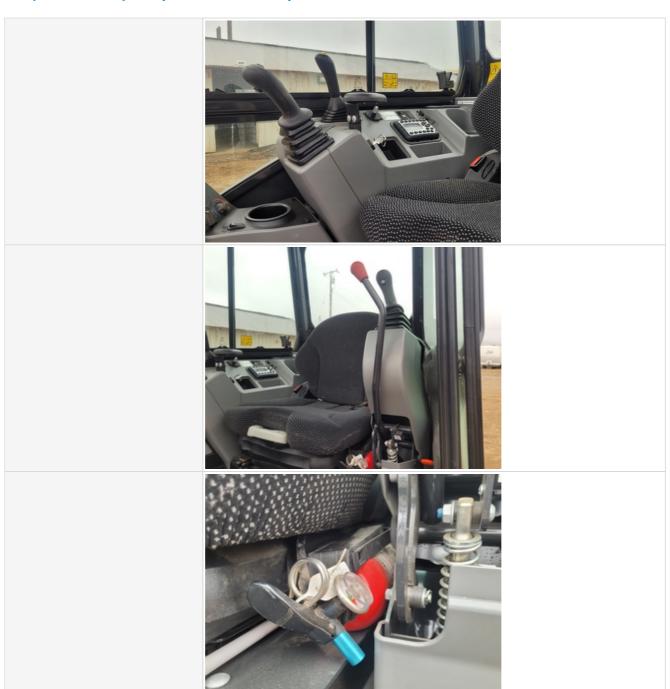
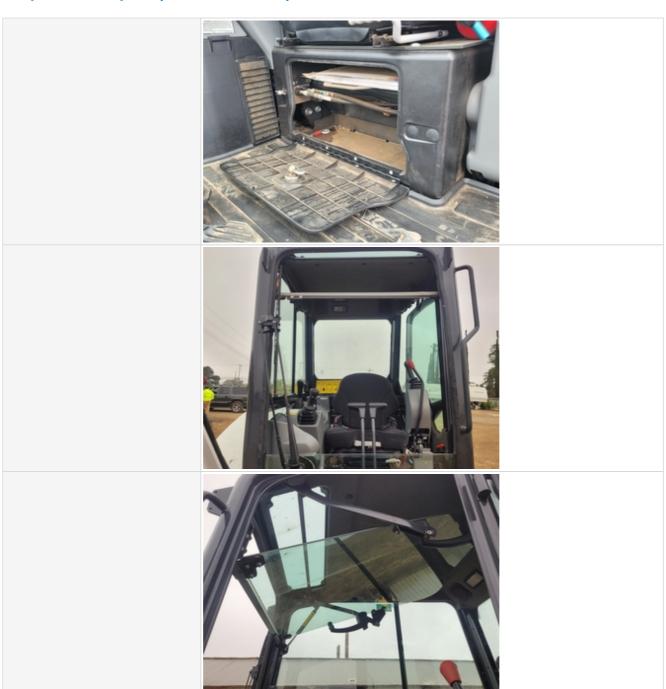
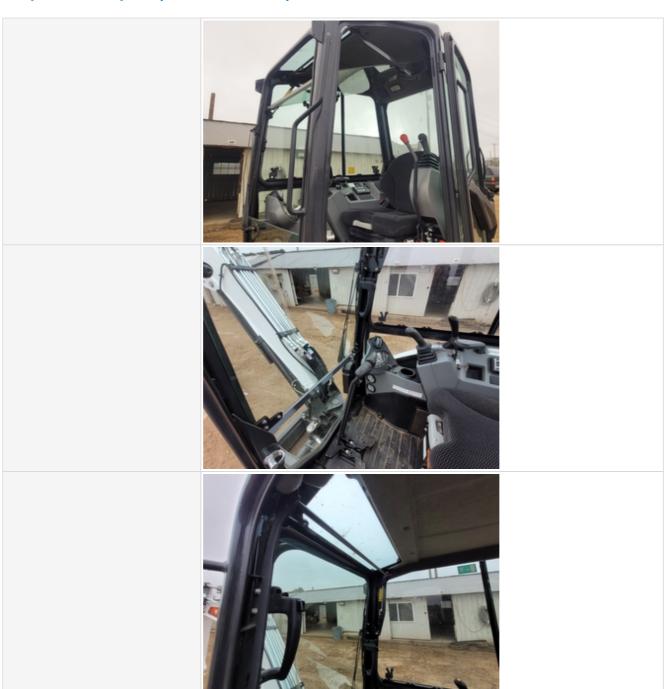
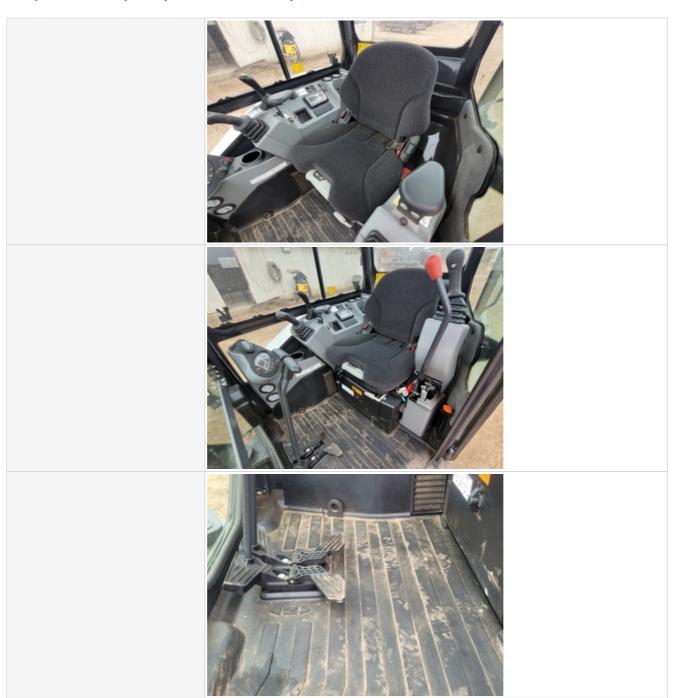
Operator Cabin Photos

Operator Cabin Overall	4 - Like New, Recently Replaced
Operator Cabin Overall Condition	Good cabin appearance, solid floors, panels, and ceiling
Operator Seat	4 - Like New, Recently Replaced
Operator Seat Condition	Seat(s) in good condition, no stains or tears in upholstery, Seat adjustment controls move through full range of travel, Seat belt secures properly, Seat belt is intact and in good condition
Cabin Lights	4 - Like New, Recently Replaced
Cabin Lights Condition	Cabin lights are installed with all light covers in place, bulbs are installed and working properly
Safety Lock Out / Stop	4 - Like New, Recently Replaced
Safety Lock Out / Stop Condition	Safety lock out device is present, in good condition, and functional
Controls & Switches	4 - Like New, Recently Replaced
Controls & Switches Condition	All switches are installed and functional
Hour Meter Activity	4 - Like New, Recently Replaced
Hour Meter Condition	Hour meter is functional and in good condition

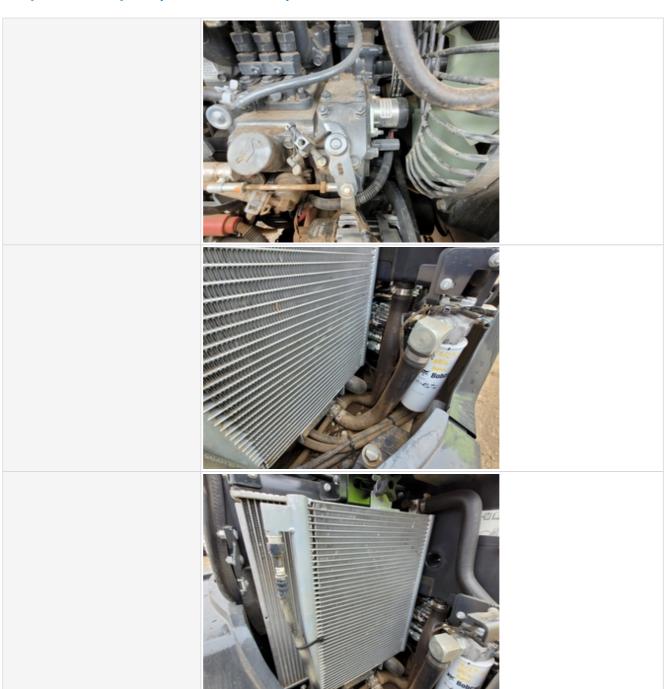
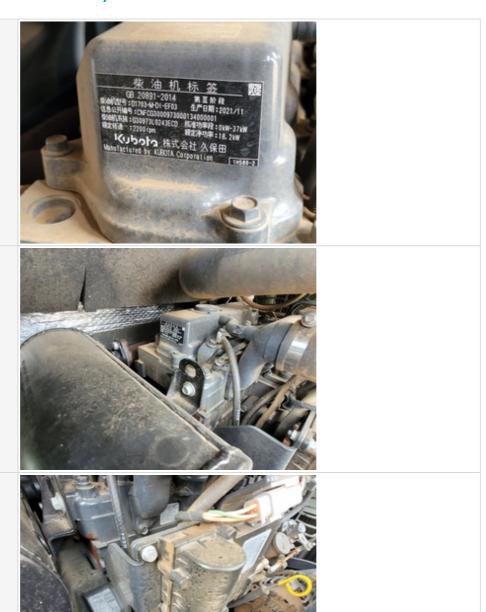
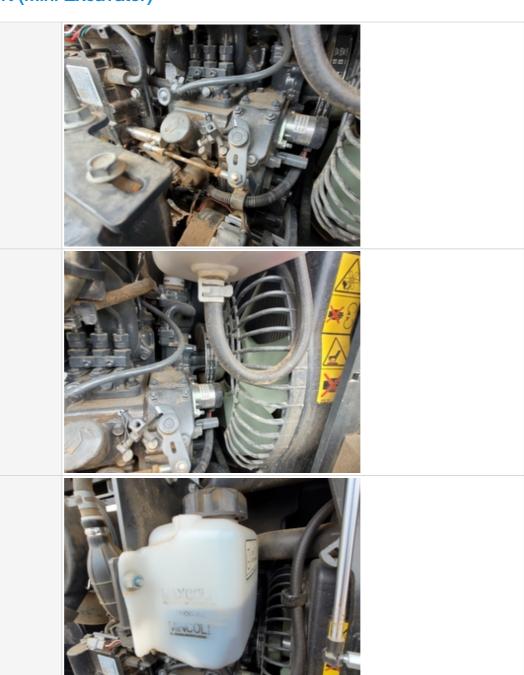
Blow-by (Visual Observation Check)	No
Unusual Noises (Upon Start-up, Idle, Shutdown)	No
Unusual Noise Notes	No unusual noises heard
Engine Smoke (Upon Start-up, Idle, Shutdown)	No
Engine Smoke Notes	No engine smoke issues observed
Engine Exhaust Color	Clear
Battery	4 - Like New, Recently Replaced
Battery Condition	Dusty & dirty appearance
Radiator	4 - Like New, Recently Replaced
Radiator Condition	Radiator fins & components appear to be in good working order, no signs of damage or leaks
Belts	4 - Like New, Recently Replaced
Belt Condition	Belts appear in good condition & alignment with proper tension
Hoses	4 - Like New, Recently Replaced
Hose Condition	Firm, pliant hoses with no signs of wear or leaks

Water Pump	4 - Like New, Recently Replaced
Water Pump Condition	No unusual pump noises heard
Cooling System Leaks	No
Coolant Color / Appearance	4 - Like New, Recently Replaced
Coolant Color/Appearance Notes	Normal Translucent appearance, no visual signs of contamination
Oil Leaks	No
Oil Color / Appearance	4 - Like New, Recently Replaced
Oil Color / Appearance Notes	Appropriate oil level, Clean oil appearance, no signs of cross contamination
Fuel Leaks	No
Requires DEF (Diesel Exhaust Fluid)	No
Overall Engine Appearance	Clean & dry, Areas of surface corrosion seen on some engine components
Overall Engine Comments	Engine still has "like new" appearance

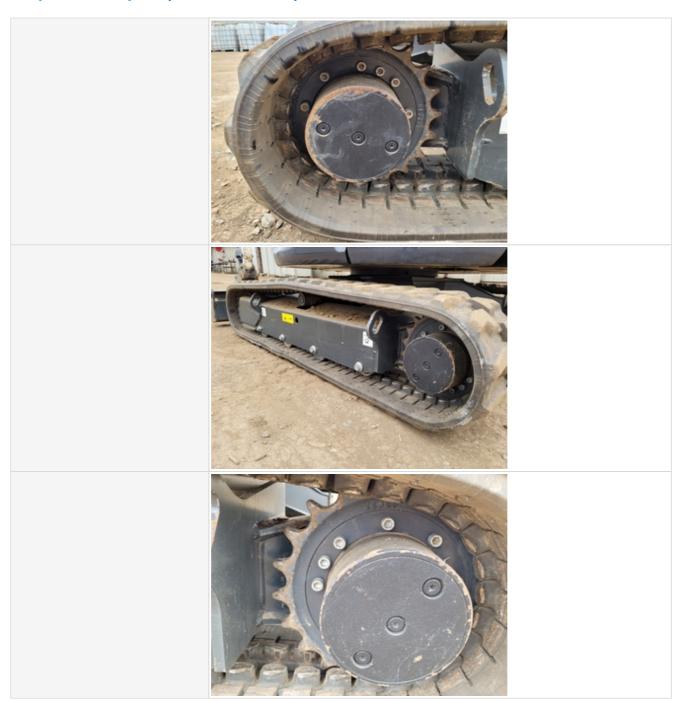
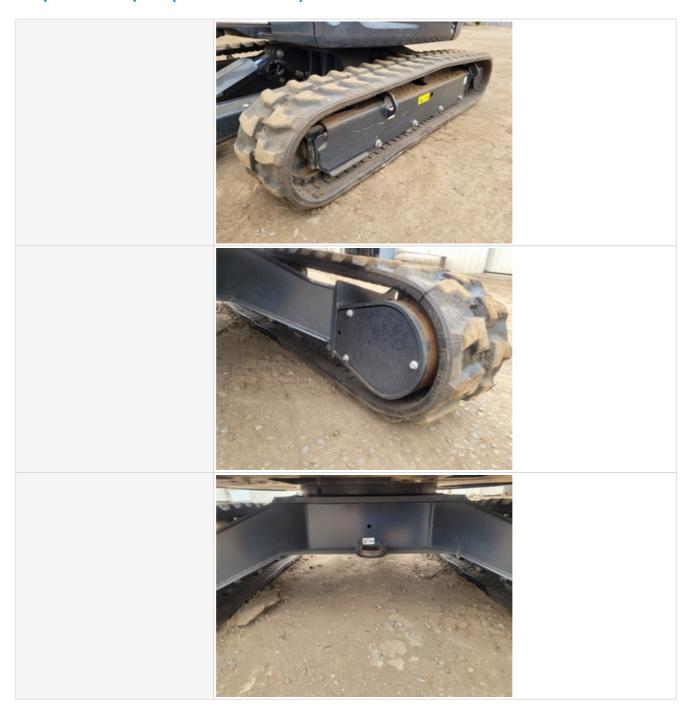
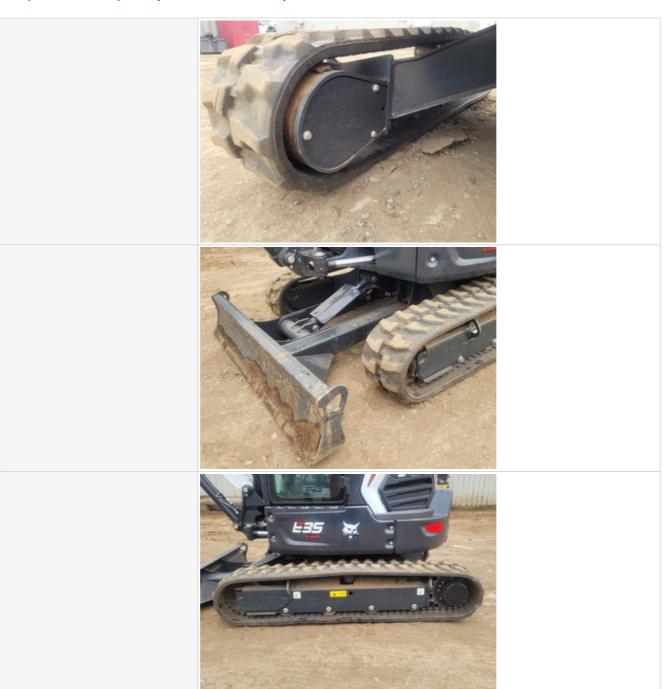
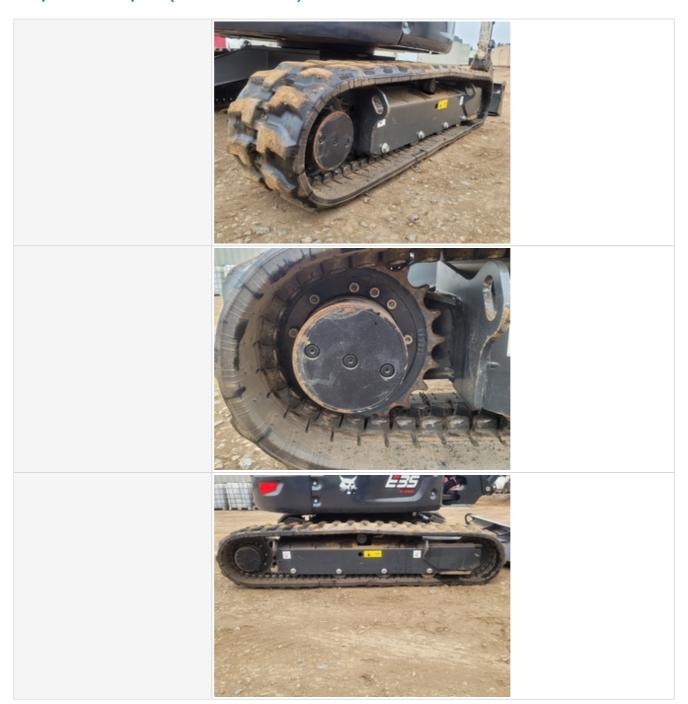
Undercarriage Photos

The state of the s
Roller Frames	4 - Like New, Recently Replaced
Track Belt	4 - Like New, Recently Replaced
Rubber Belt Drive Lugs	4 - Like New, Recently Replaced
Track Tensioners	4 - Like New, Recently Replaced
Front Idlers	4 - Like New, Recently Replaced
Rear Idlers	0
Track Rollers	4 - Like New, Recently Replaced
Sprockets	4 - Like New, Recently Replaced

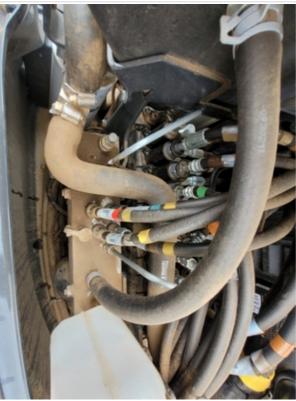
Main Hydraulic Pump

Wet or Damp Hydraulic Lines / Fittings	No
Appearance of Hydraulic Lines / Fittings	4 - Like New, Recently Replaced
Hydraulic Lines / Fittings Condition	Hydraulic lines & fittings are clean and in good condition
Unusual Noises (Hydraulic Pump)	No
Hydraulic Pump Notes	No unusual noises heard during operation
