General Info

Year	2014
Make	CAT
Model	450F
Serial Number	HJR00248
Hour Meter Reading	2,040
Previous Application (e.g., earth moving, mining, demolition, etc)	Demolition General Construction

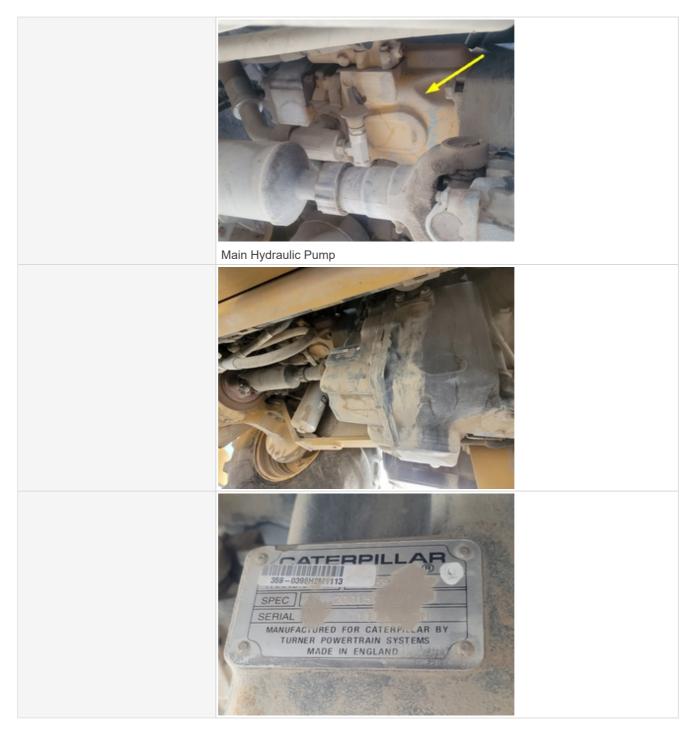
Parking Brake Pads

Comments	Parking brake electronic sensor works properly. Mechanical brake cable needs adjustment (Parking brake not working properly)
Parking Brake Photos	
Overall Drivetrain Comments	Overall Drivetrain visually in excellent condition and operating well during inspection.

Quality Rating	4 - Like New, Recently Replaced
Functionality Rating	4 - Operating Within Factory Spec
Overall Rating	4 - Like New, Recently Replaced
What's Great About the Machine	Machine has been well maintained and all main core functions are operating well. This backhoe has a bunch of extra add-ons that provide value and ergonomics for the owner/operator. No active leaks observed from Transmission, Engine or Hydraulics.
What Needs Work	Parking brake should be adjusted. Top beacon light inoperable.
Date/Time	05-03-2023

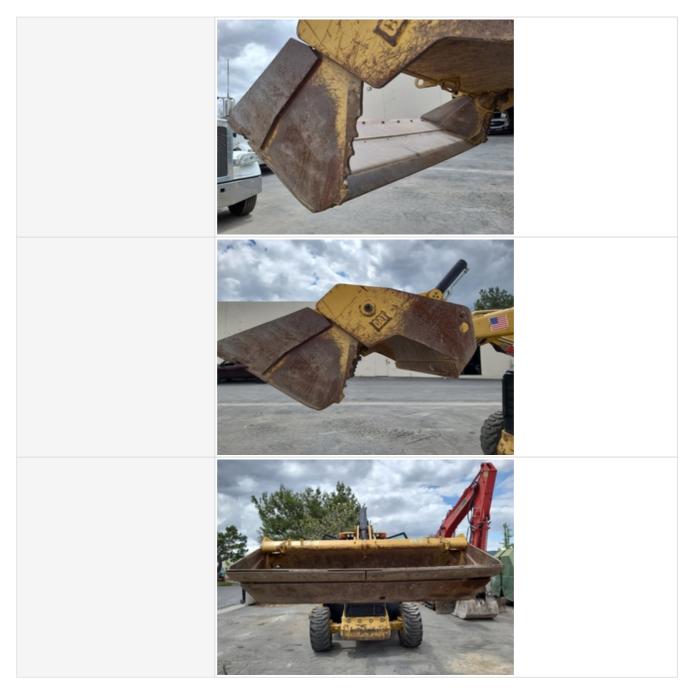
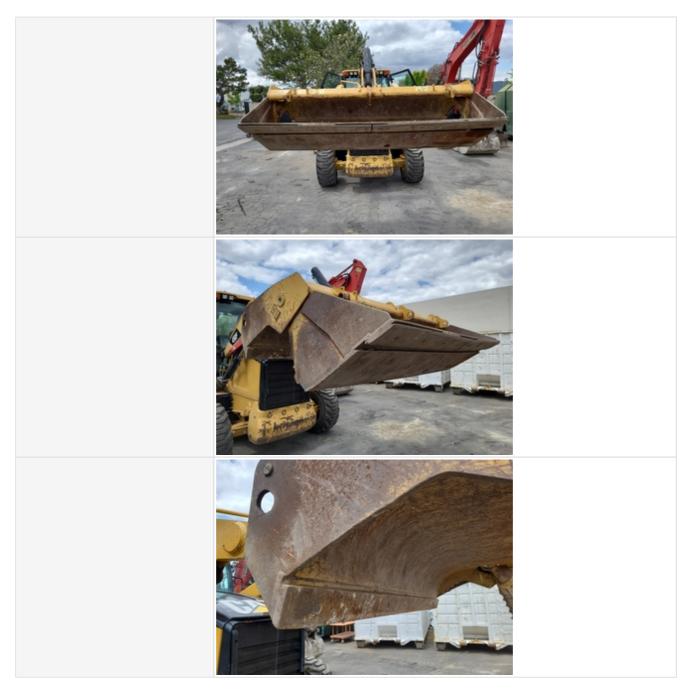
Loader Bucket Edge / Deflectors	3 - Normal Wear & Tear
Backhoe Bucket	3 - Normal Wear & Tear
Comments	Comes with 18" (Not the 4' seen in photos)
Backhoe Bucket Photos	Ta'' B.H. Bucket

Backhoe Bucket Edge / Deflectors	3 - Normal Wear & Tear
Comments	18" Missing 1 tooth
Functional Test	
Forward & Reverse	3 - Normal, Operating as Expected
Steering	3 - Normal, Operating as Expected
Loader Bucket Functionality	3 - Normal, Operating as Expected
Backhoe Bucket Functionality	3 - Normal, Operating as Expected
Overall Functional Test Comments	All functions operating great
Operating Video	Click to Download
Additional Video	Click to Download
Additional Video	Click to Download
Overall Assessment
