Inspection Report (Trailer)

Year	2006
Make	Trailking
Model	TK70HT - 482
Serial Number	ITKA0482X7M087662
Current Inspection / State Cert / DOT	N/A
Previous Application (e.g., earth moving, mining, demolition, etc)	Demolition General Construction

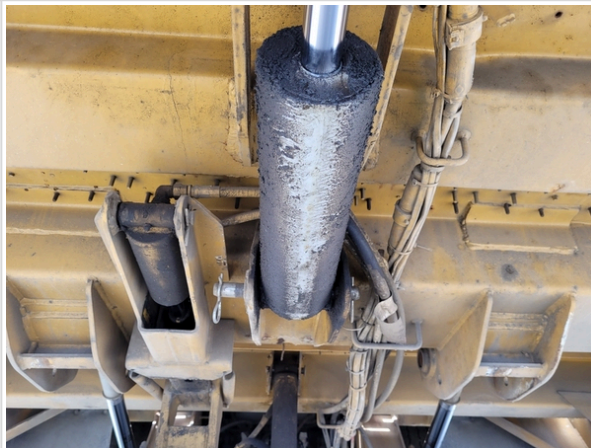
Cylinder has residual oil and may be leaking

Hydraulic System	Take close-up photos of the hydraulic components including the pump, lines, fittings, controls, and levers. Note any damage, wear, or leaks.
Hydraulic Cylinder(s)	3 - Normal Wear & Tear
Cylinder(s): Oil Leaks	Yes
Comments	Some cylinders may be leaking at rear ramps

Exterior Rating	3 - Normal Wear & Tear
Interior Rating	3 - Normal Wear & Tear
Safety Rating	0
Quality Rating	3 - Normal Wear & Tear
Functionality Rating	0
Overall Rating	3 - Normal Wear & Tear
What's Great About the Machine	Trailer's hydraulics working normal. Brakes visually in good condition with brake shoes and drums having plenty of life left.
What Needs Work	Air brakes and Air suspension should be tested for proper operation. 90 day inspection recommended. Some hydraulic cylinders may need to be repaired soon.
Date/Time	05-03-2023

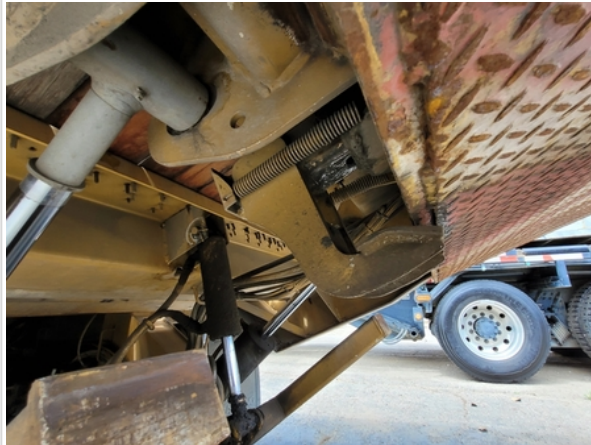
Cylinder may be leaking

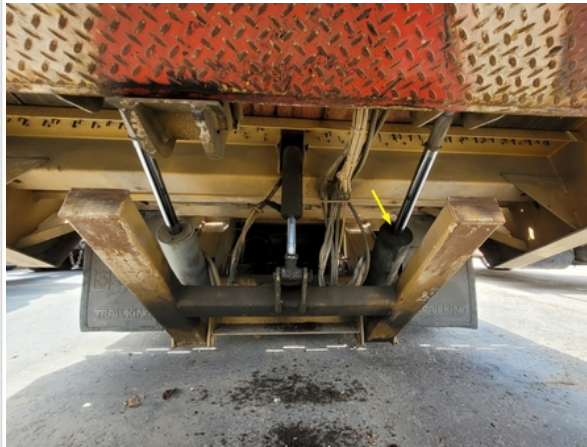
Cylinder may be leaking

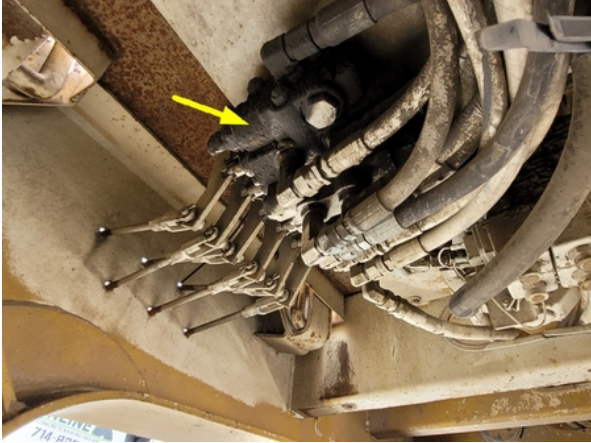
<p>Minor seepage buildup on Main Control Valve (No active leak observed)</p>

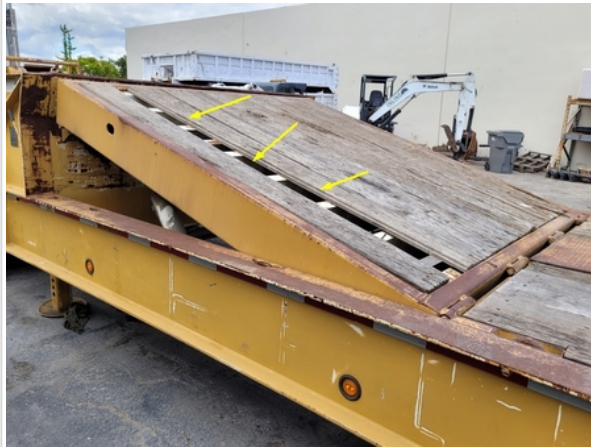
Flatbed Body	Check the condition of the flat bed body. Note any damage or wear. Take photos.
Bed Details (Deck Type, Additional Features)	Top Deck Has Hydraulic winch and has 8' of surface space available for loads. Hydraulic Ramp equipped to top deck
Flatbed Body	3
Comments	Some floor boards missing and some have damage

Floor board missing wood piece

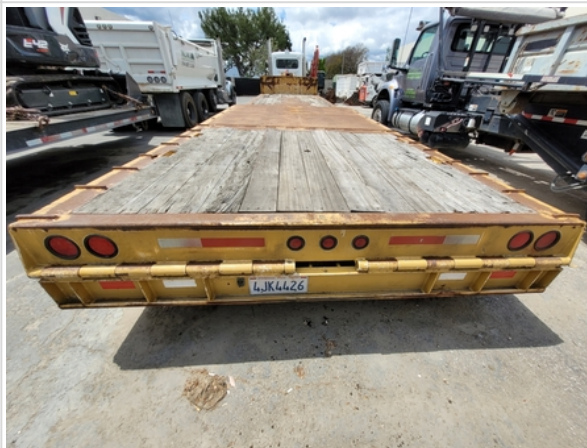
Wood damaged at front part of deck
