Inspection Report (Excavator)

Year	2008
Make	Hitachi
Model	ZX270LC-3
Serial Number	1FFASROXPAO820124
Hour Meter Reading	10,070 Hrs.
Previous Application (e.g., earth moving, mining, demolition, etc)	General Construction

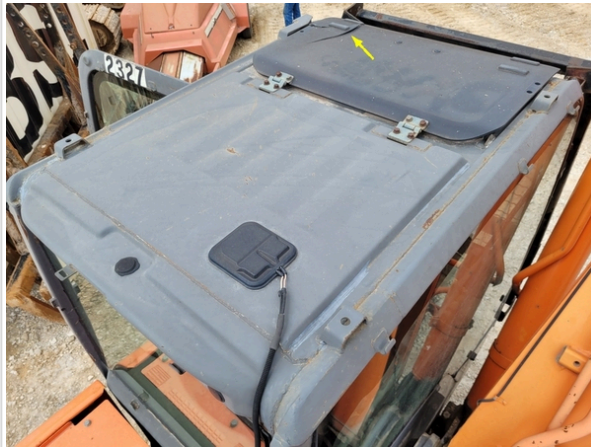
Cracked Sun Visor

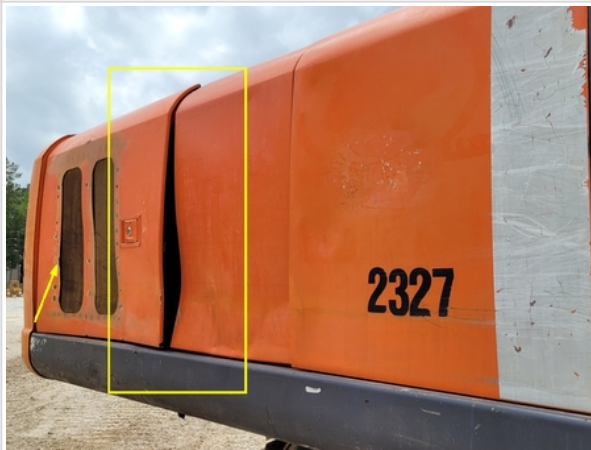
Panels Bent

Body Panels	2 - Above Average Wear
Body Panel Condition	Some panel misalignment observed, Large dents or cracks, Other (see comments)
Doors / Canopy Latches	3 - Normal Wear & Tear
Doors / Canopy Latches Condition	No visible damage
Steps / Ladders	2 - Above Average Wear
Steps / Ladders Condition	Steps/ladders are fully intact and appear structurally sound, Bent or broken steps or rungs
Handrails	3 - Normal Wear & Tear

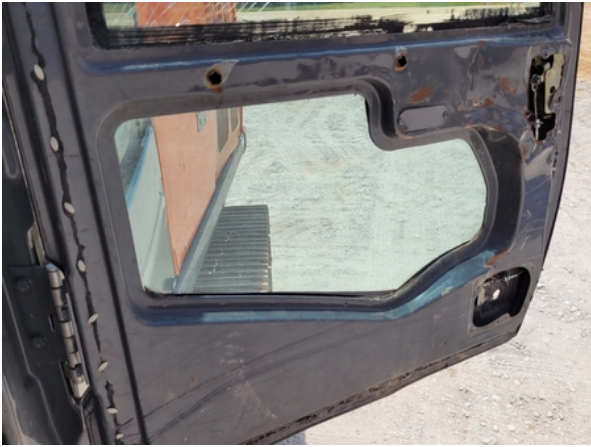
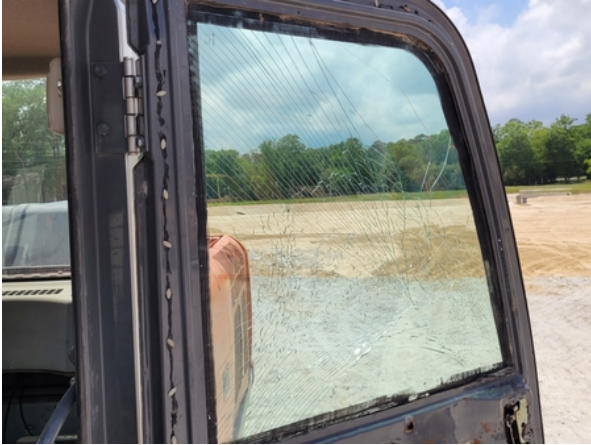
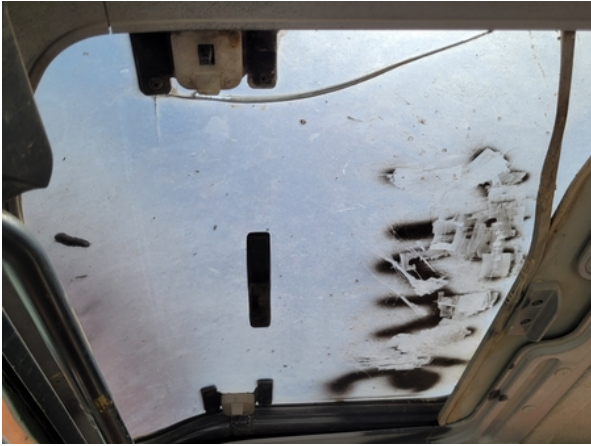
Handrails Condition	Handrails are fully intact and appear structurally sound
Glass	2 - Above Average Wear
Glass Condition	Major chips or cracks observed, Other (see comments)
Comments	Left Side Cab window broken
Glass Condition Photos

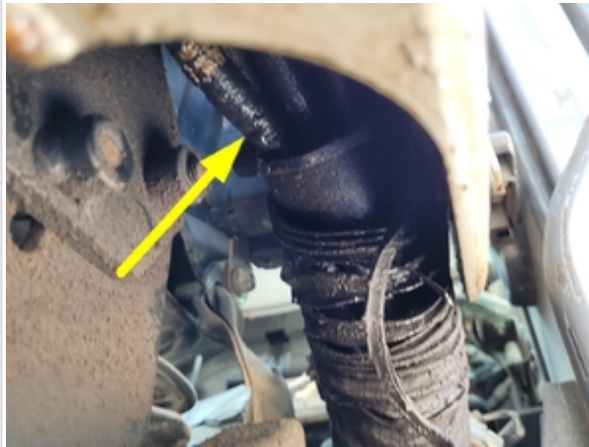
Hydraulic Pilot Control Hoses Leaking

Control Station Overall Rating	2 - Above Average Wear
Control Station Overall Condition	Significant wear and tear to cabin floor, panels, and ceiling, Other (see comments)
Comments	Oil leaks seen at left side joystick console area
Operator Seat	3 - Normal Wear & Tear
Operator Seat Condition	Seat(s) has major surface staining or tears
Cabin Lights	2 - Above Average Wear
Cabin Lights Condition	Cabin lights are installed with all light covers in place, bulbs are installed and working properly
Safety Lock Out / Stop	3 - Normal Wear & Tear
Safety Lock Out / Stop Condition	Safety lock out device is present, in good condition, and functional
Controls & Switches	3 - Normal Wear & Tear
Controls & Switches Condition	All switches are installed and functional
Hour Meter Activity	3 - Normal Wear & Tear
Hour Meter Condition	Hour meter is functional and in good condition

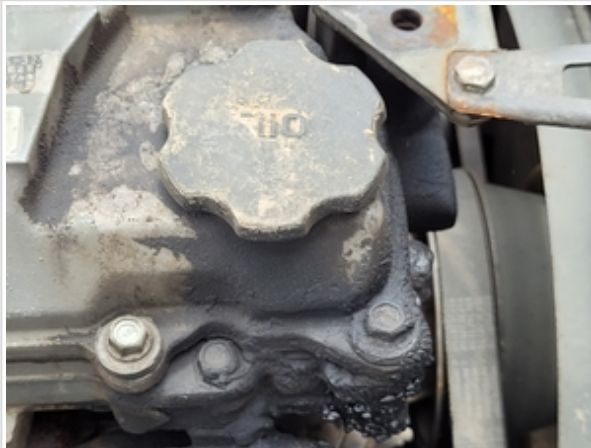
Active Engine Oil Leak

Belt Condition	Belts appear in good condition & alignment with proper tension
Hoses	3 - Normal Wear & Tear
Hose Condition	Firm, pliant hoses with no signs of wear or leaks
Water Pump	3 - Normal Wear & Tear
Water Pump Condition	No unusual pump noises heard
Cooling System Leaks	No
Coolant Color / Appearance	3 - Normal Wear & Tear
Coolant Color/Appearance Notes	Normal Translucent appearance, no visual signs of contamination
Oil Leaks	Yes
Oil Leak Notes	Wetness & discoloration observed
Comments	Engine leak observed at valve cover area
Oil Color / Appearance	3 - Normal Wear & Tear
Oil Color / Appearance Notes	Clean oil appearance, no signs of cross contamination, Appropriate oil level
Fuel Leaks	No
Equipped with DPF (Diesel Particulate Filter)	No
Requires DEF (Diesel Exhaust Fluid)	No
Overall Engine Appearance	Active leaks/pooling observed in & around engine compartment, Dusty & dry
Overall Engine Comments	Engine fires right up and sounds okay under load. A few active leaks observed around topside of engine.

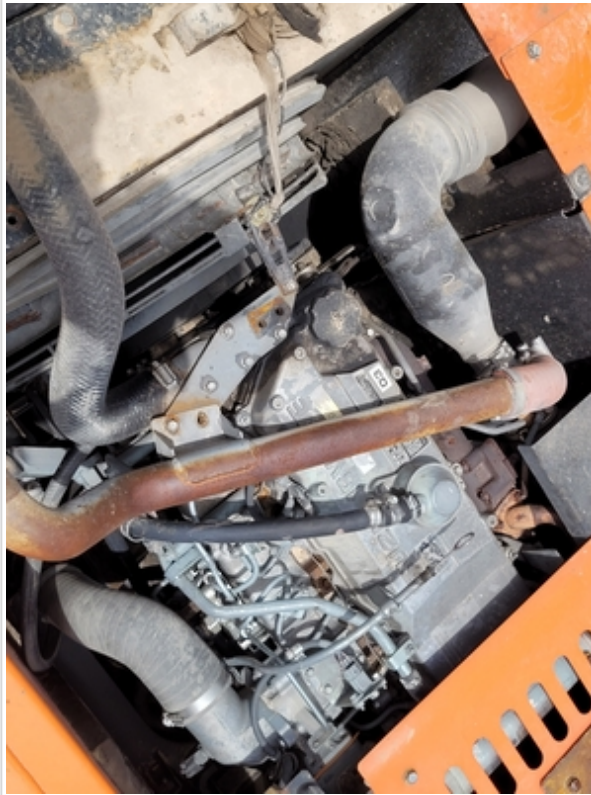
Helping support Radiator Mount

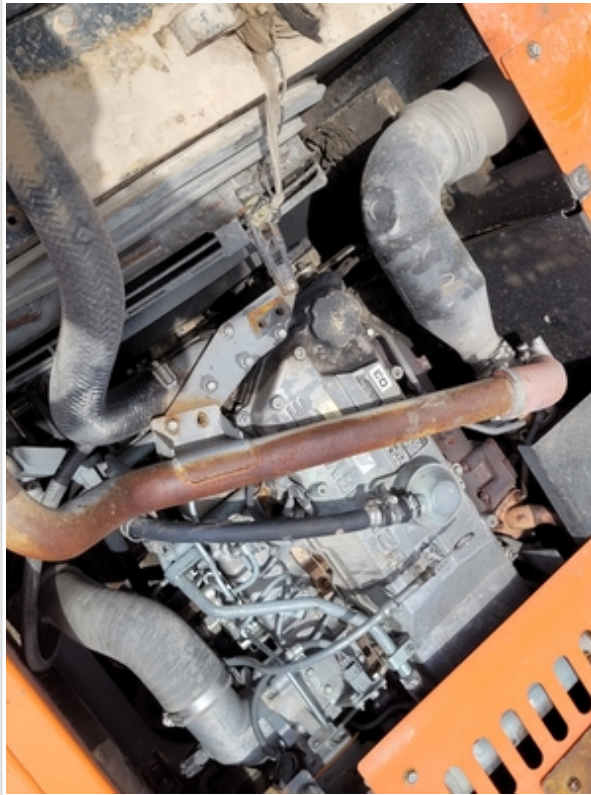
Helping Support Fan Guard

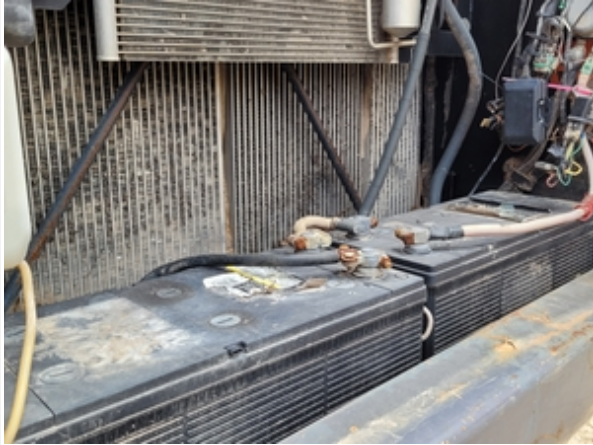
<p>Battery Hold Down Missing</p>

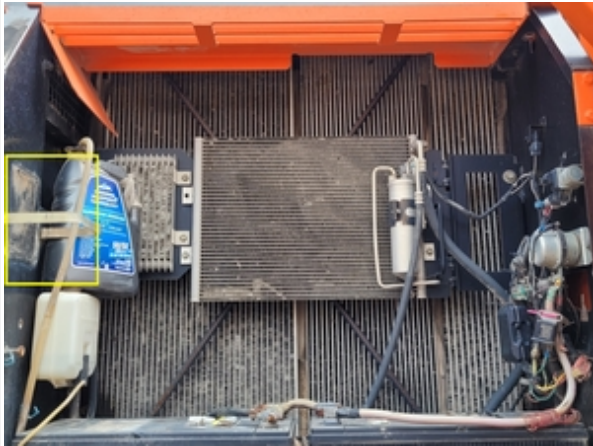
<p>Coolant overflow container missing</p>
Blow-by (Visual Observation Check)	Yes
Comments	Some blow-by seen
Unusual Noises (Upon Start-up, Idle, Shutdown)	No
Unusual Noise Notes	No unusual noises heard
Engine Smoke (Upon Start-up, Idle, Shutdown)	No
Engine Smoke Notes	No engine smoke issues observed
Engine Exhaust Color	Clear
Battery	3 - Normal Wear & Tear
Battery Condition	Other (see comments), Dusty & dirty appearance
Comments	Battery Mounting Brackets Missing
Radiator	3 - Normal Wear & Tear
Radiator Condition	Radiator fins & components appear to be in good working order, no signs of damage or leaks
Belts	3 - Normal Wear & Tear

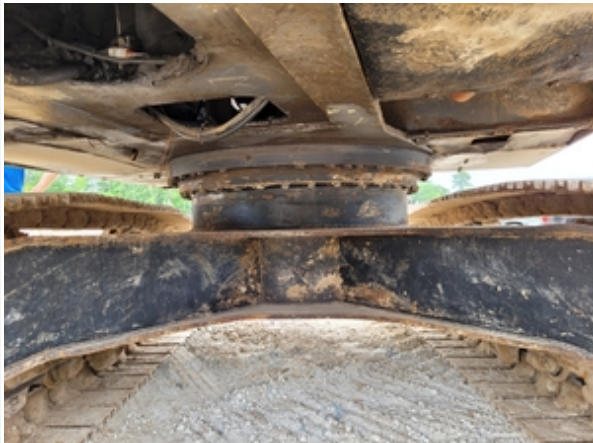
Bottom Covers	3 - Normal Wear & Tear	
Comments	Some covers bent and some missing	
Bottom Covers Photos

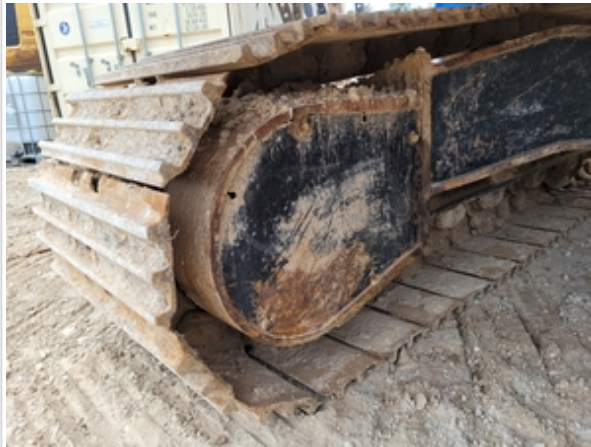
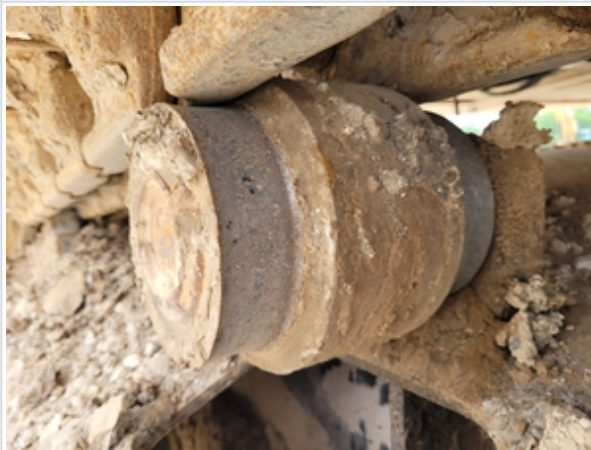
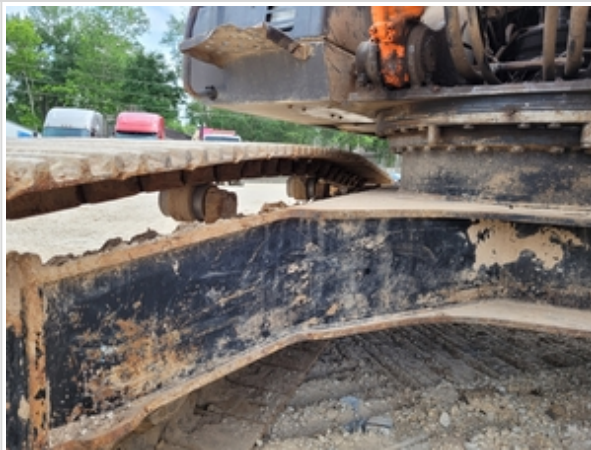
Undercarriage Overall Condition	3 - Normal Wear & Tear	
Comments	Sprocket segments worn and upper rollers worn past 50%	
Undercarriage Overall Photos

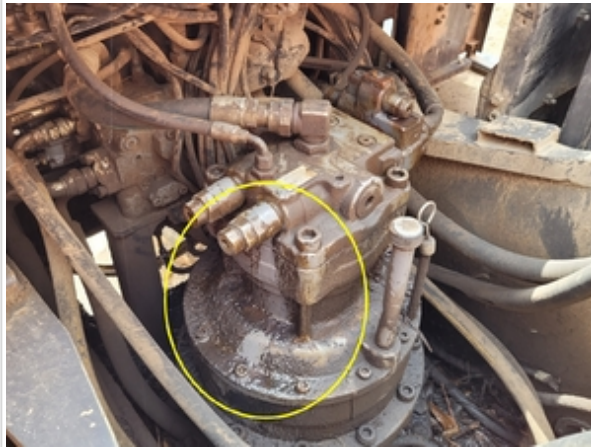
Active Leak

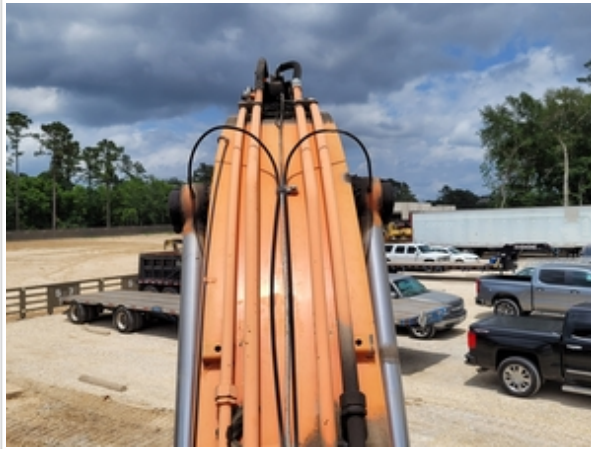
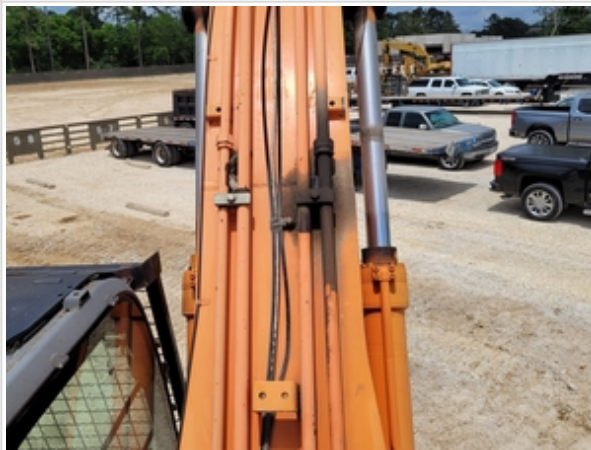
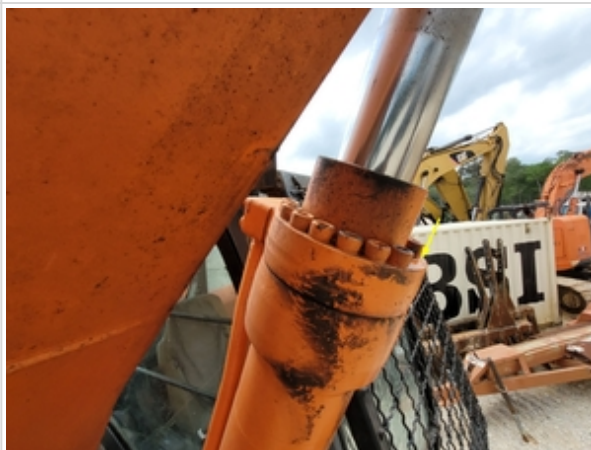
Boom Cylinder	Check the boom cylinder. Note any wear, pitting, discoloration, etc. Take photos.
Boom Cylinder: Mounting Pin	3
Boom Cylinder: Oil Leaks	Yes
Comments	Both Cylinders may be leaking at rod seals

Minor oil leakage seen at both boom cylinders

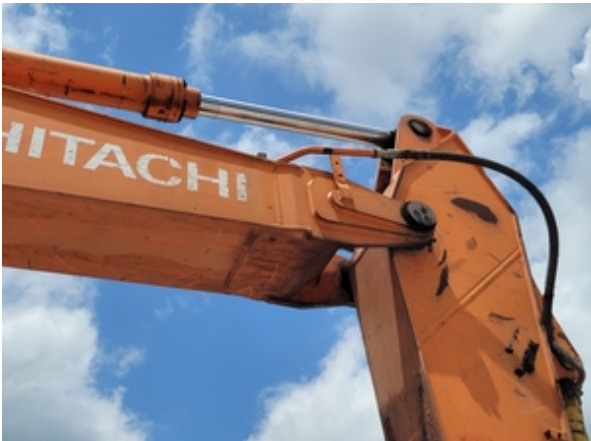
Stick Cylinder	Check the stick cylinder. Note any wear, pitting, discoloration, etc. Take photos.	
Stick Cylinder: Mounting Pin	3	
Stick Cylinder: Oil Leaks	Yes	
Comments	Minor leaking observed	
Stick Cylinder Photos
