Inspection Report (On-Highway Service Truck)

Year	2015
Make	Ford
Model	F 550
Serial Number	1FDUF5GT1FED32839
Truck Odometer Reading	156787
Current Inspection / State Cert / DOT	06/22 TX D6545930
Previous Application (e.g., earth moving, mining, demolition, etc)	service truck

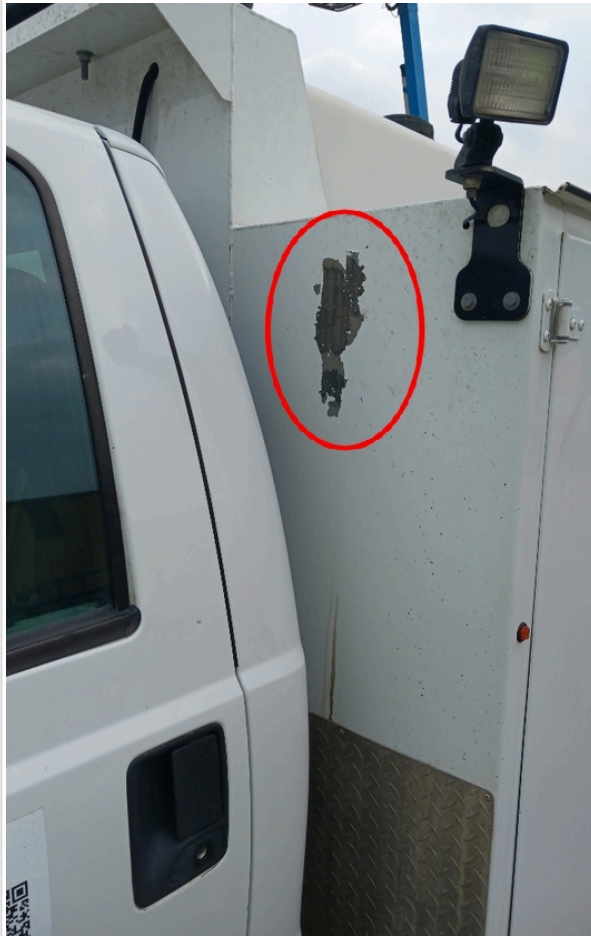
on the left-hand side of the box, there is some paint missing. 9inches long and 3 1/2 inches wide

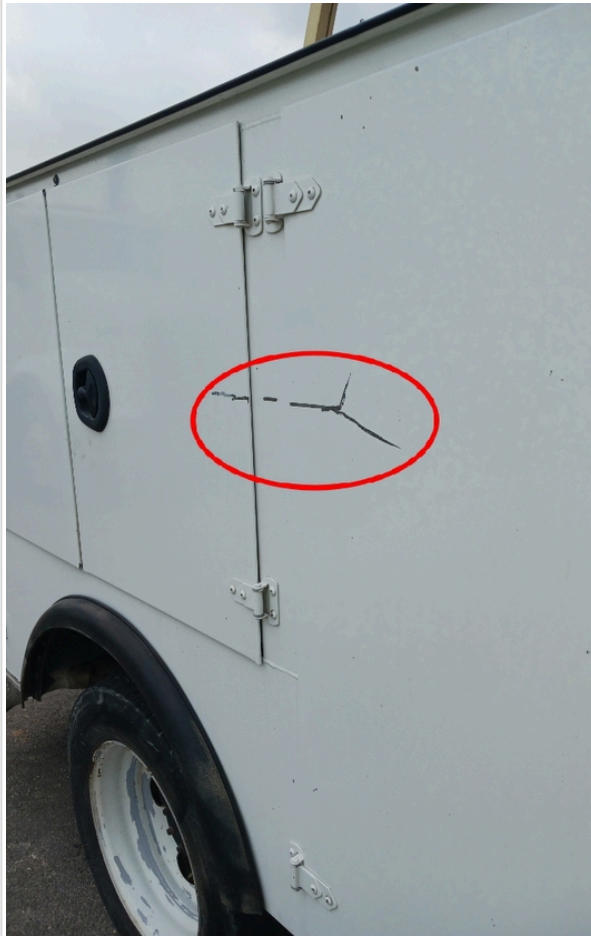
on the right side of the box, some paint is missing. 15 1/2 inches long and it is less than 1/4inch wide

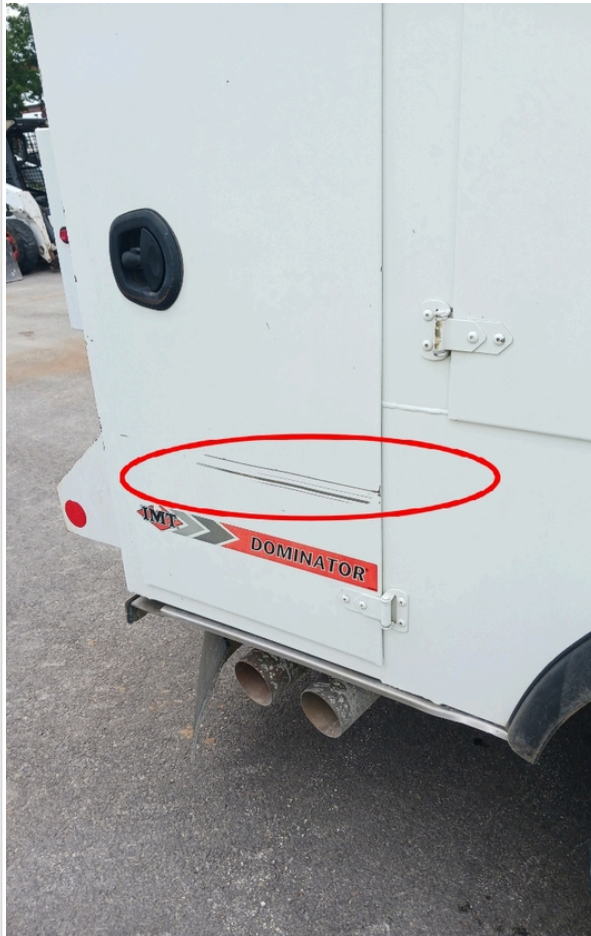
scratch on the right hand side box. 14inches long less than 1/4inch wide

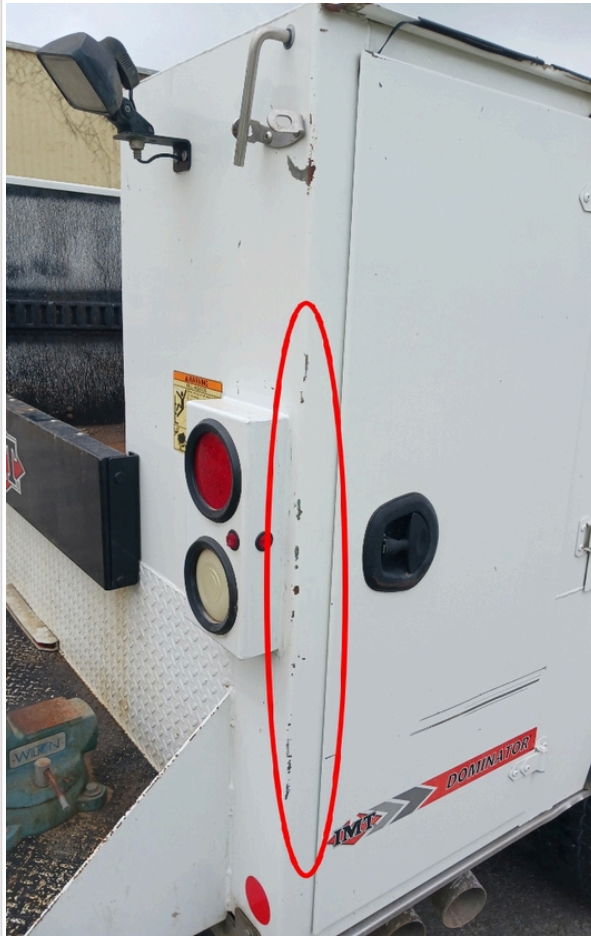
scratches on the right hand side box towards tailgate.

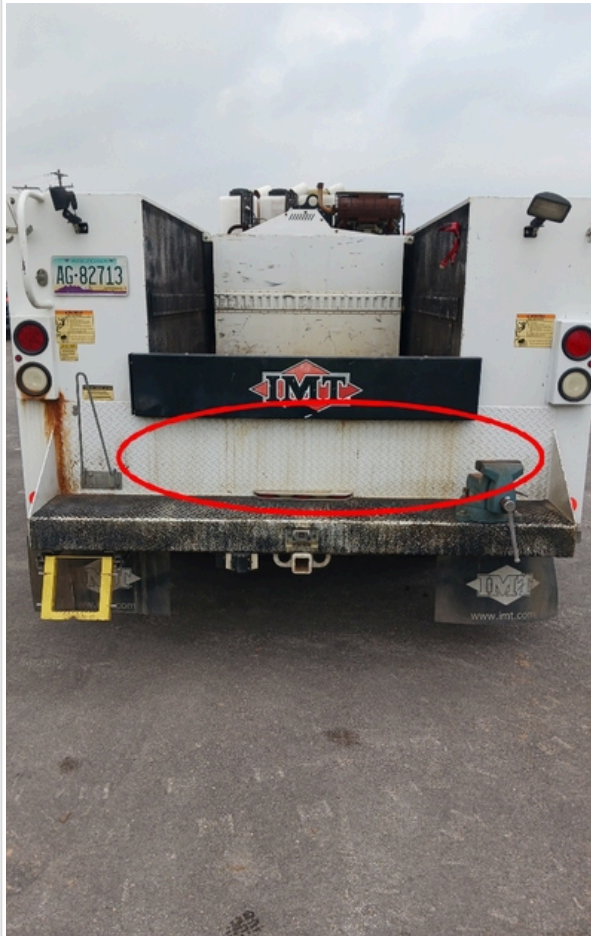
small amount of rust

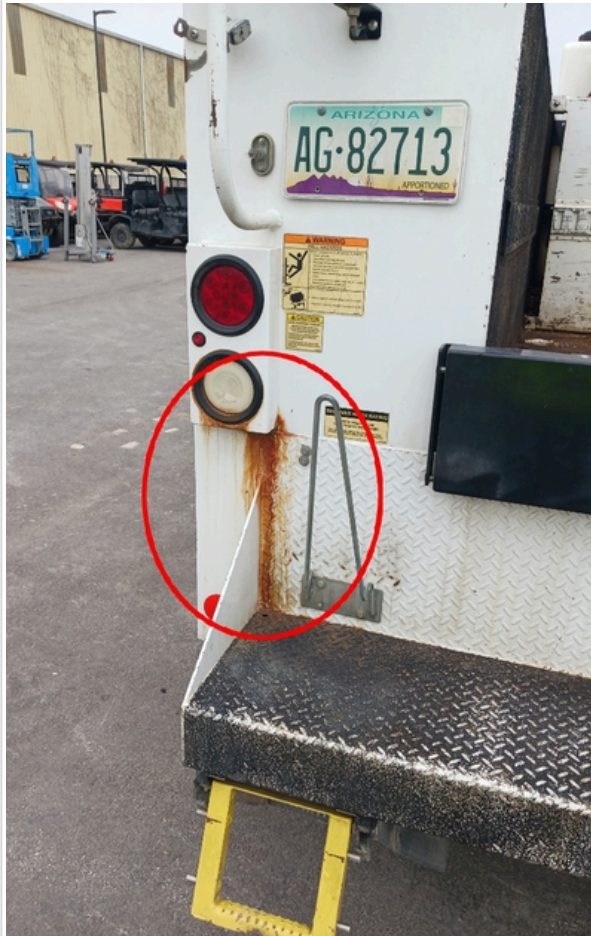
rusted area located on the left hand side of the box near the tailgate. the area is 17inches long

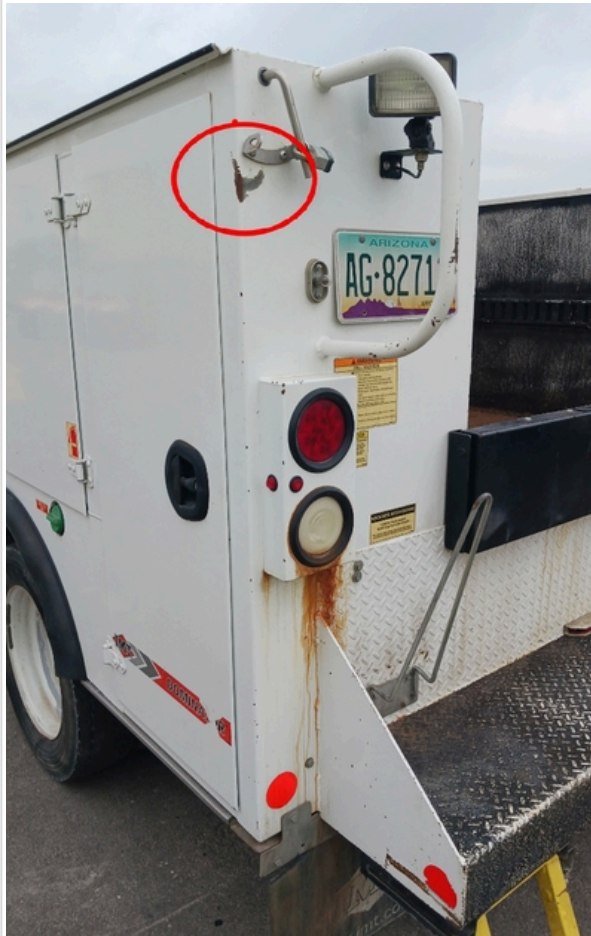
small area missing a little paint, 2inches wide and 2inches tall

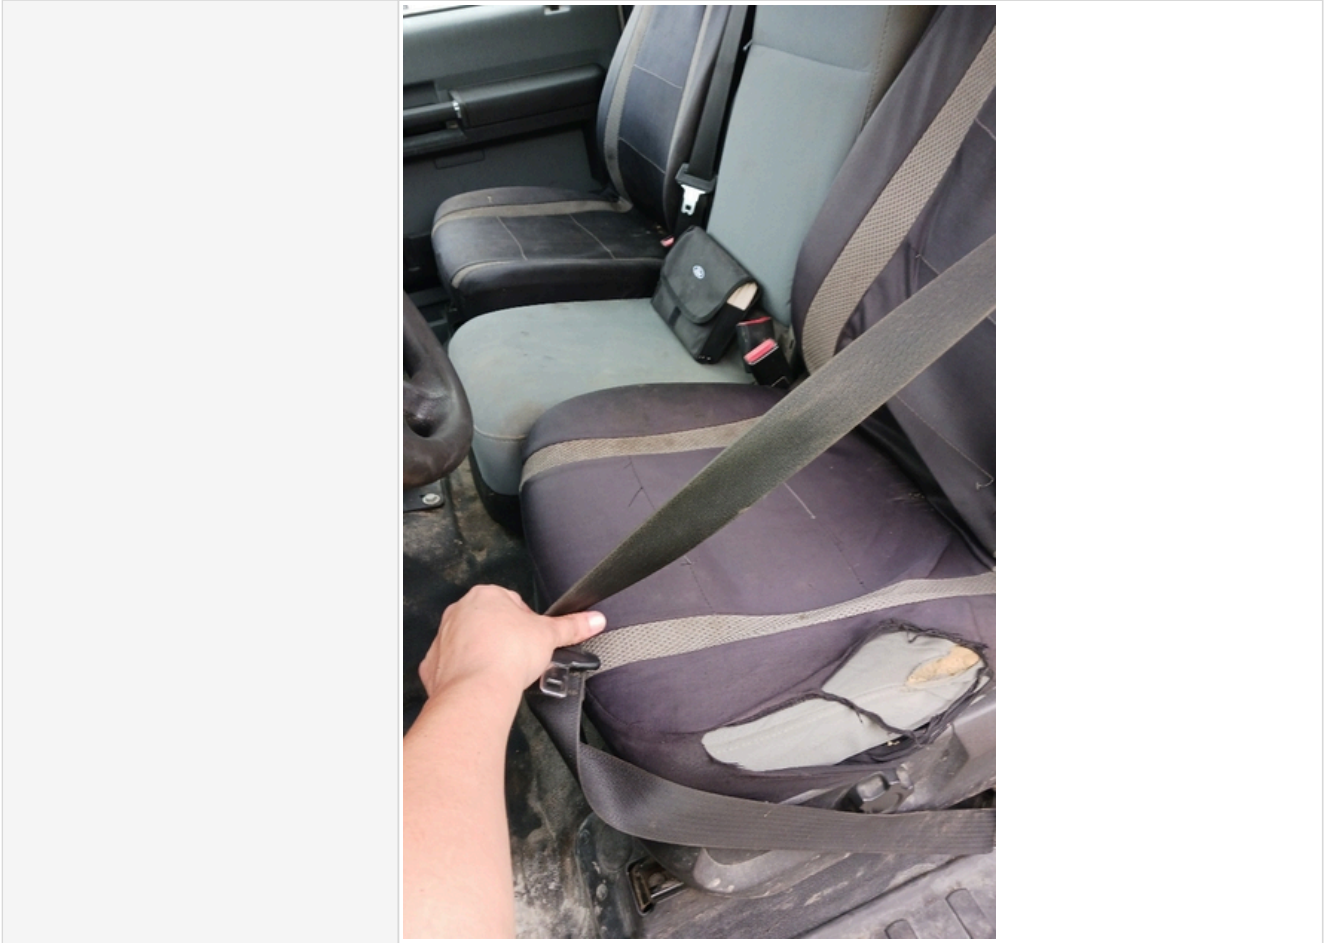
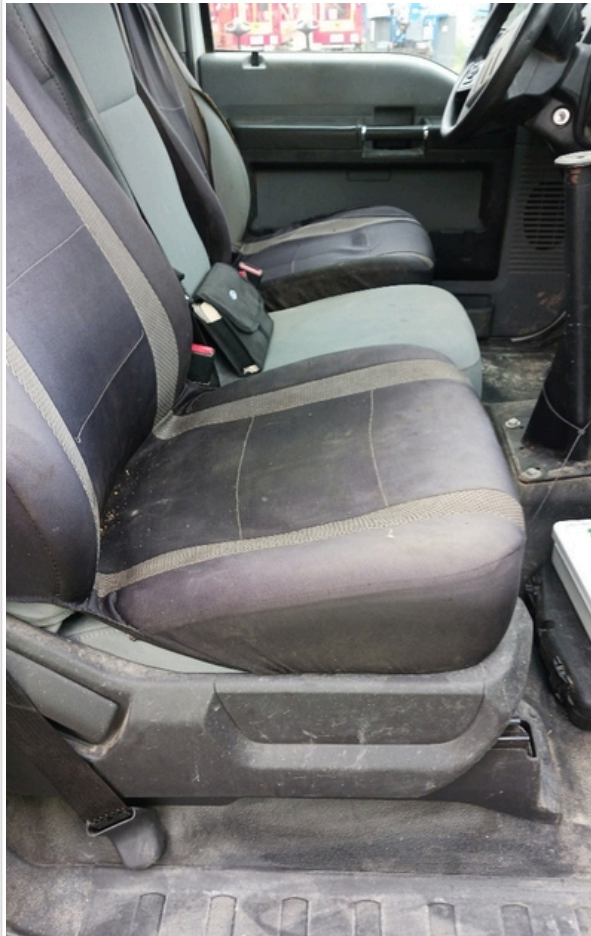
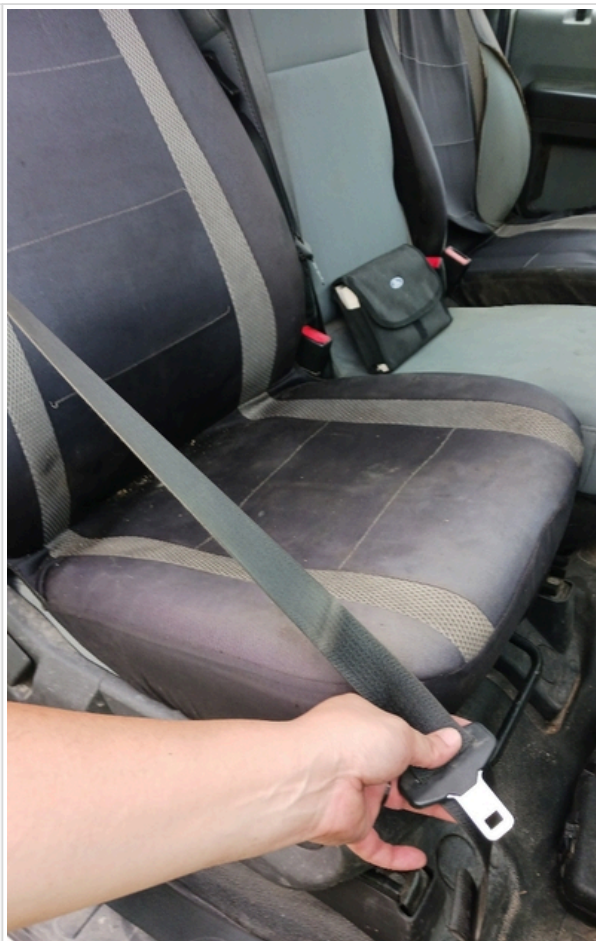
Seats/ Seat Belt Photos

Heater & A/C	3 - Normal Wear & Tear
Heat & A/C Condition	Heater and A/C work as expected
Interior Lights	3 - Normal Wear & Tear
Interior Lights Condition	All interior lights are installed and functioning
Seats/Seat Belts	3 - Normal Wear & Tear
Seats/Seat Belt Condition	Seat(s) have minor surface staining or small tears, Seat belt secures properly
Comments	there are some small tears on the driver side seat

Cab Interior Overall Rating	3 - Normal Wear & Tear
Comments	cab has a minor tear on the driver side seat and the interior has some minor staining, but it is in good condition.

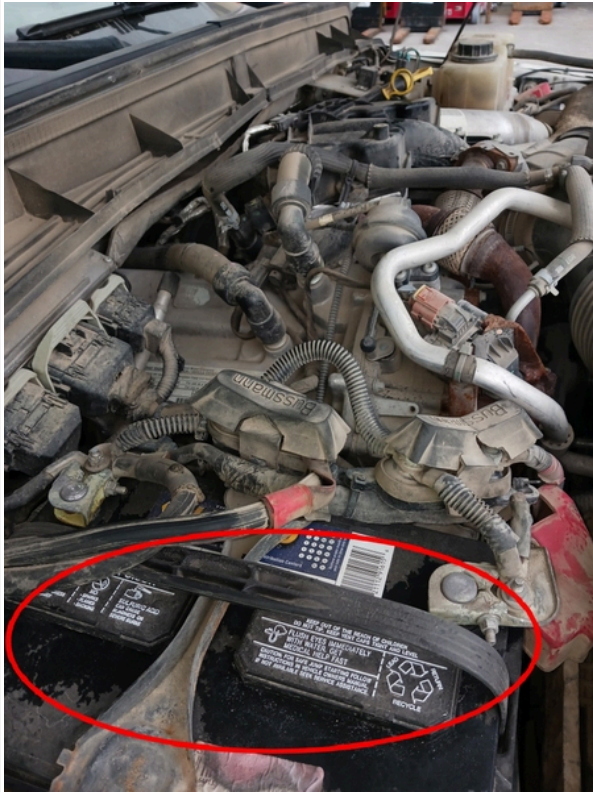
<p>wet appearance on battery but no corrosion was seen</p>

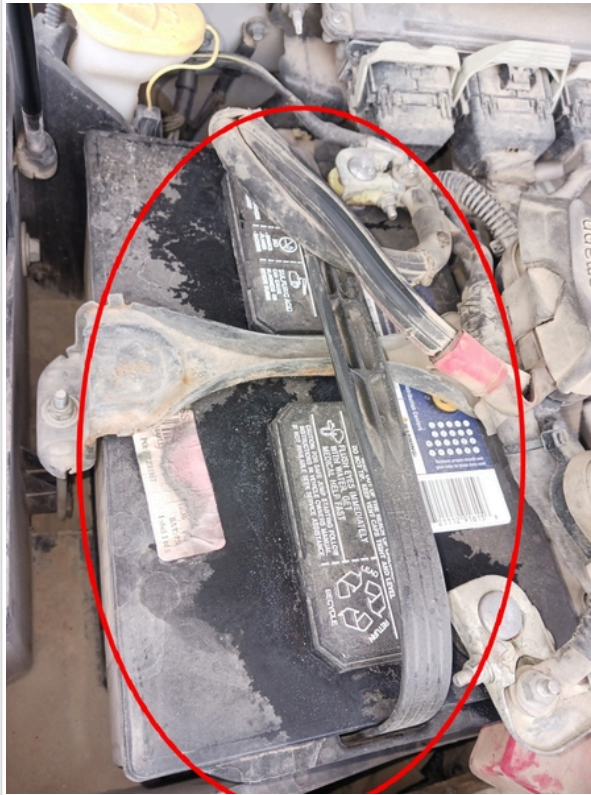
area on the battery looks wet, but no corrosion was seen

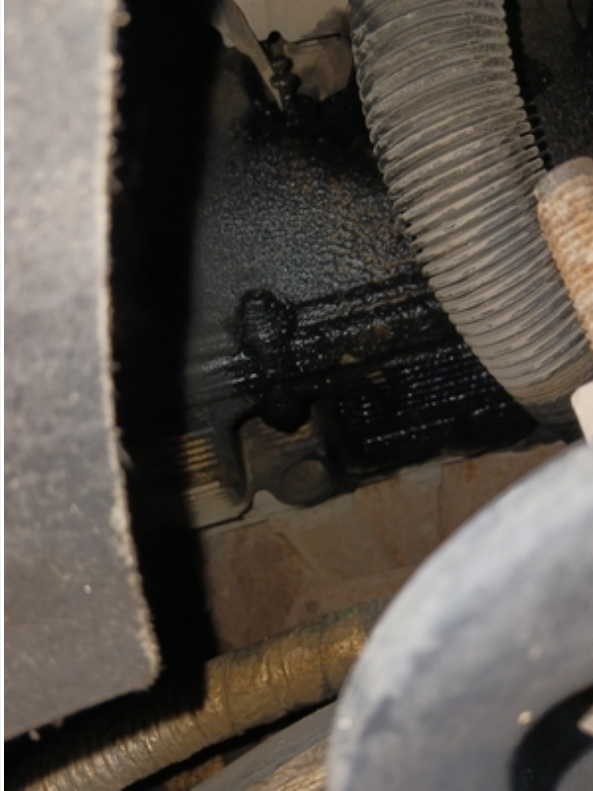
Oil Leak Photos

Radiator	3 - Normal Wear & Tear
Radiator Condition	Radiator fins & components appear to be in good working order, no signs of damage or leaks
Belts	3 - Normal Wear & Tear
Belt Condition	Belts appear in good condition & alignment with proper tension
Hoses	3 - Normal Wear & Tear
Hose Condition	Firm, pliant hoses with no signs of wear or leaks
Water Pump	3 - Normal Wear & Tear
Water Pump Condition	No unusual pump noises heard
Cooling System Leaks	No
Coolant Color / Appearance	3 - Normal Wear & Tear
Coolant Color/Appearance Notes	Normal Translucent appearance, no visual signs of contamination
Oil Leaks	Yes
Oil Leak Notes	Wet areas with drops forming due to oil leakage
Comments	on the right side of the engine, a leak was seen.

Overall Rating	3 - Normal Wear & Tear
What's Great About the Machine	The vehicle is operational and works very well. The A/C works great and so does the radio.
What Needs Work	There is a small leak coming from the right side of the engine block located behind the right front tire.
Date/Time	05-12-2023

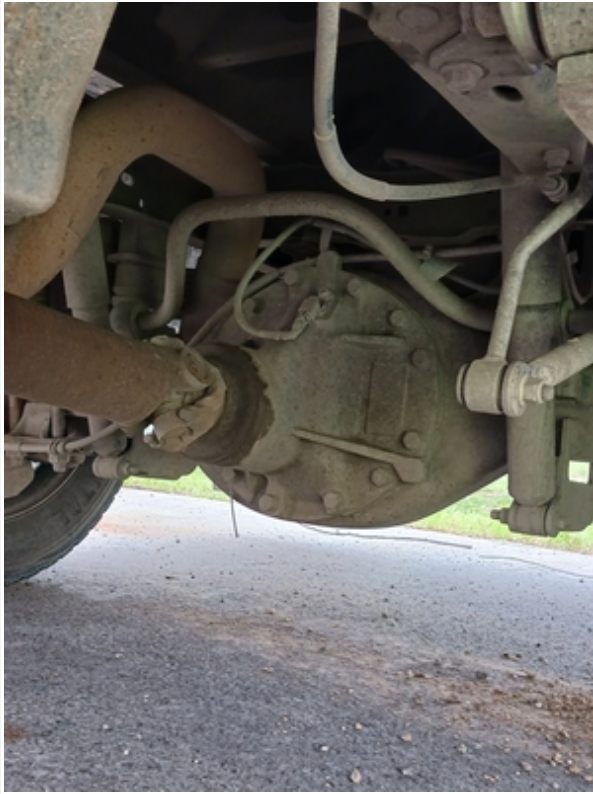
Rear Differential Condition	Dry housing appearance, no unusual noises heard during operation
Rear Differential Photos

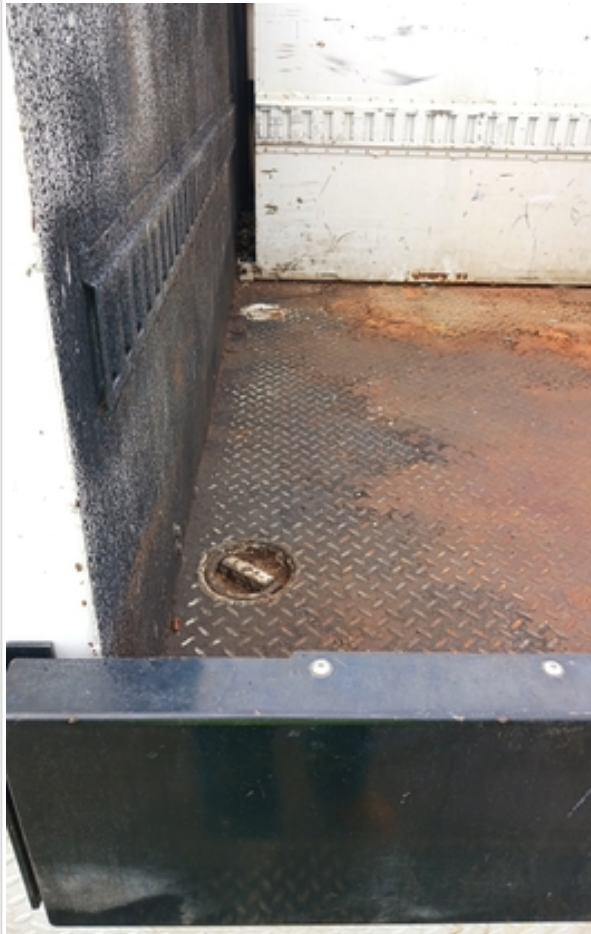
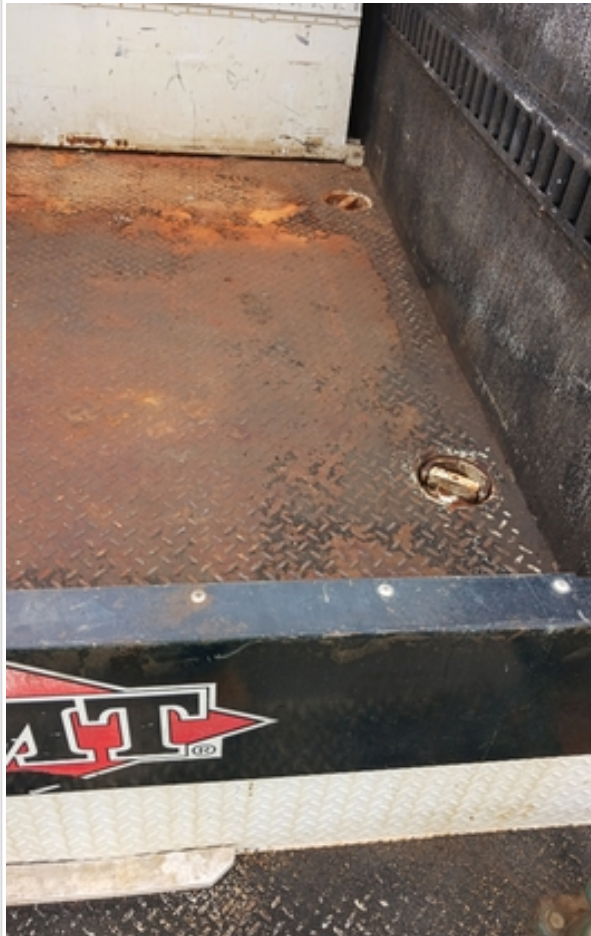
Bed Body Photos

Tool Truck Body	Check the condition of the tool truck bed body, tool boxes (interior and exterior), and lift gate (if equipped).
Bed Body	3
Comments	has rust but is still in good condition

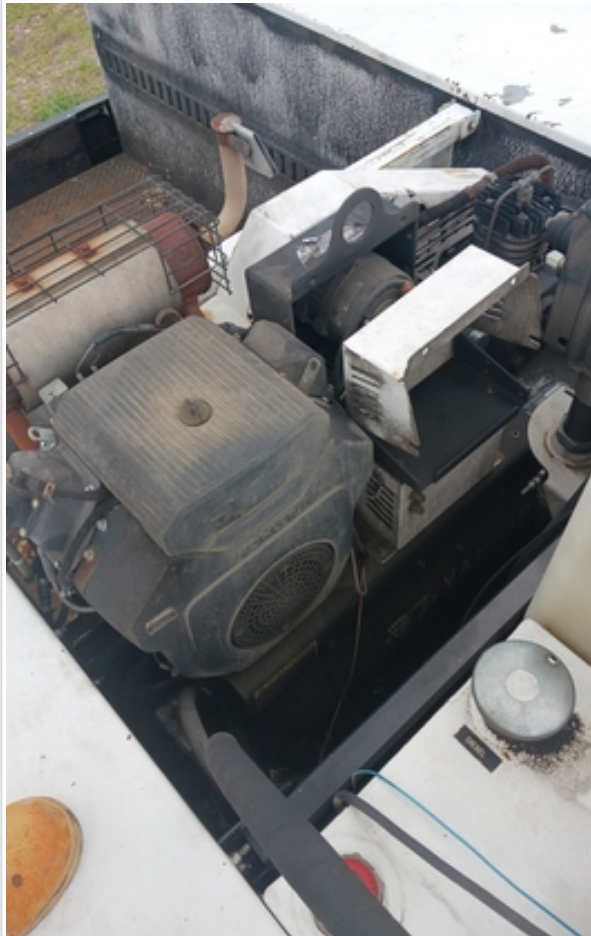
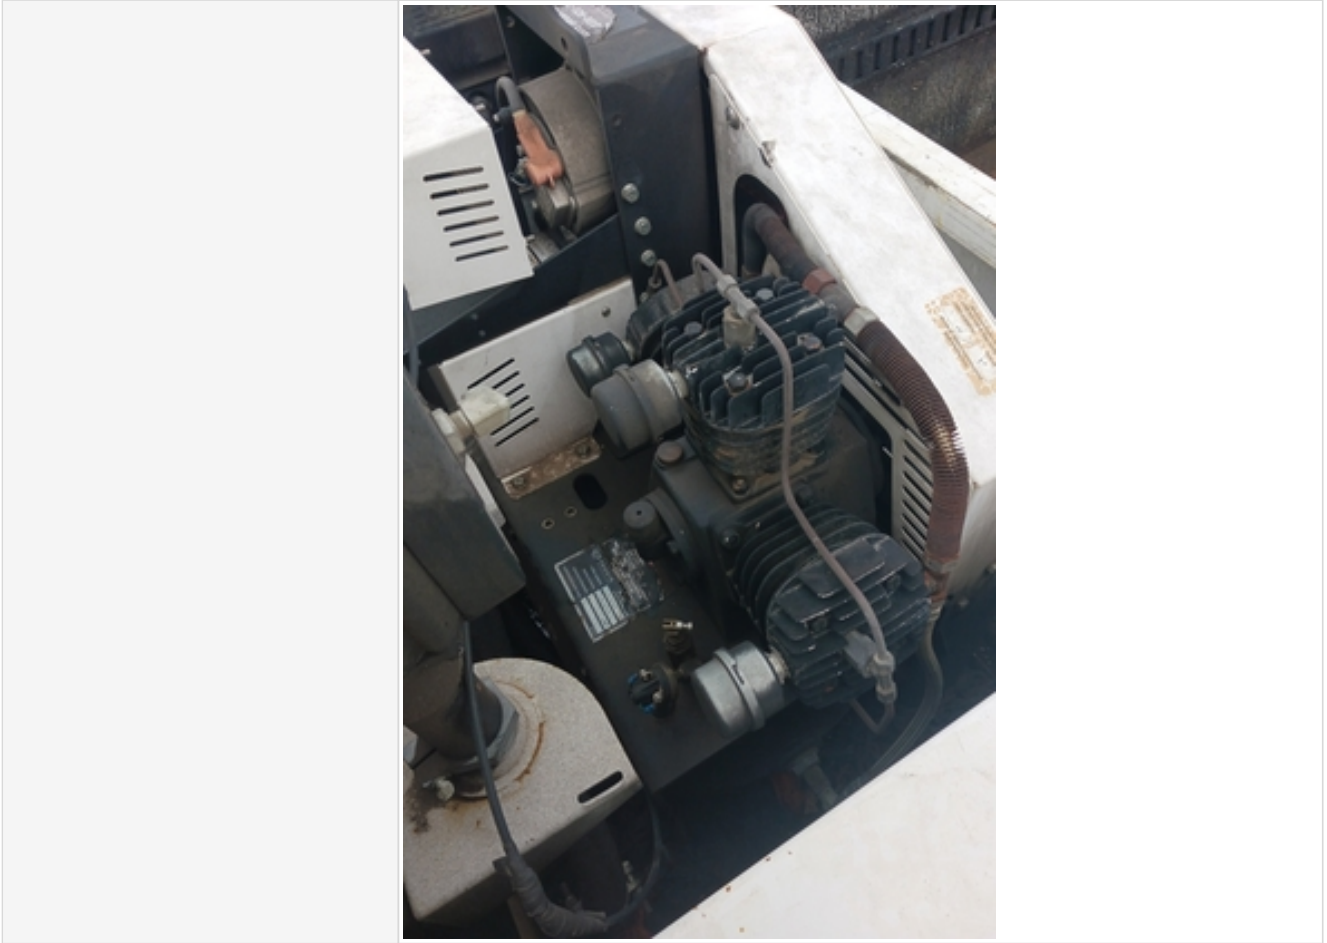
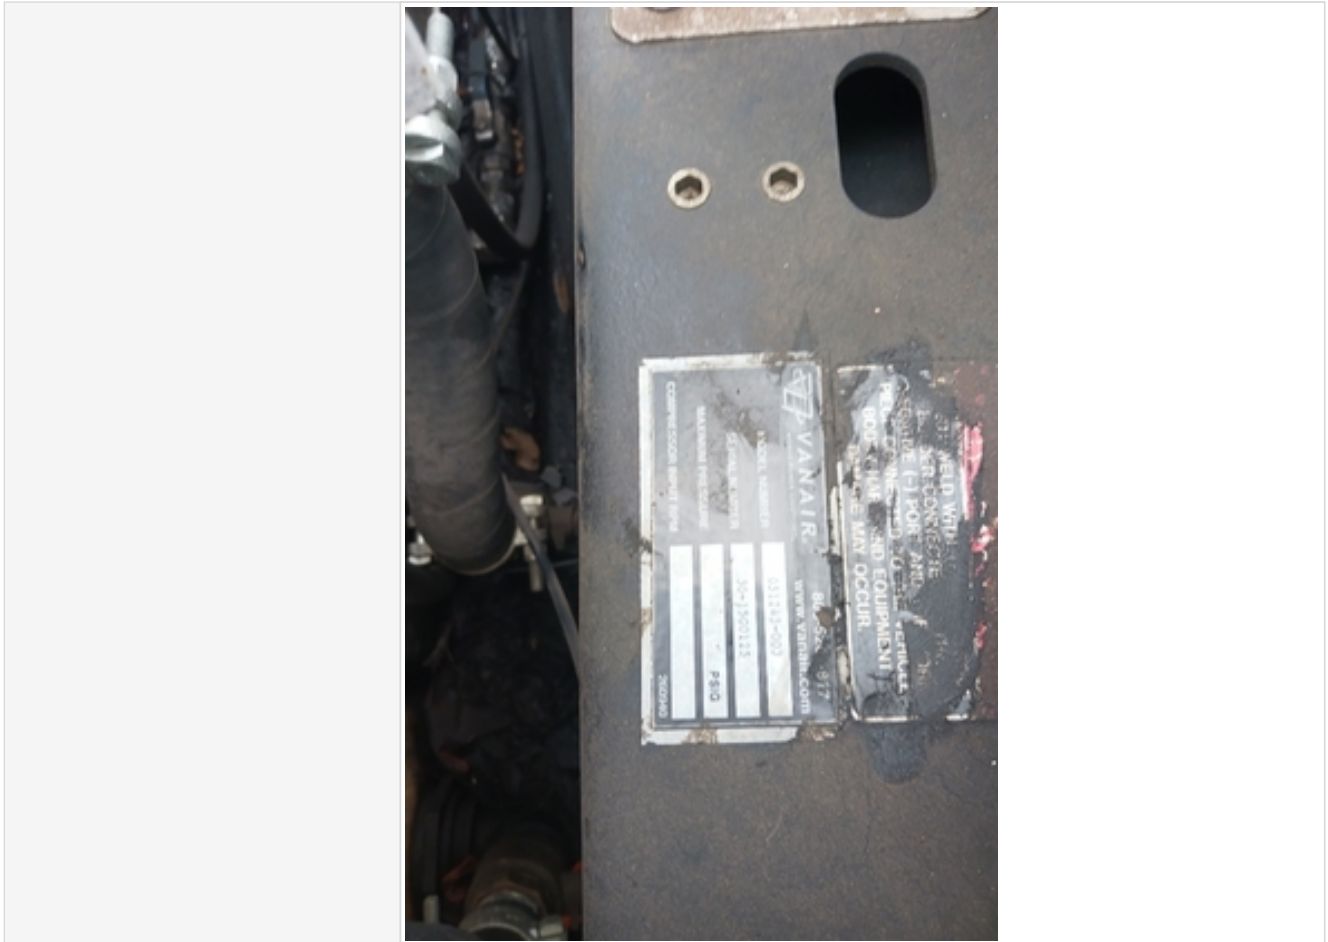
Air Compressor Photos

Air Compressor Condition	3 - Normal Wear & Tear
Air Compressor Functionality	Not tested
Comments	truck is equipped with an air compressor, but it is not known if the compressor is operational.
