## Inspection Report (On-Highway Truck Cab + Chassis)

Year	2013
Make	kenworth
Model	T 800
Serial Number	1XKDDP9X6EJ387089
Truck Odometer Reading	267372
Current Inspection / State Cert / DOT	12/21 TX DOT D6993293
Previous Application (e.g., earth moving, mining, demolition, etc)	transport

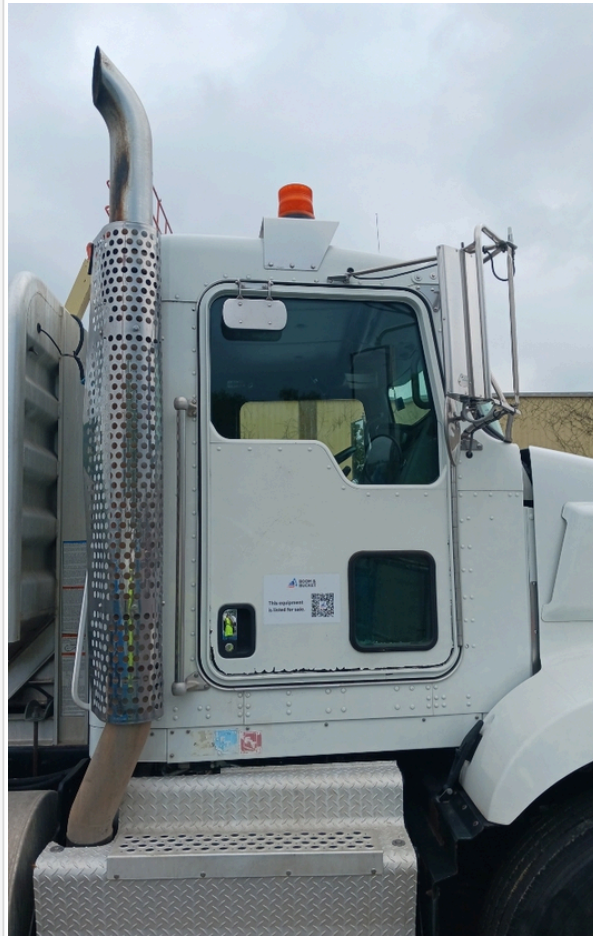
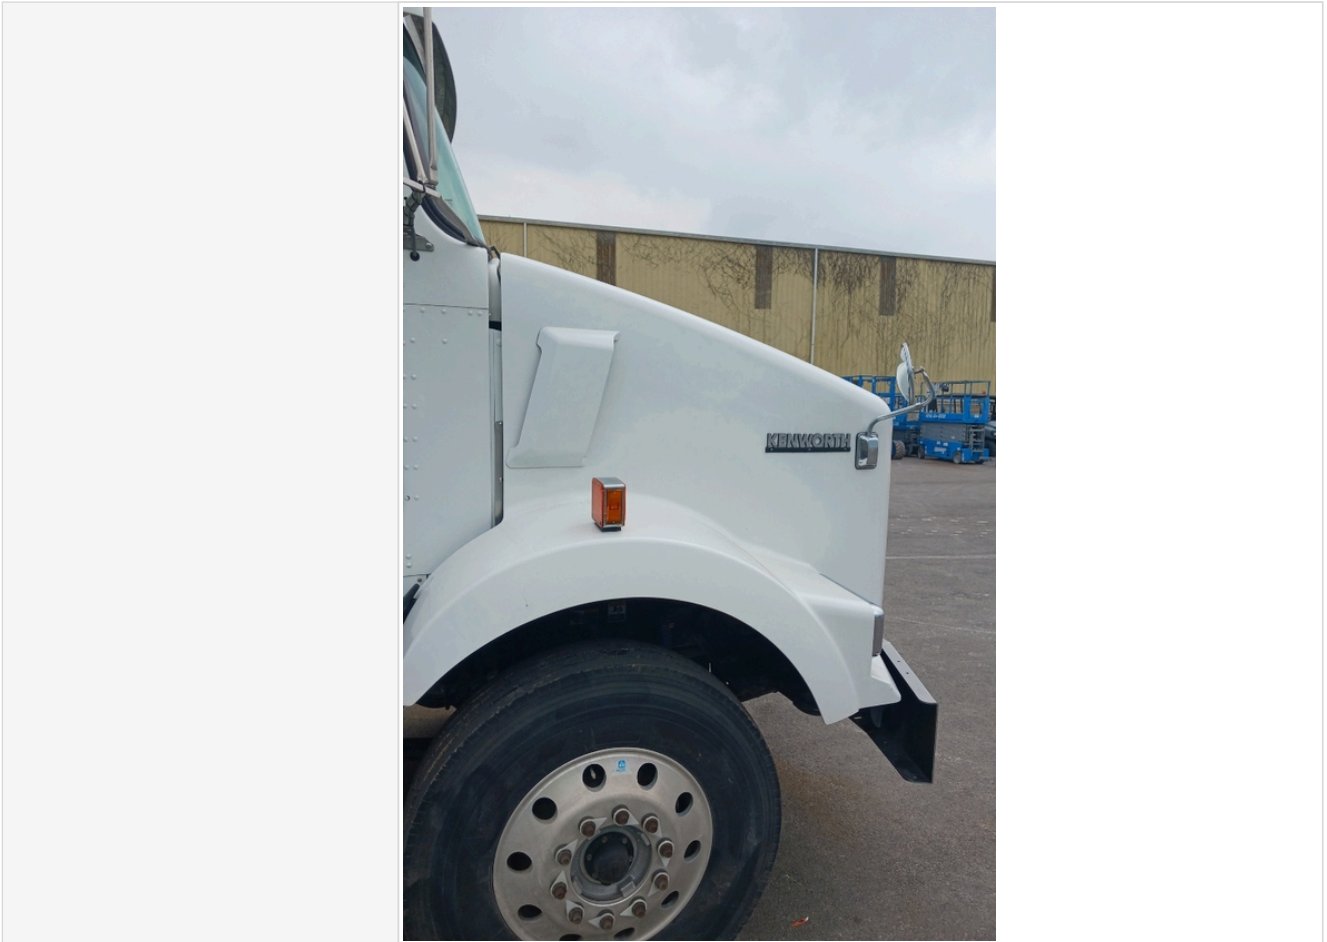
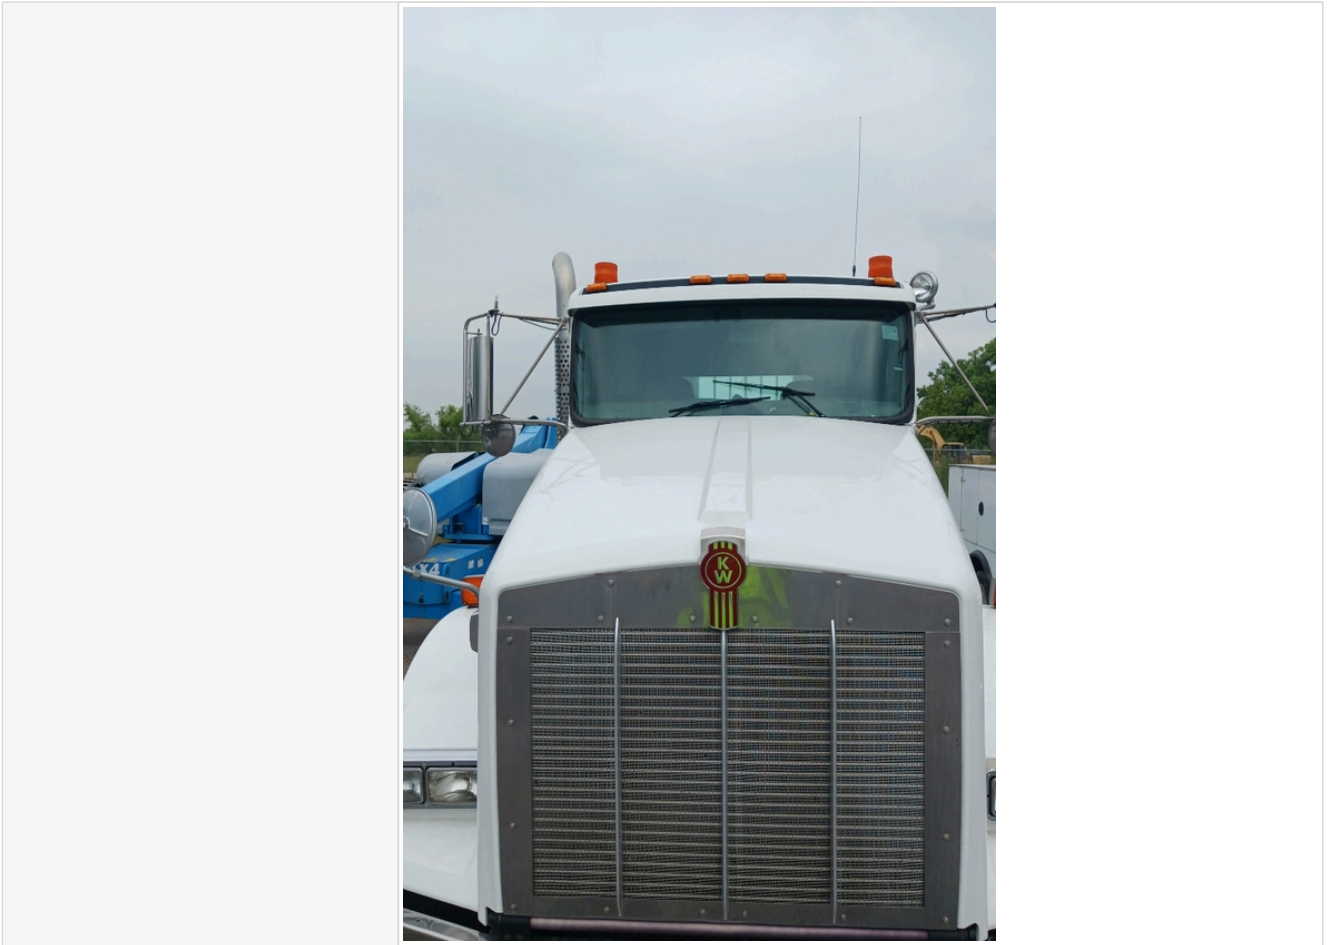
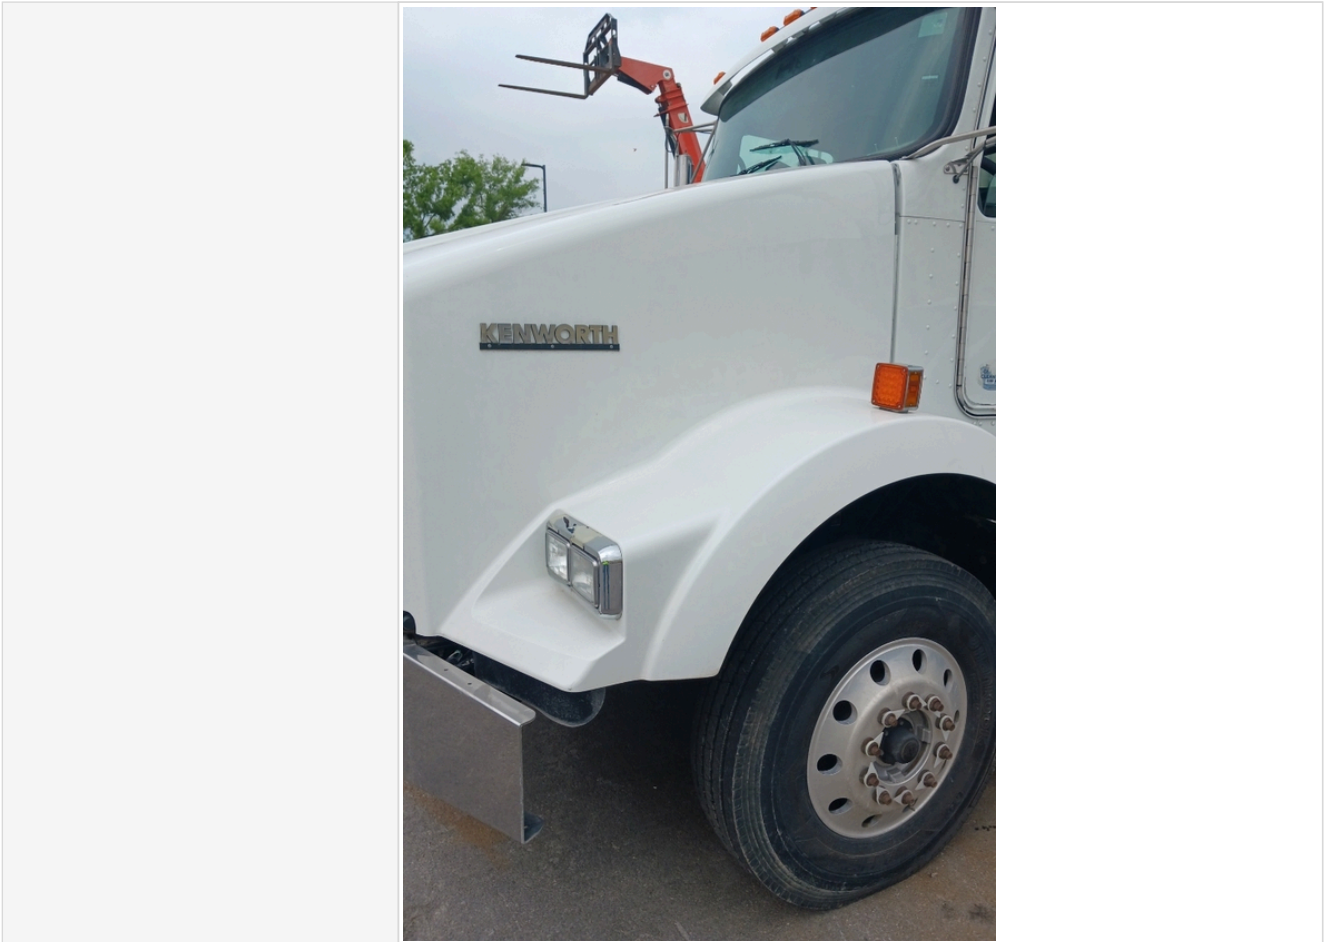
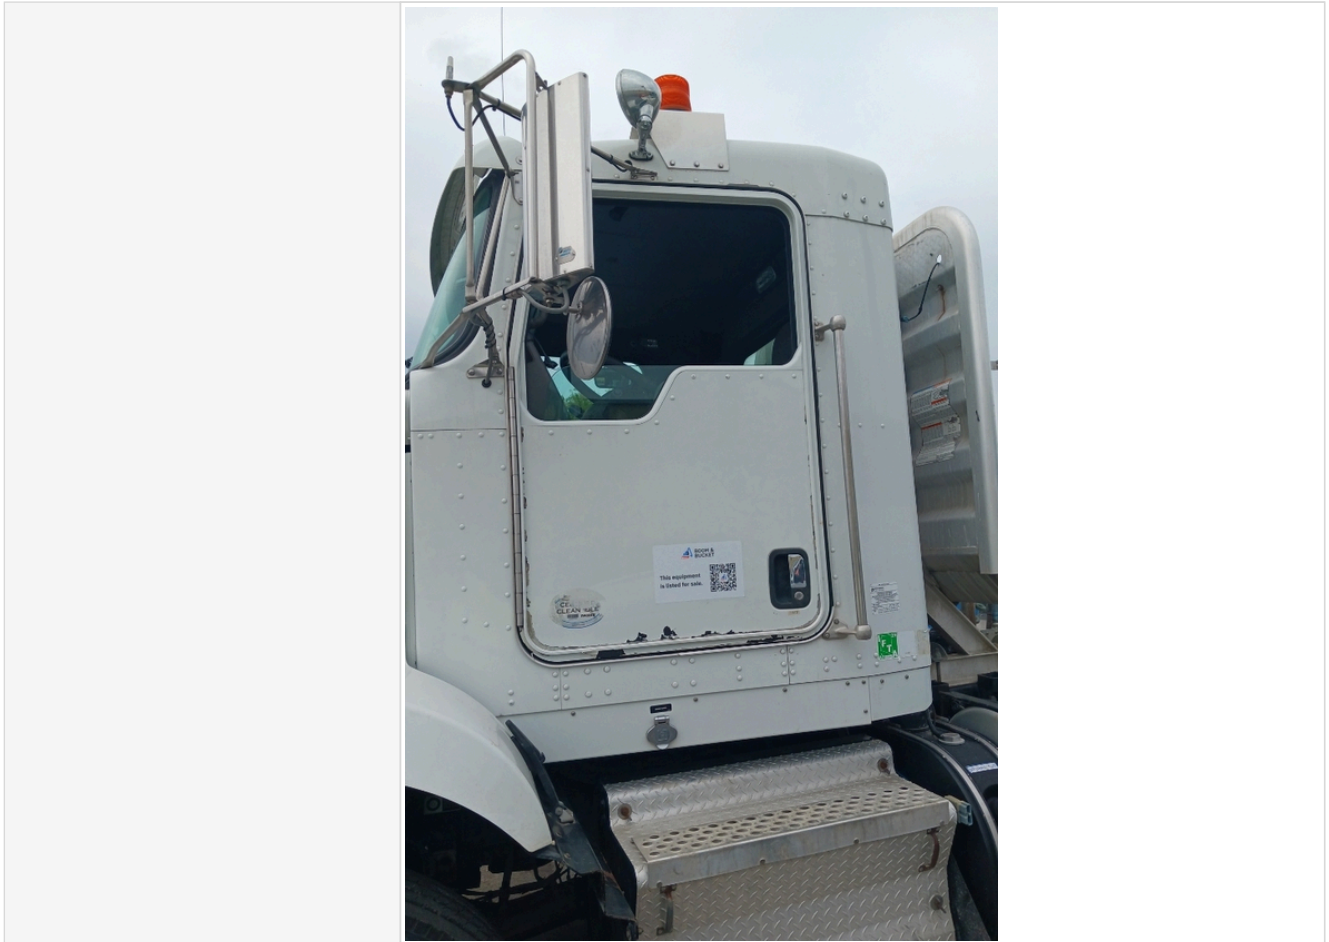
Body Panels Photos

<b>Body Panels</b>	3 - Normal Wear & Tear
<b>Body Panel Condition</b>	Visible chipped paint or dents

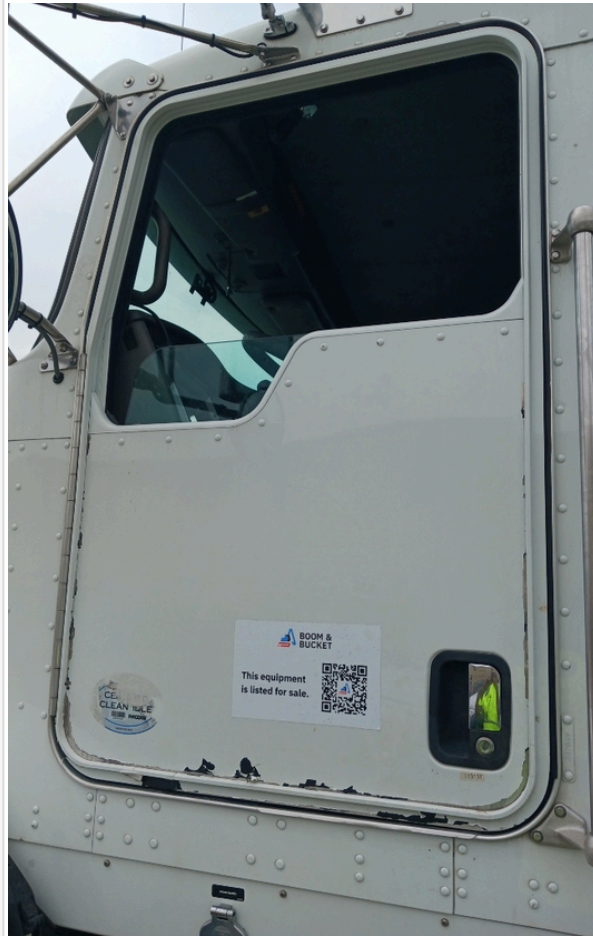
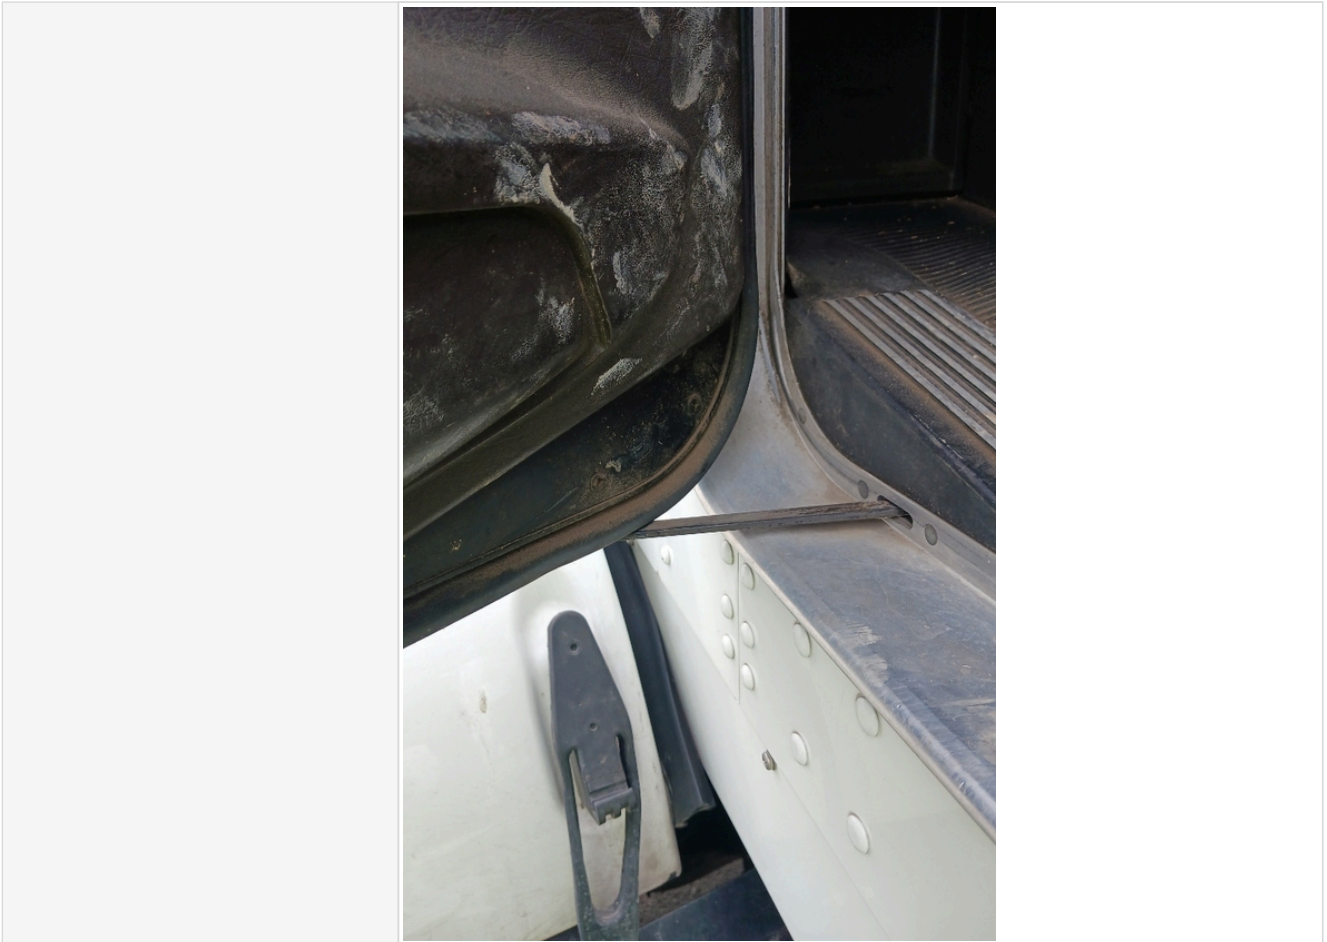
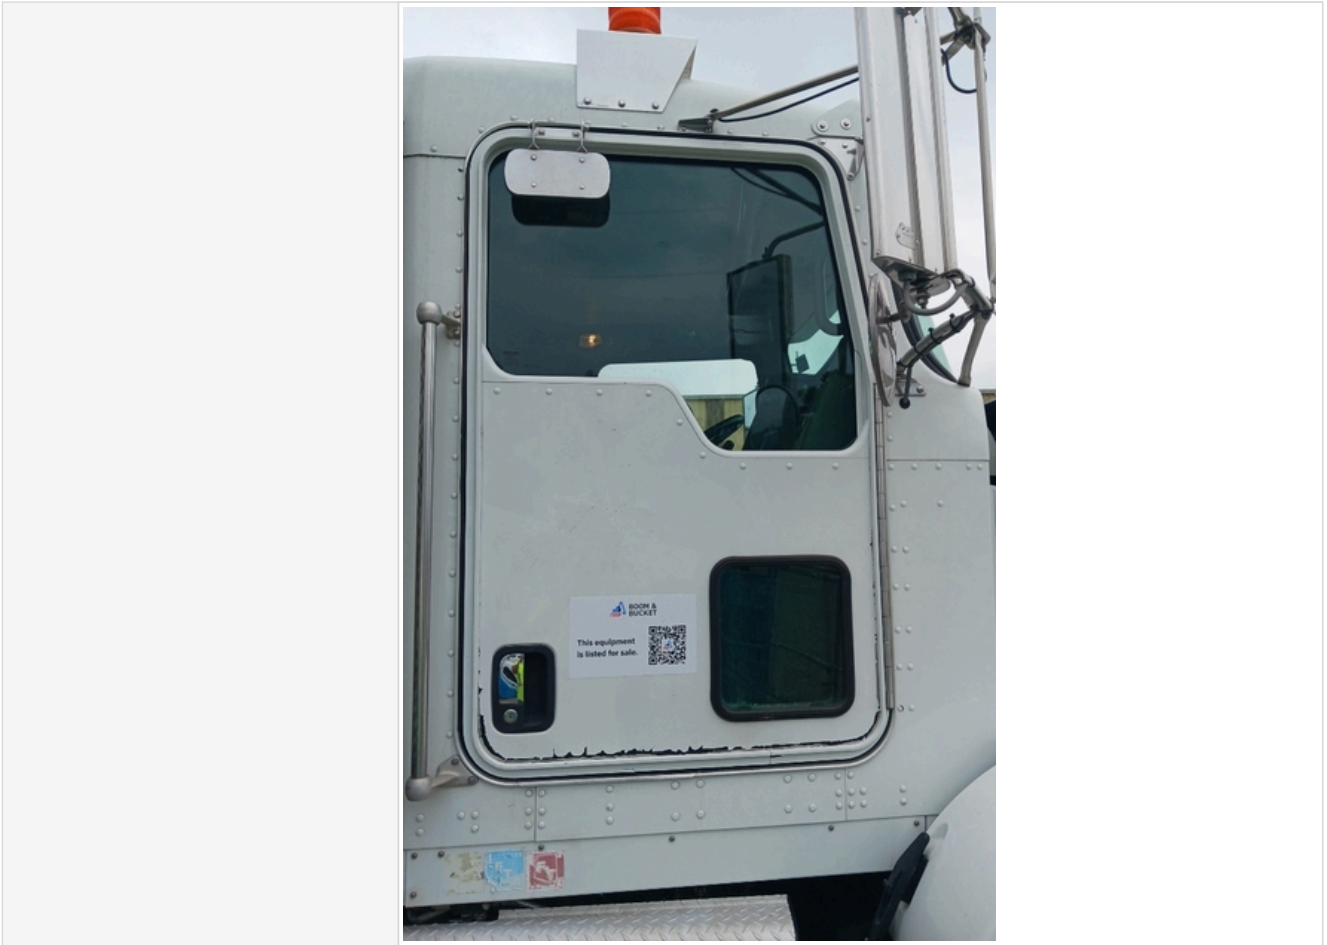
Doors / Canopy Latches Photos

<b>Doors / Canopy Latches</b>	3 - Normal Wear & Tear
<b>Doors / Canopy Latches Condition</b>	Other (see comments)
<b>Comments</b>	doors gave small chips and cracks on the paint, but are still in good condition and operational

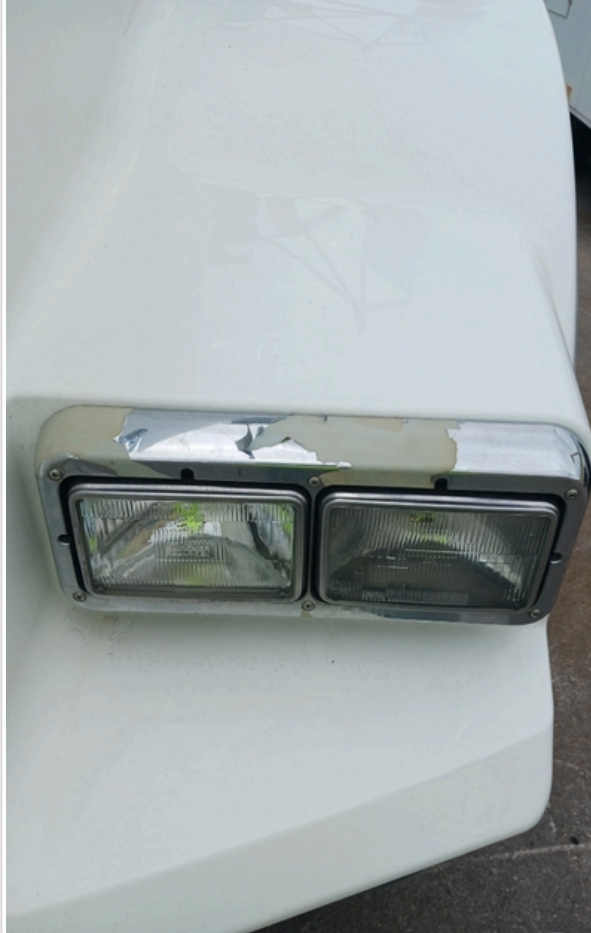
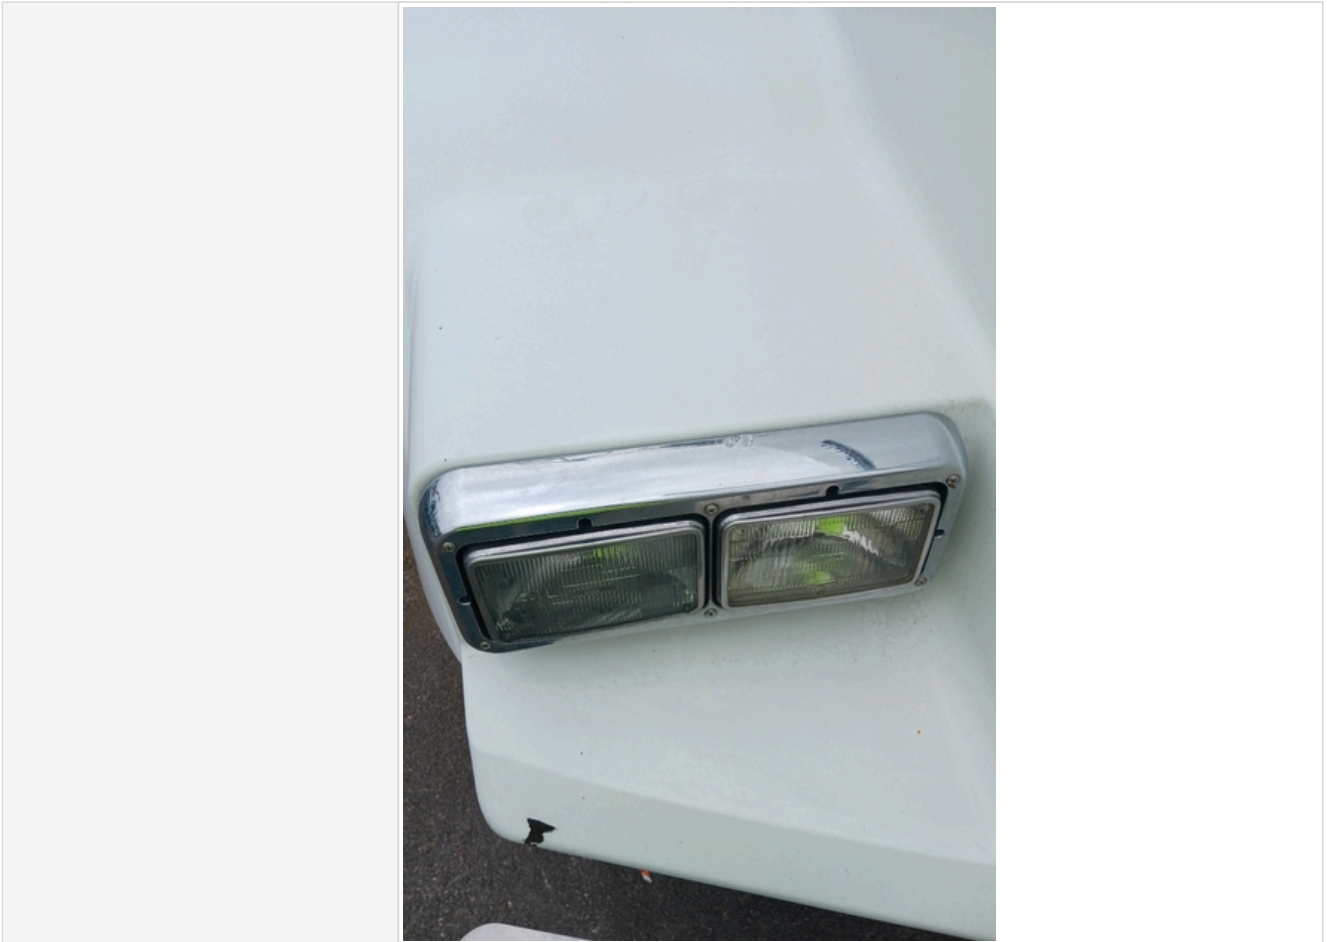
Exterior Lights Photos

<b>Steps / Ladders</b>	3 - Normal Wear & Tear
<b>Steps / Ladders Condition</b>	Steps/ladders are fully intact and appear structurally sound
<b>Handrails</b>	3 - Normal Wear & Tear
<b>Handrails Condition</b>	Handrails are fully intact and appear structurally sound
<b>Glass</b>	3 - Normal Wear & Tear
<b>Glass Condition</b>	Glass intact, no visible damage
<b>Mirrors</b>	3 - Normal Wear & Tear
<b>Mirror Condition</b>	Mirrors present and intact, no visible damage
<b>Exterior Lights</b>	3 - Normal Wear & Tear
<b>Exterior Lights Condition</b>	No visible damage, lighting system is operational, Other (see comments)
<b>Comments</b>	lights are in good condition, there is some minor lifting or the chrome casing surrounding the head lights

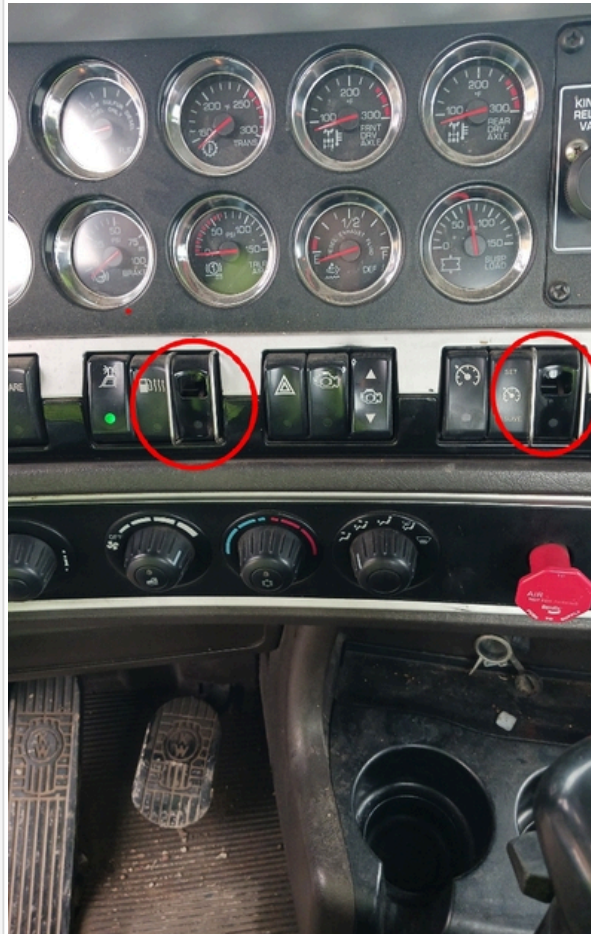
### Controls/Switches/Gauges Photos

<b>Odometer Activity</b>	3 - Normal Wear & Tear
<b>Odometer Condition</b>	Odometer is working and in good condition
<b>Controls/Switches/Gauges</b>	3 - Normal Wear & Tear
<b>Controls/Switches/Gauges Condition</b>	Minor cosmetic wear to switches/gauges, good functionality, Other (see comments)
<b>Comments</b>	2 switches near parking breaks are missing a small cover.

2 switches are missing small covers for switches

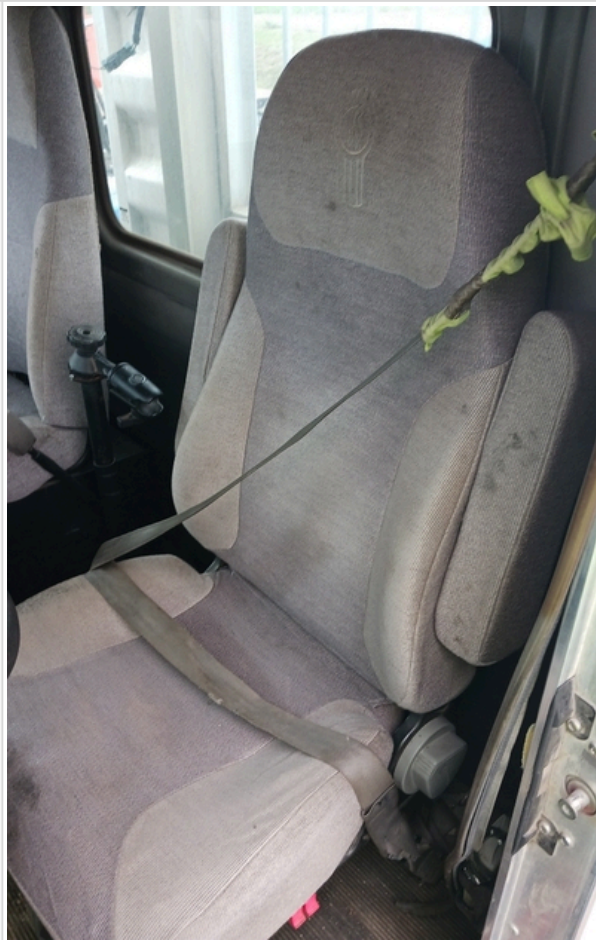
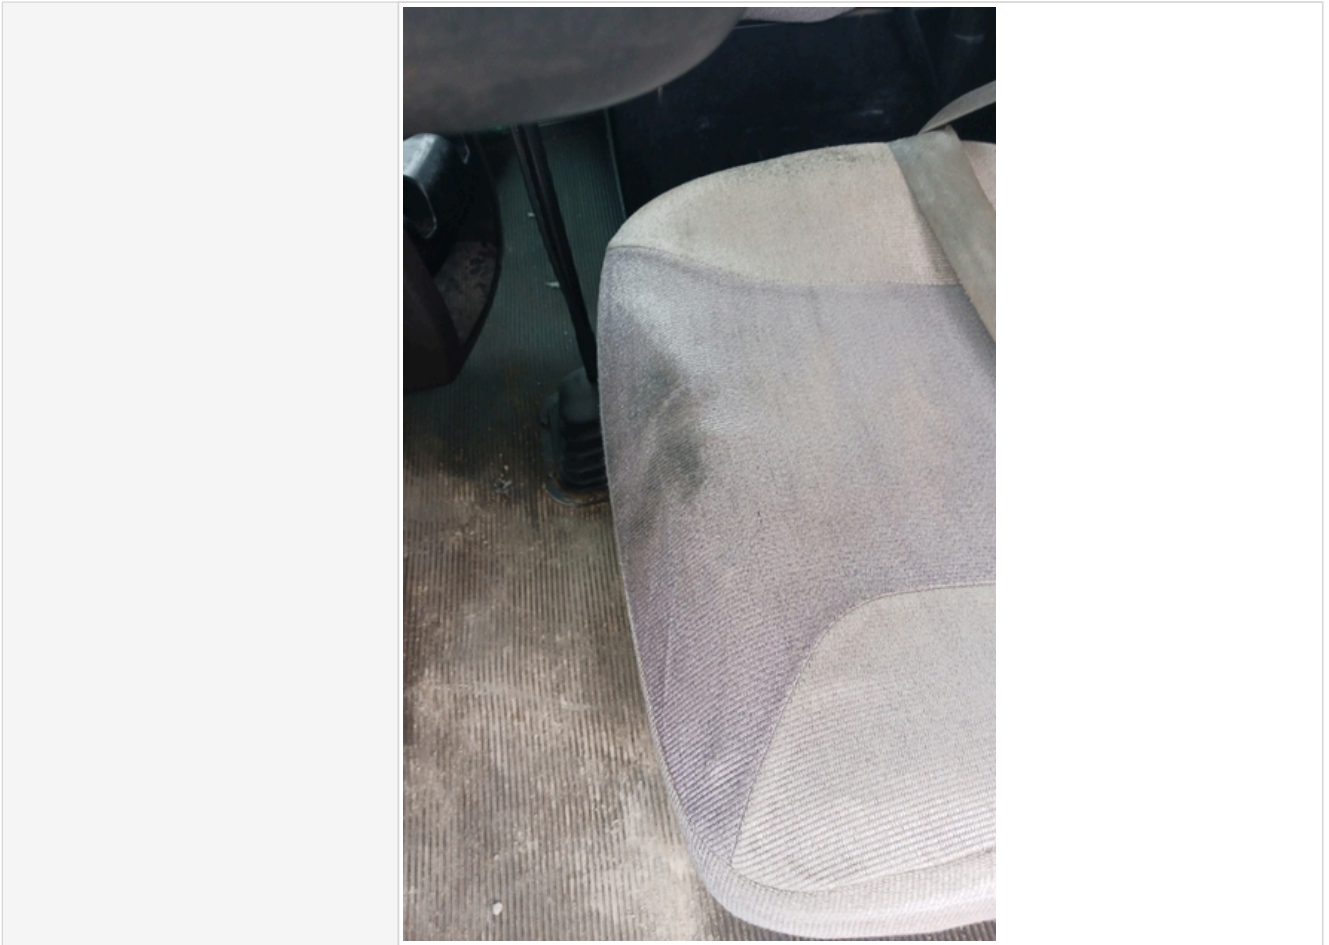
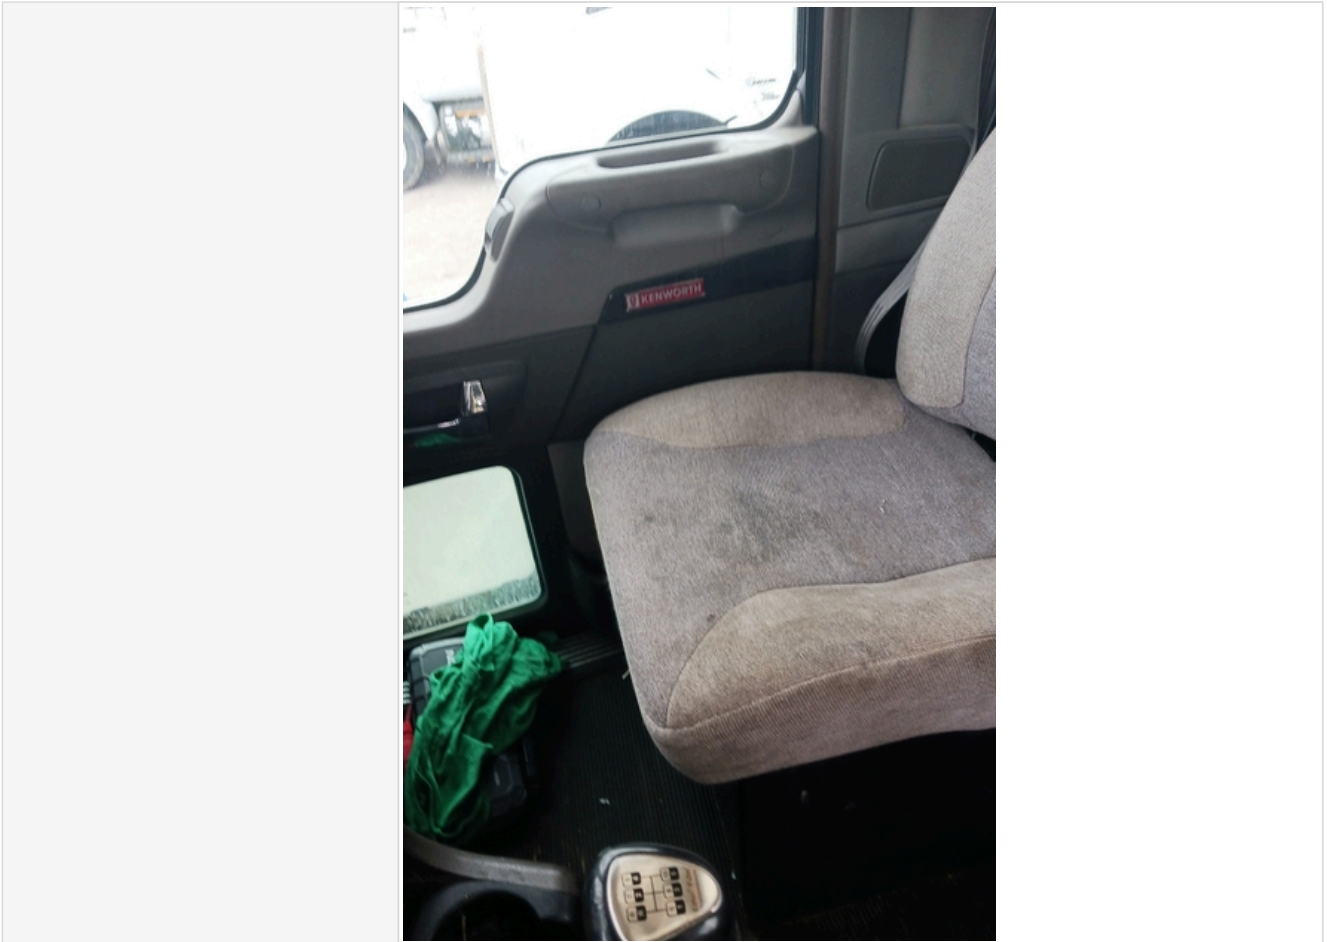
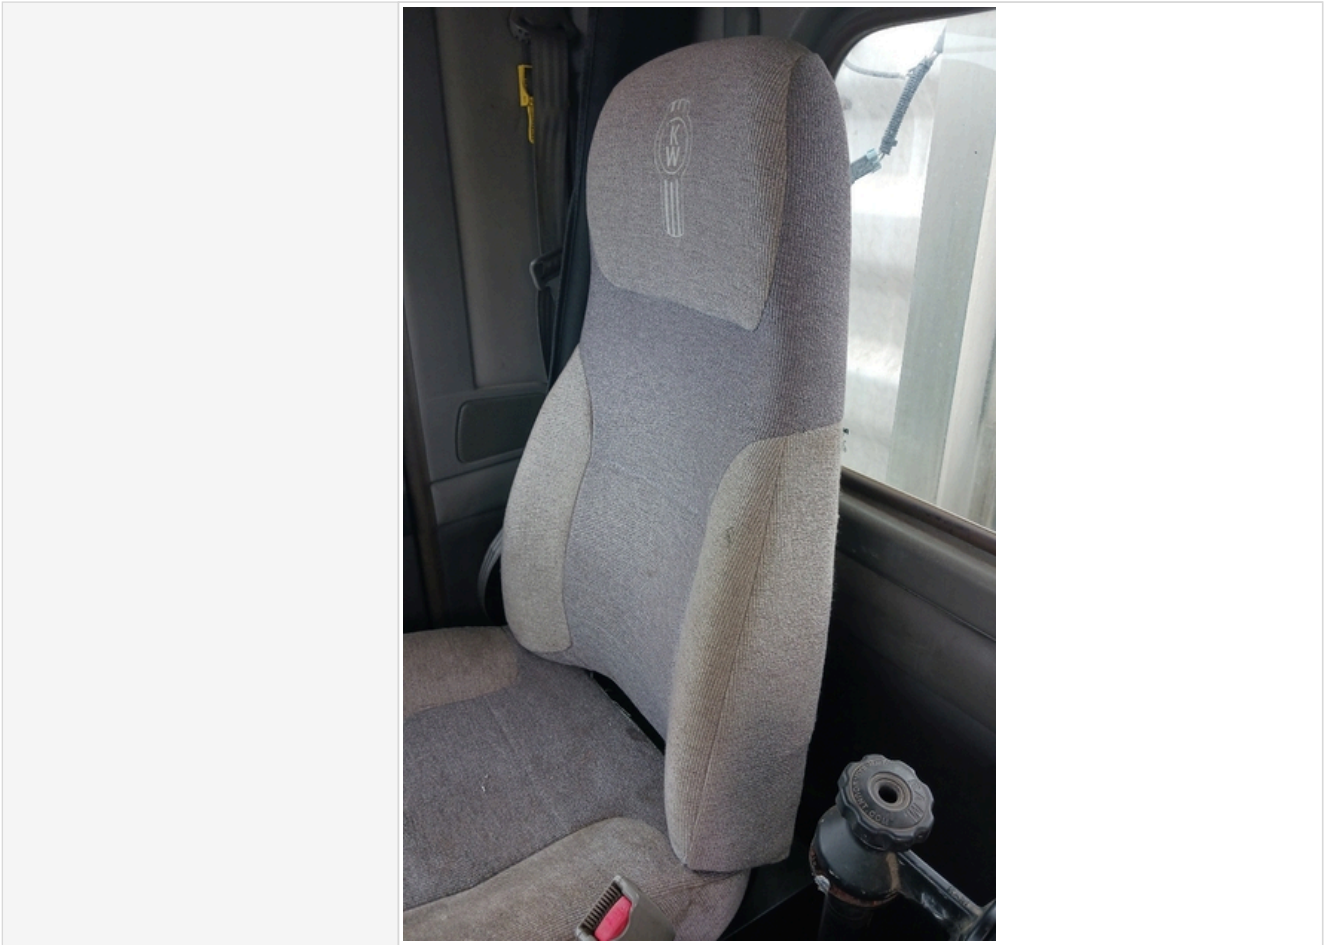
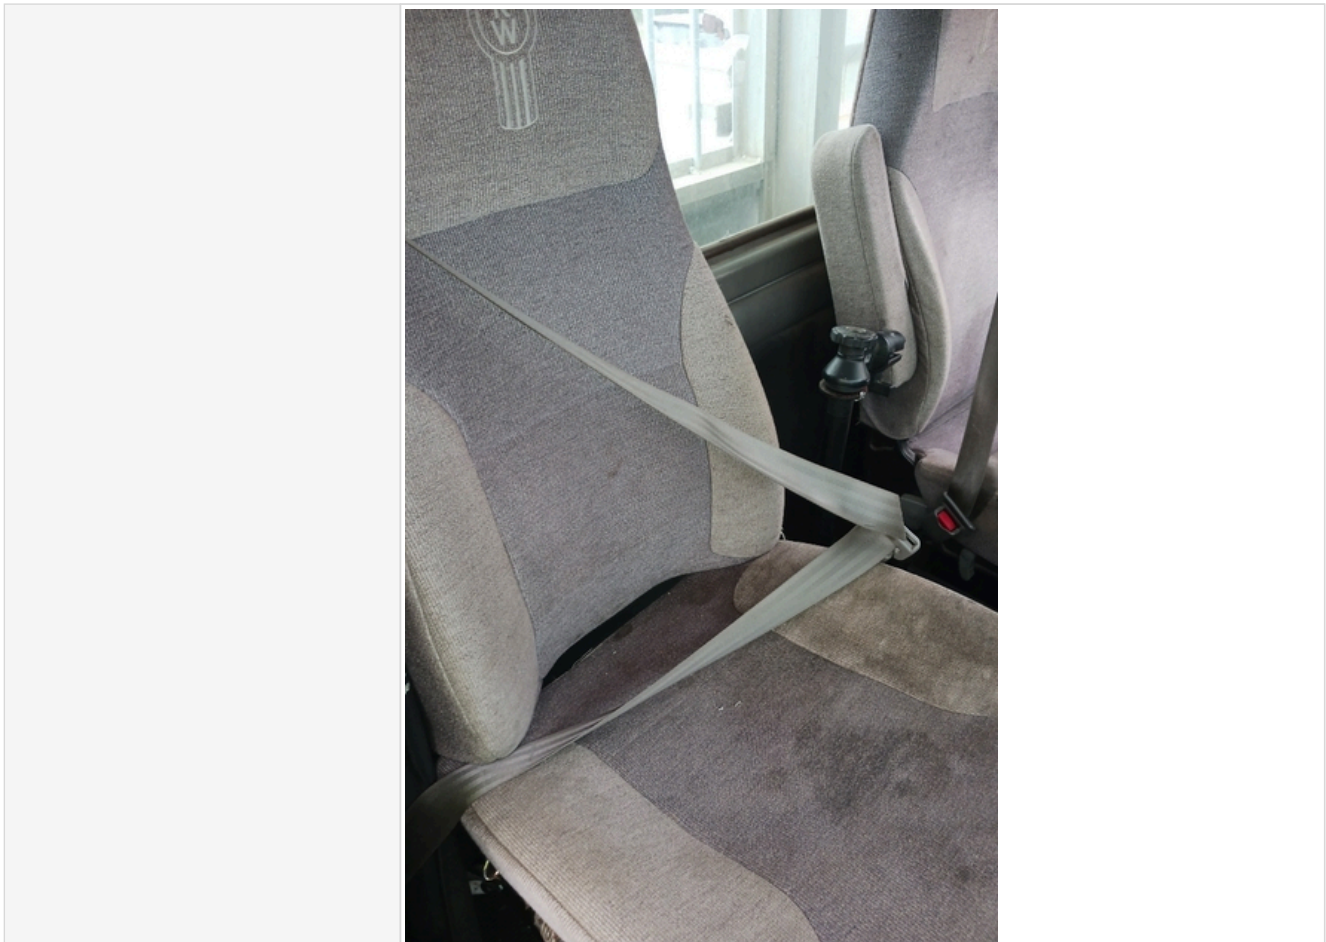
<b>Comments</b>	driver side seat belt has a little fraying on seat belt. seats have some stains on them but are in good working condition
<b>Seats/ Seat Belt Photos</b>

<b>Cab Interior Overall Rating</b>	3 - Normal Wear & Tear
<b>Comments</b>	cab has some stains and there is a small area on the driver side seat belt that is frayed

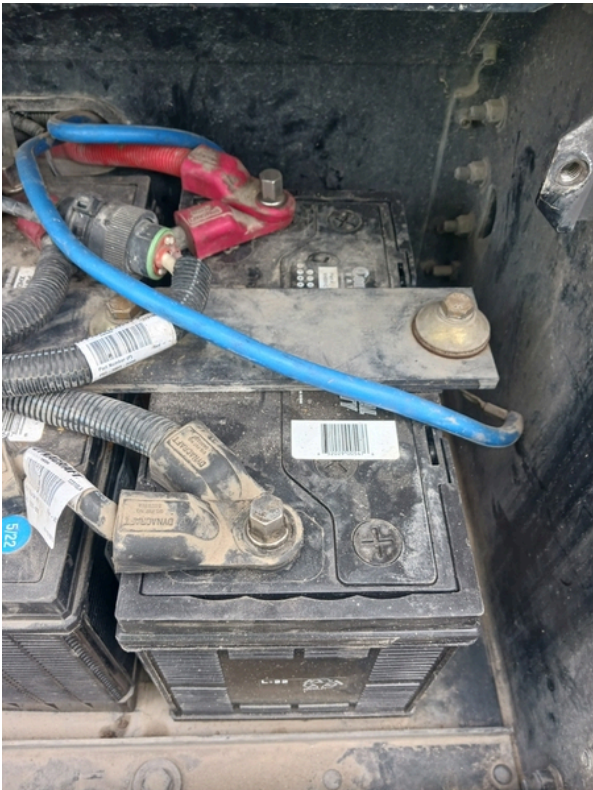
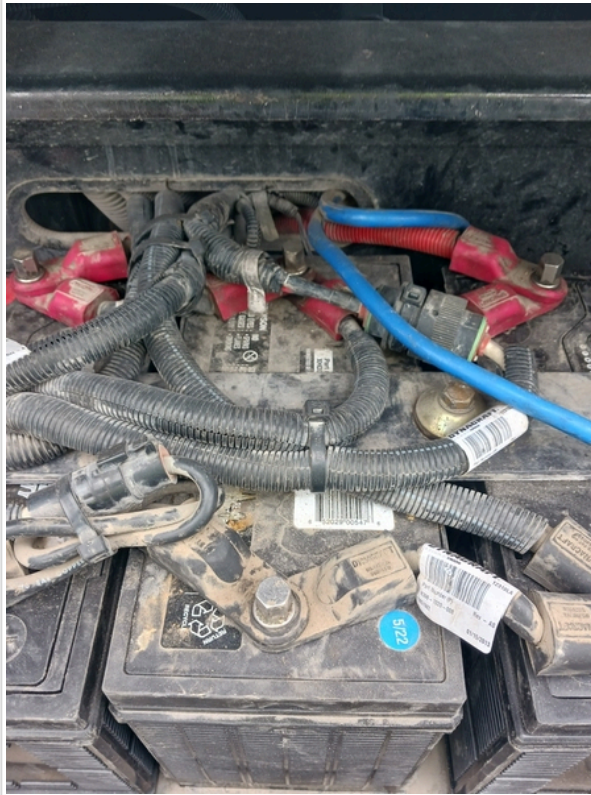
Unusual Noise Notes	No unusual noises heard
Engine Smoke (Upon Start-up, Idle, Shutdown)	No
Engine Smoke Notes	No engine smoke issues observed
Engine Exhaust Color	Clear
Battery	3 - Normal Wear & Tear
Battery Condition	Dusty & dirty appearance
Battery Condition Photos

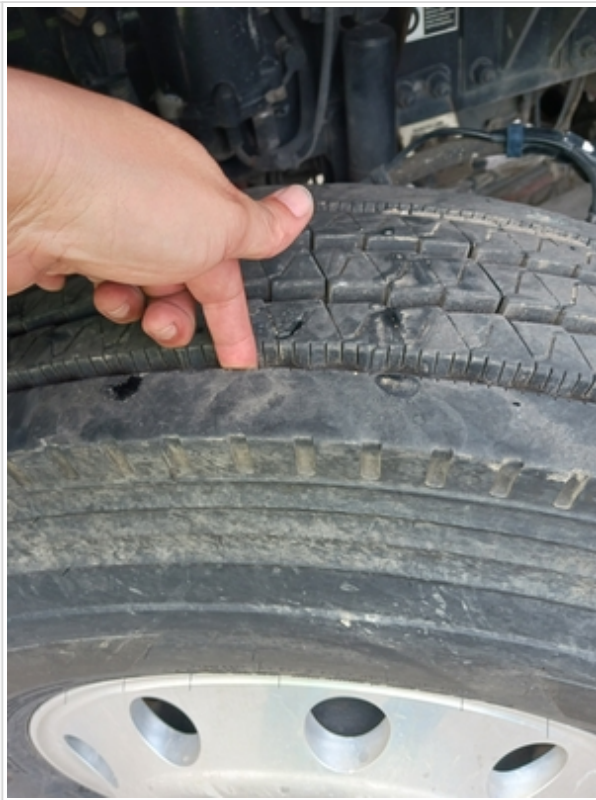
<p>Front Left Tire Photos</p>

<b>Wheel Seal Leaks</b>	No
<b>Tire Brand</b>	hancock
<b>Tire Size</b>	11r22.5
<b>Front Left Tire - Ratio Remaining</b>	70%

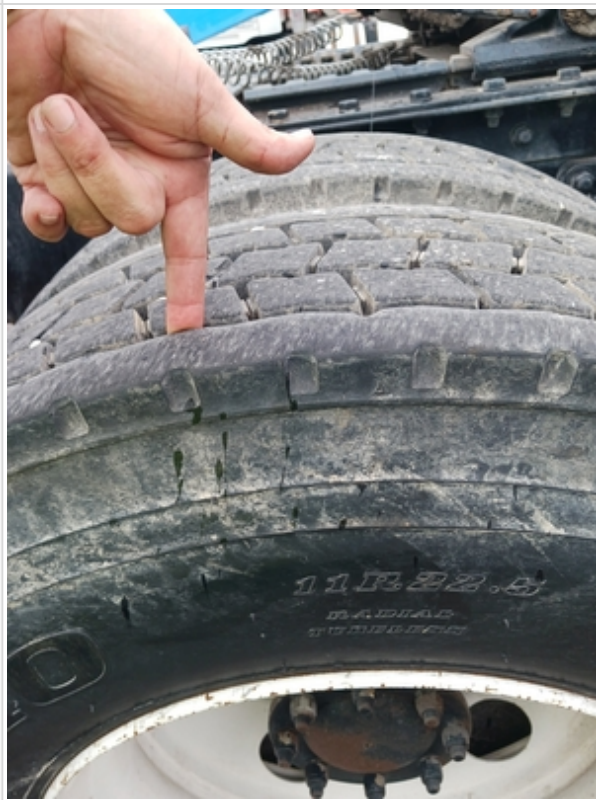
<p>Front Right Tire - Ratio Remaining</p>	<p>70%</p>
<p>Front Right Tire Photos</p>

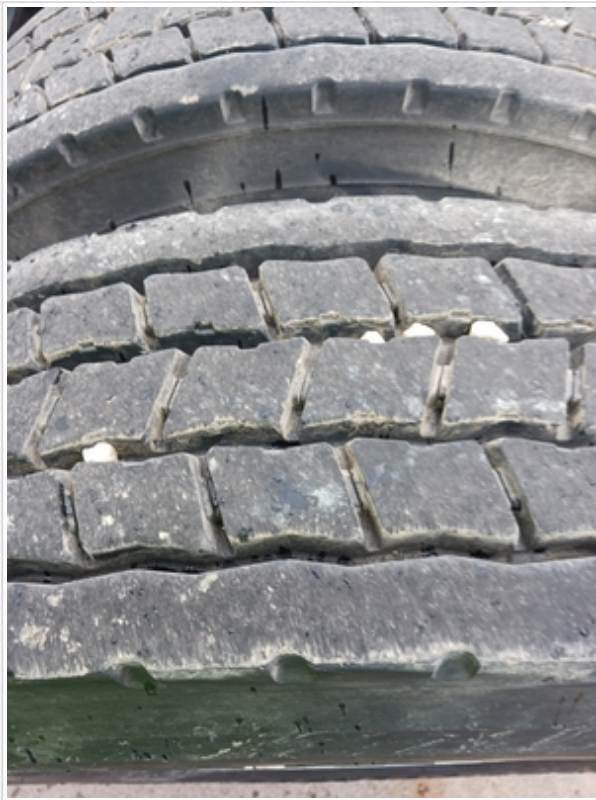
<p>Rear Right Tire Photos</p>

<p>Rear Right Tire - Ratio Remaining</p>	<p>70%</p>
