Inspection Report (Telehandler)

Year	2012
Make	skytrack
Model	8042
Serial Number	0160044925
Hour Meter Reading	4523
Previous Application (e.g., earth moving, mining, demolition, etc)	Rental Equipment

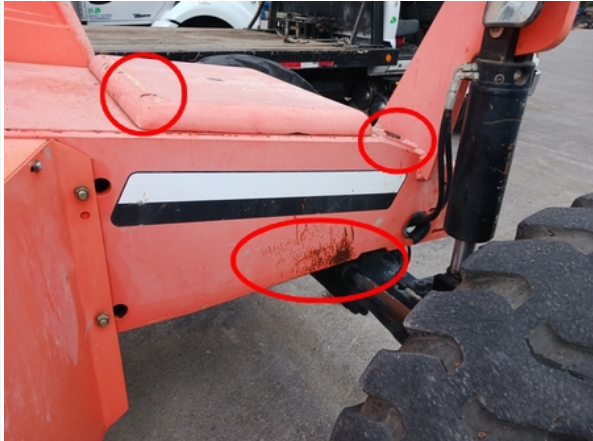
areas of rust and missing paint

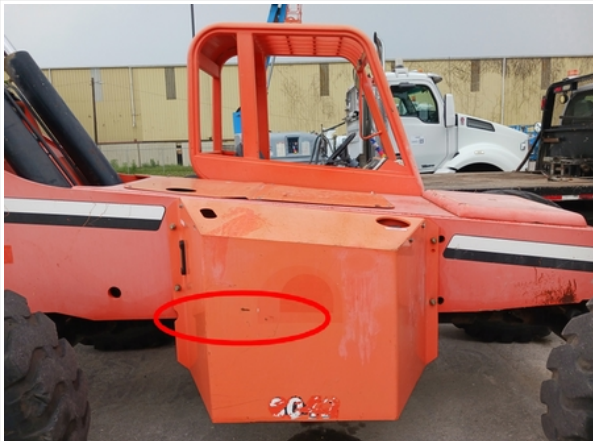
small area of rust

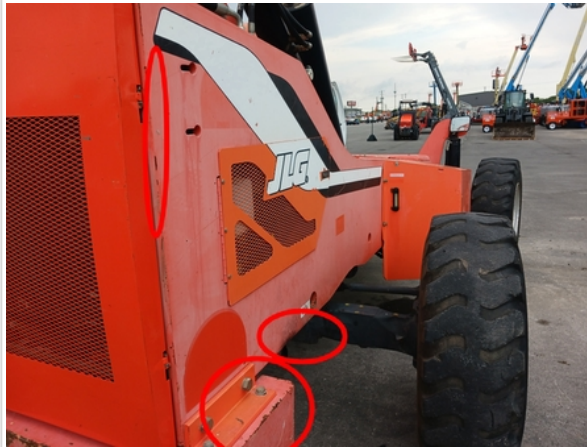
small amounts of rust

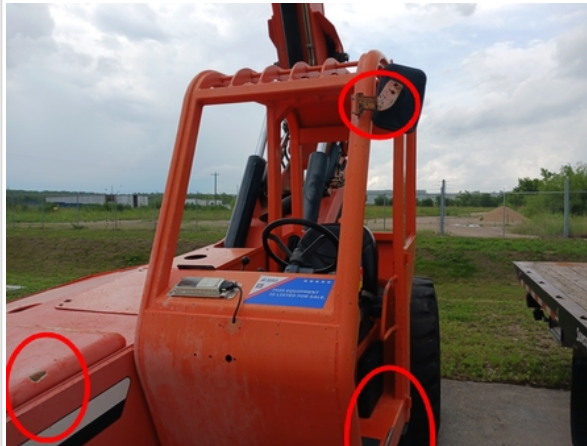
areas of rust and scrapes

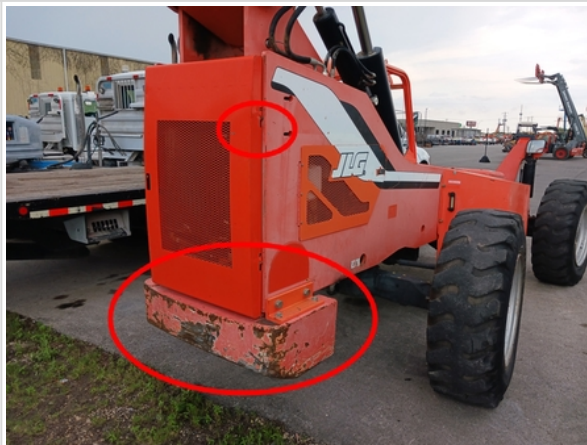
areas of scratches and rust

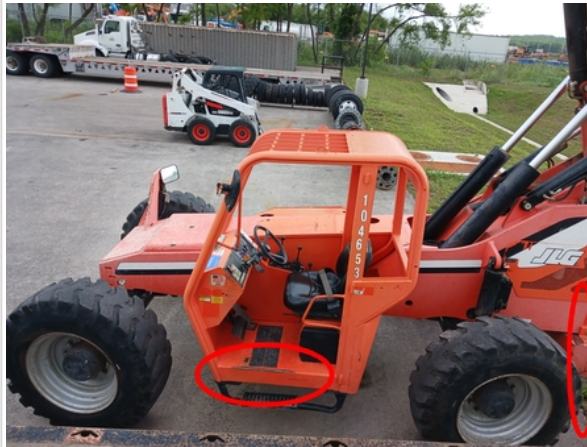
area of rust and missing paint

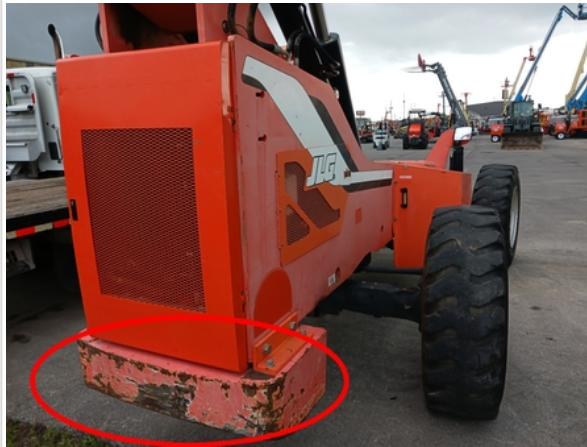
scratches and rust

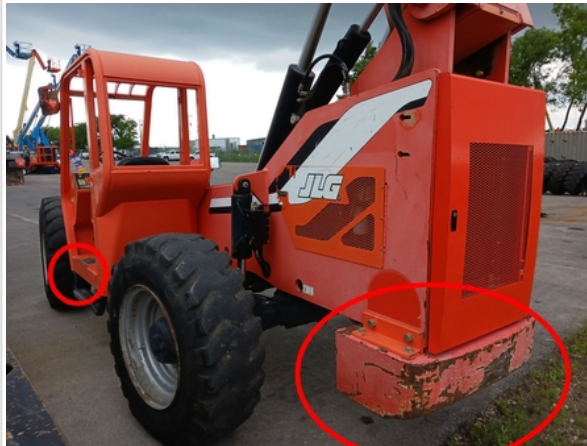
areas of scratches and rust

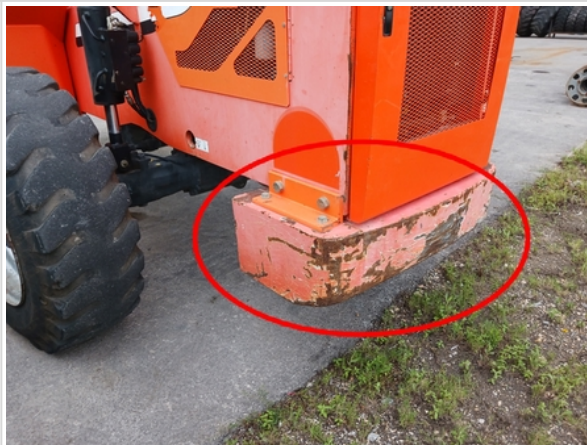
areas of scratches and rust

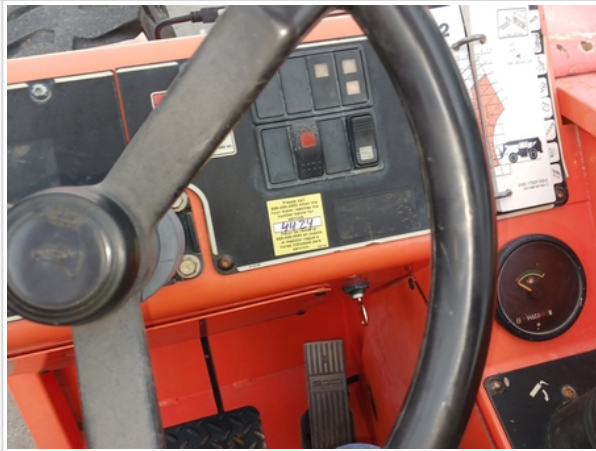
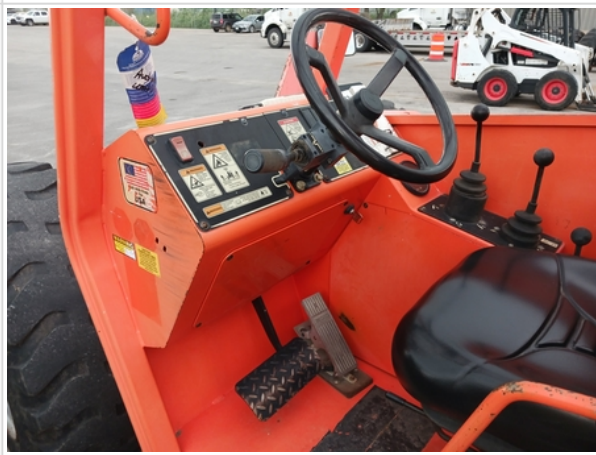
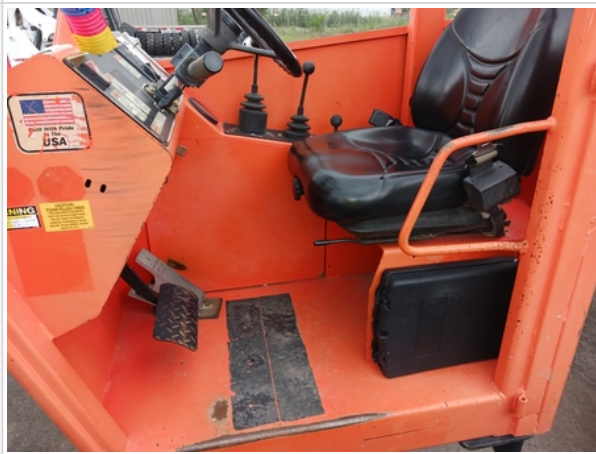
Hour Meter Activity	3 - Normal Wear & Tear
Hour Meter Condition	Hour meter is functional and in good condition

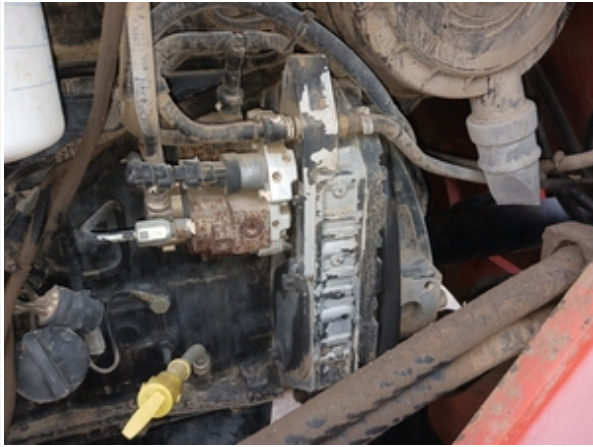
<p>old dirt and gunk but in good condition</p>

Overall Engine Appearance	Very dirty
---------------------------	------------

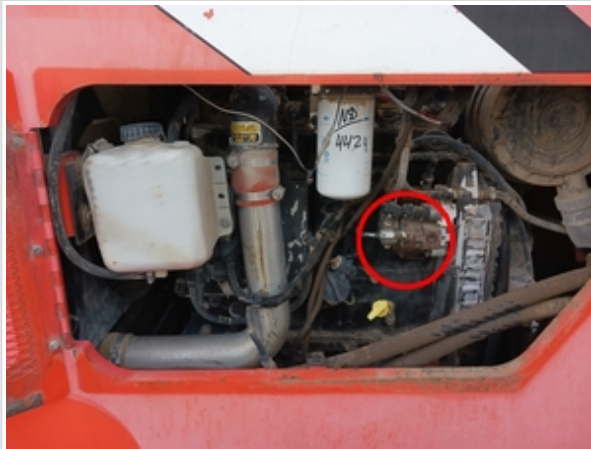
some rust on surface area

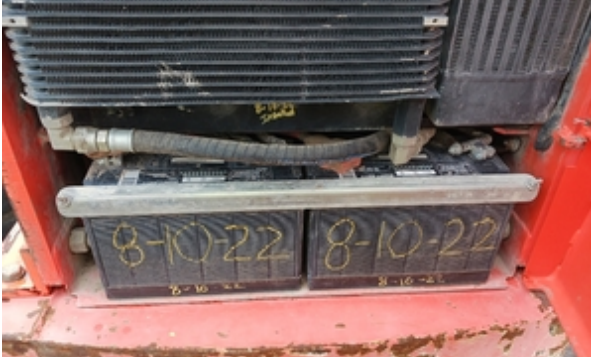
<p>Warning: improper use may result and warranty is voided. Always use proper operation.</p> <p>Engine Serial No. 6013-7166</p> <p>Remanufactured by: Engine Components Technology Limited Cummins No. 200 Epi 122 Industrial Code: 72309 Serial Unit Prefix: 4018419</p> <p>DR6348-RX 4018419</p> <p>Timing Valve L Fitted LOW M E 03</p>
Blow-by (Visual Observation Check)	N/A
Unusual Noises (Upon Start-up, Idle, Shutdown)	No
Unusual Noise Notes	No unusual noises heard
Engine Smoke (Upon Start-up, Idle, Shutdown)	No
Engine Smoke Notes	No engine smoke issues observed
Engine Exhaust Color	Clear
Battery	3 - Normal Wear & Tear
Battery Condition	Dusty & dirty appearance
Battery Condition Photos

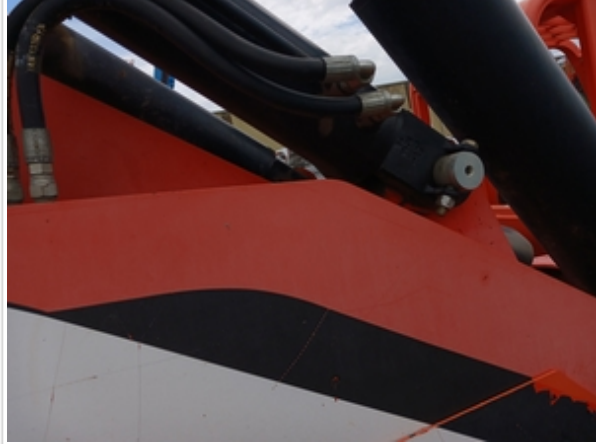
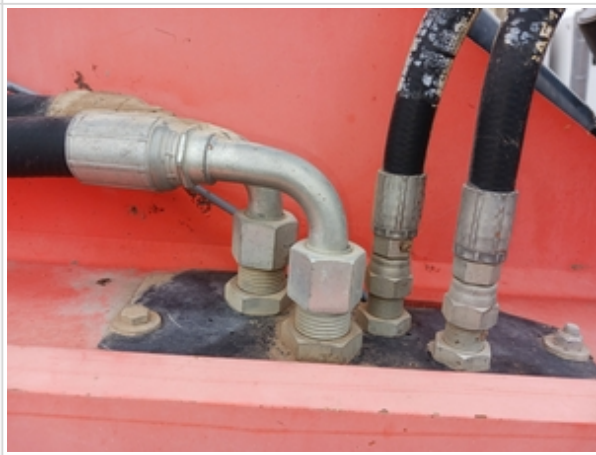
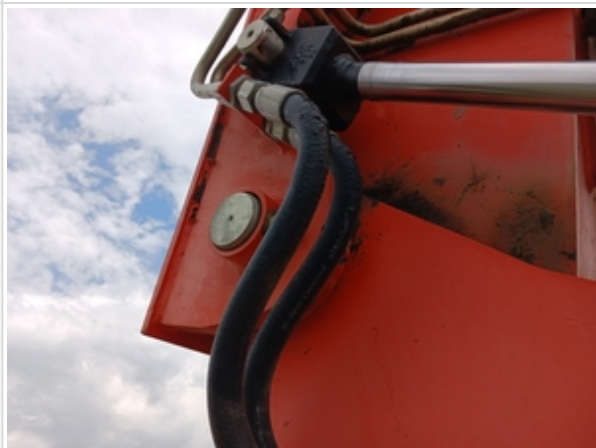
Wet or Damp Hydraulic Lines / Fittings	No
Appearance of Hydraulic Lines / Fittings	3 - Normal Wear & Tear
Hydraulic Lines / Fittings Condition	Hydraulic lines & fittings are clean and in good condition, Cracking, stiff, or charred hydraulic hoses
Appearance of Hydraulic Lines / Fittings Photos
