Enterprise Equipment Inspection

Category	Excavator
Travel System	Track Undercarriage
Comments	
Year	2016
Make	Kobelco
Model	SK140SRLC-3
Serial Number	YH07-10093
Serial Number Plate

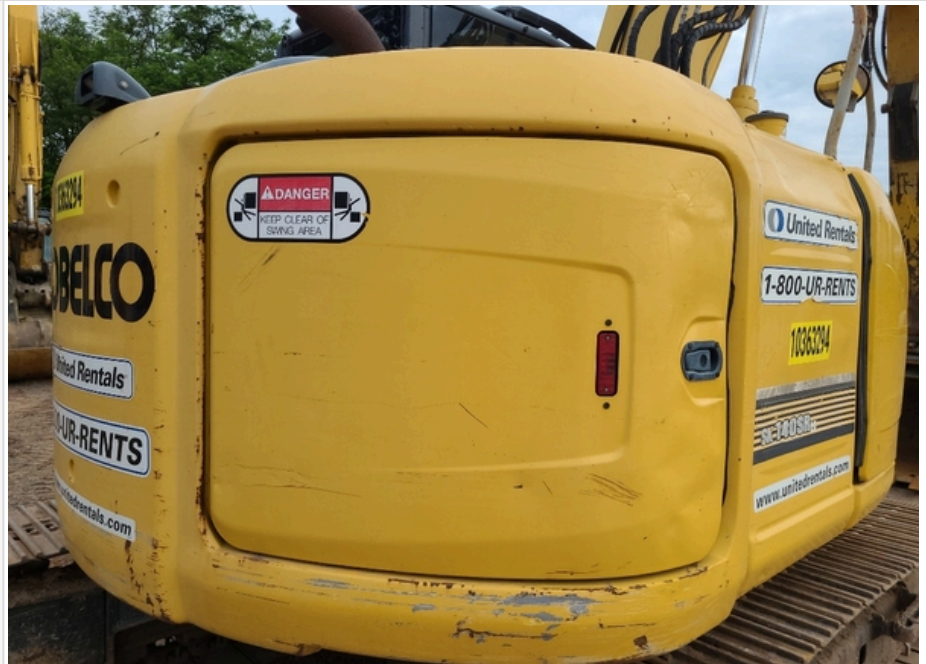
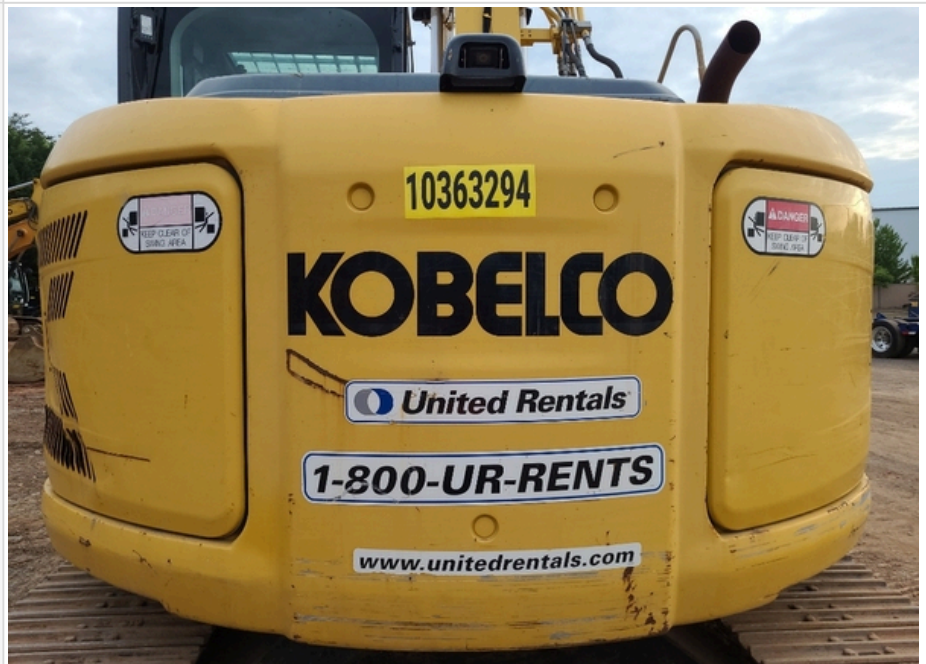
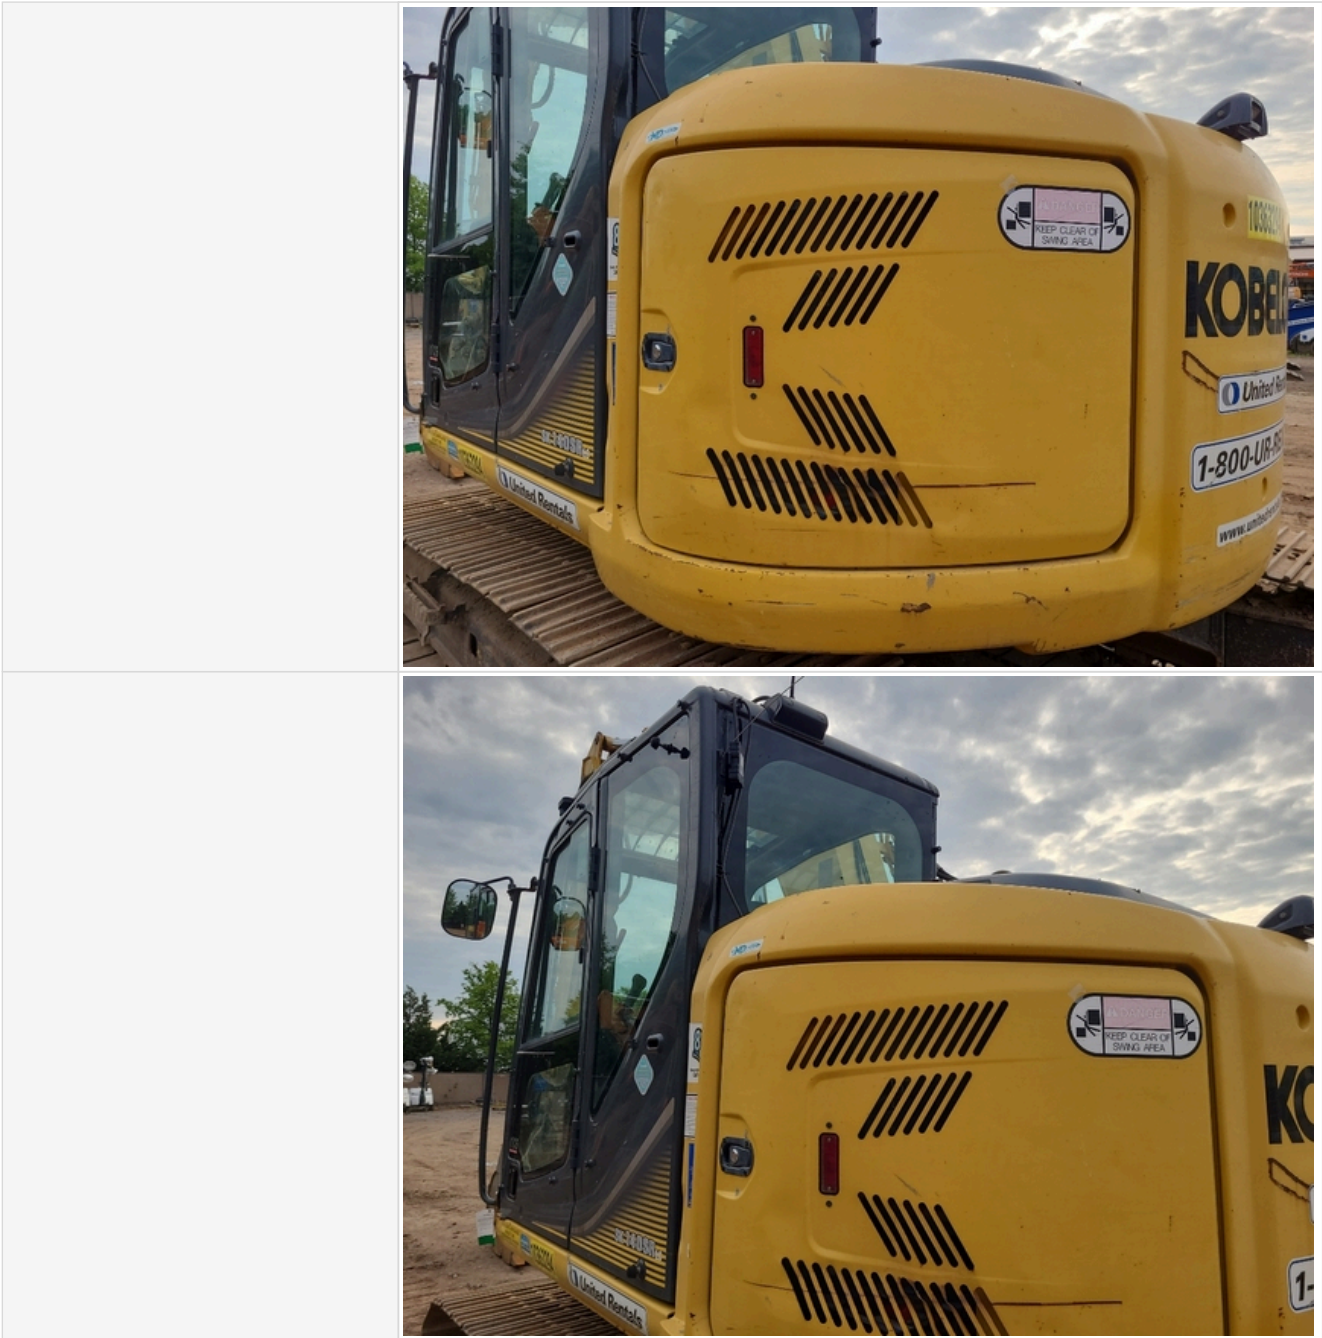
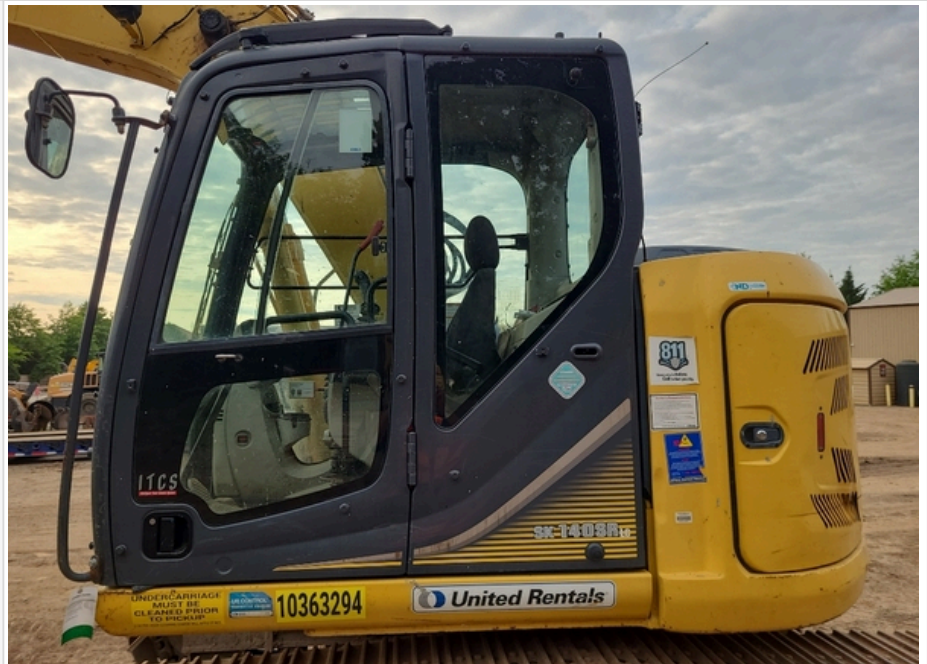
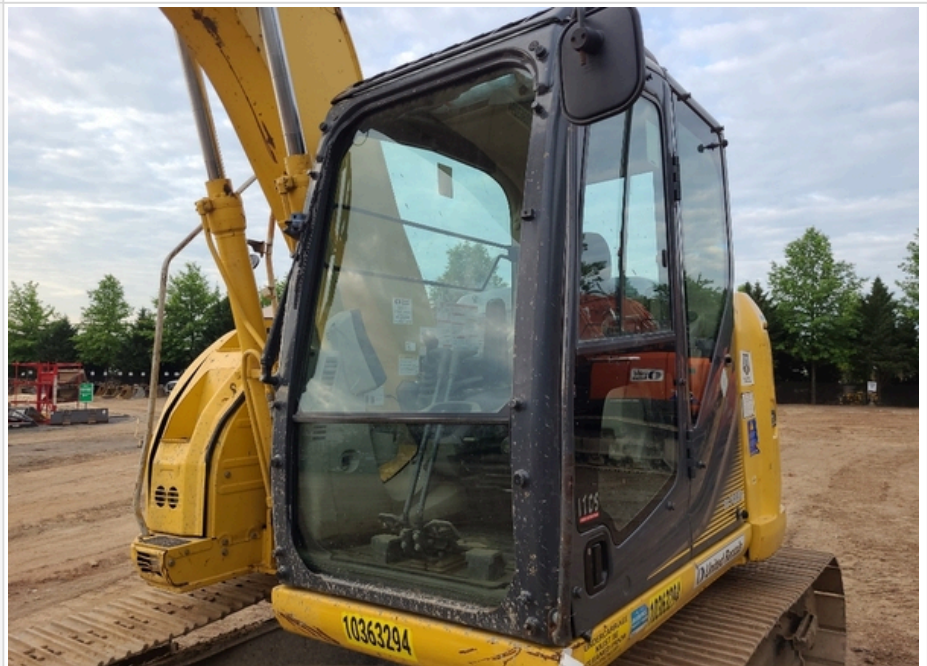
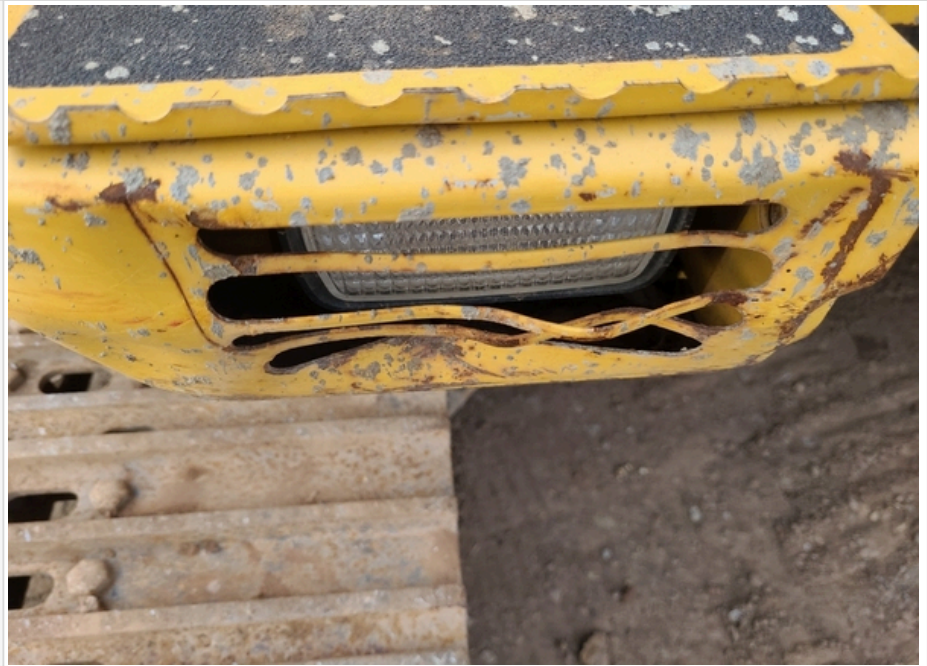
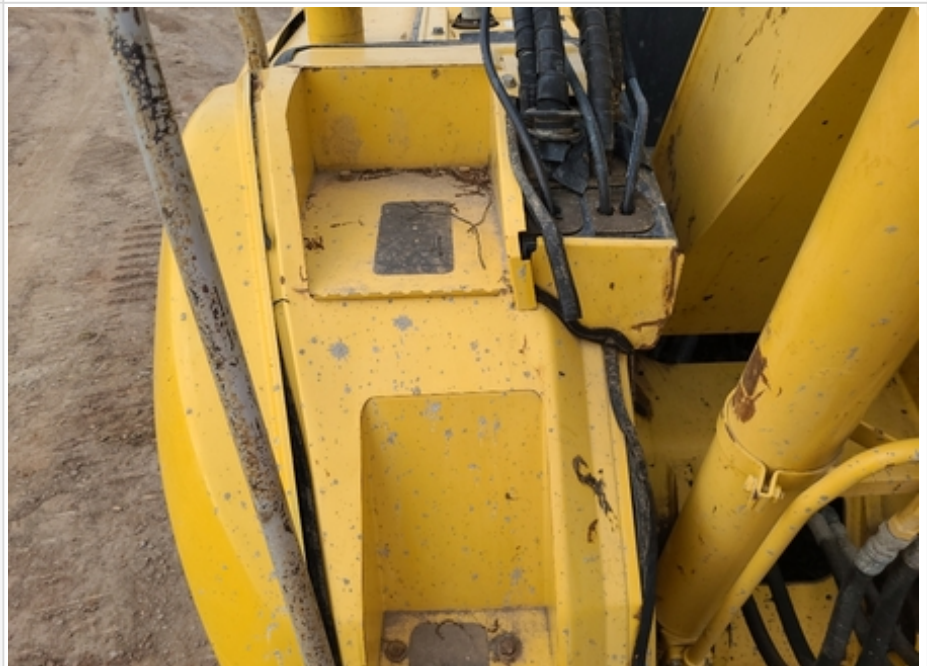
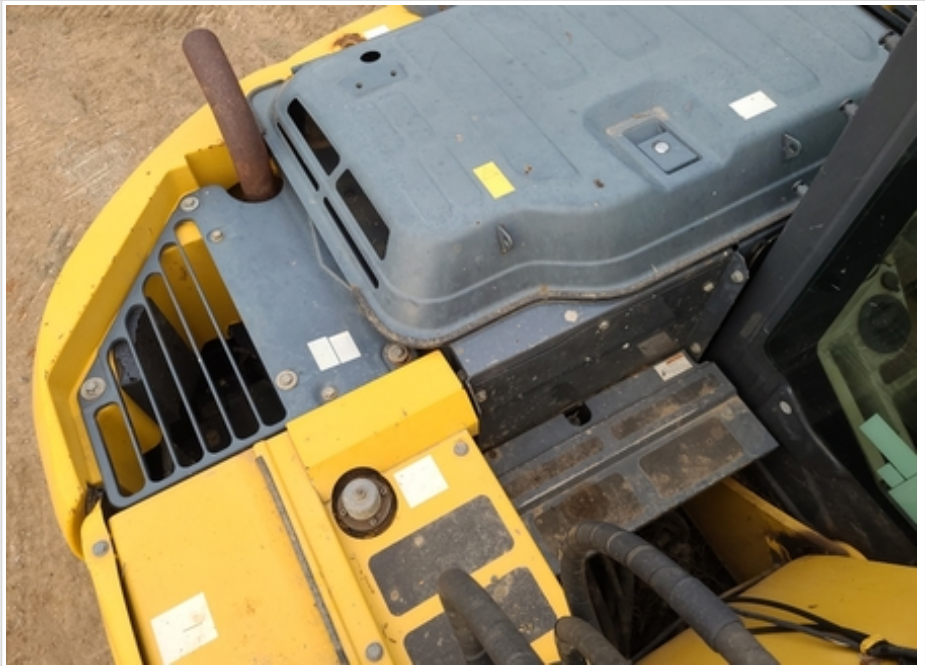
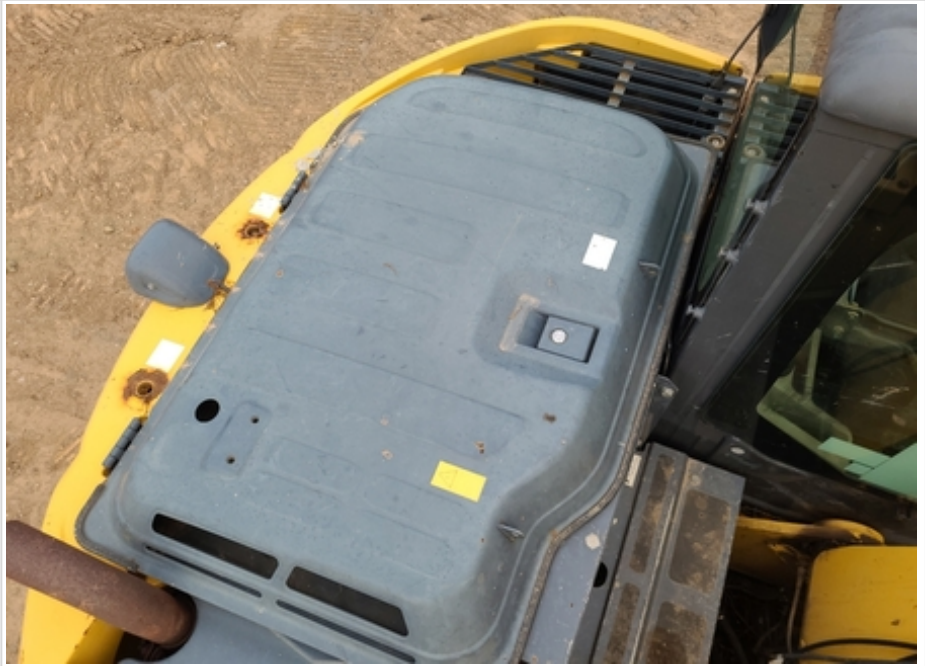
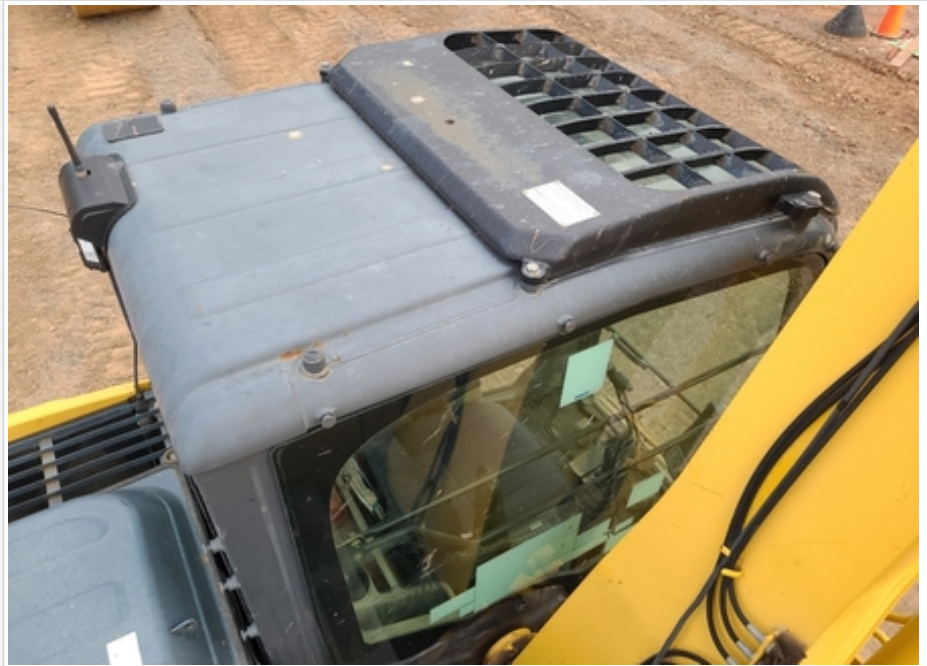
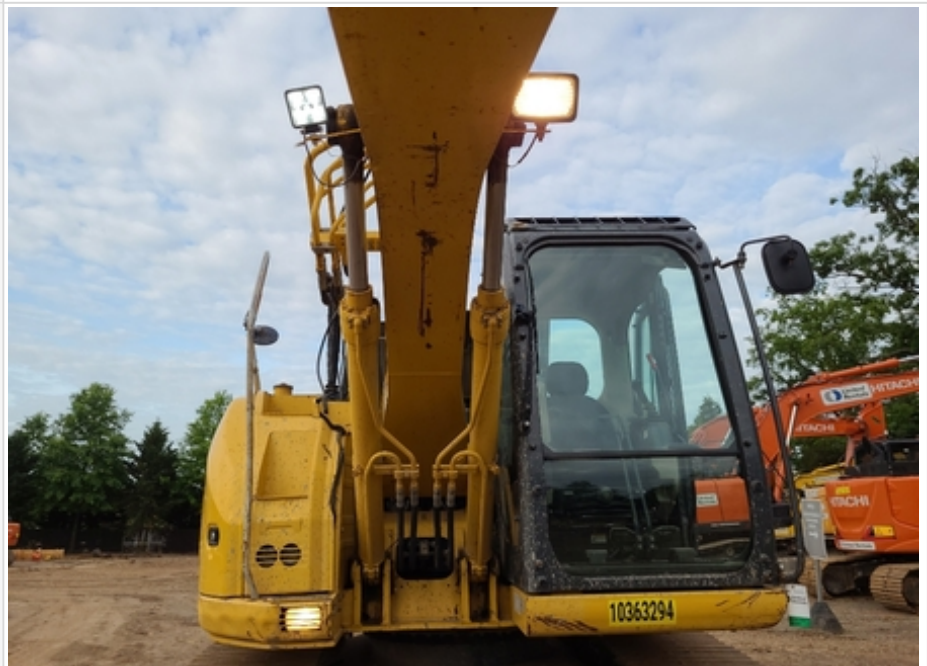
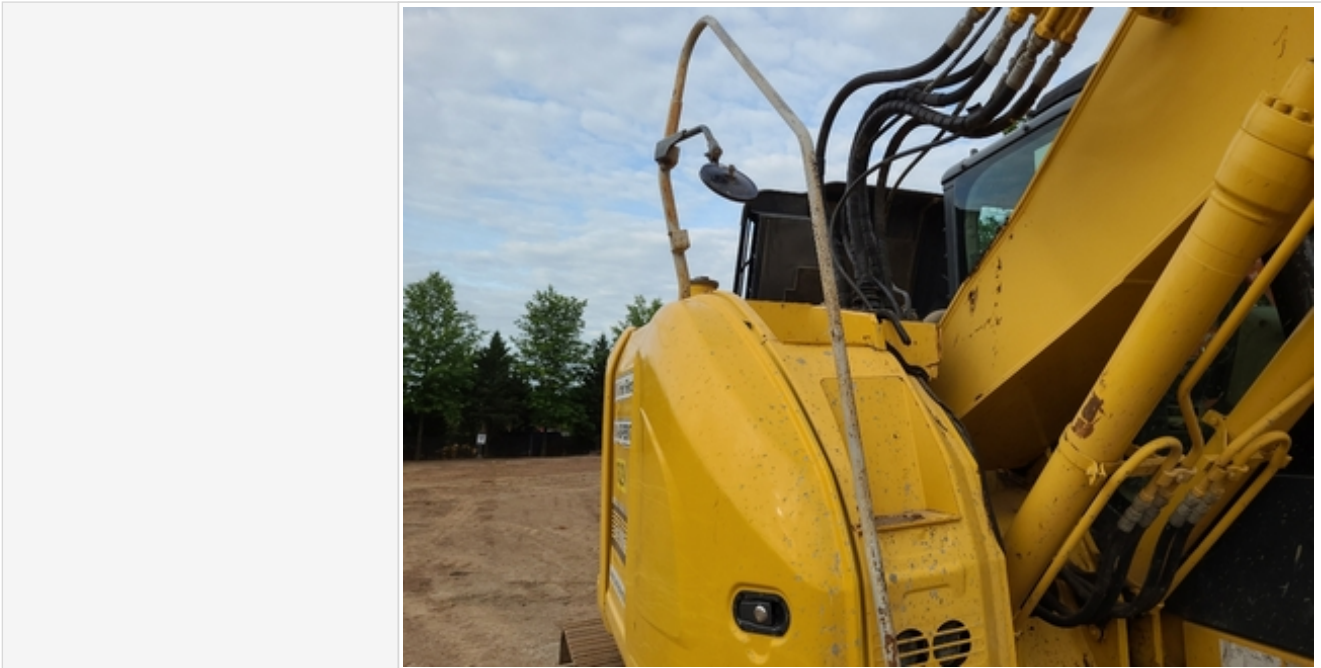
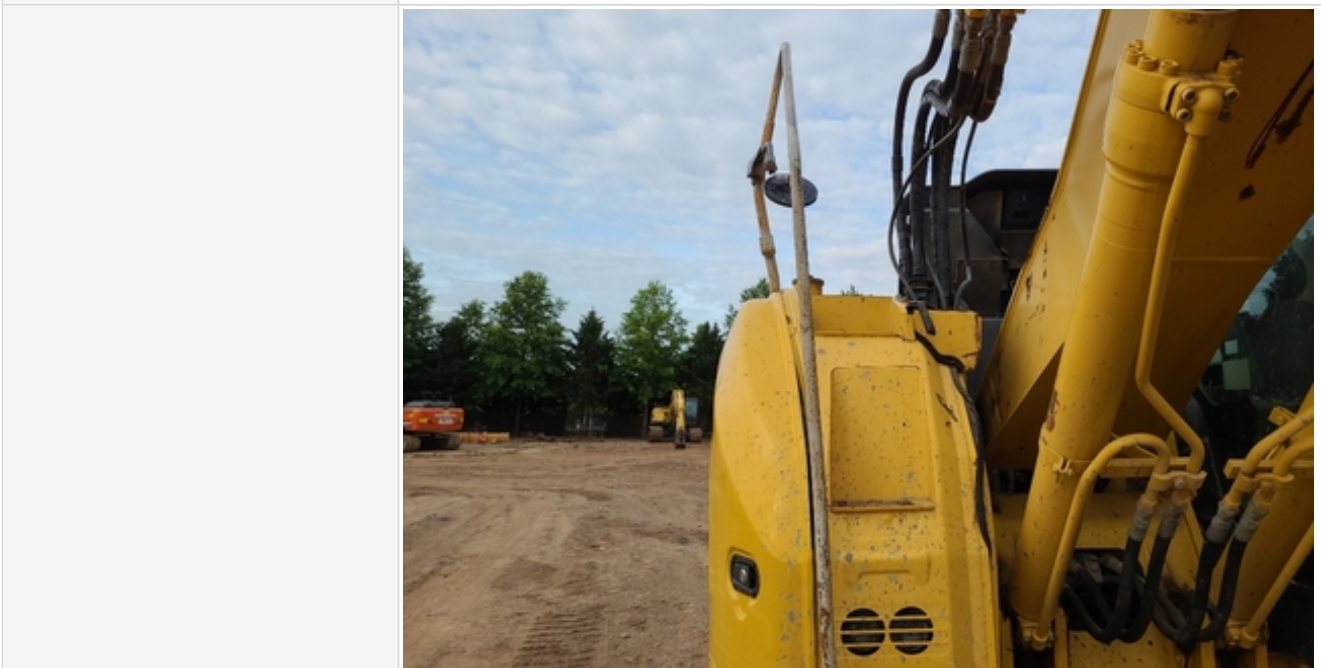
Close-Up Exterior Photos

Exterior Rating	3 - Normal Wear & Tear
Exterior Comments	Exterior in good shape, minor dent in front right work light panel.

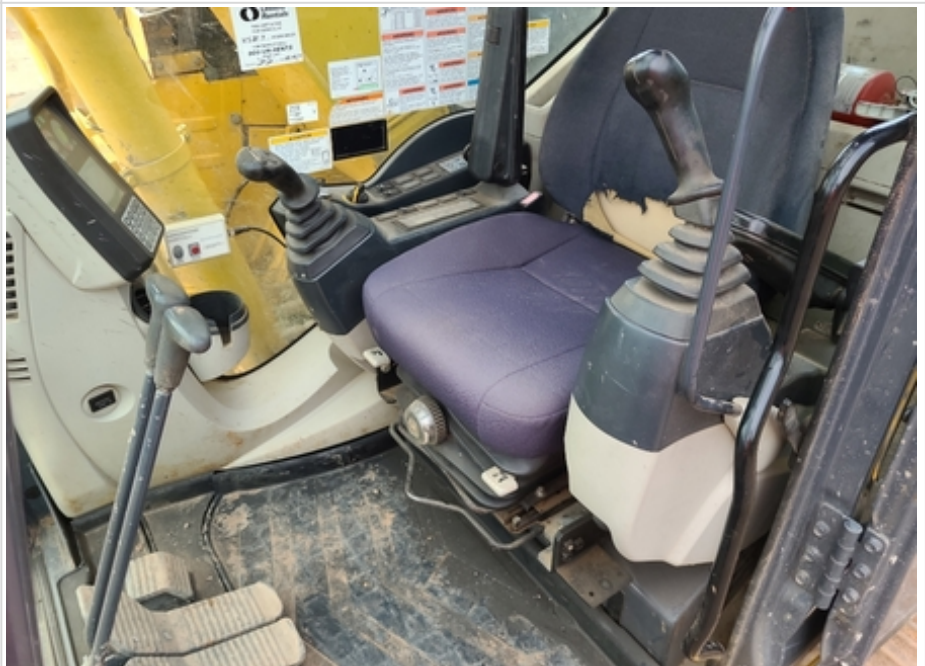
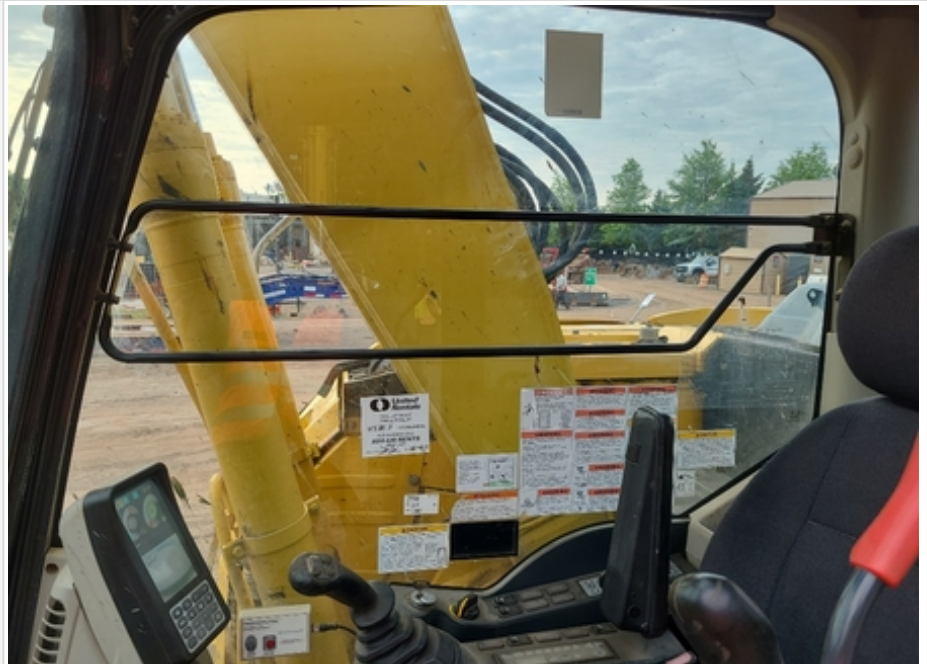
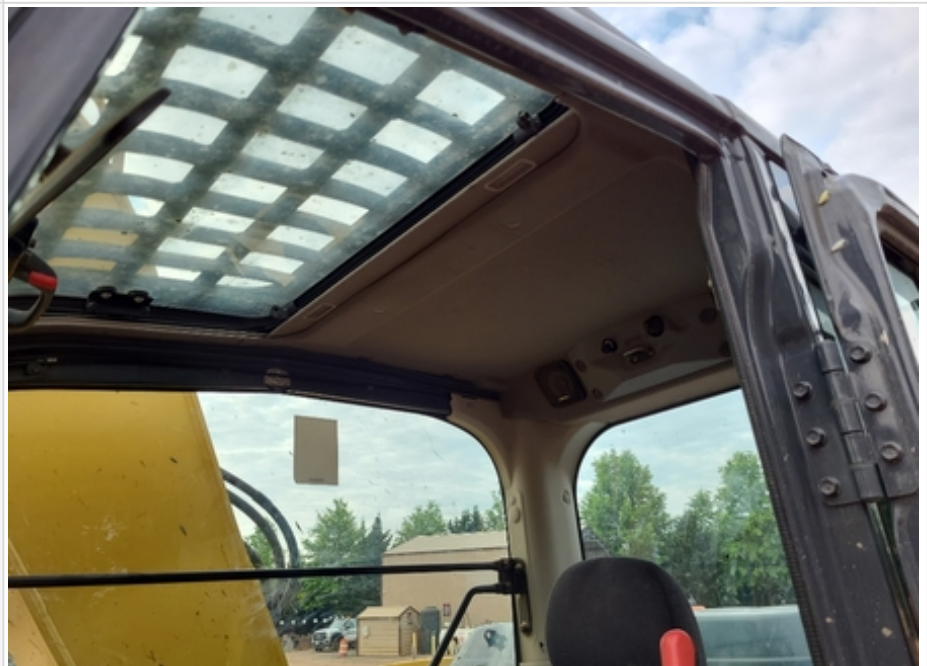
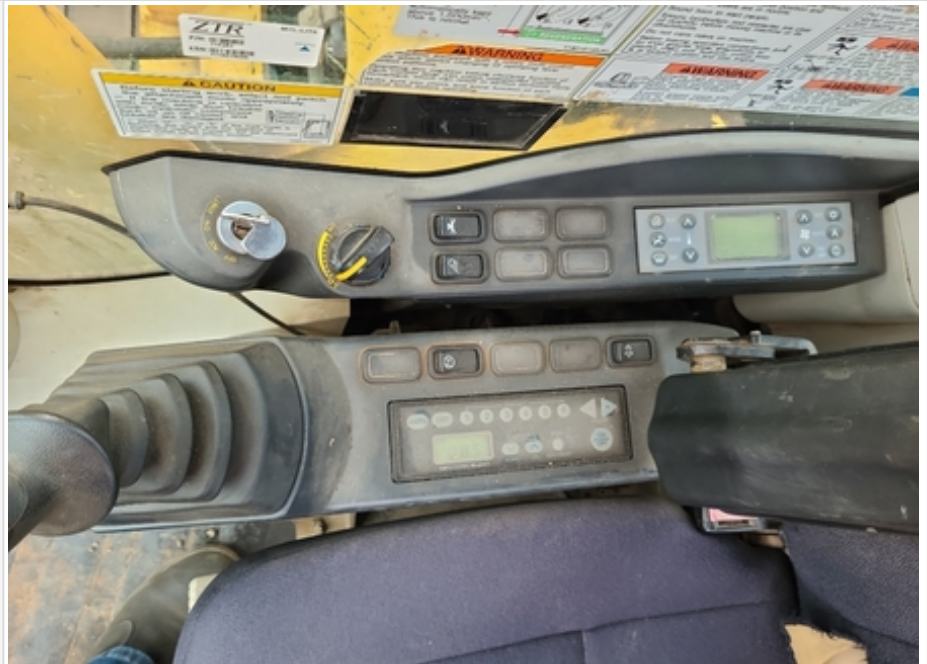
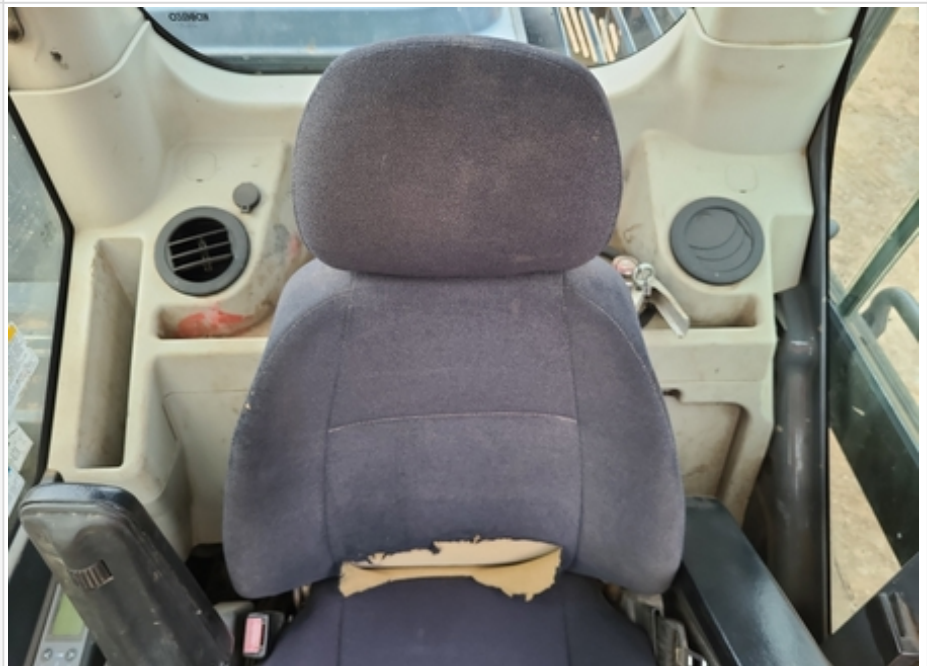
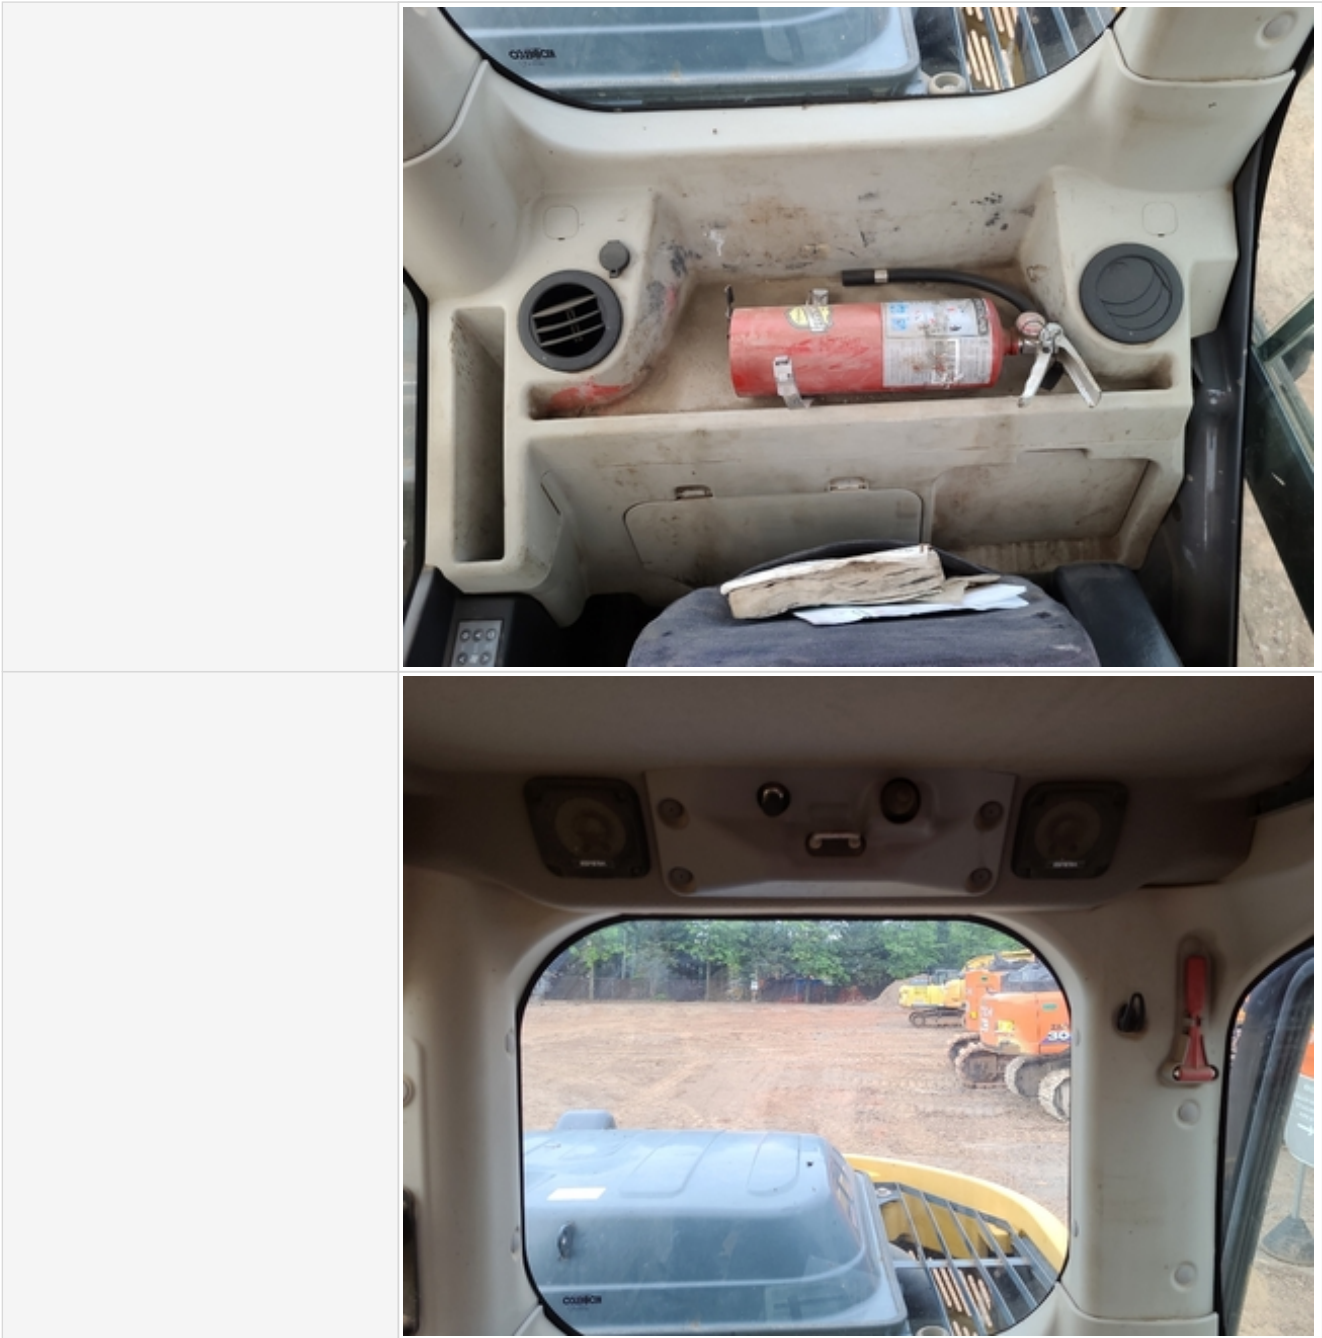
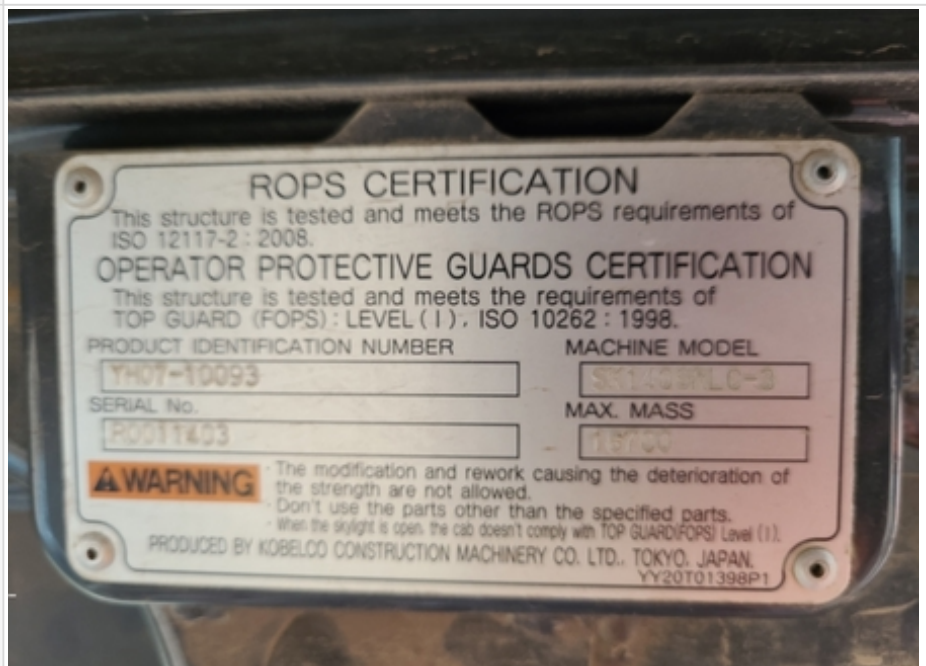
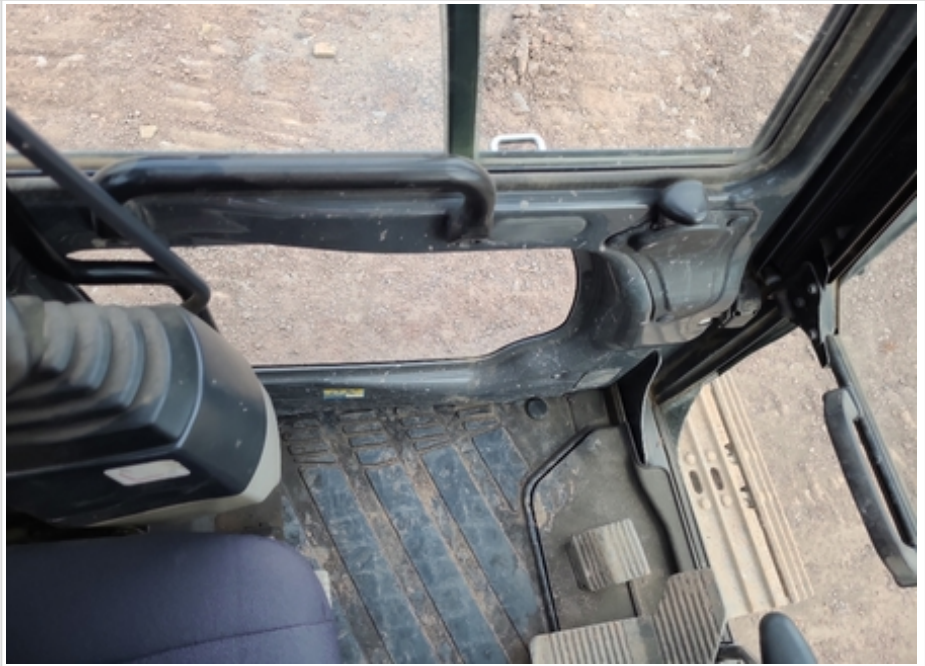
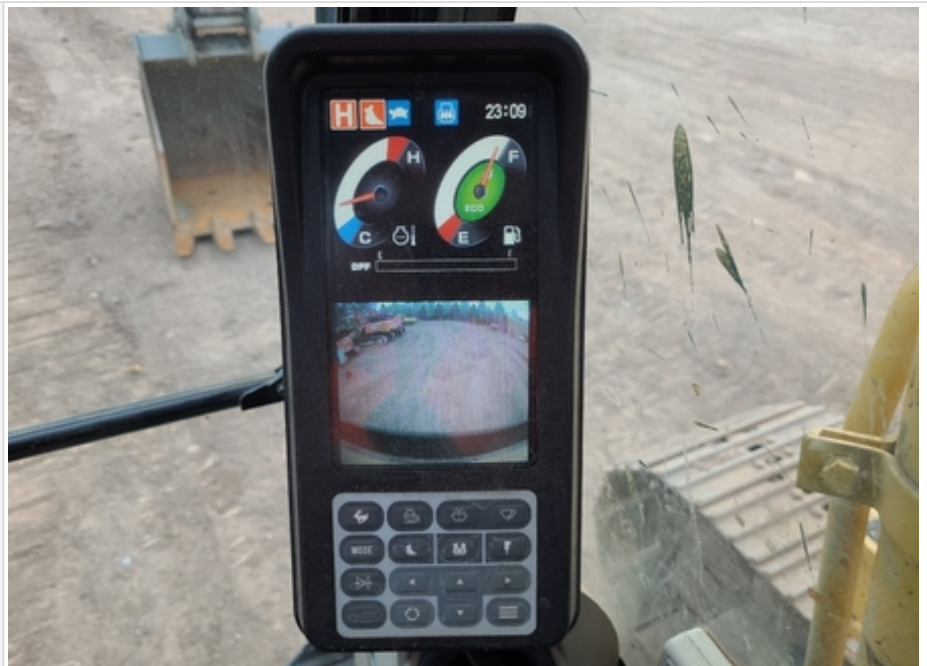
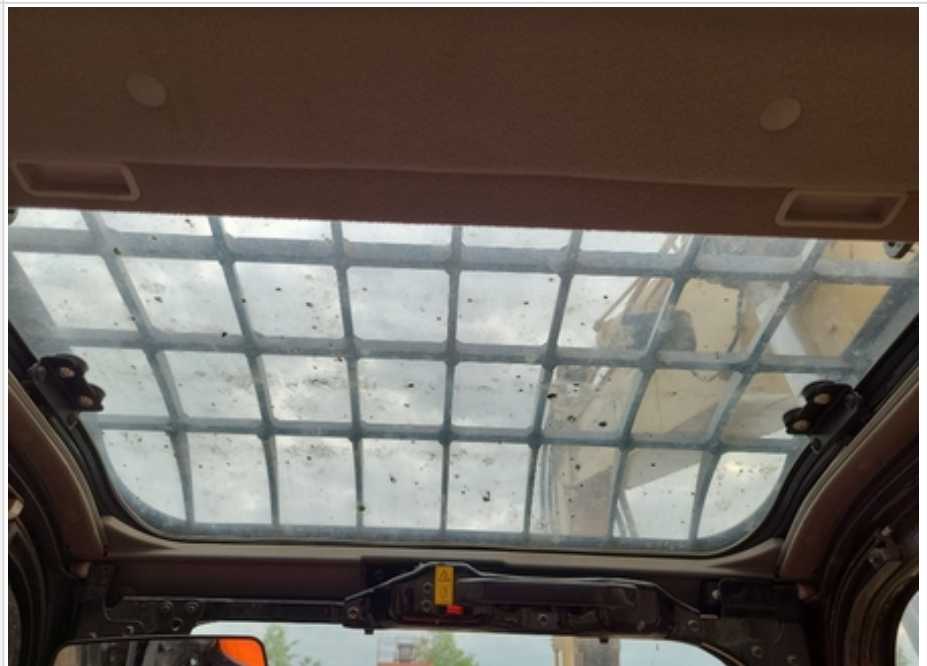
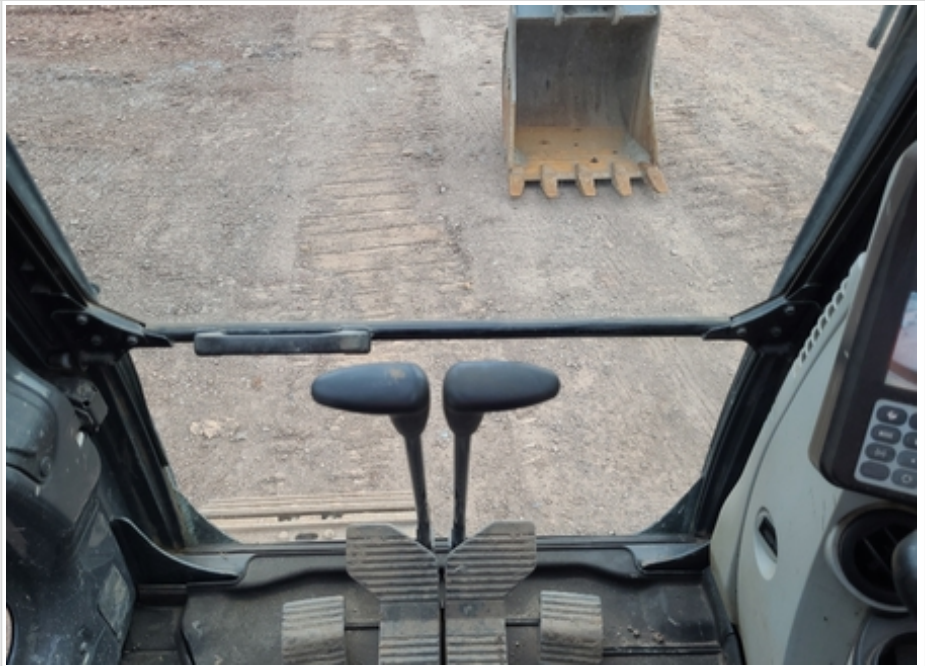
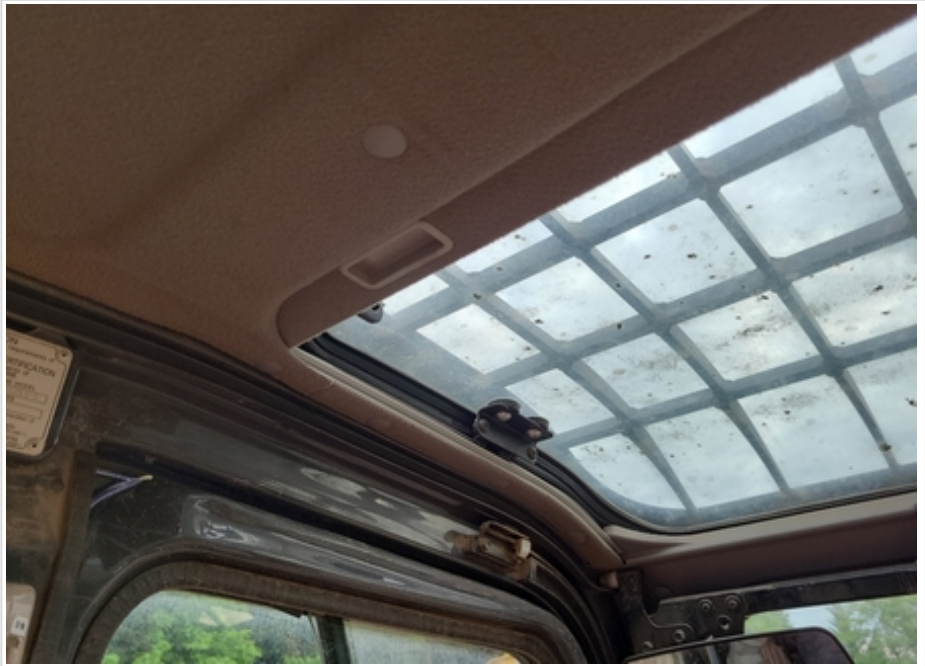
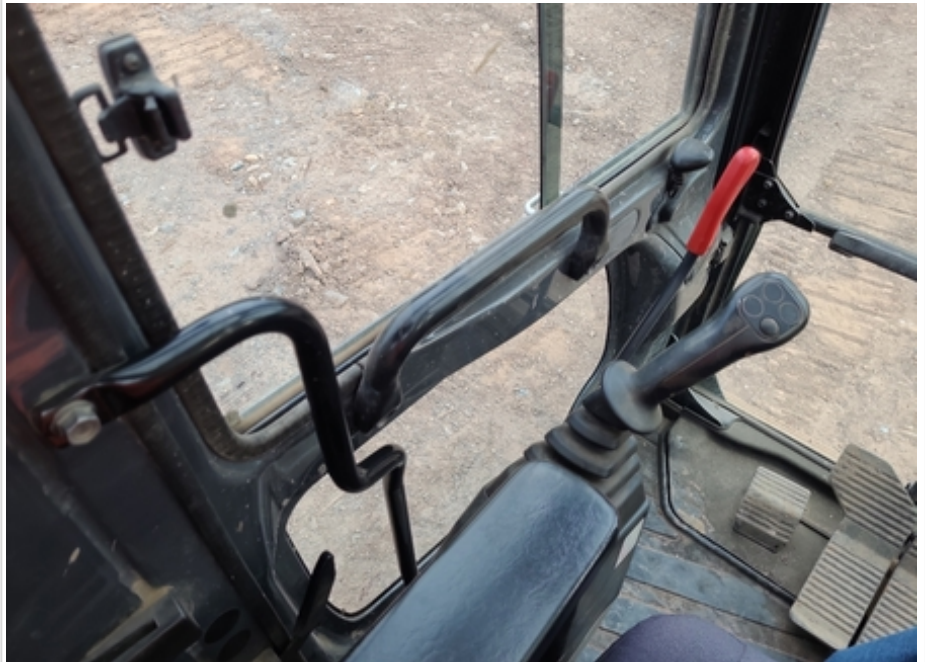
Control Station Rating	3 - Normal Wear & Tear
Control Station Overall Comments	Seat a bit torn, could use a detail. Structurally in good shape.

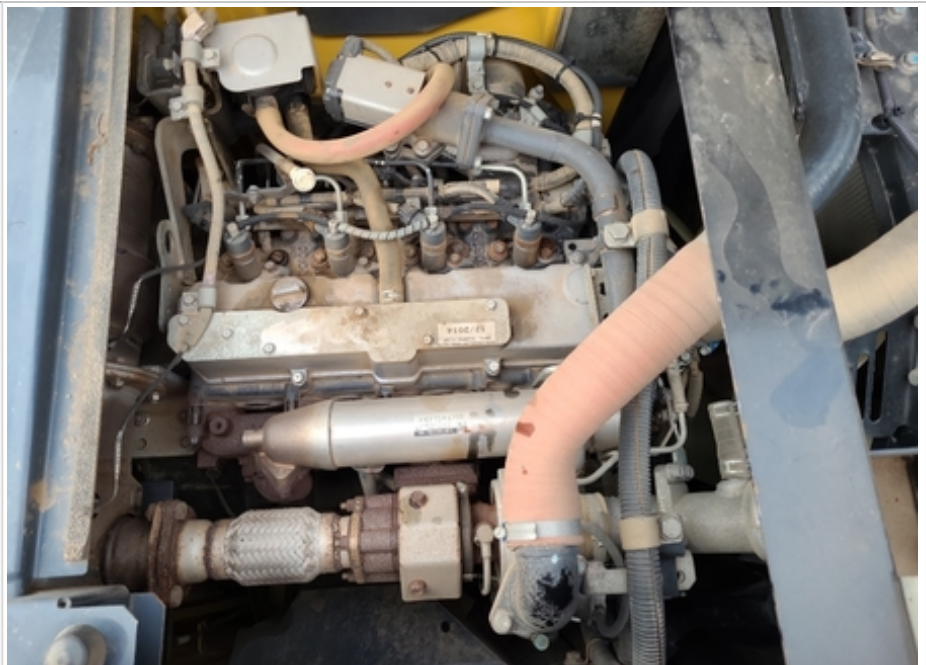
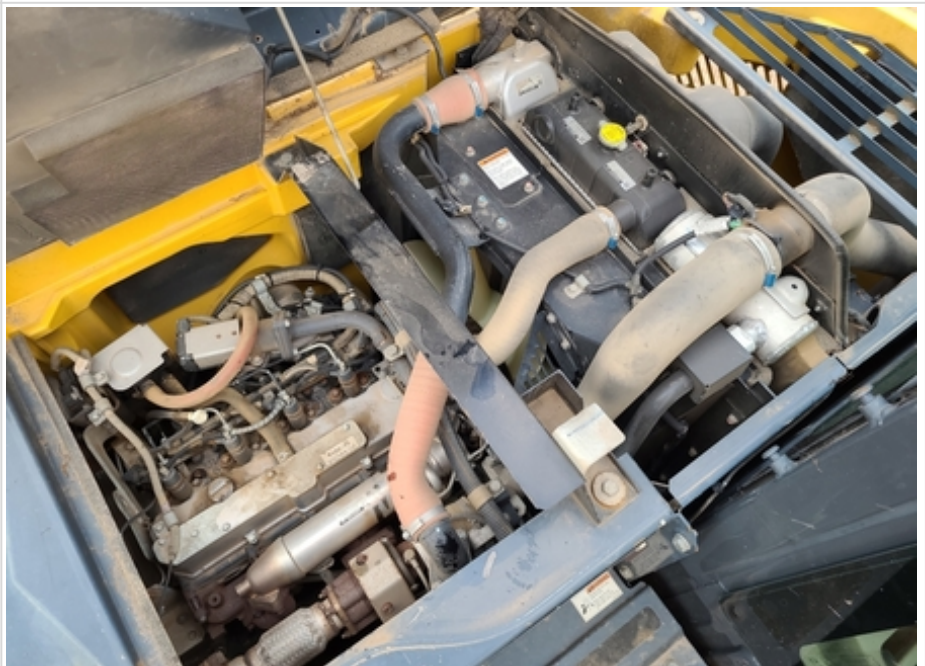
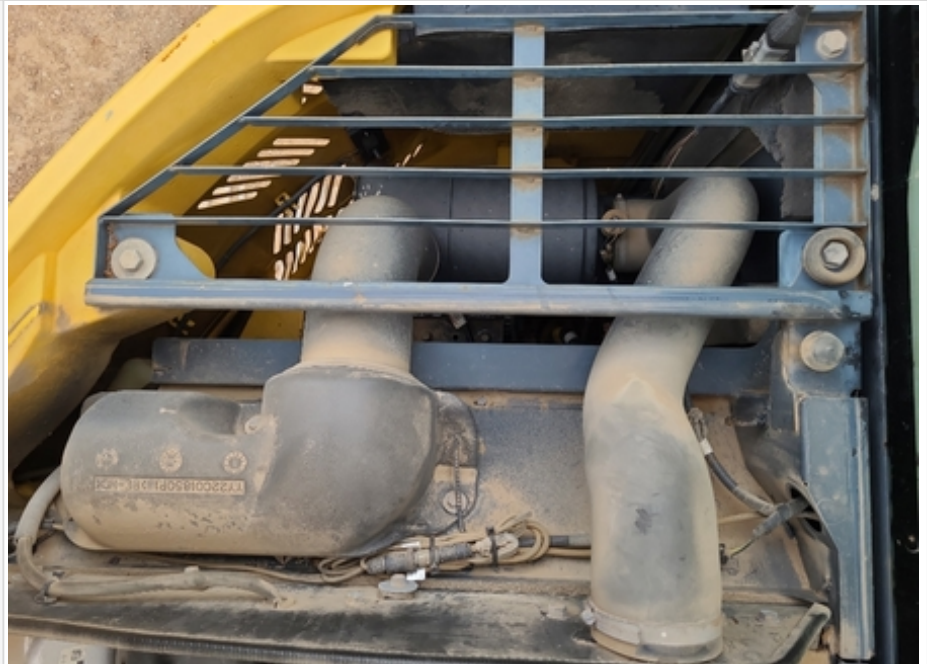
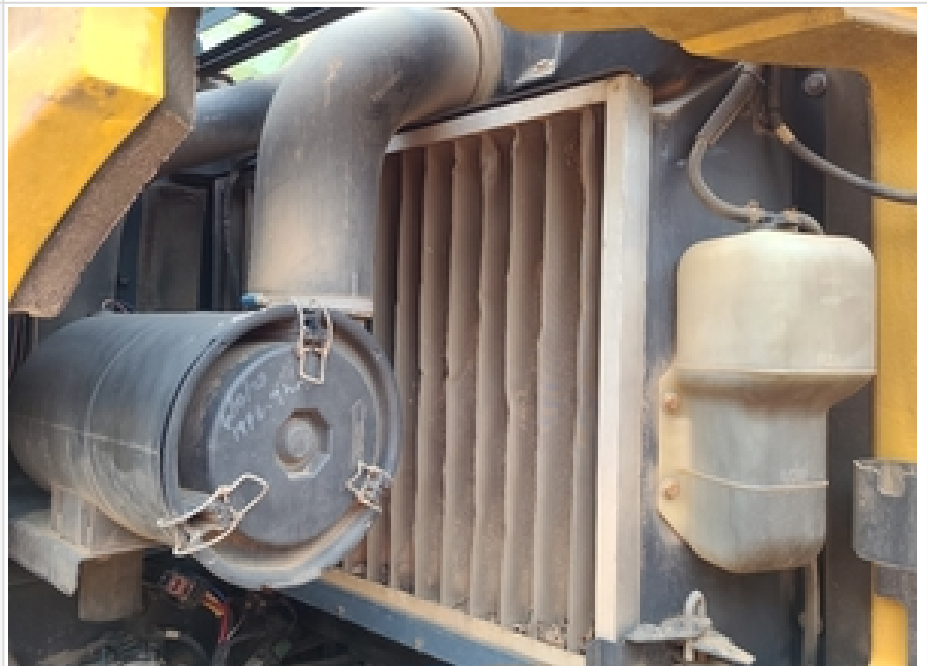
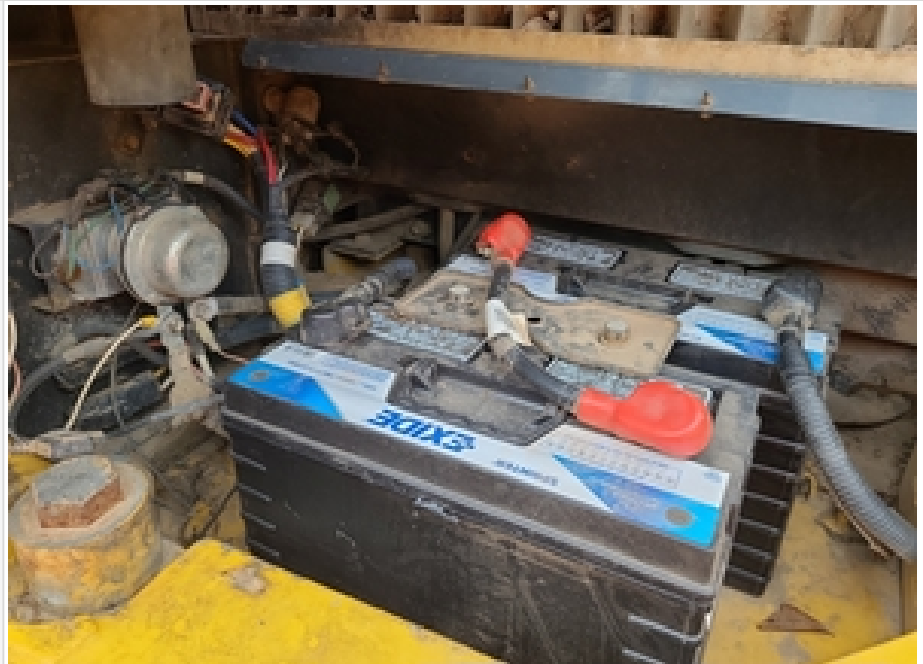
Engine Compartment

Engine Rating	3 - Normal Wear & Tear
Engine Overall Comments	Engine has well maintained healthy appearance.

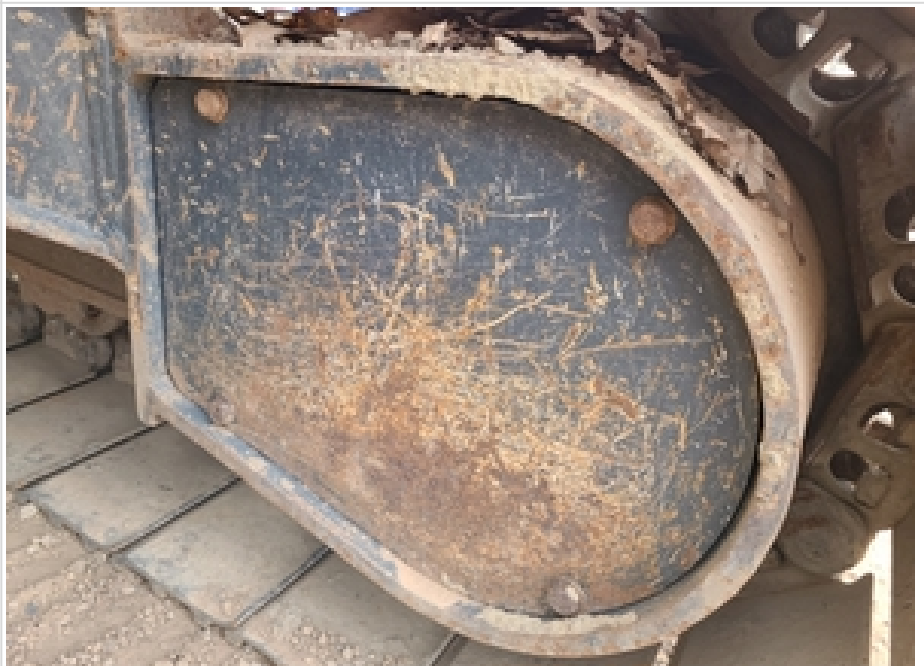
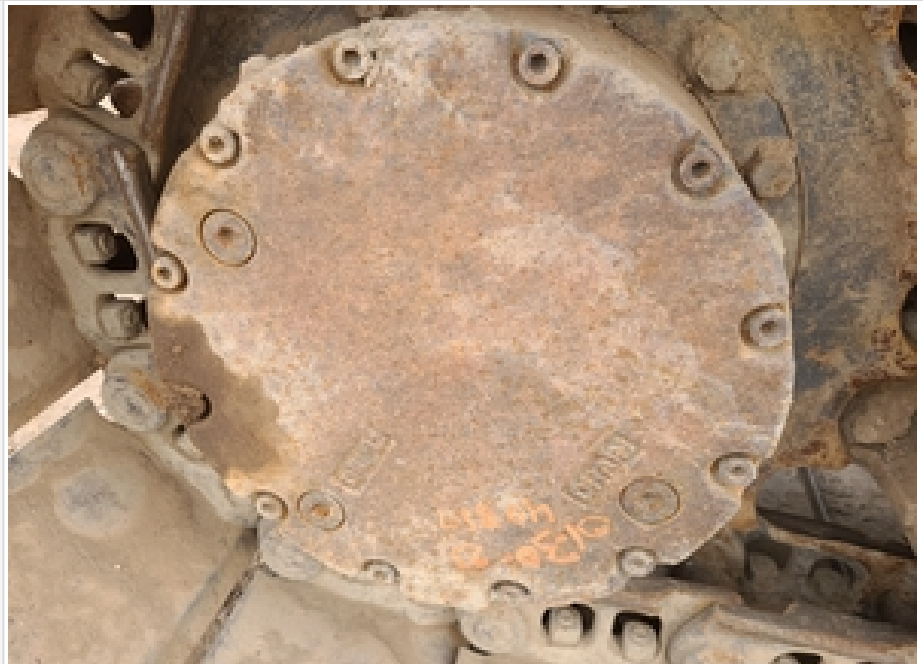
Drivetrain Photos	 
-------------------	--

Drivetrain operating well and final drives look to have been recently serviced.
