Enterprise Equipment Inspection

Category	Excavator
Travel System	Track Undercarriage
Comments	
Year	2016
Make	Kobelco
Model	SK140SRLC-3
Serial Number	YH07-10093
Serial Number Plate

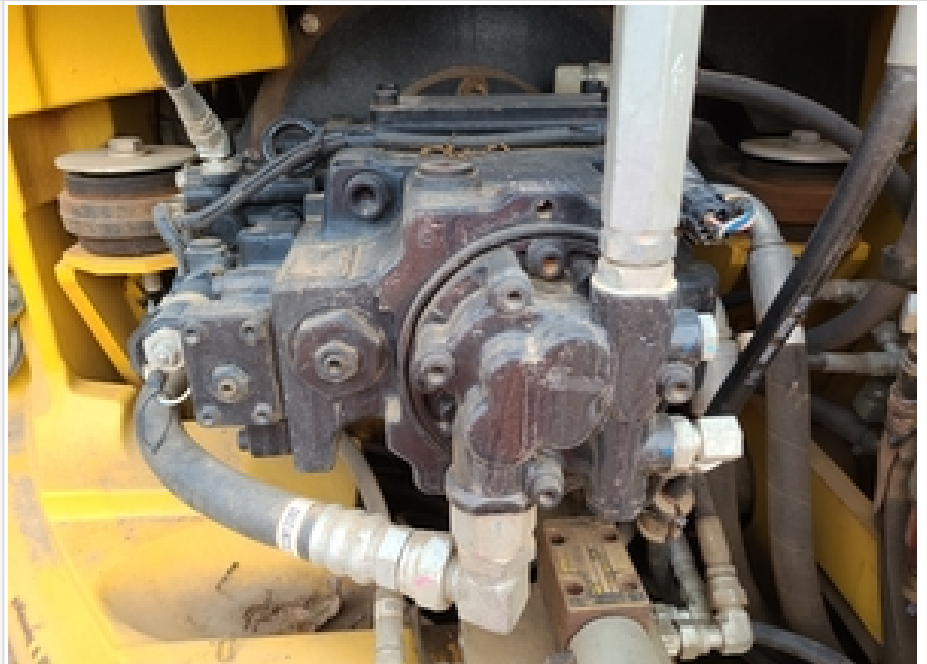
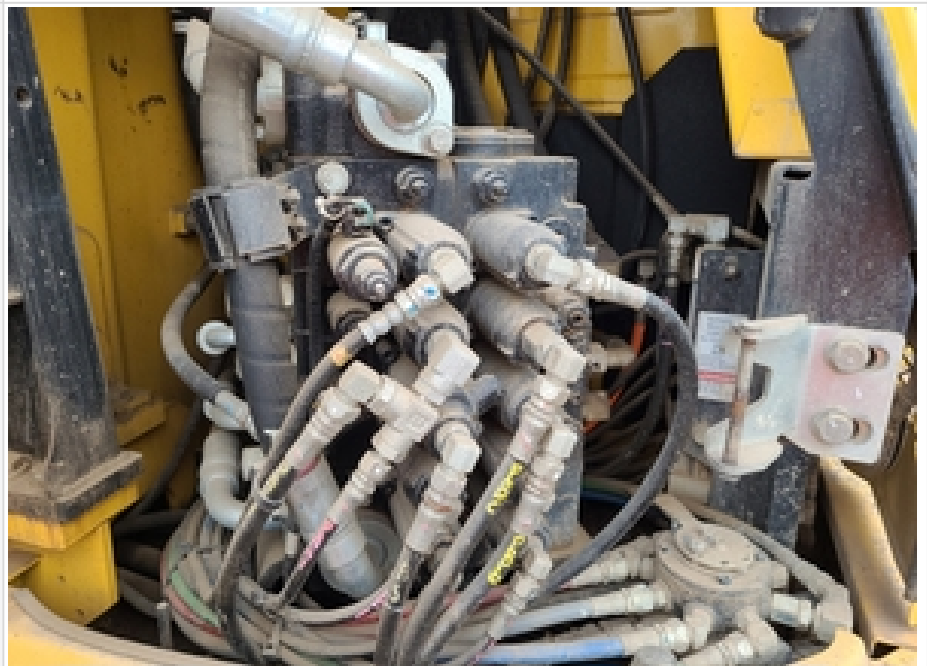
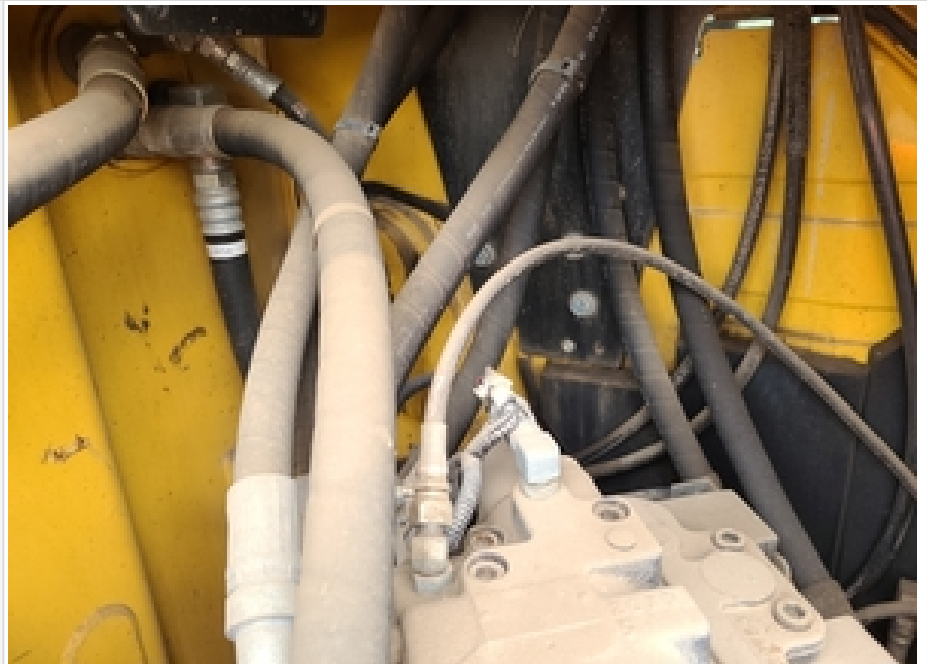
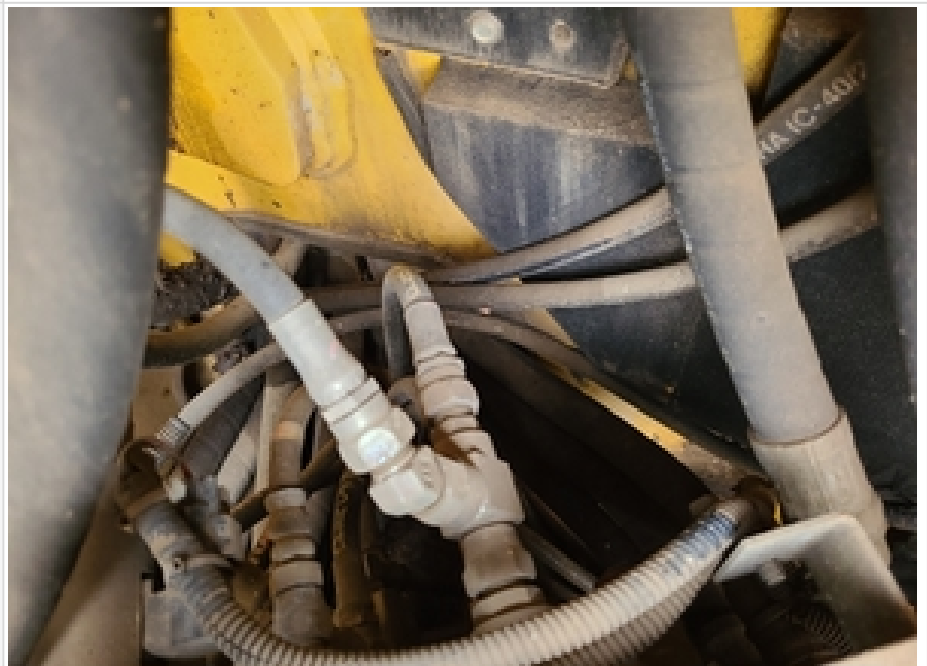
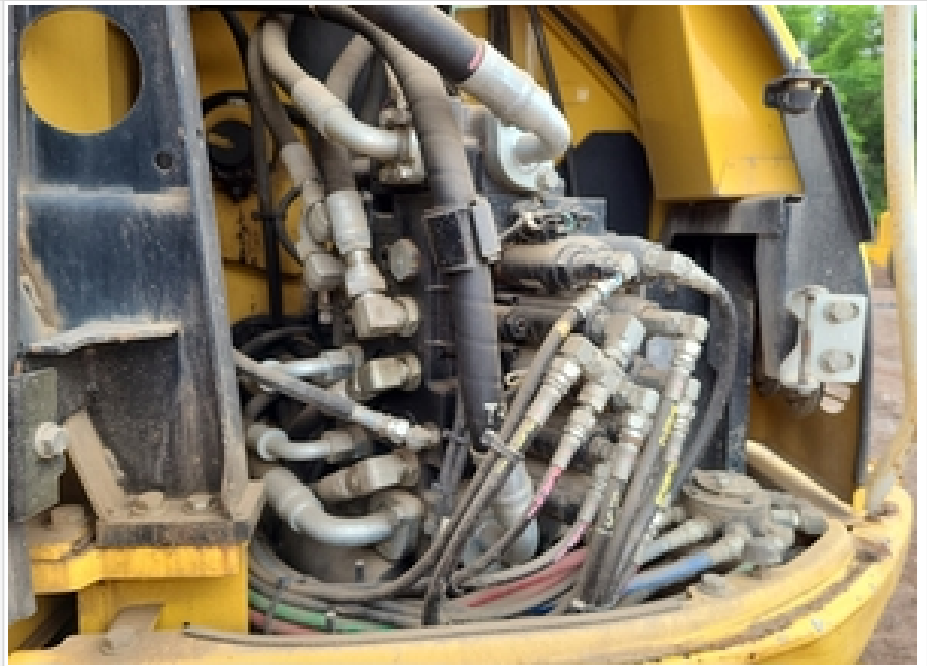
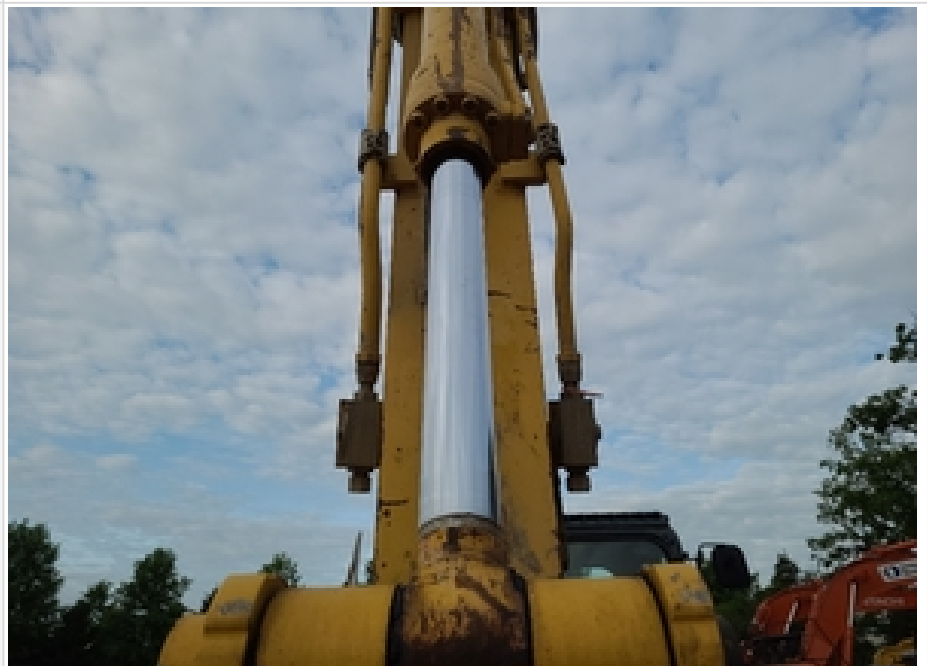
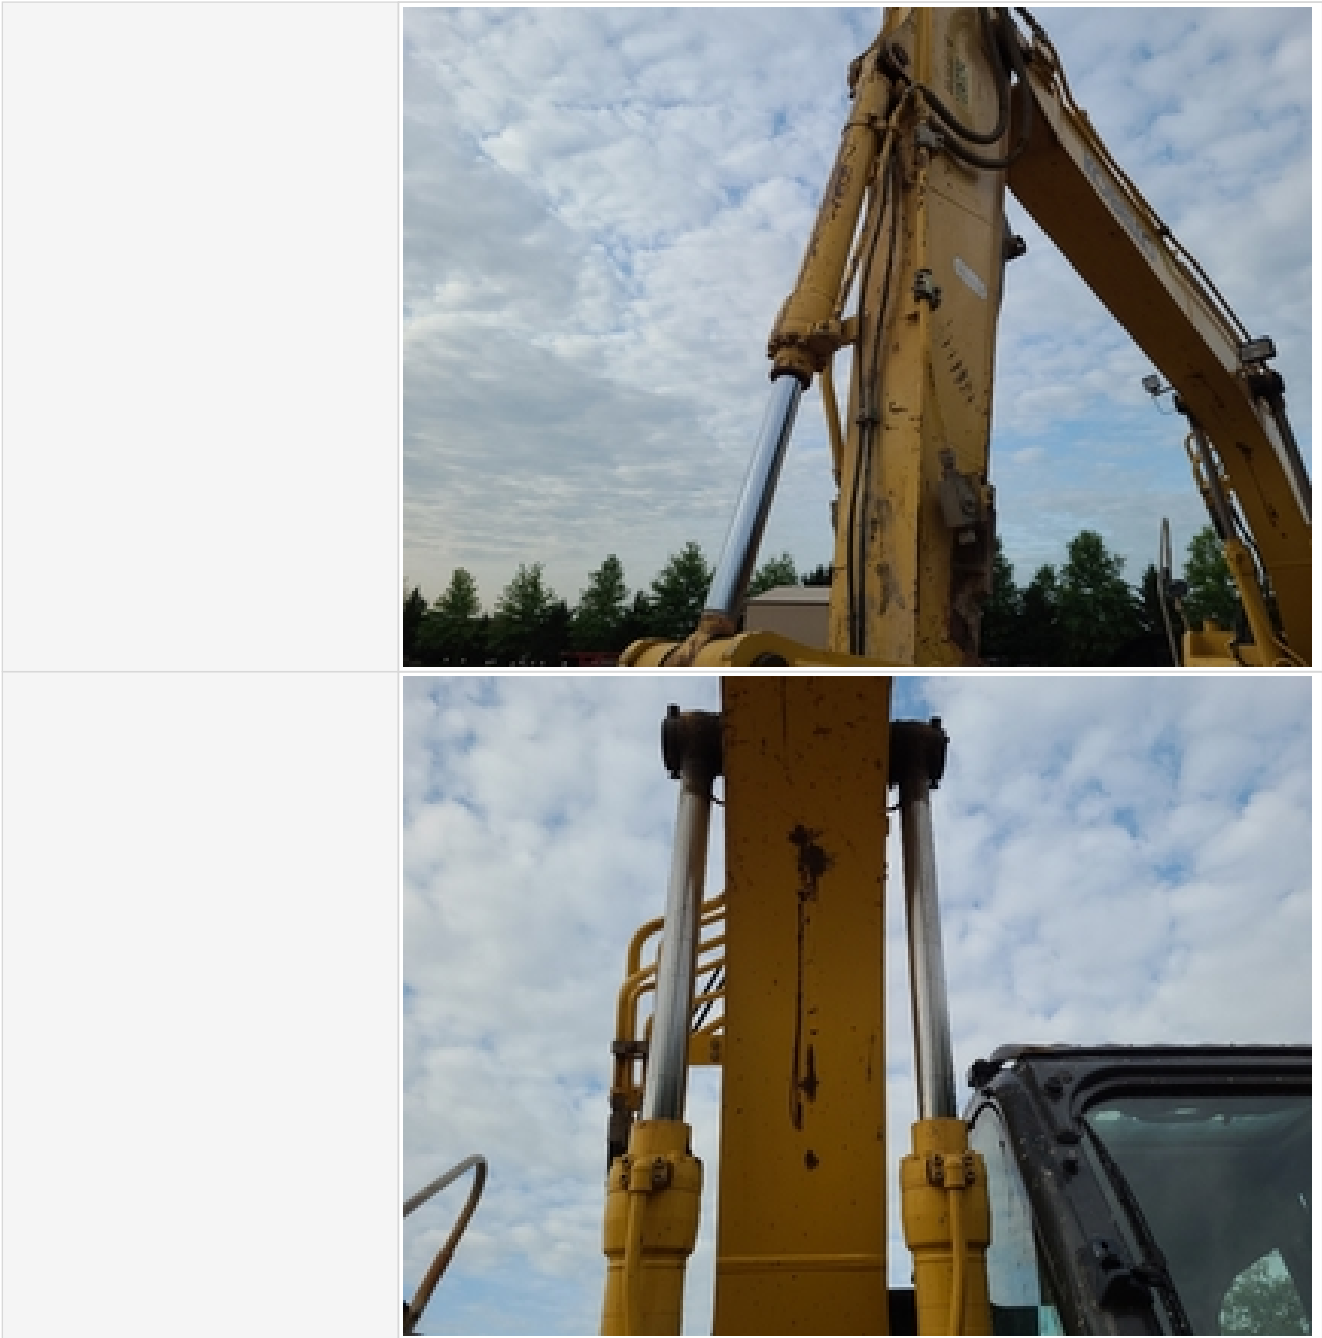
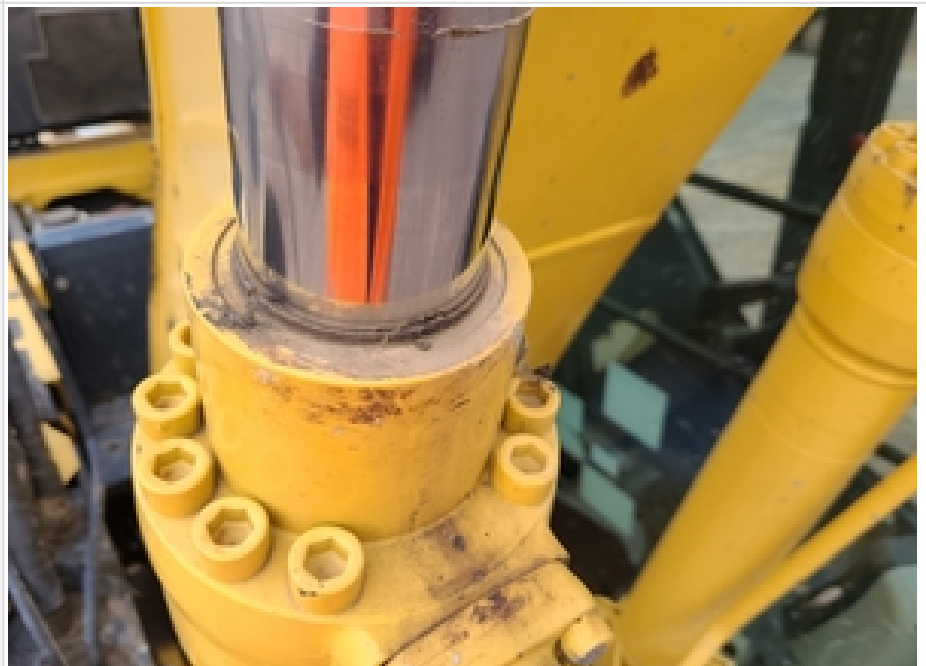
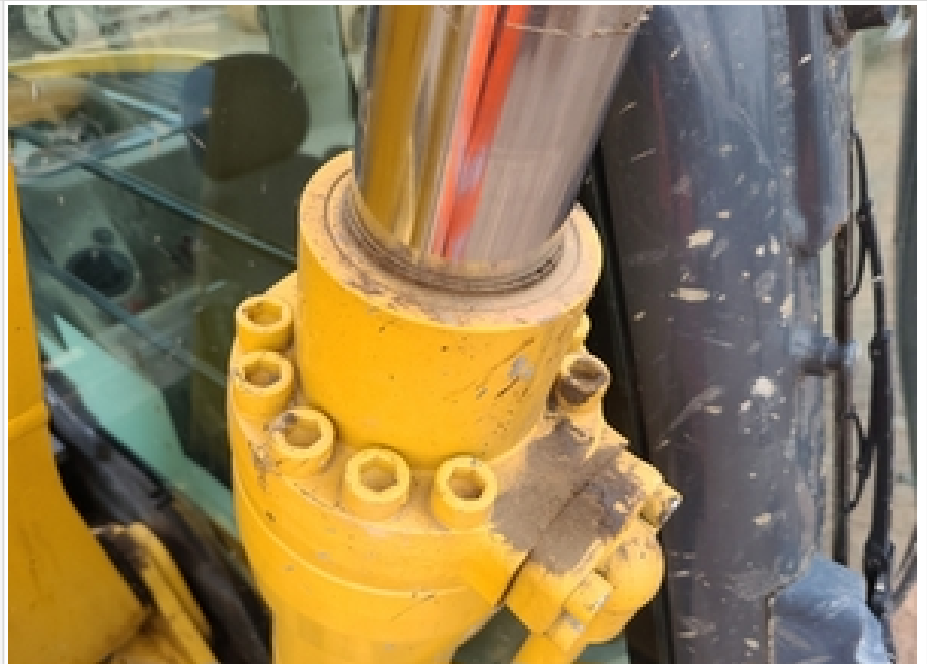
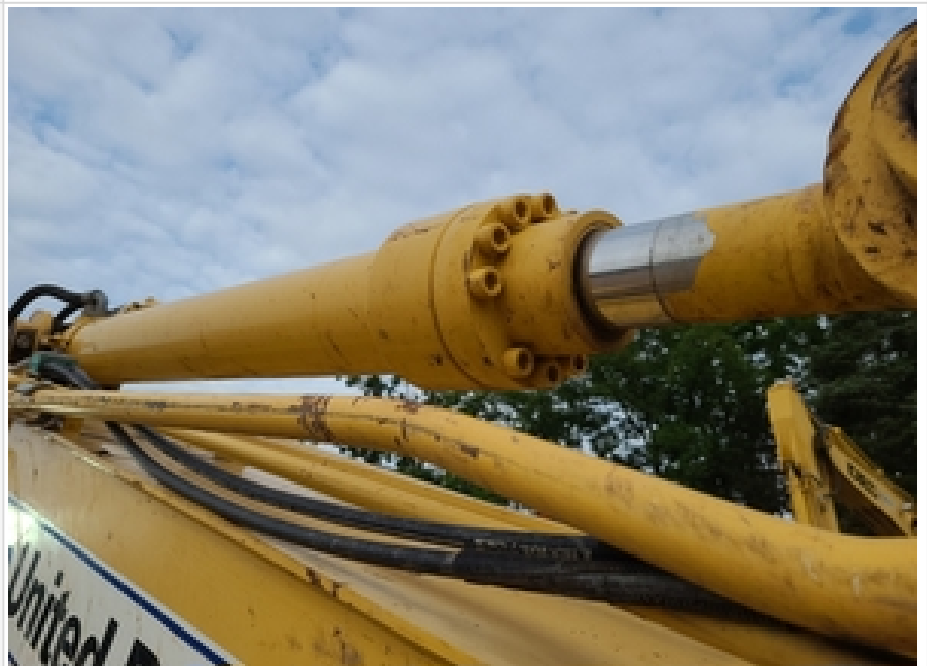
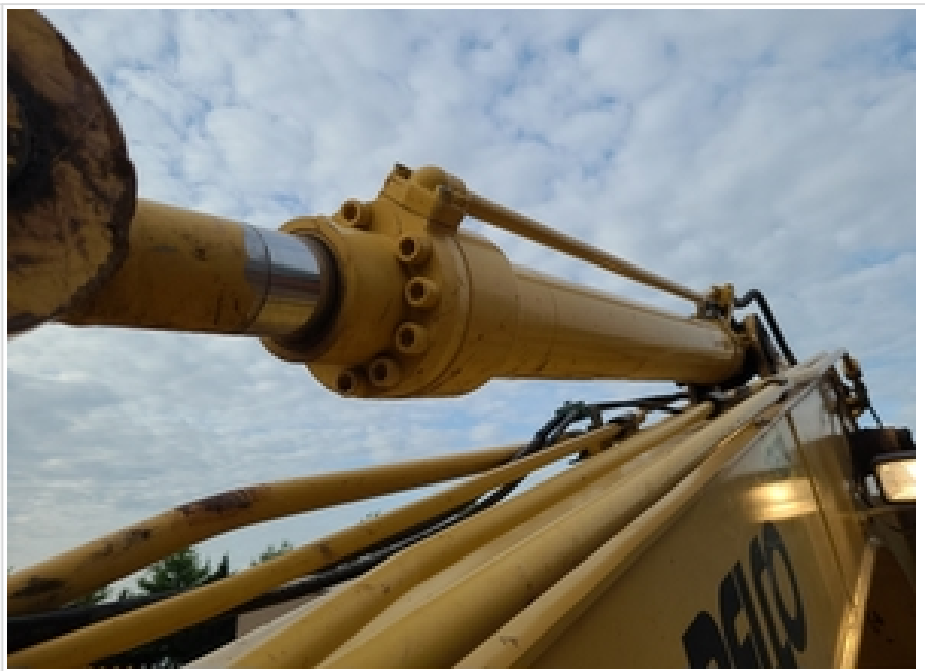
Hydraulic Pump/Fittings/Hoses

Hydraulic System Rating	3 - Normal Wear & Tear
Hydraulic System Comments	No active leaks observed and system running well.

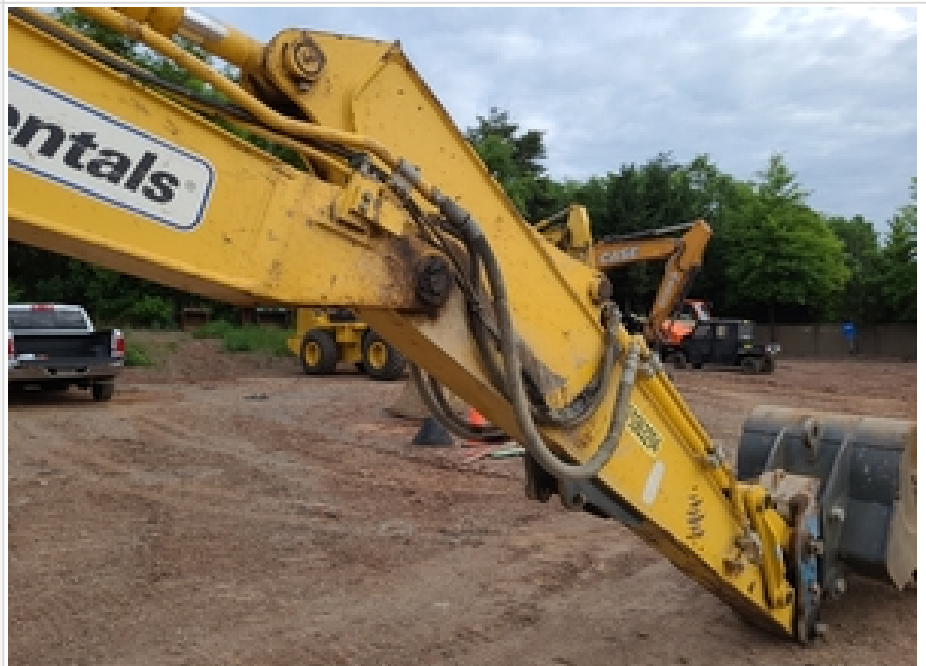
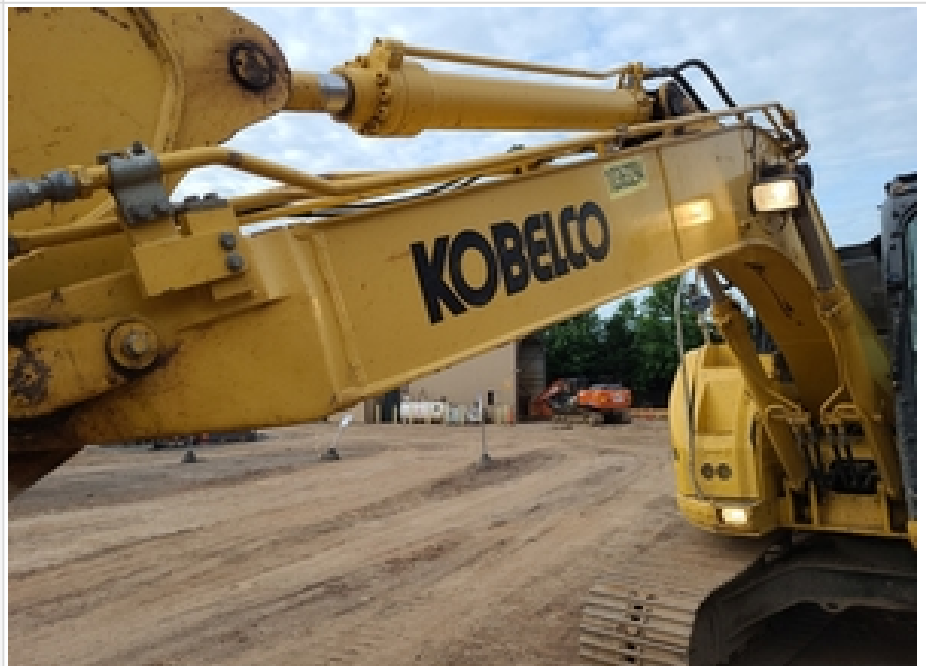
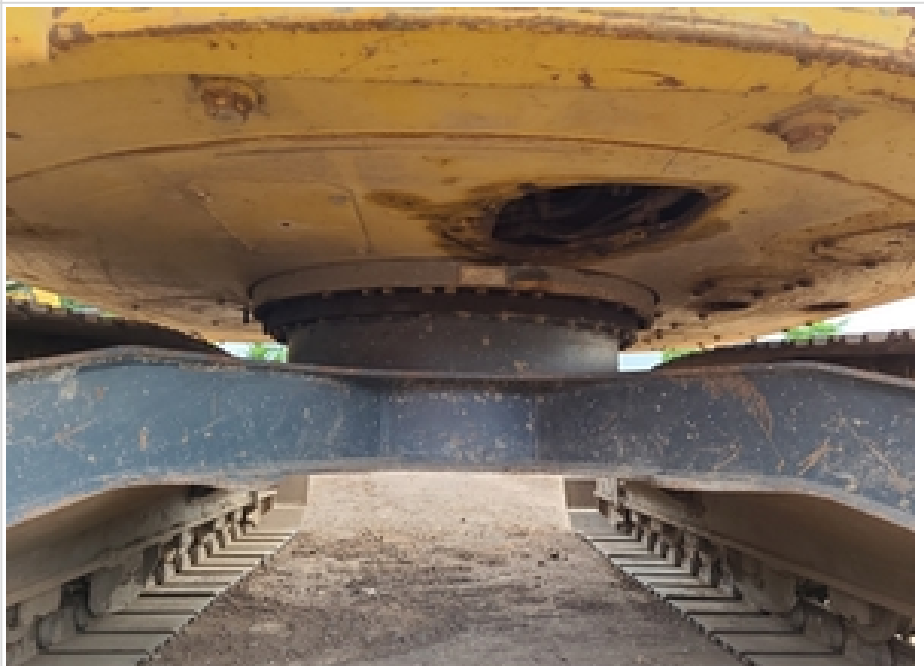
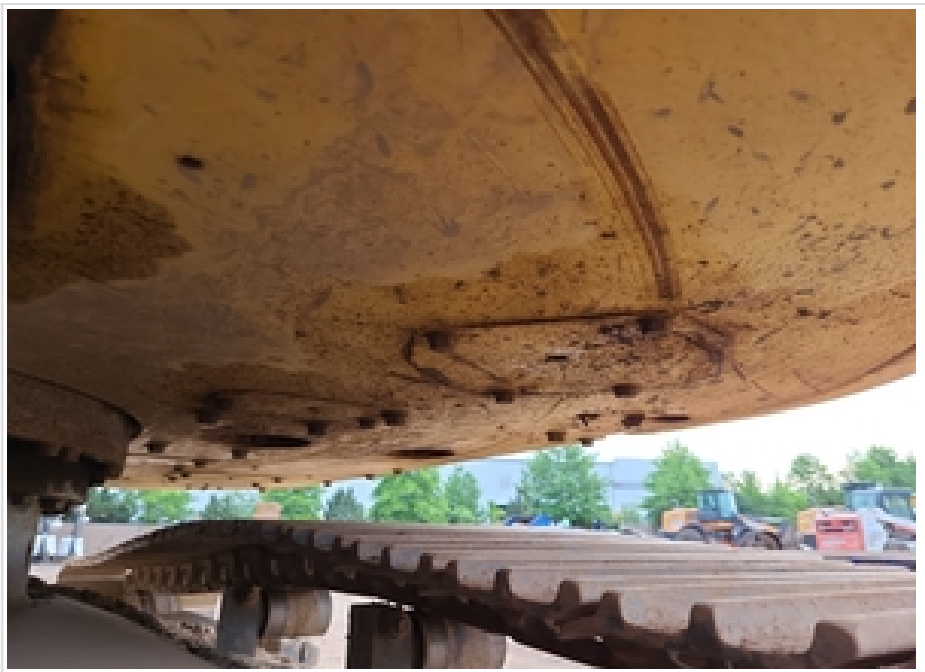
Chassis Photos

Chassis Rating	3 - Normal Wear & Tear
Comments	Boom, Stick, and main frame in solid shape with no excessive playseen in implements.

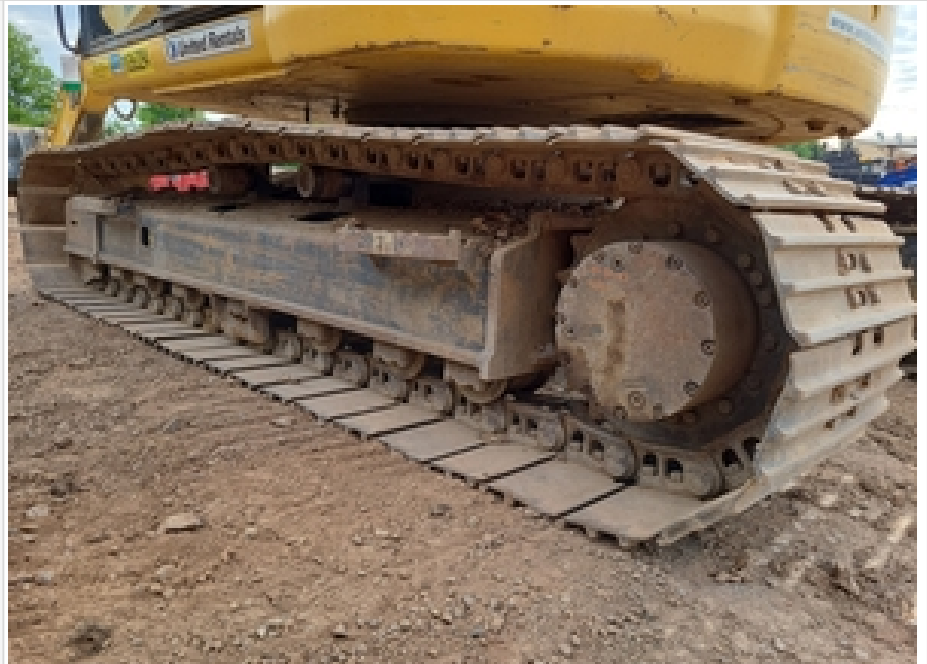
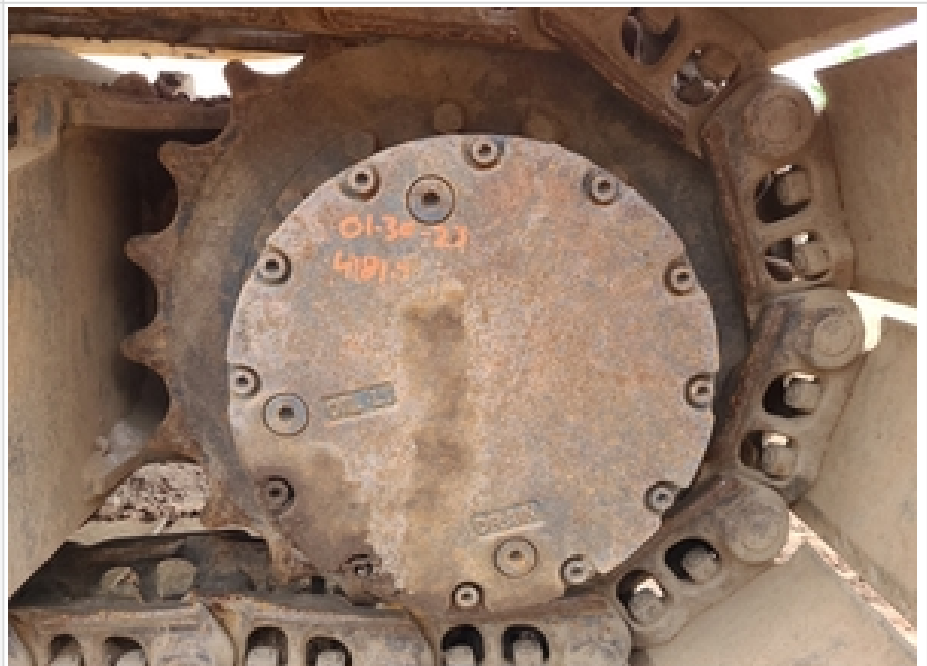
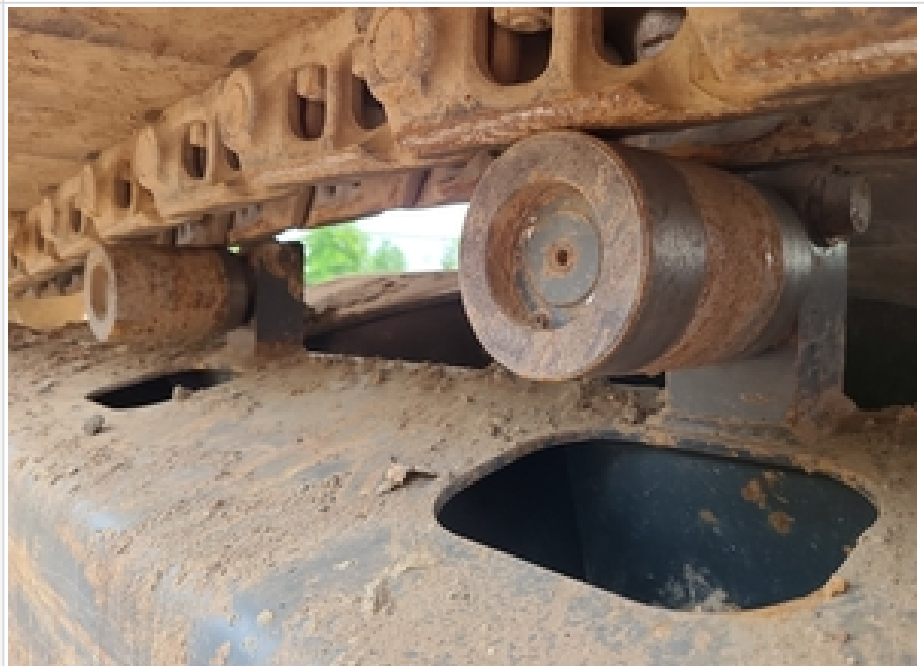
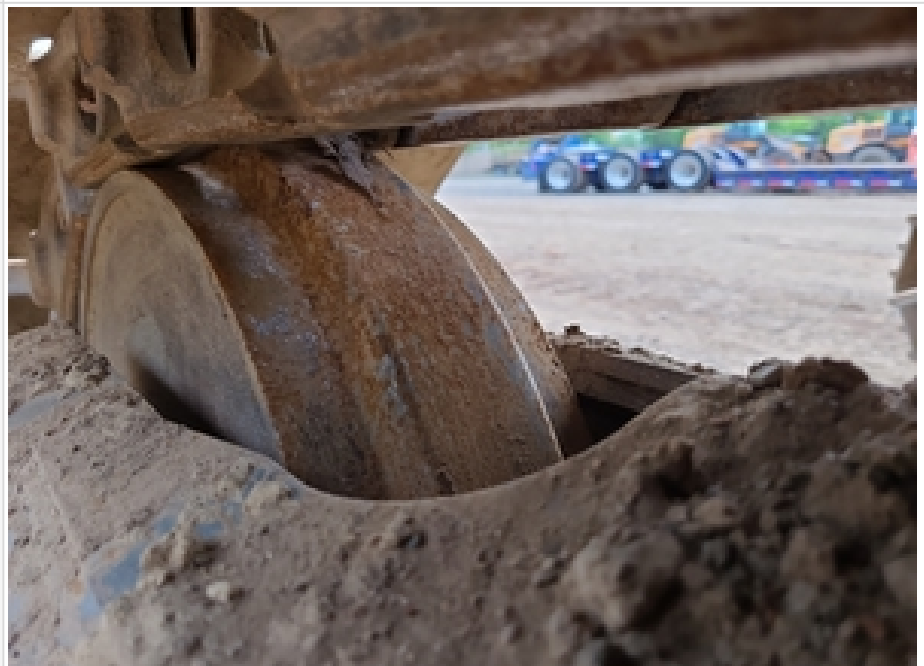
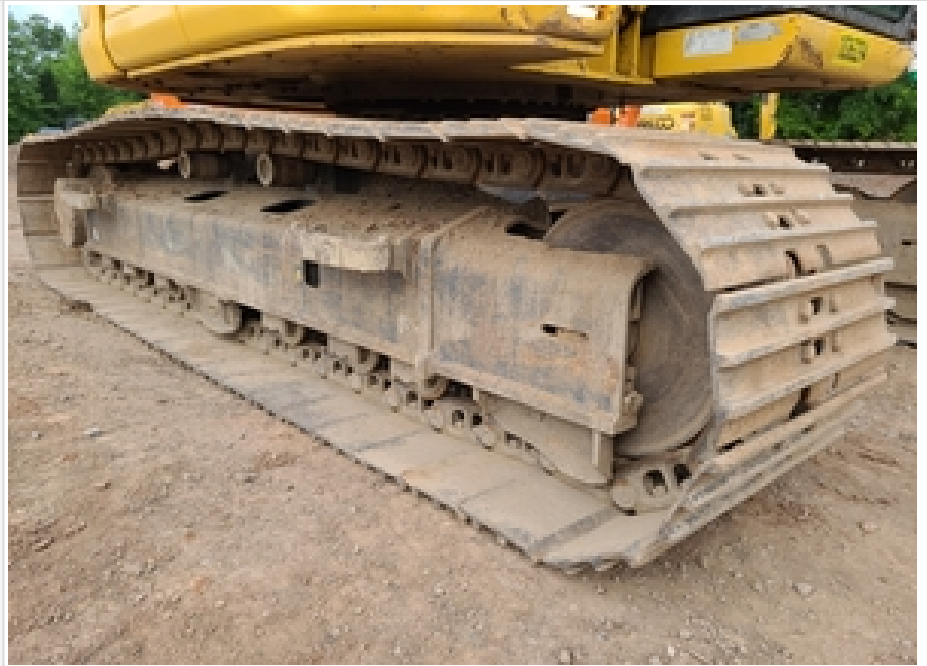
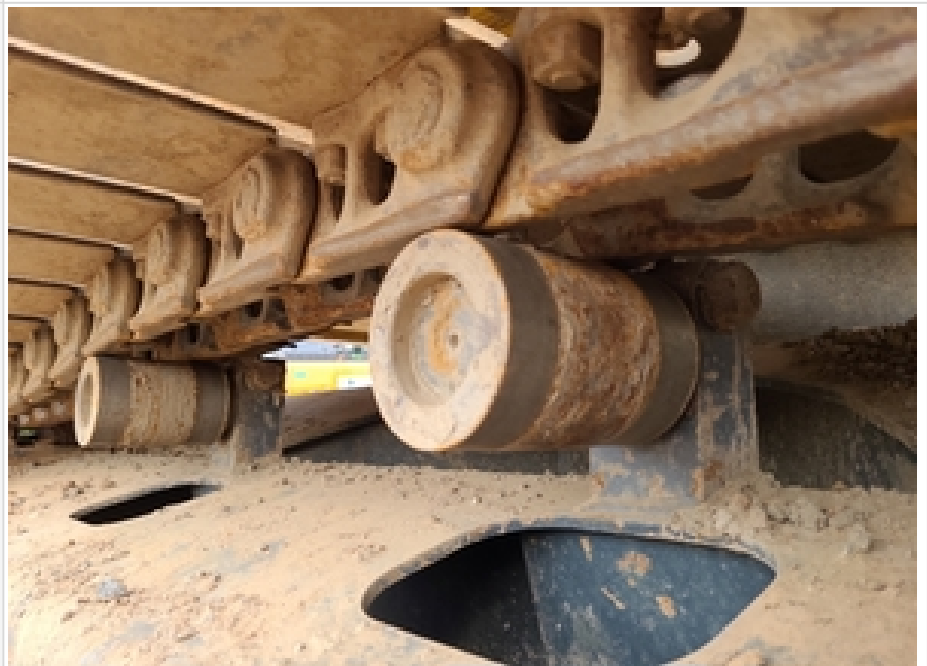
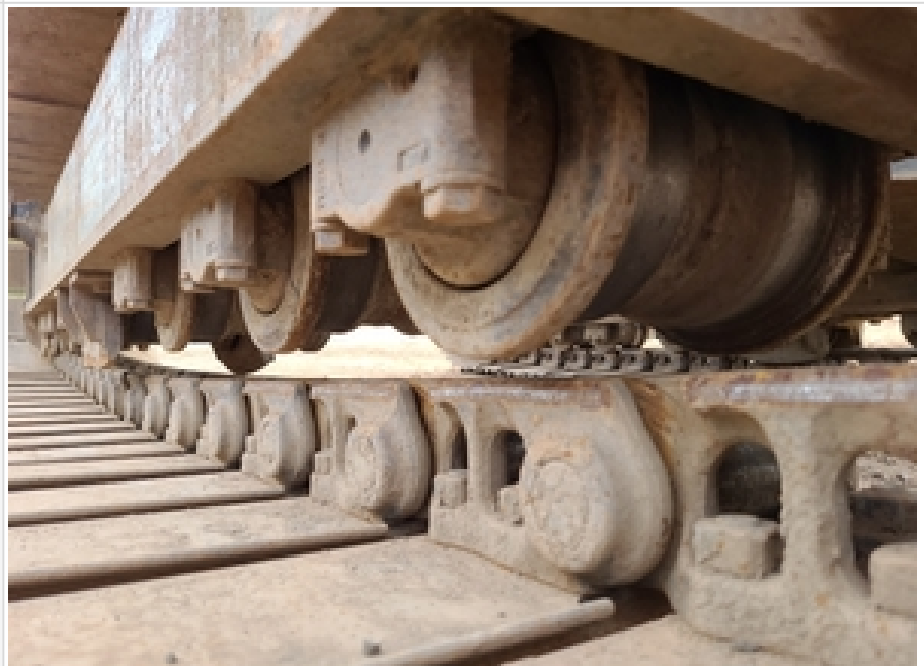
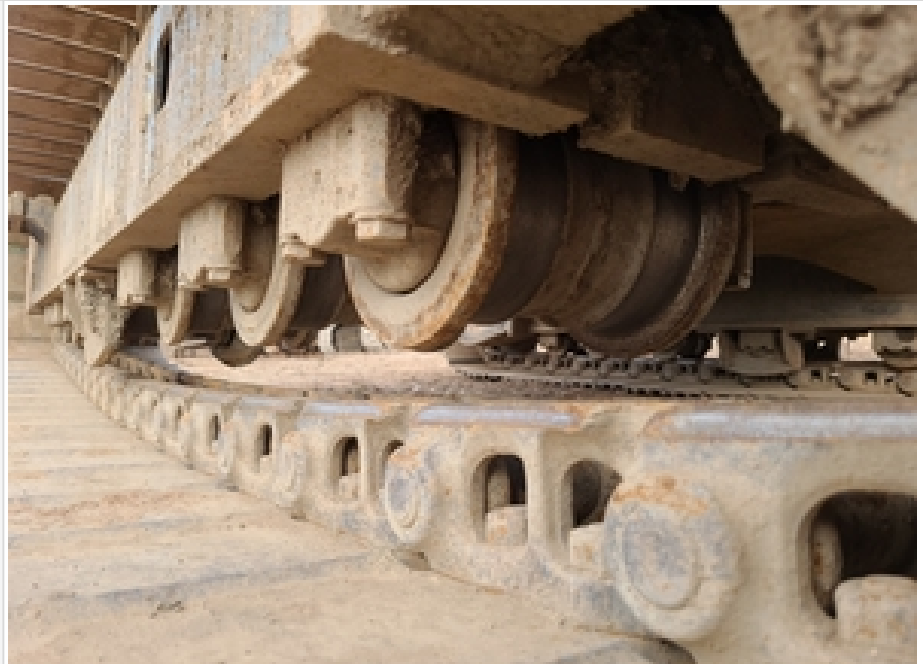
Undercarriage Photos

Undercarriage Rating	3 - Normal Wear & Tear
Undercarriage Comments	Undercarriage in great condition and both sides have plenty of life left.

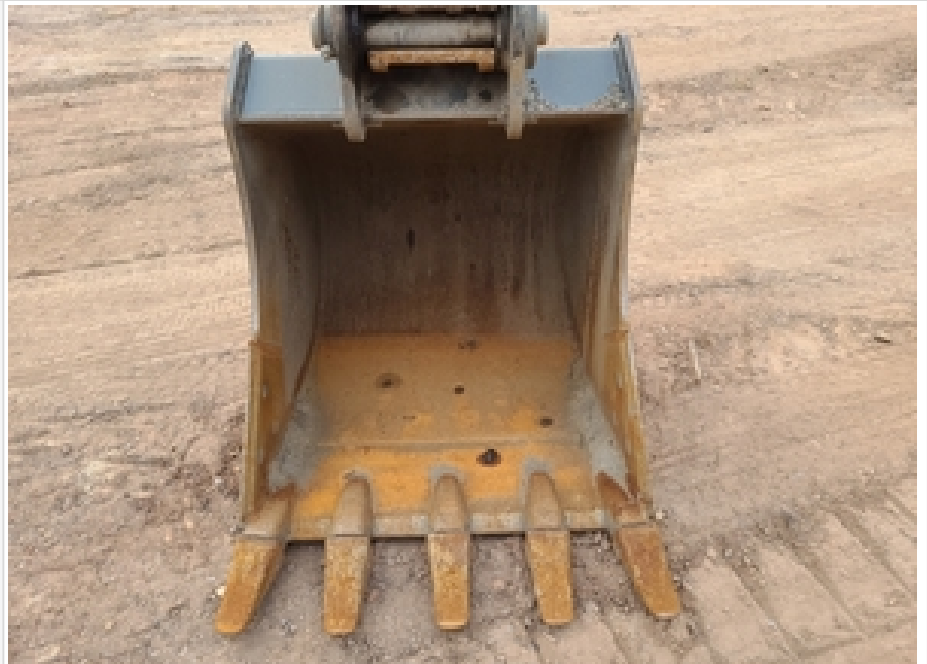
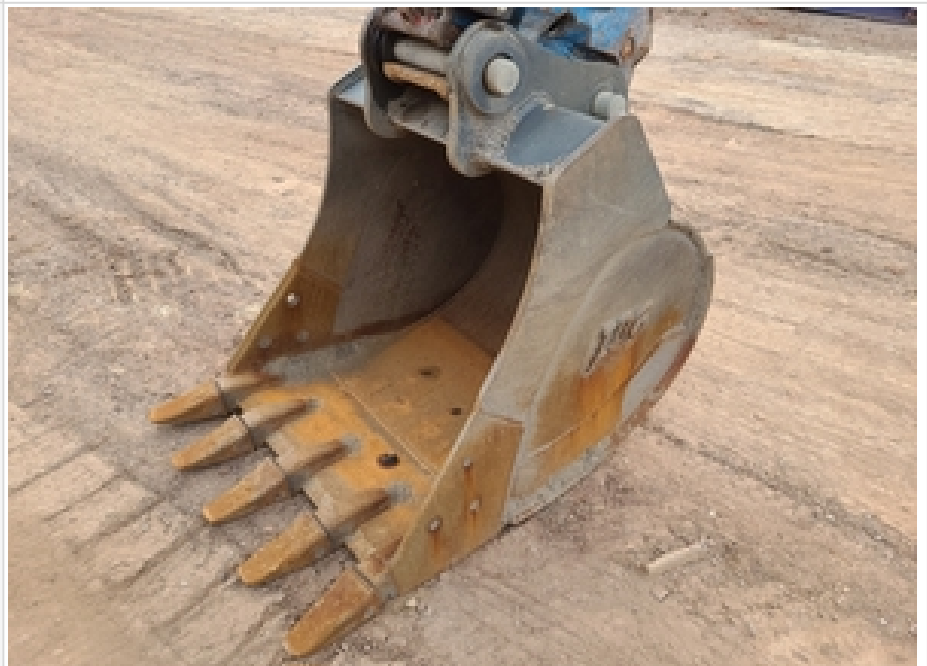
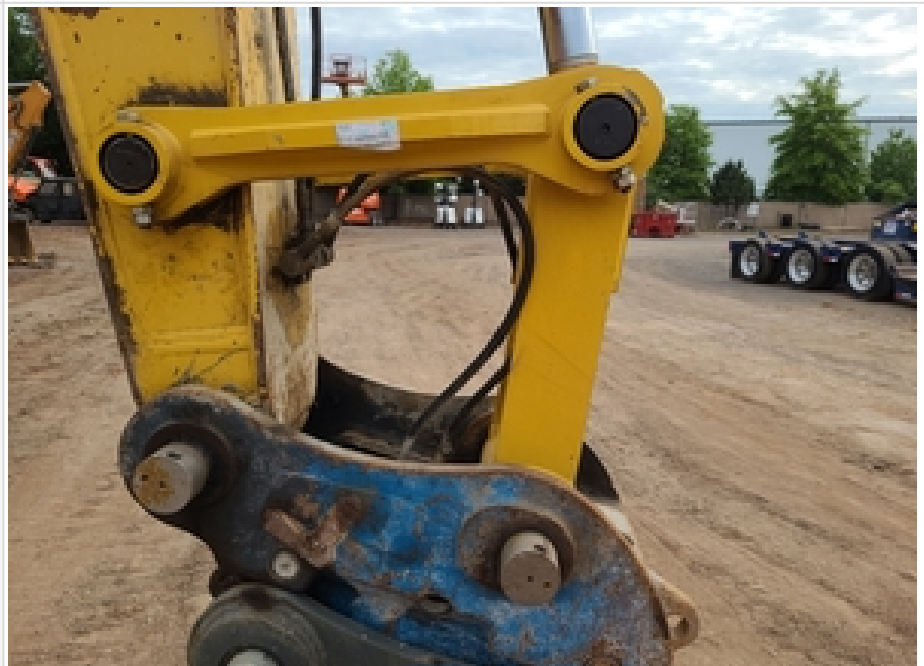
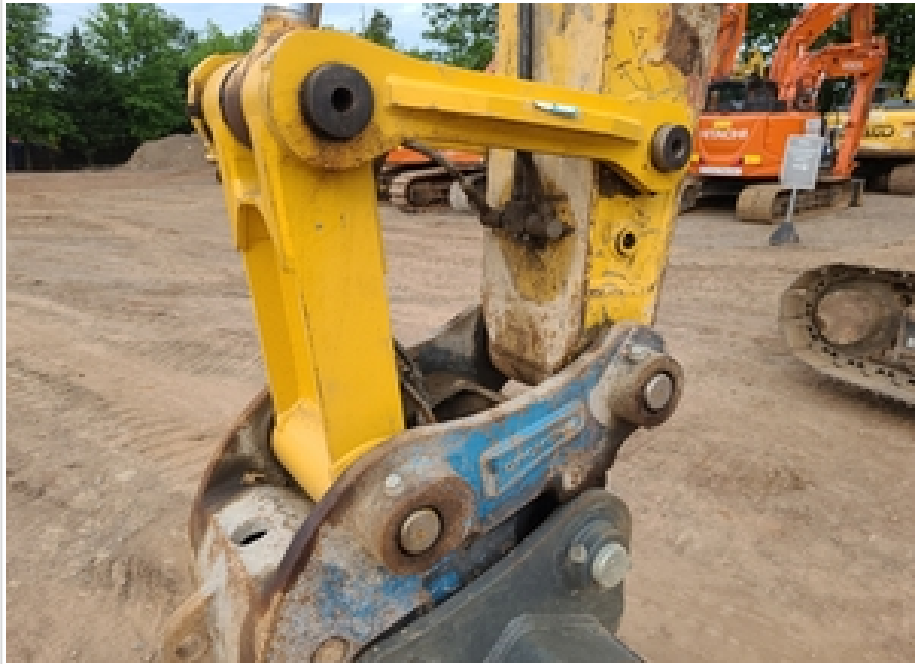
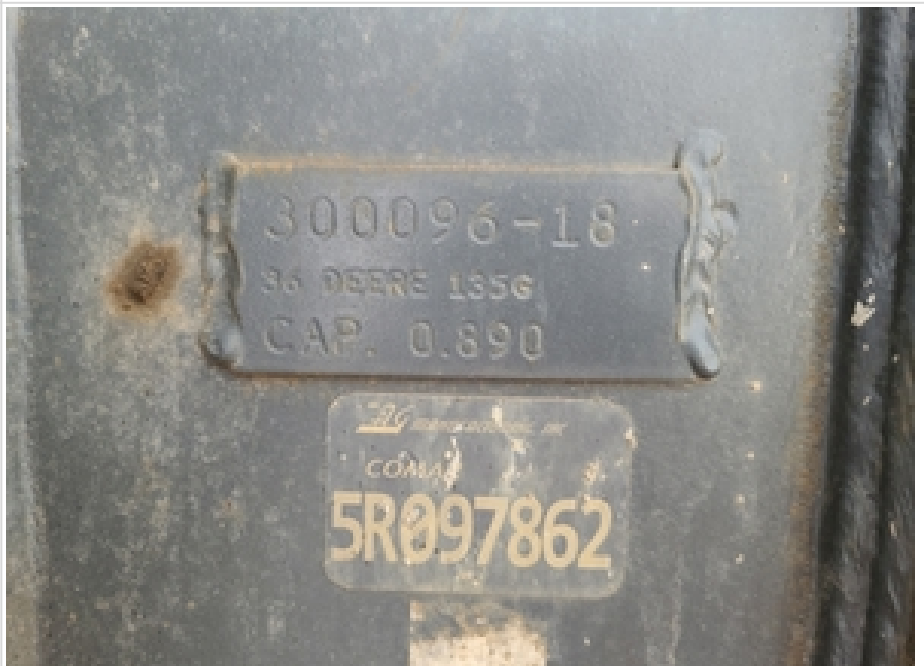
Attachment Photos	 
-------------------	--

Attachment Rating	4 - Very Light or Minimal Wear
Attachment Comments	36" bucket and quick coupler in great shape.
