General Info

Conordi IIIIC	
Category	Skid Steer
Travel System	Track Undercarriage
Comments	
Year	2017
Make	Bobcat
Model	T450
Serial Number	AUVP13481
Serial Number Plate	Bobcat. COMPACT SKID STEER TRACK LOADER MODEL *AUVP13481* PRODUCT IDENTIFICATION NUMBER MADE N CZECH REPUBLC Bobcat Company West Fargo, ND 58078 USA www.bobcat.com FOR A LIST OF UNITED STATES PATENTS THAT COVER THIS PRODUCT, GO TO:
Hour Meter Reading	1,448
-

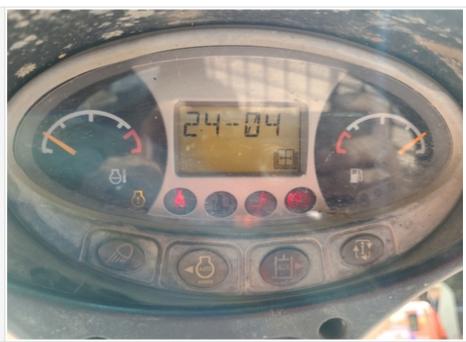
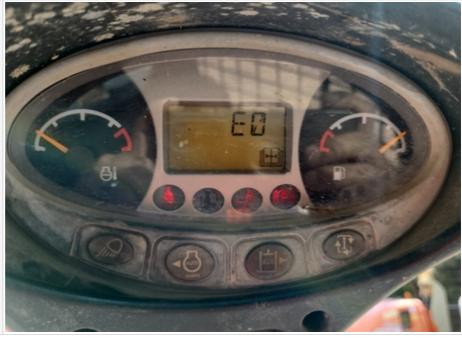
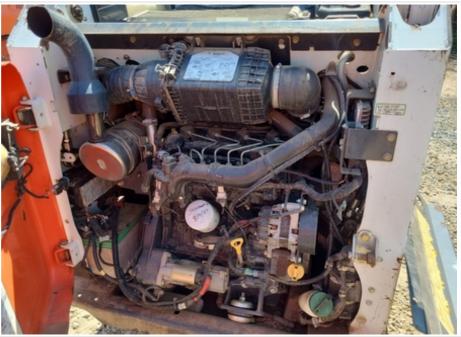
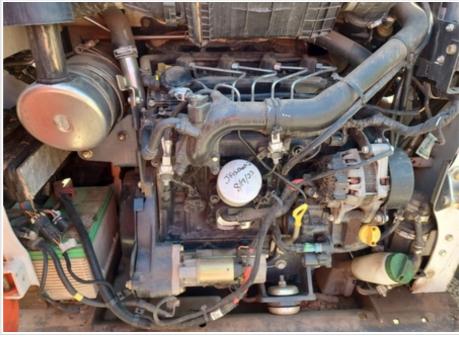
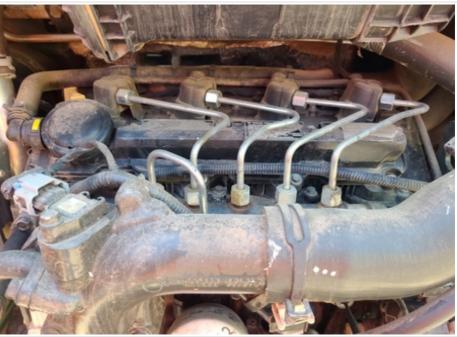
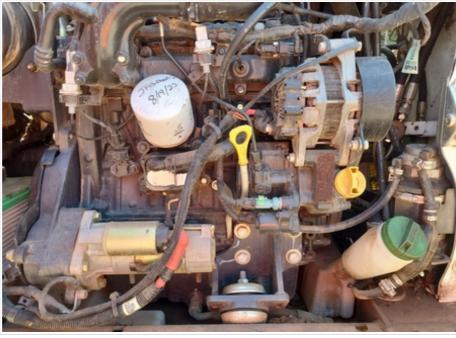
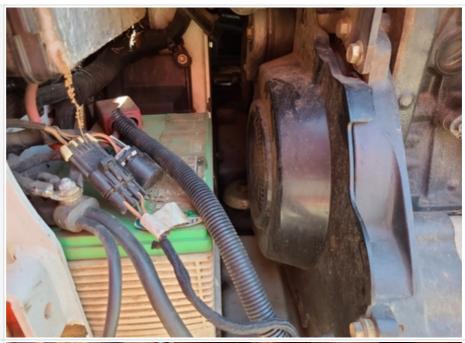
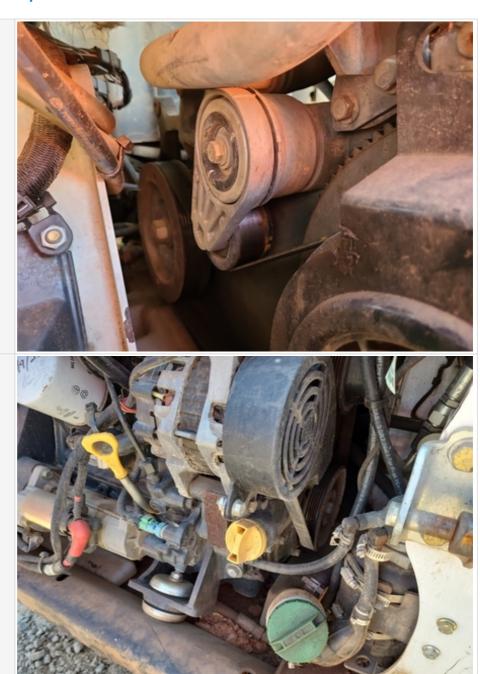
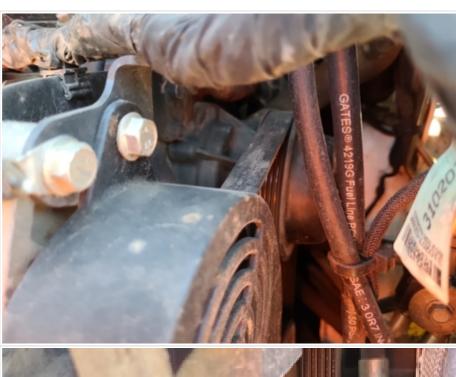
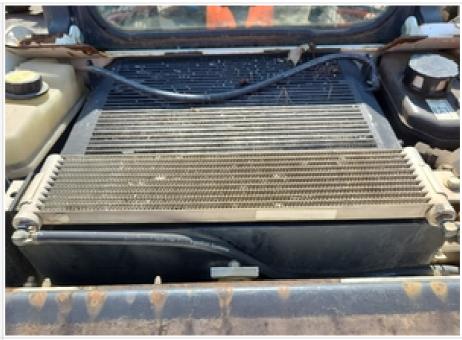
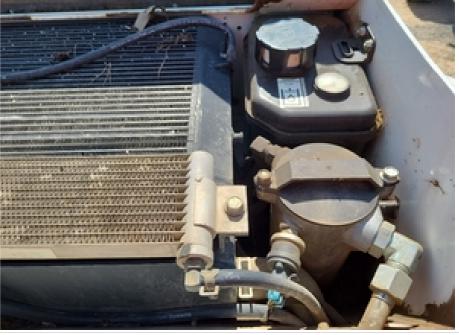
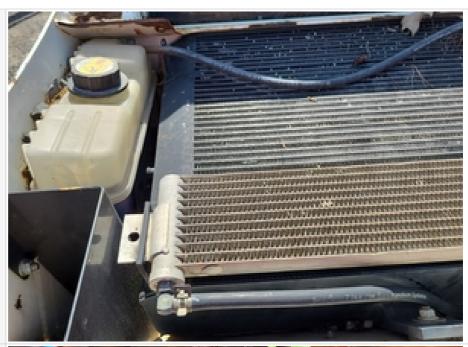
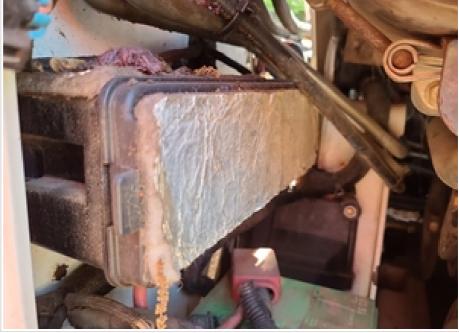
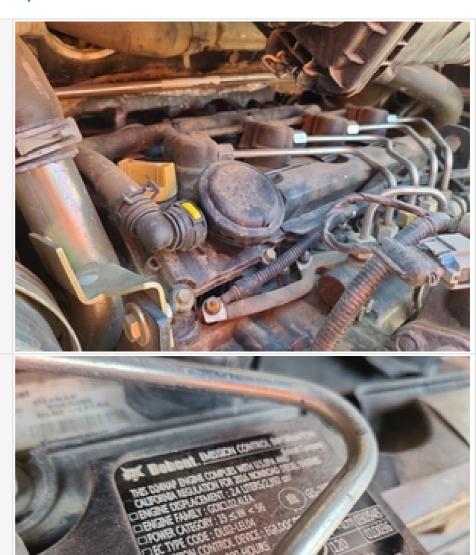
Engine Compartment

Engine Rating	3 - Normal Wear & Tear
Engine Overall Comments	Engine has well maintained appearance. Engine warning light comes on at initial startup but goes away after 30 seconds.

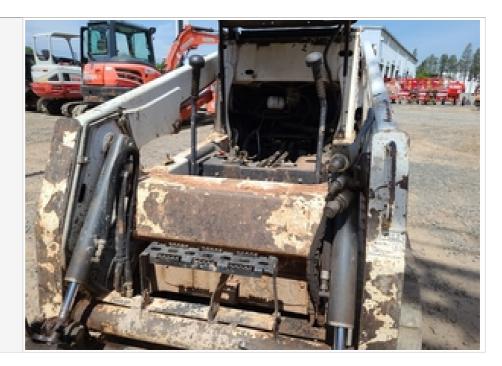
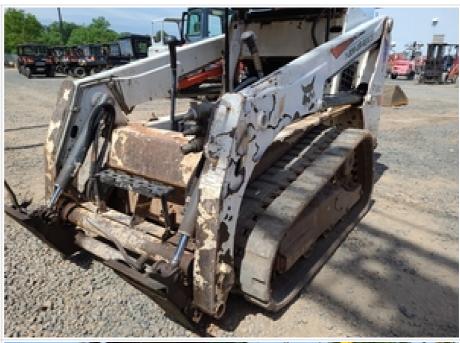
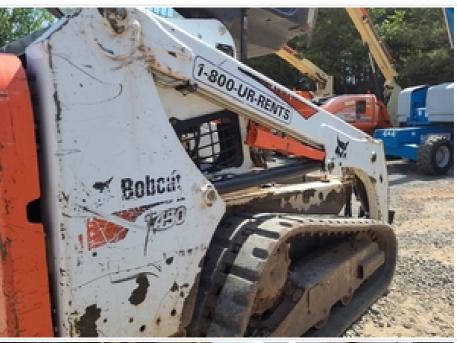
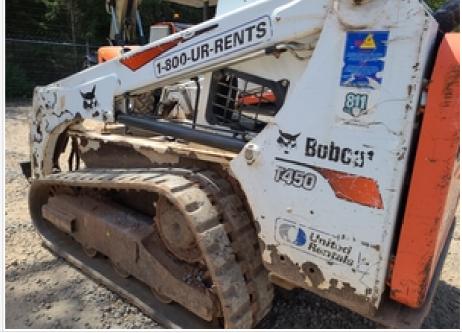
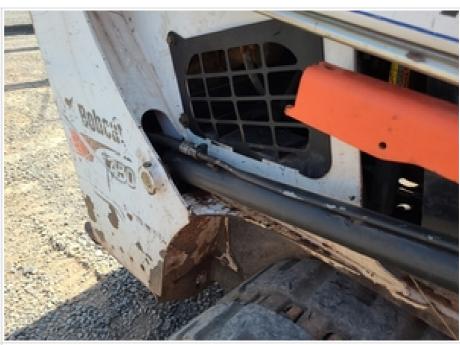
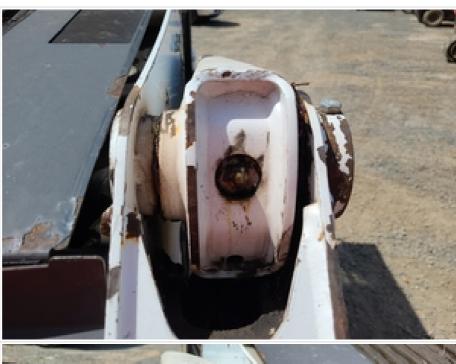
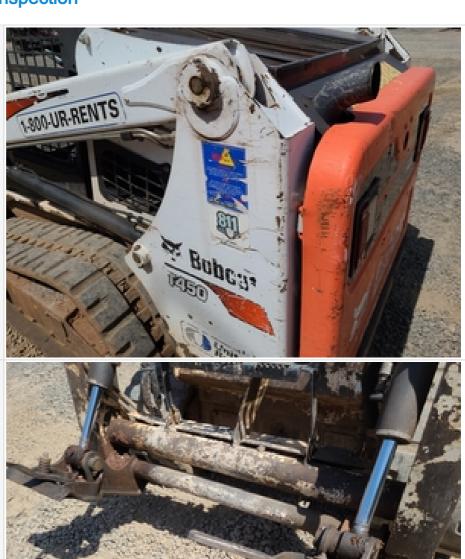
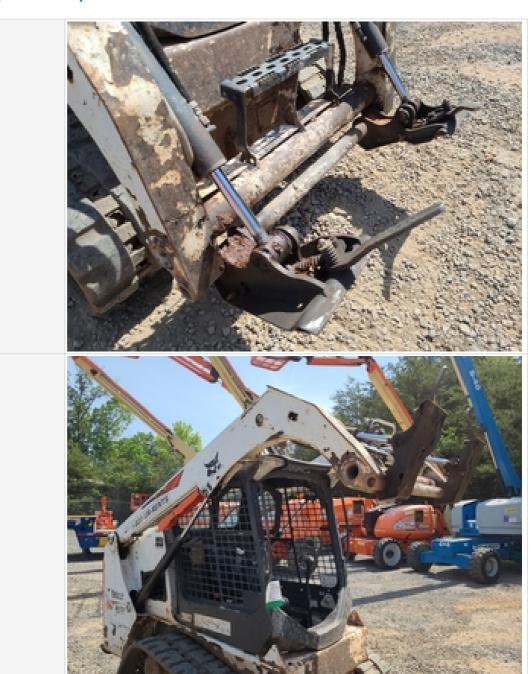
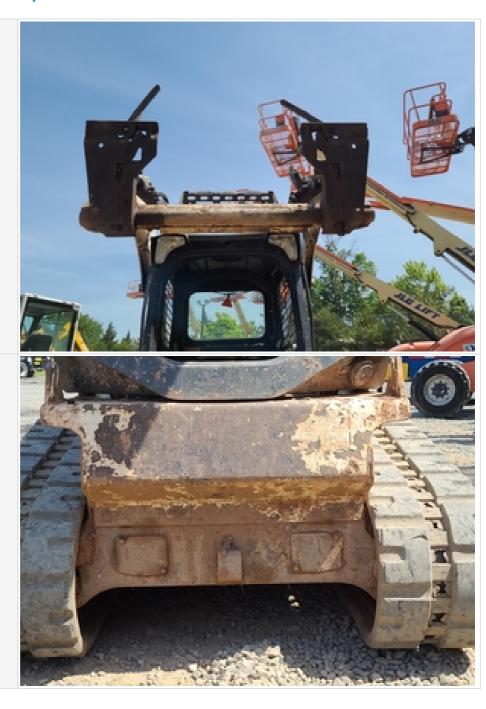
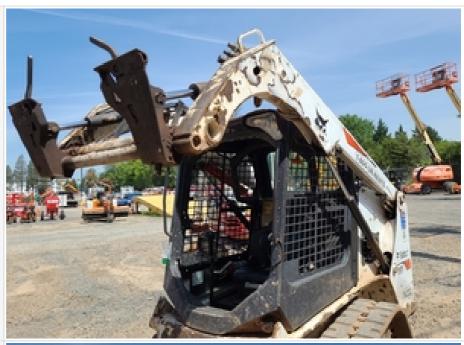
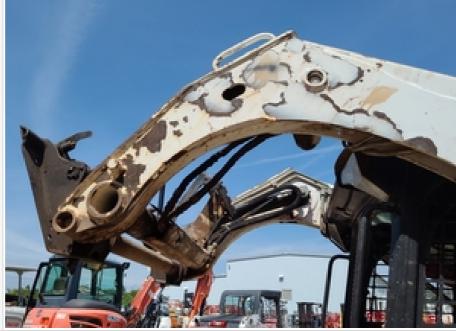
Chassis Photos

Chassis Rating	3 - Normal Wear & Tear	
Comments	Loaders arms, Tilt linkage and main frame in great shape.
