Inspection Report (Asphalt Paver)

Year	2022
Make	Dynapac
Model	Sd2550cs
Serial Number	10002161cng004212
Hour Meter Reading	40.2
Previous Application (e.g., earth moving, mining, demolition, etc)	Paving

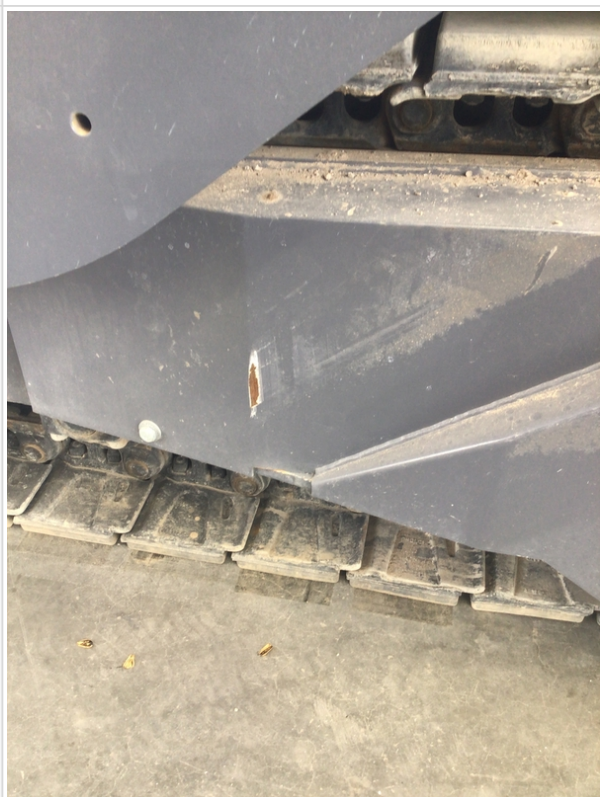
<p>Body Panels</p>	<p>3 - Normal Wear & Tear</p>
<p>Body Panel Condition</p>	<p>Visible chipped paint or dents</p>
<p>Body Panels Photos</p>

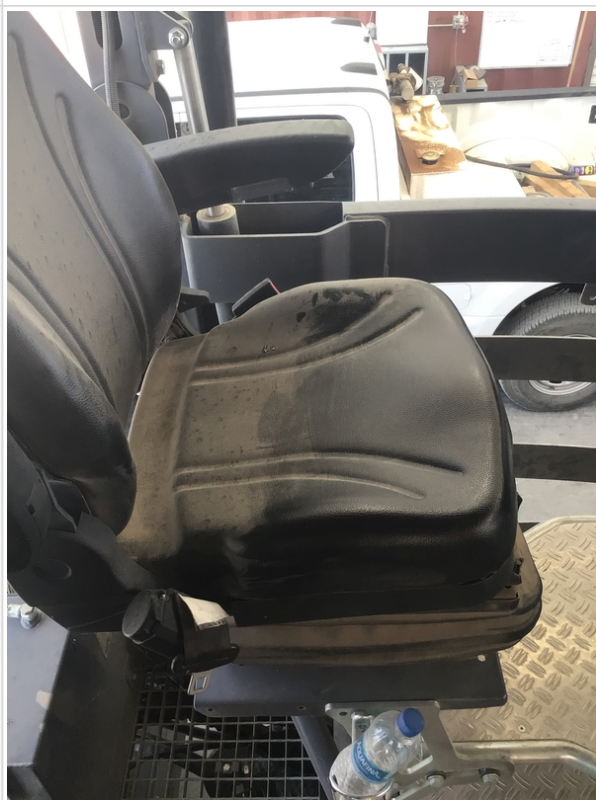
<p>Operator Cabin Overall</p>	<p>4 - Like New, Recently Replaced</p>
<p>Operator Seat</p>	<p>4 - Like New, Recently Replaced</p>
<p>Operator Seat Photos</p>

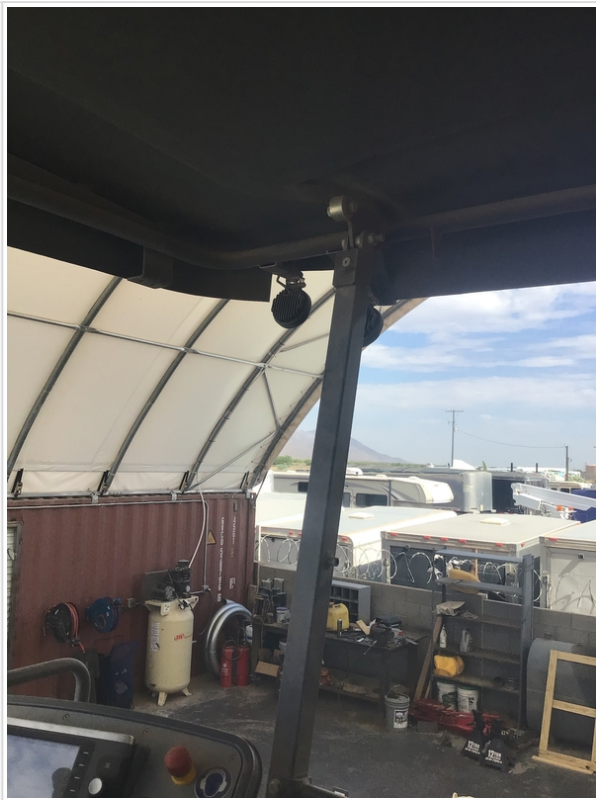
<p>Cabin Lights</p>	<p>4 - Like New, Recently Replaced</p>

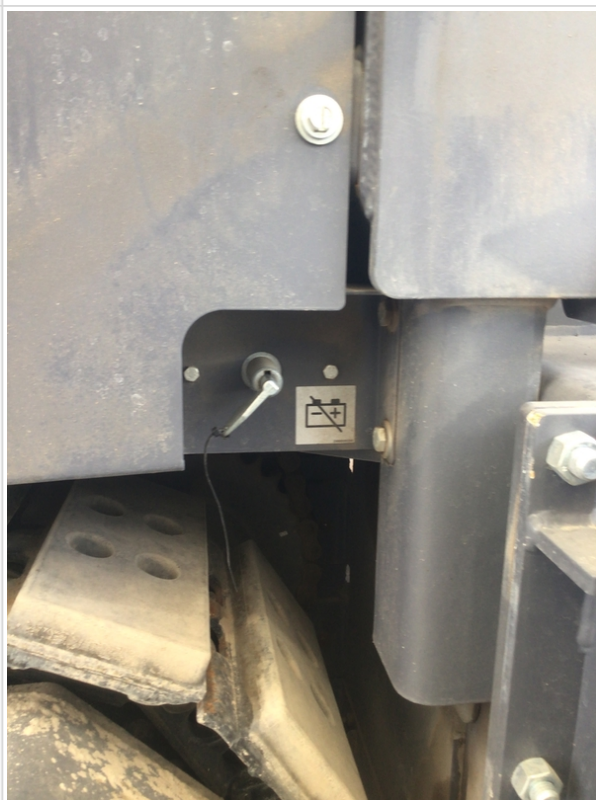
<p>Safety Lock Out / Stop</p>	<p>4 - Like New, Recently Replaced</p>
<p>Safety Lock Out / Stop Condition</p>	<p>Safety lock out device is present, in good condition, and functional</p>
<p>Safety Lock Out / Stop Photos</p>

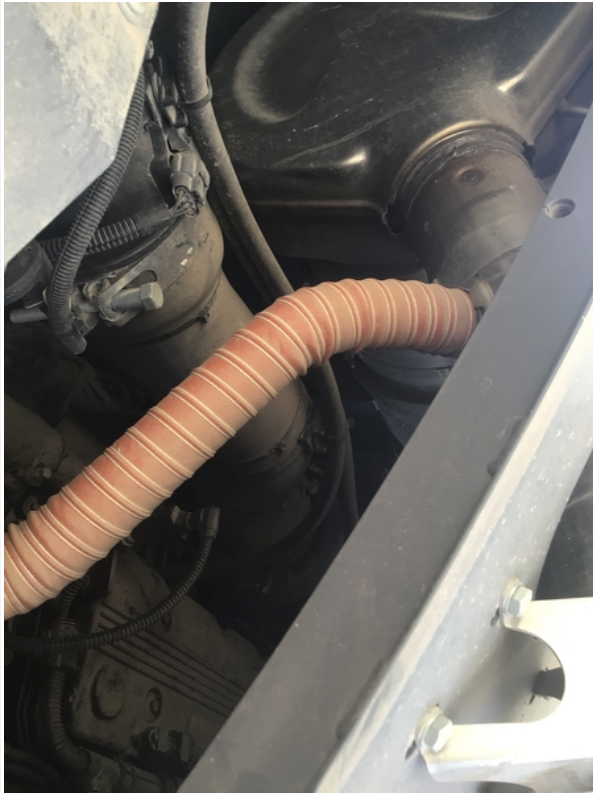
Engine Type (Make, Model, Cylinders, Hp)	Cummins 6.7 6cyl
Emissions Tier	Tier 4F
Engine Fuel Type	Diesel
Engine Photos

Engine Smoke (Upon Start-up, Idle, Shutdown)	No
Engine Smoke Notes	No engine smoke issues observed
Engine Exhaust Color	Clear
Battery	4 - Like New, Recently Replaced
Battery Condition	Clean & dry appearance, tight connections
Radiator	4 - Like New, Recently Replaced

Radiator Condition	Radiator fins & components appear to be in good working order, no signs of damage or leaks
Belts	4 - Like New, Recently Replaced
Belt Condition	Belts appear in good condition & alignment with proper tension
Hoses	4 - Like New, Recently Replaced
Hose Condition	Firm, pliant hoses with no signs of wear or leaks
Water Pump	4 - Like New, Recently Replaced
Water Pump Condition	No unusual pump noises heard
Cooling System Leaks	No
Coolant Color / Appearance	4 - Like New, Recently Replaced
Coolant Color/Appearance Notes	Normal Translucent appearance, no visual signs of contamination
Oil Leaks	No
Oil Color / Appearance	3 - Normal Wear & Tear
Oil Color / Appearance Notes	Appropriate oil level
Fuel Leaks	No
Requires DEF (Diesel Exhaust Fluid)	Yes
DEF Tank	4 - Like New, Recently Replaced
DEF Tank Condition	Area around DEF tank cap is clean, fluid is clear & appears free of contaminants
Overall Engine Appearance	Dusty & dry

Overall Engine Comments	Engine main cover doesn't open

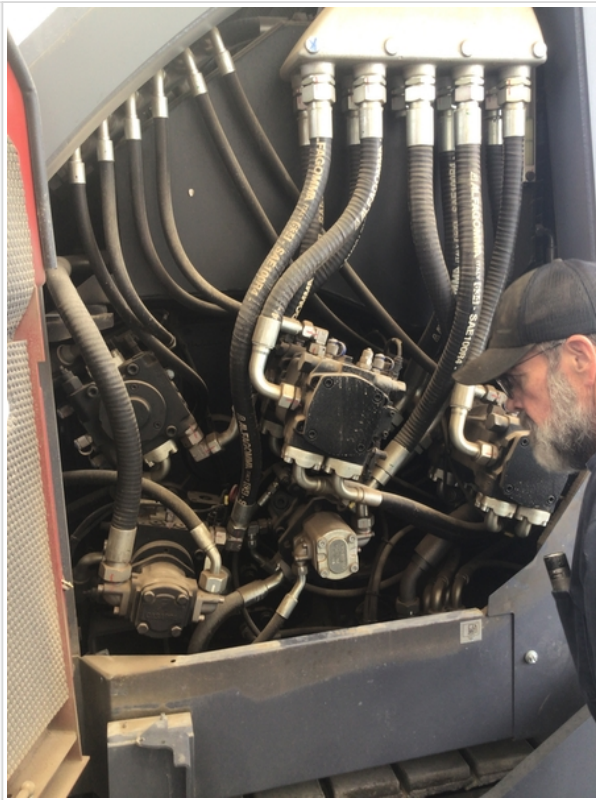
Transmission Info	Hydrostatic drive
Transmission	4 - Like New, Recently Replaced

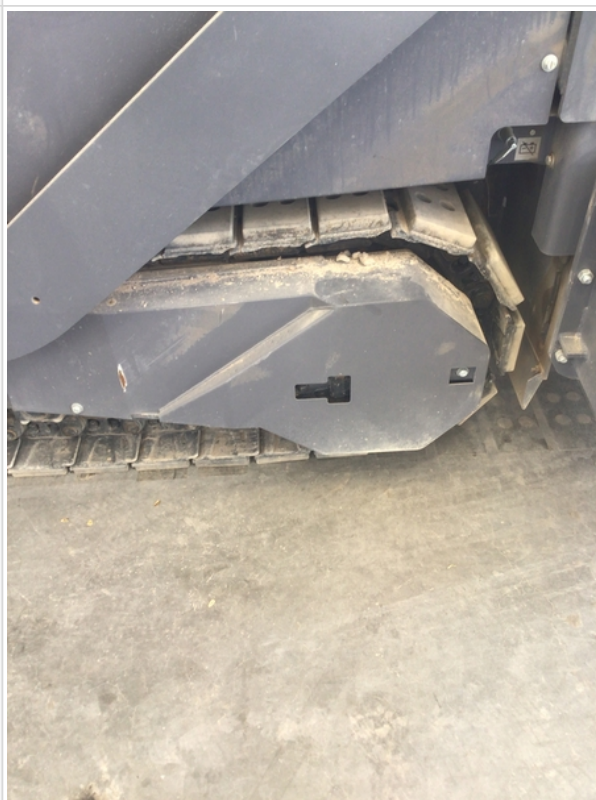
Shift Lever	0
Left Drive Motor	4 - Like New, Recently Replaced
Left Drive Motor Photos

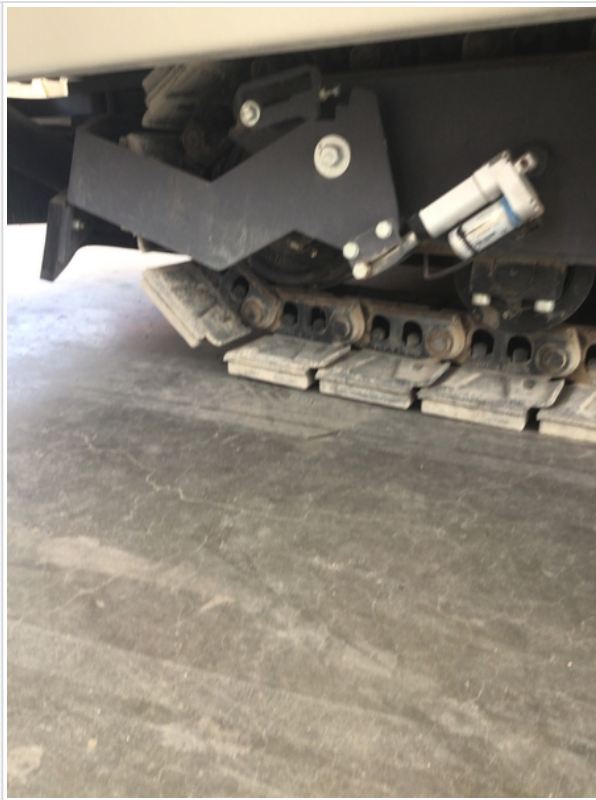
Left Final Drive	4 - Like New, Recently Replaced

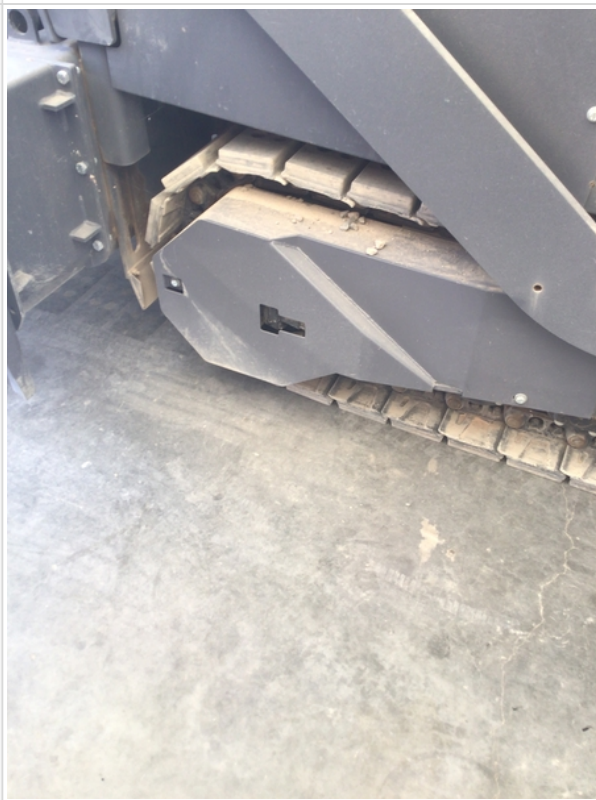
<p>Right Drive Motor</p>	<p>4 - Like New, Recently Replaced</p>
<p>Right Drive Motor Photos</p>

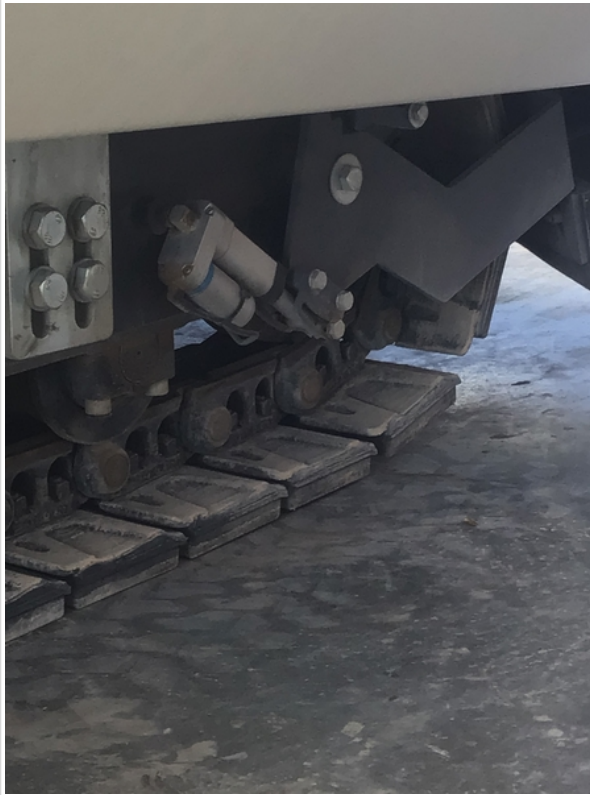
<p>Right Final Drive</p>	<p>4 - Like New, Recently Replaced</p>

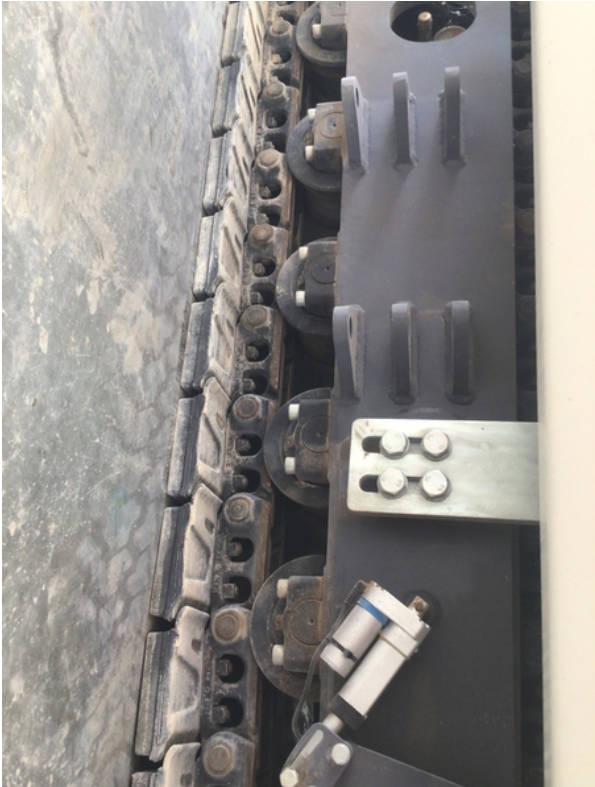
Track Width (inches)	1.05 feet
Roller Frames	4 - Like New, Recently Replaced
Roller Frames Photos

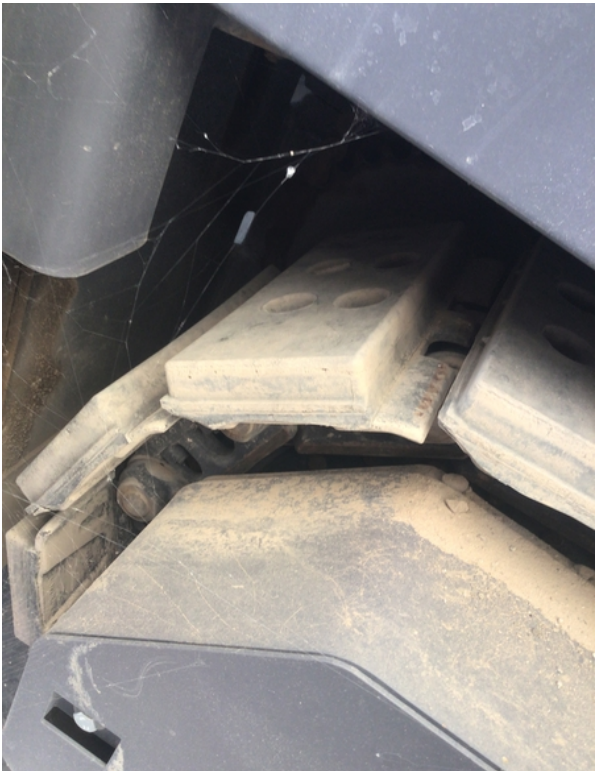
Track Belt	4 - Like New, Recently Replaced
Track Belt Photos

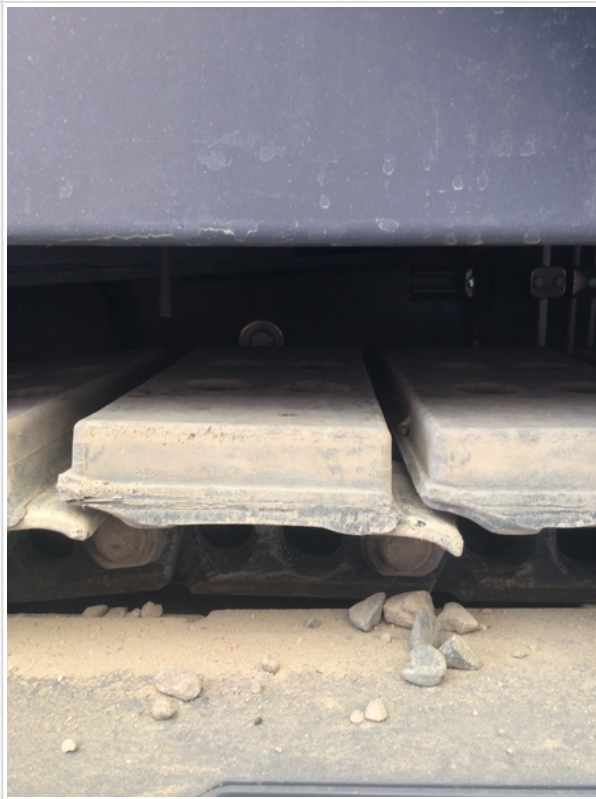
Rubber Belt Drive Lugs	4 - Like New, Recently Replaced
Rubber Belt Drive Lugs Photos

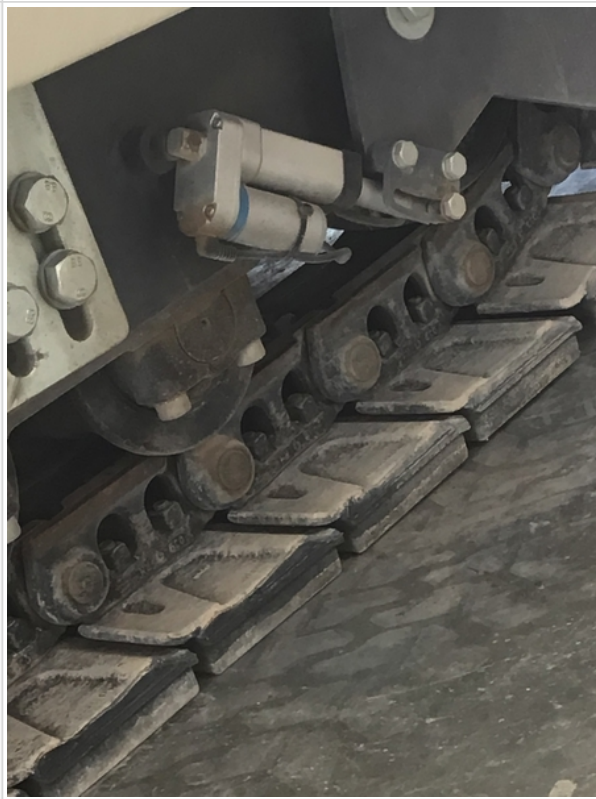
Track Tensioners	4 - Like New, Recently Replaced
Track Tensioners Photos

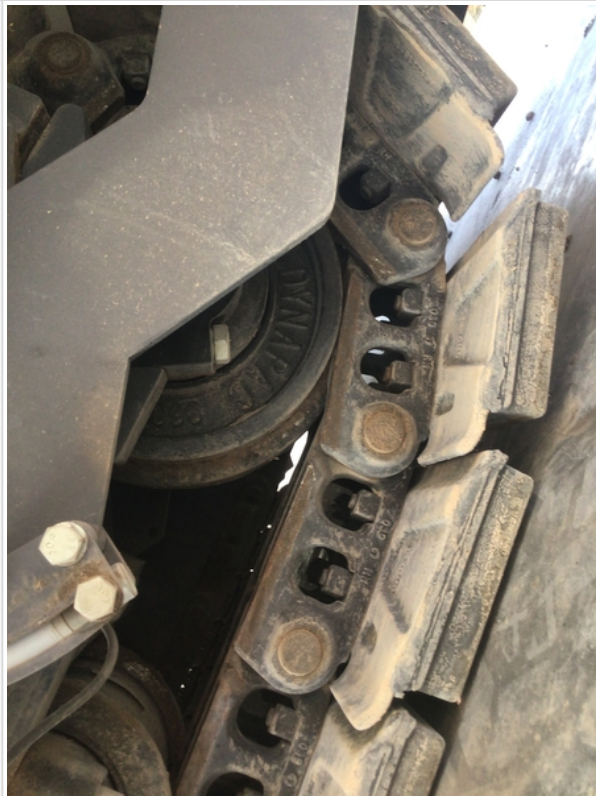
Front Idlers	4 - Like New, Recently Replaced

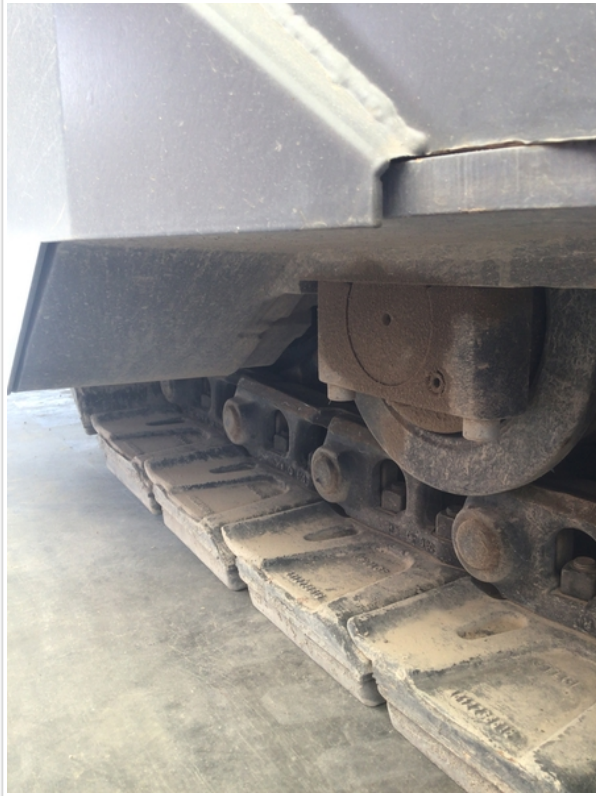
<p>Rear Idlers</p>	<p>4 - Like New, Recently Replaced</p>
<p>Rear Idlers Photos</p>

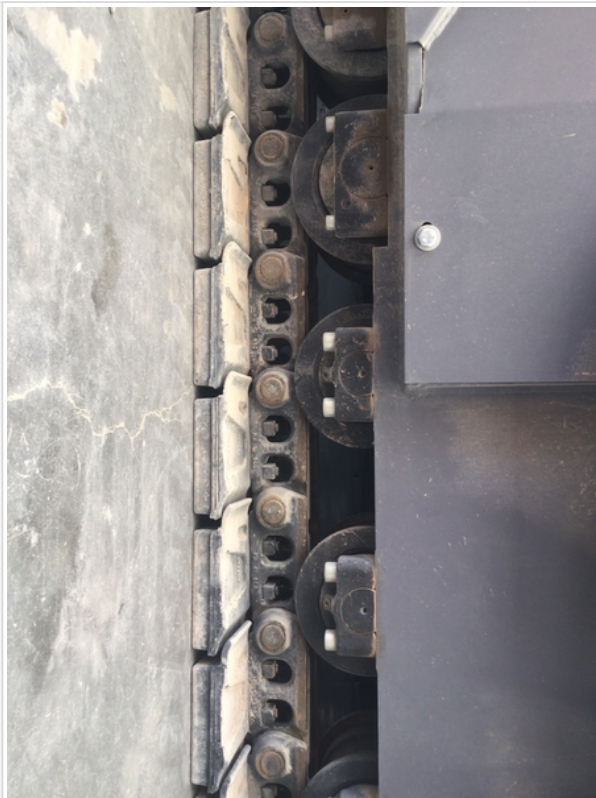
<p>Track Rollers</p>	<p>4 - Like New, Recently Replaced</p>

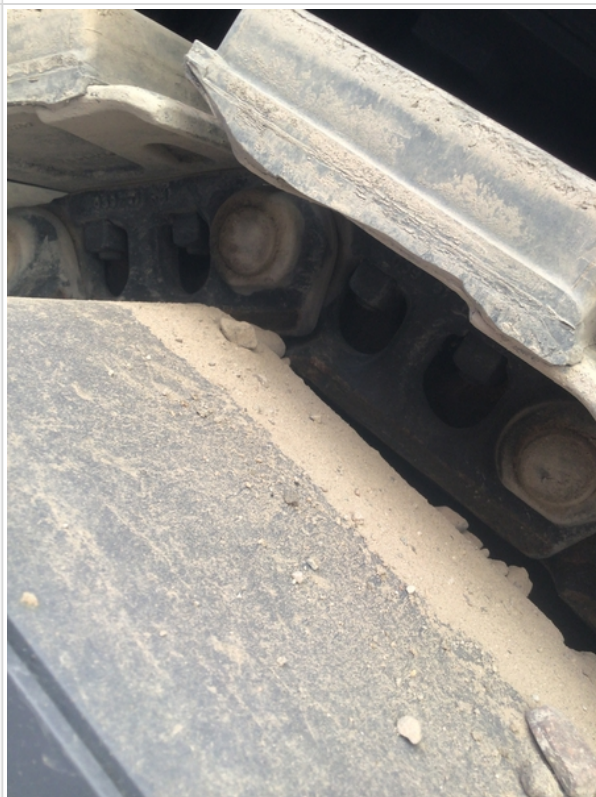
<p>Sprockets</p>	<p>4 - Like New, Recently Replaced</p>
<p>Sprockets Photos</p>

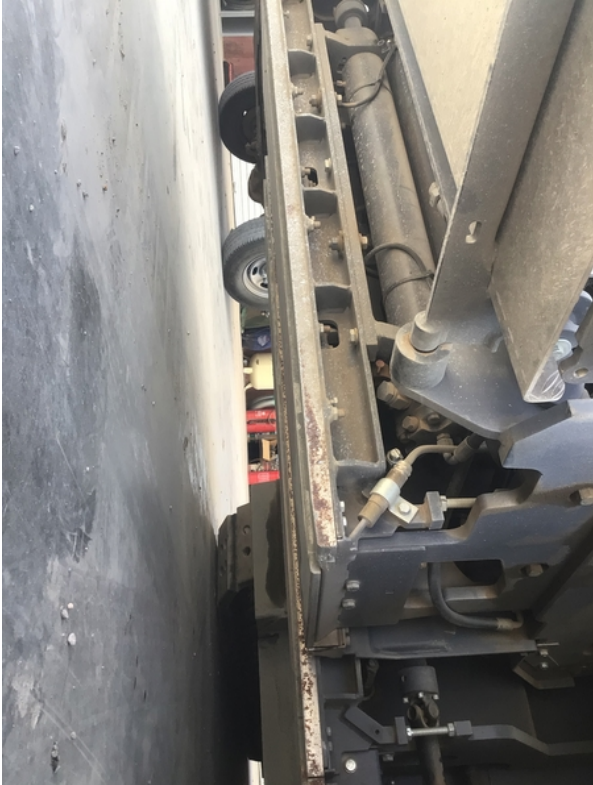
Screed Plates/Adjusters	3 - Normal Wear & Tear
Screed Plates/Adjusters Photos

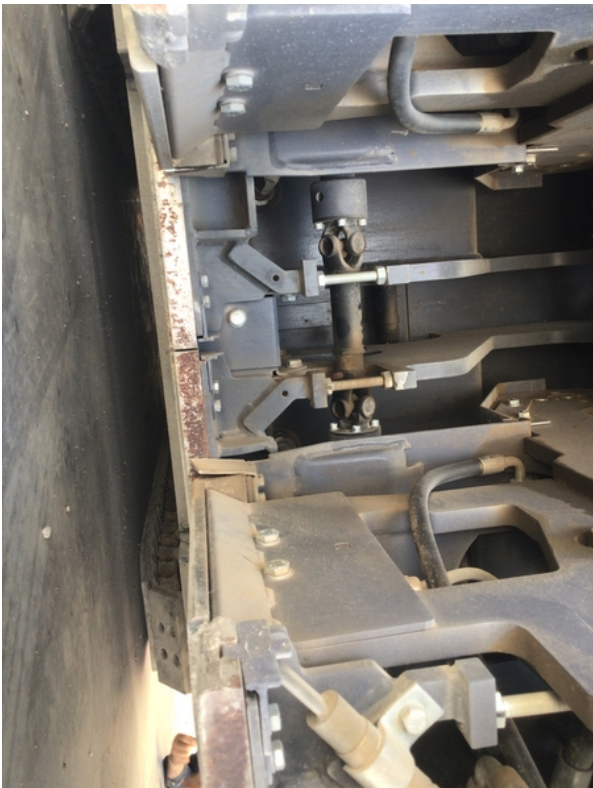
Screed Vibrate Shaft Bearings & U Joints	3 - Normal Wear & Tear
Screed Vibrate Shaft Bearings & U Joints Photos

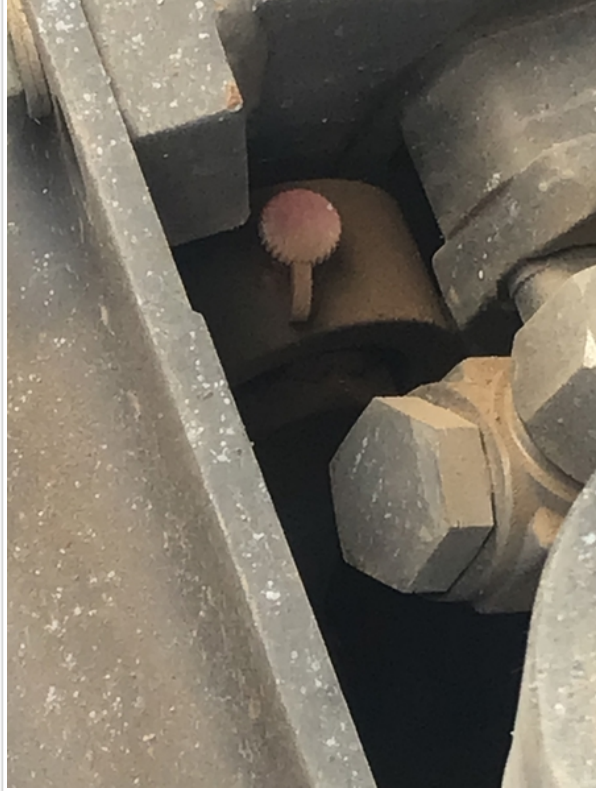
Screed Transverse Beam	0
Screed Tamper Bars/Shafths/Drives	0
Screed Arm Pivot Point Bearing	4 - Like New, Recently Replaced
Screed Arm Pivot Point Bearing Photos

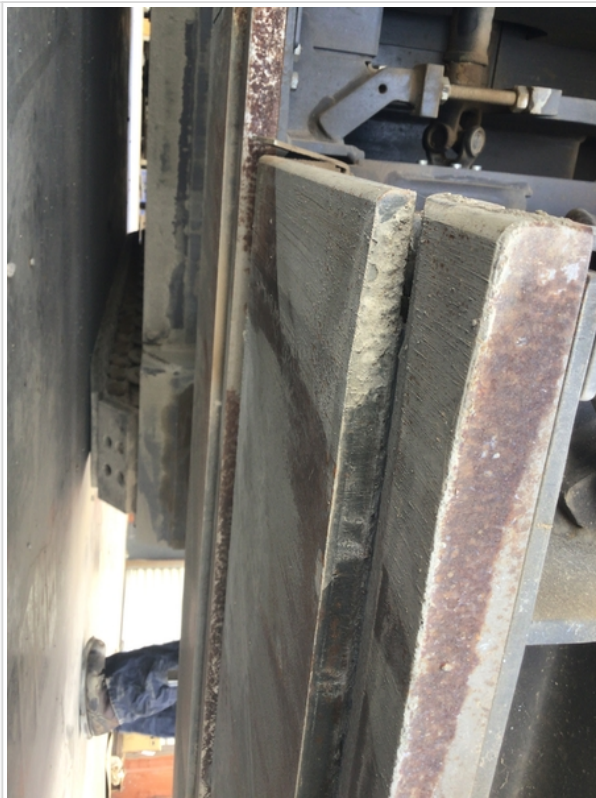
Screed Pre-Strikeoff Plate	4 - Like New, Recently Replaced

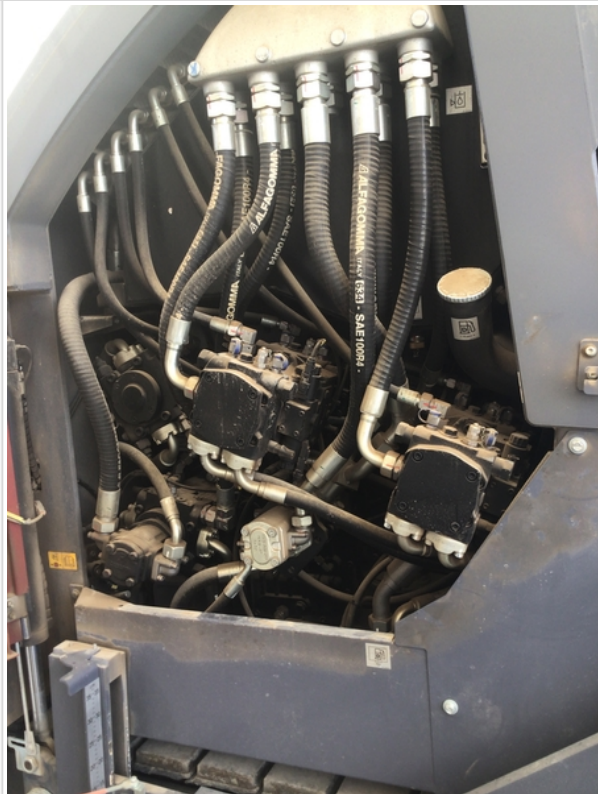
Wet or Damp Hydraulic Lines / Fittings	No
Appearance of Hydraulic Lines / Fittings	4 - Like New, Recently Replaced
Hydraulic Lines / Fittings Condition	Hydraulic lines & fittings are clean and in good condition
Unusual Noises (Hydraulic Pump)	No

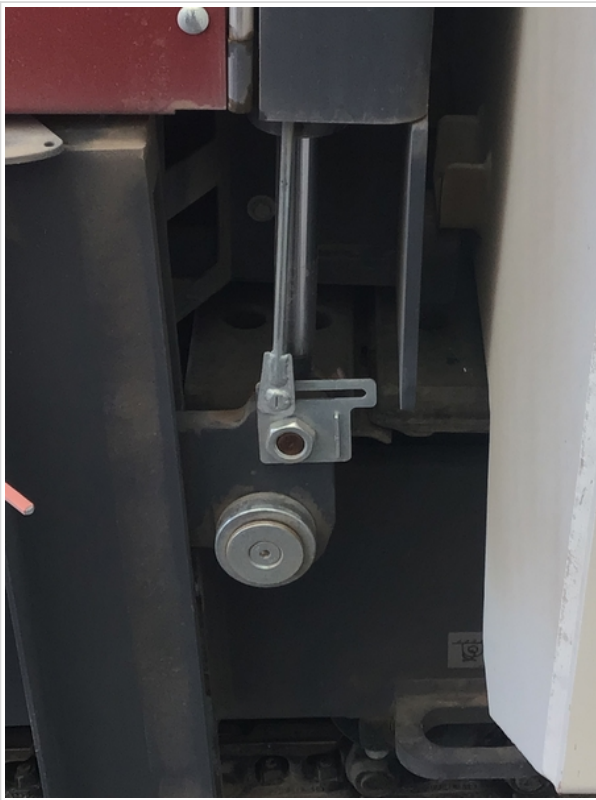
Hopper Wing Cylinders: Mounting Pin	4
Hopper Wing Cylinders: Oil Leaks	No

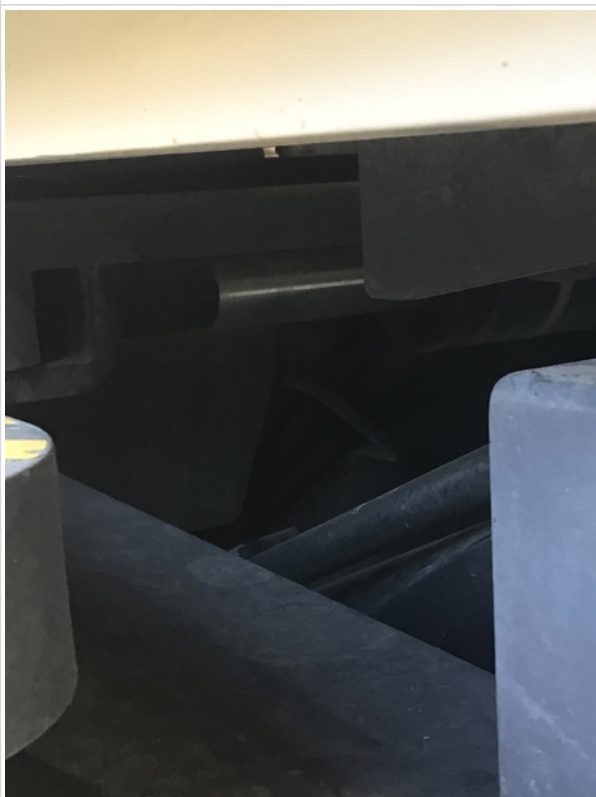
Screed Extension Cylinders: Mounting Pin	3
Screed Extension Cylinders: Oil Leaks	No
Screed Extension Cylinders Photos
