General Info

Features & Configuration

360 Walkaround Photos

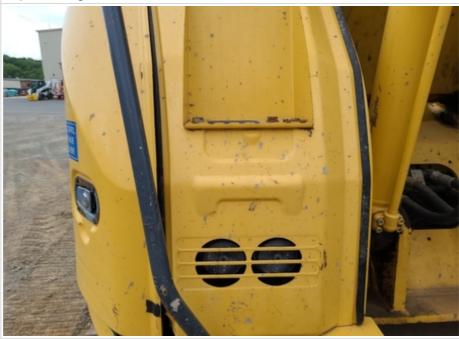
Impact Damaged

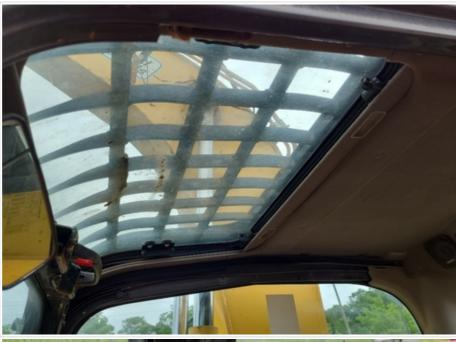
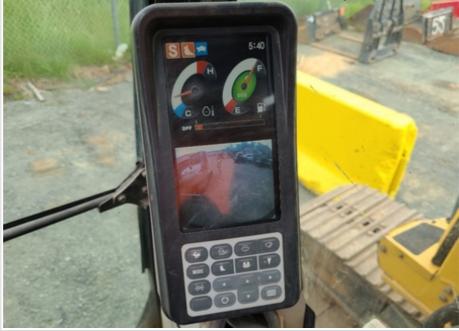
Control Station Rating	3 - Normal Wear & Tear
Control Station Overall Comments	Operator Station in good condition. Operator seat has cover and did not remove.

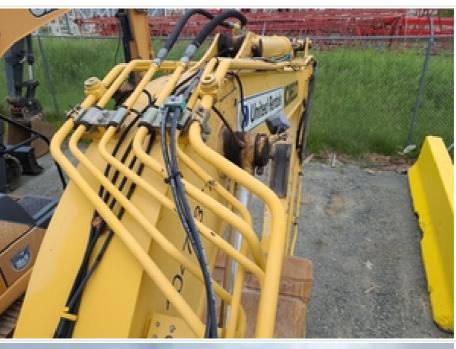
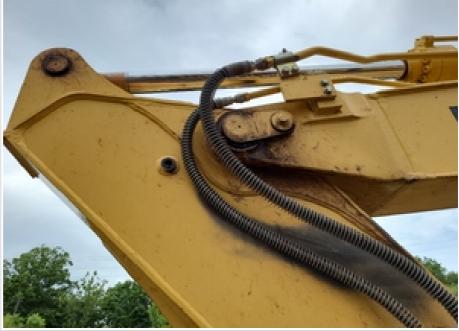
Chassis Rating	3 - Normal Wear & Tear	
Comments	Excess play on boom to stick and bucket coupler. Further inspection recommende to determine proper repairs.

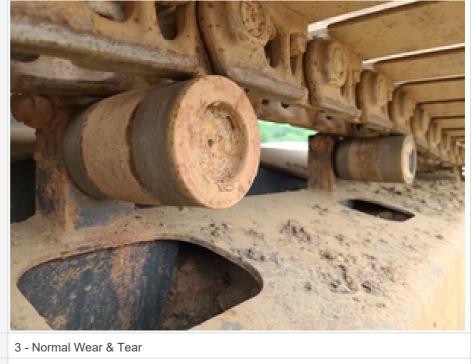
Undercarriage Rating	3 - Normal Wear & Tear	
Undercarriage Comments	Undercarriage in good shape and no obvious issues observed.

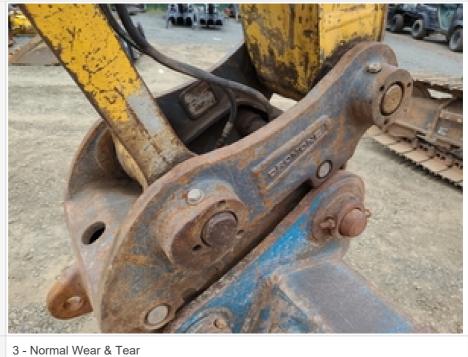
Attachment Rating	3 - Normal Wear & Tear
Attachment Comments	36"
