Enterprise Equipment Inspection

| Year | 2006 |
| Make | leeboy |
| Model | 8510T |

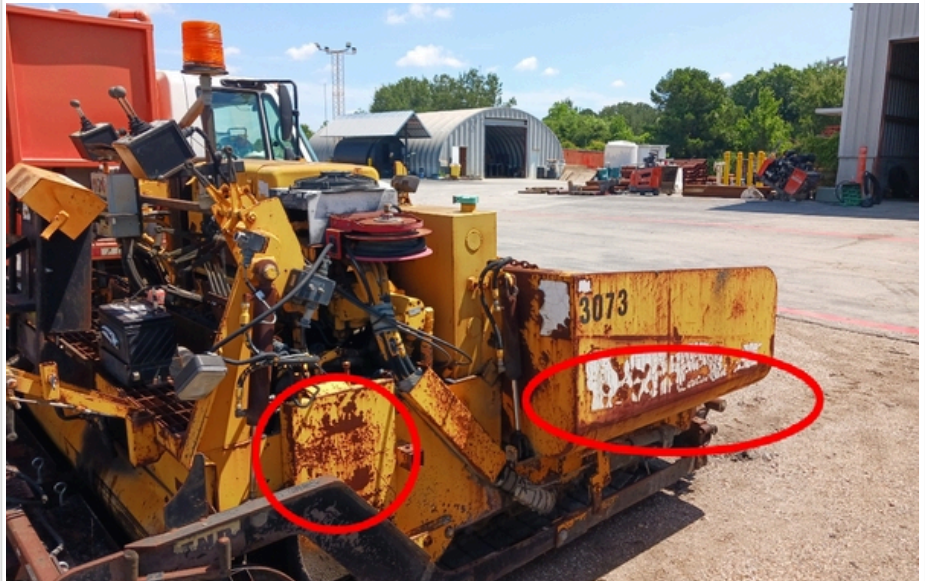
areas of rust

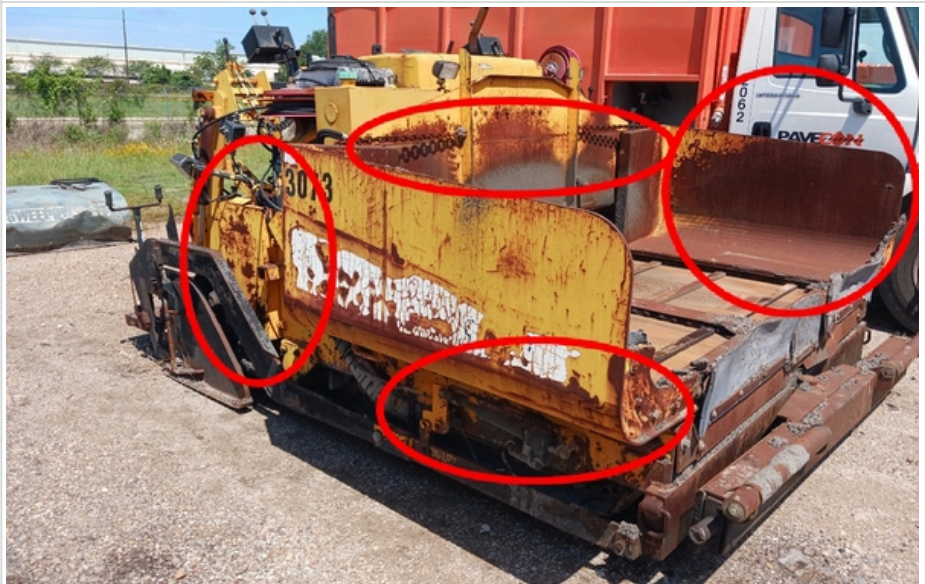
areas of rust

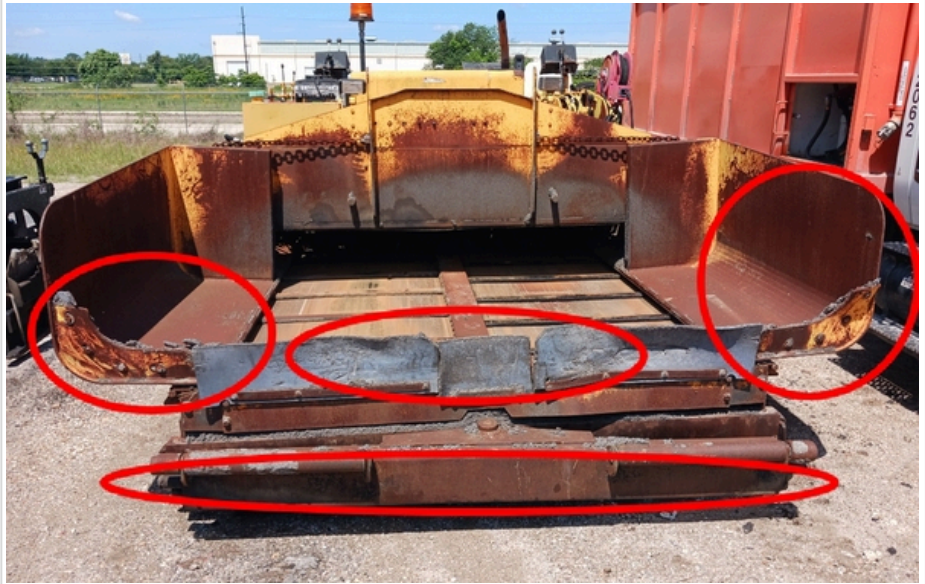
push rollers are in working condition and are rusted. The hoppers are missing the rubber side wings on the left and right hand side. rubber lips in the center, left and right all show above normal wear and tear

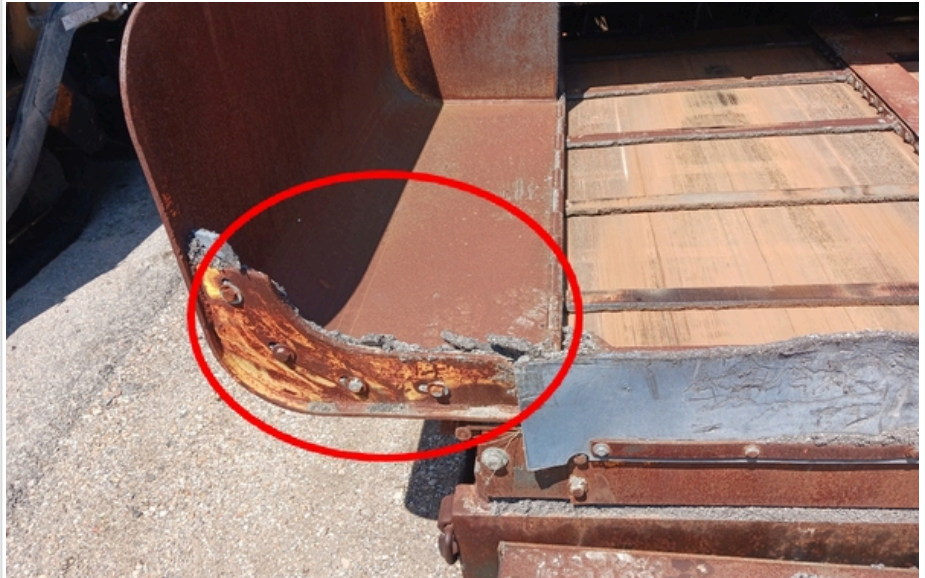
right side hopper is missing rubber side wings

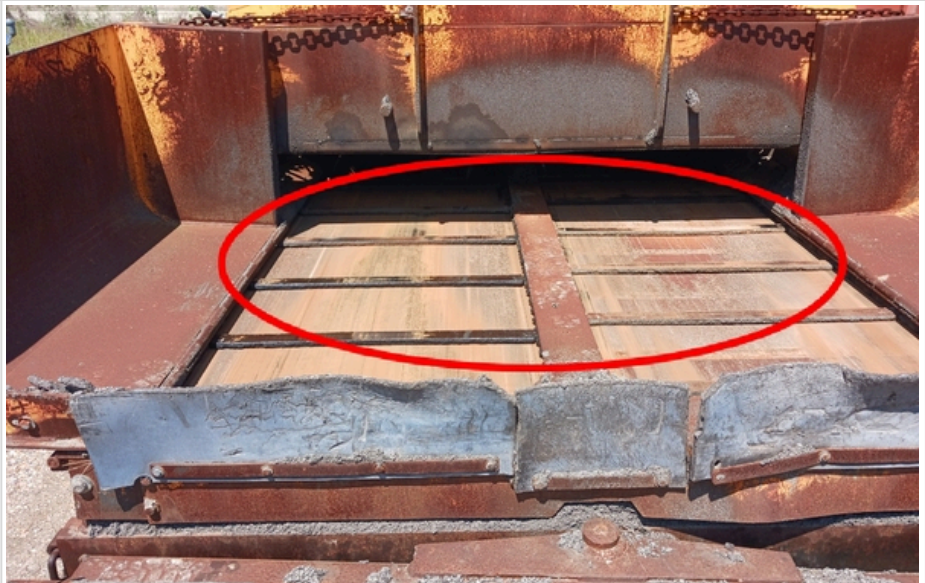
center portion of asphalt hopper has rust

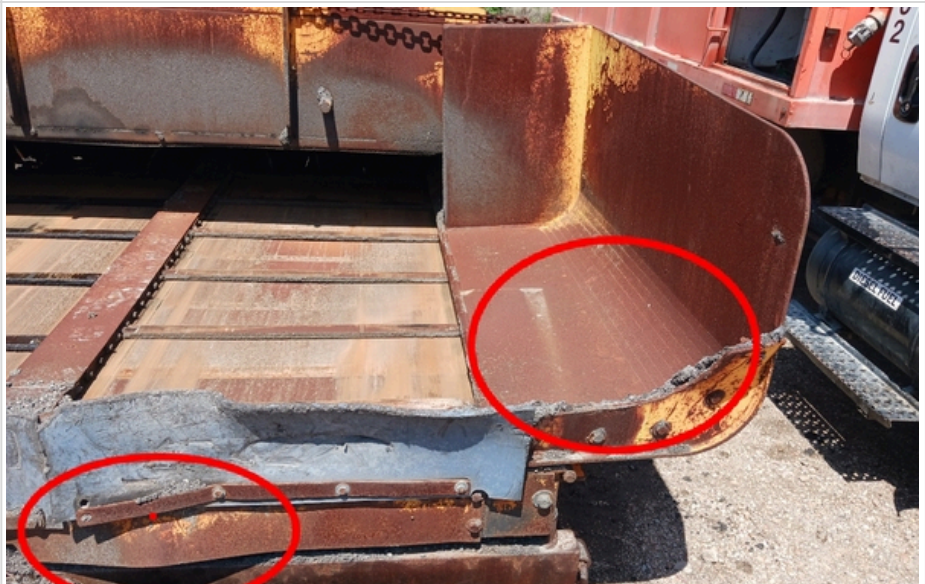
left hand hopper is missing rubber side wing and front strip is bent

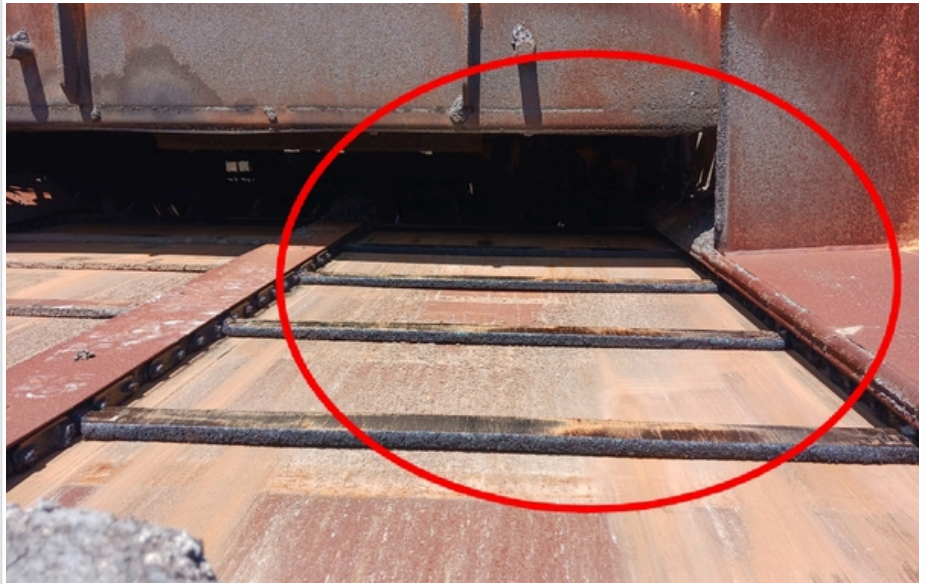
left side of hopper has rust

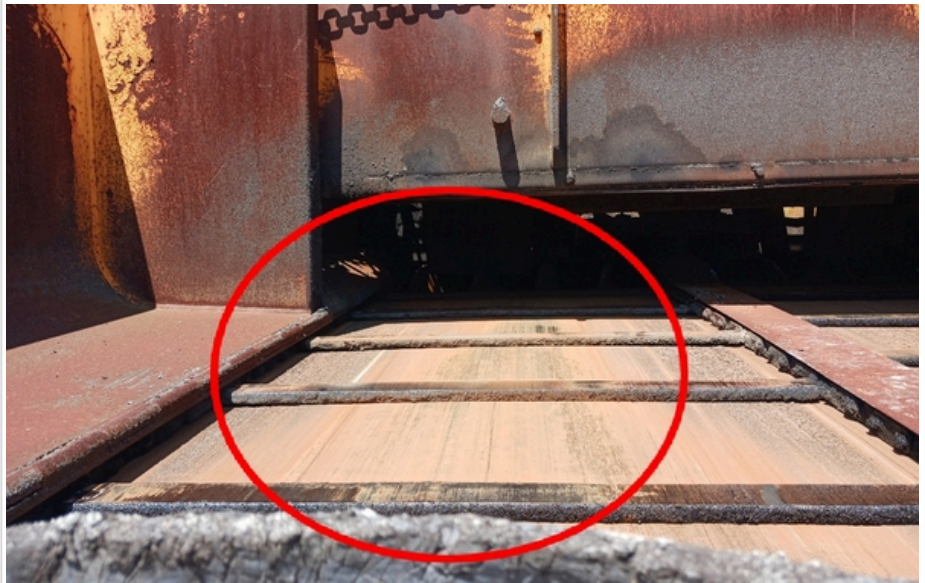
right side hopper has rust

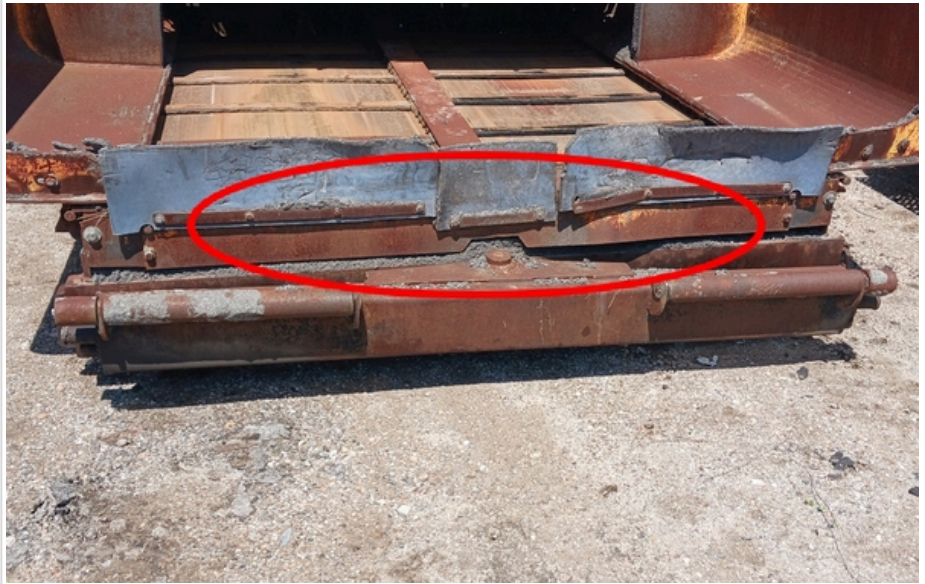
flashing front strips are bent/warped

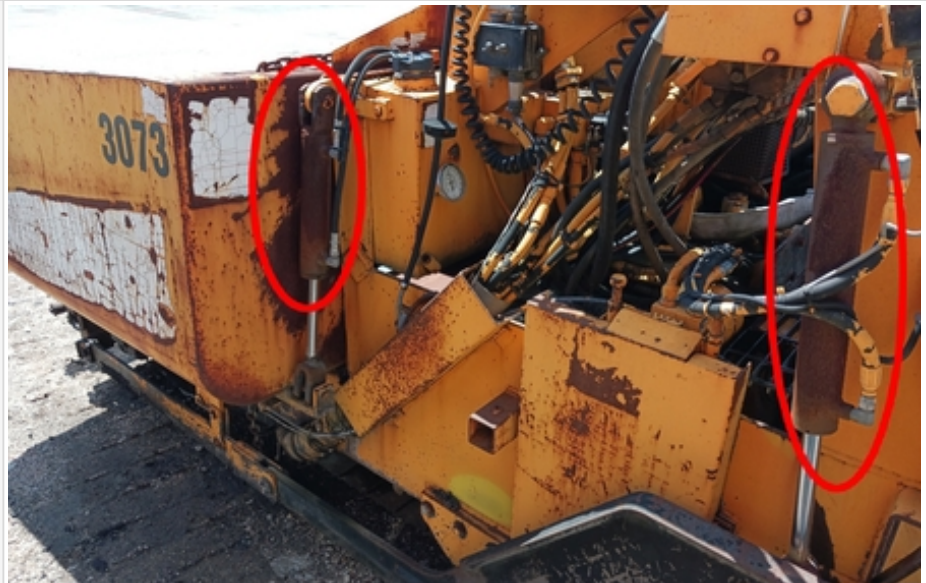
areas of rust on hydraulic cylinders

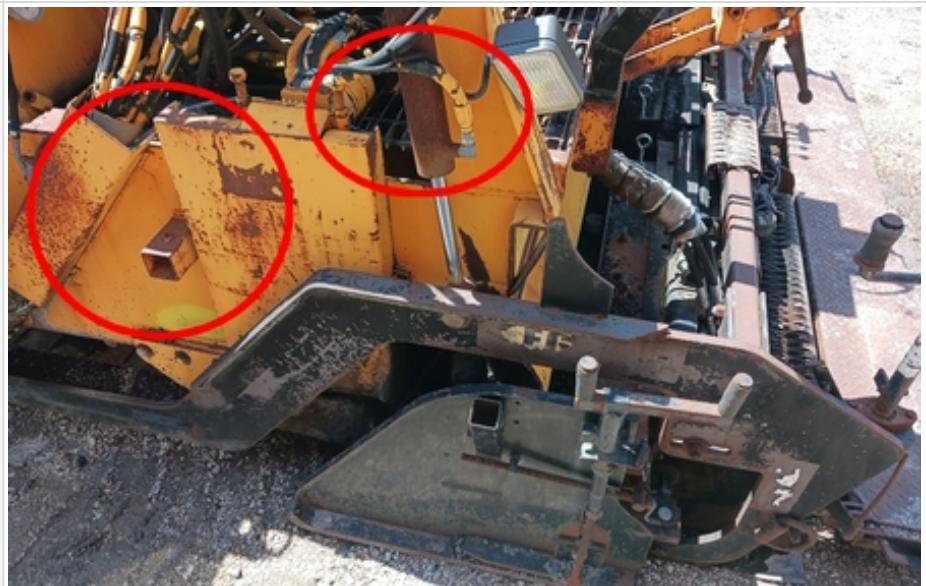
rust on hydraulic cylinder and body

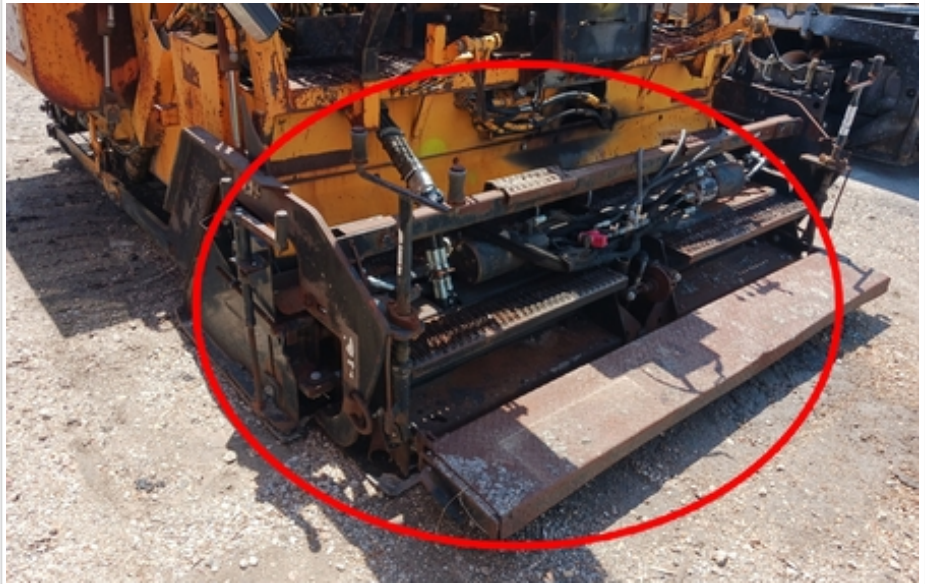
screed shows signs of above wear and tear and is missing 2 burners, so the screed platform does not heat up.

| Overall Functional Test Comments | The machine can move around just fine, but the skreet platform is missing 2 burners. |

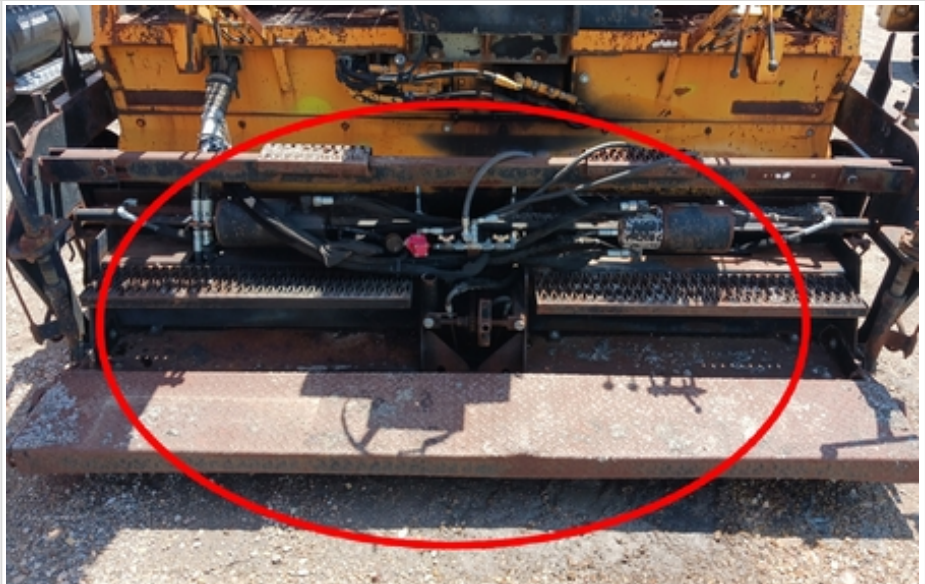
above normal wear and tear

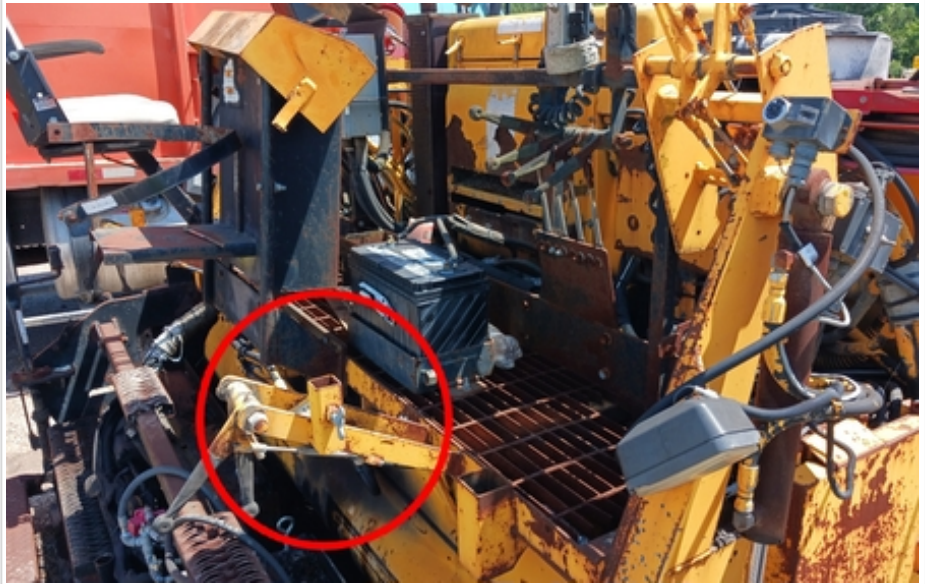
right side operators seat is missing

| Control Station Overall Comments | The right hand side of the control station is missing a seat. All controls show more than normal wear and tear. On the left hand there is a hydraulic leak coming from the controls. The leak is pretty constant. All controls are hard to move. |

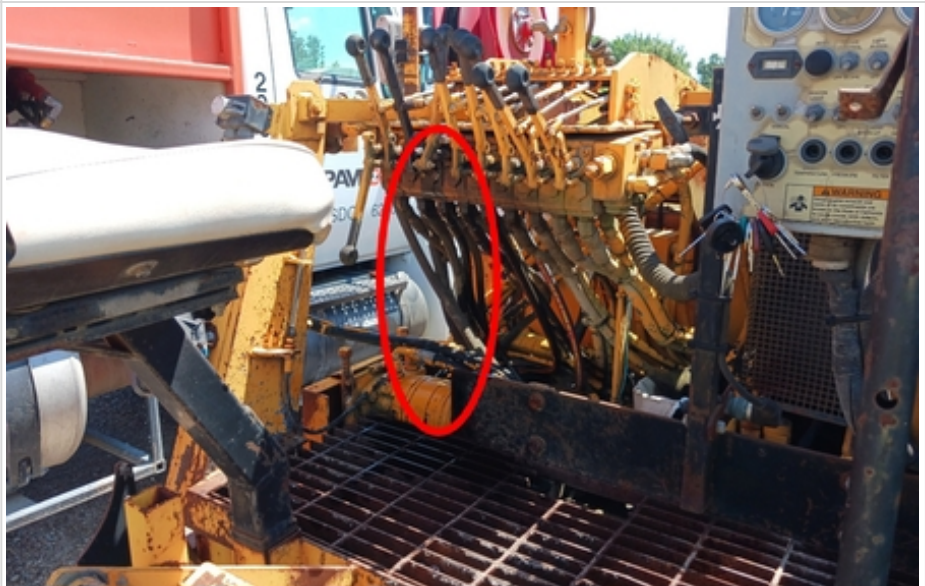
left side lever control panel is leaking hydraulic fluid

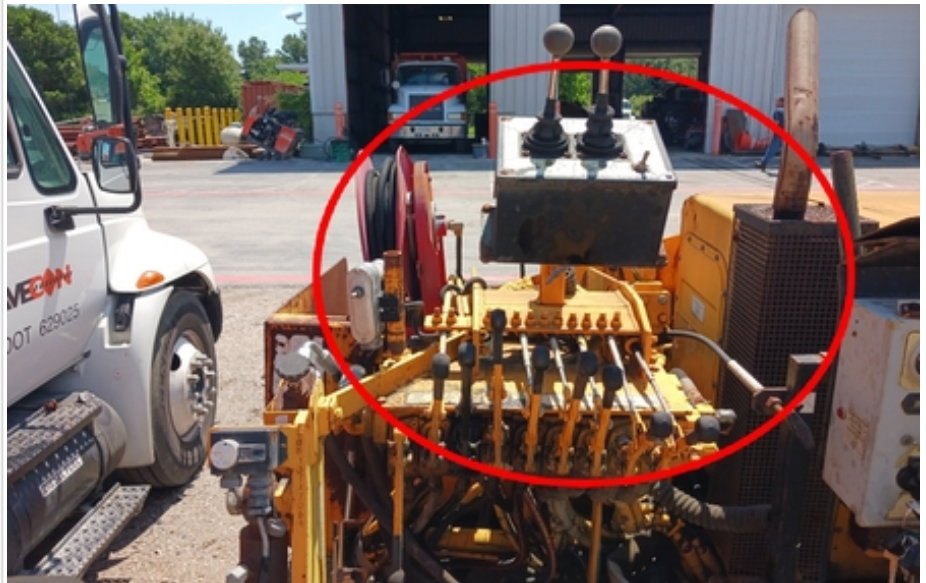
| <p>Control Station</p> | <p>above normal wear and tear on controls</p> |

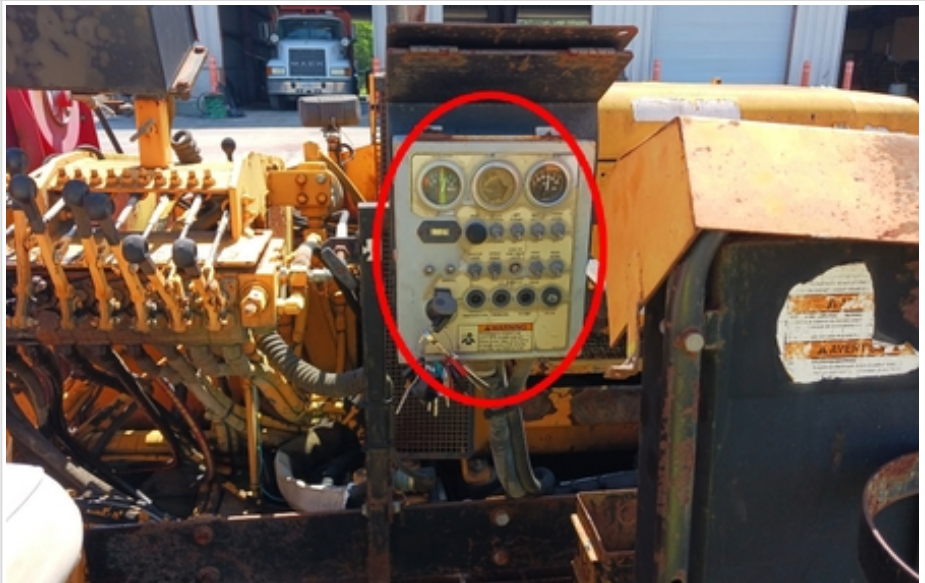
above normal wear on gauges

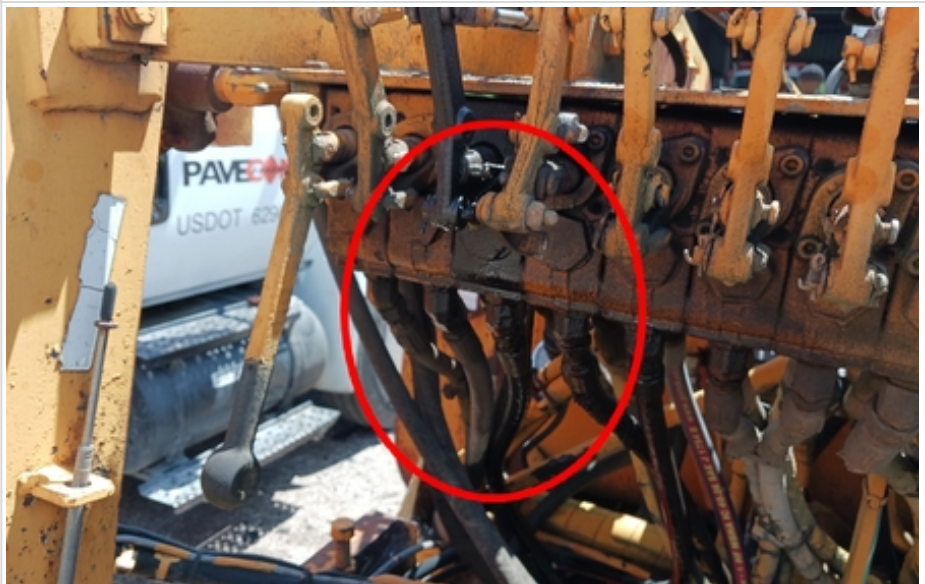
hydraulic fluid leaks out from the controls

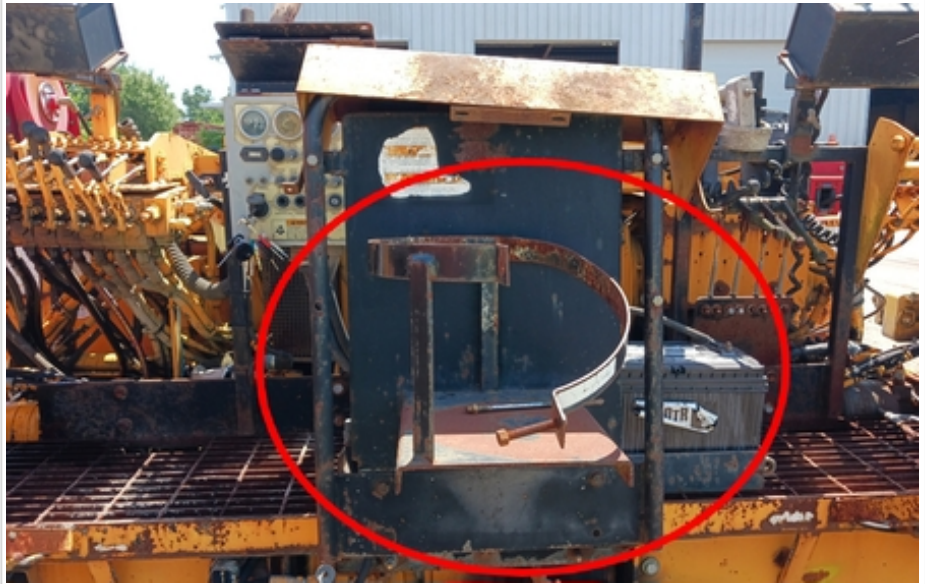
bent water jug attachment

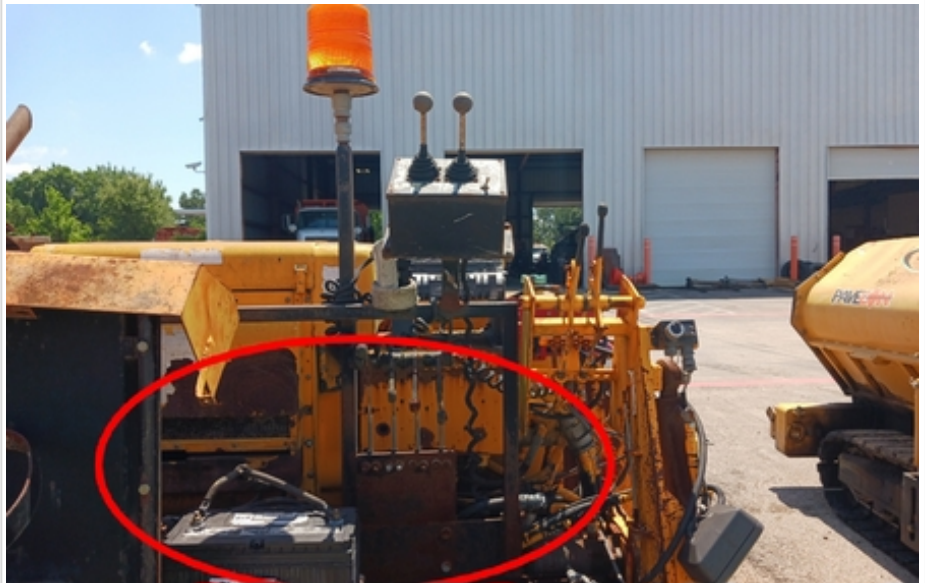
areas of rust

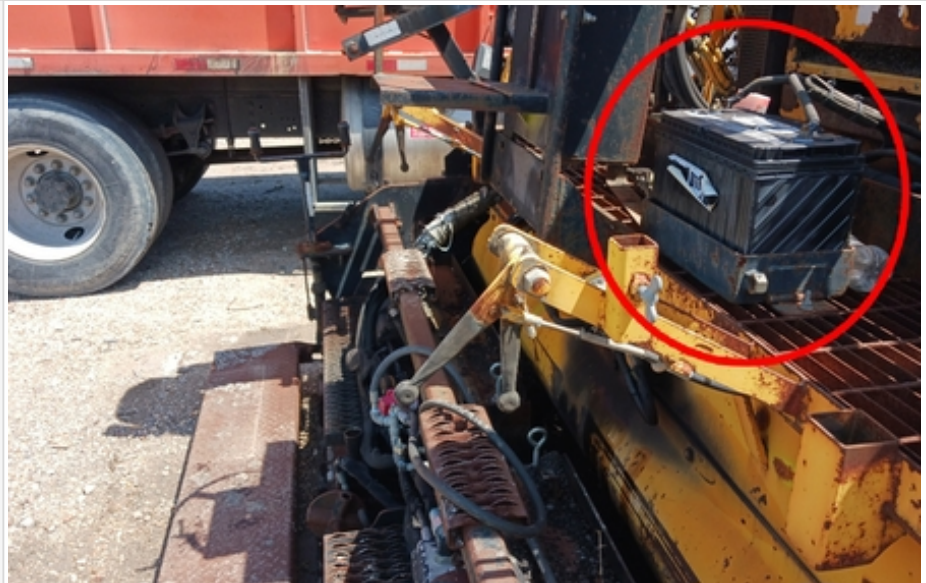
exposed battery

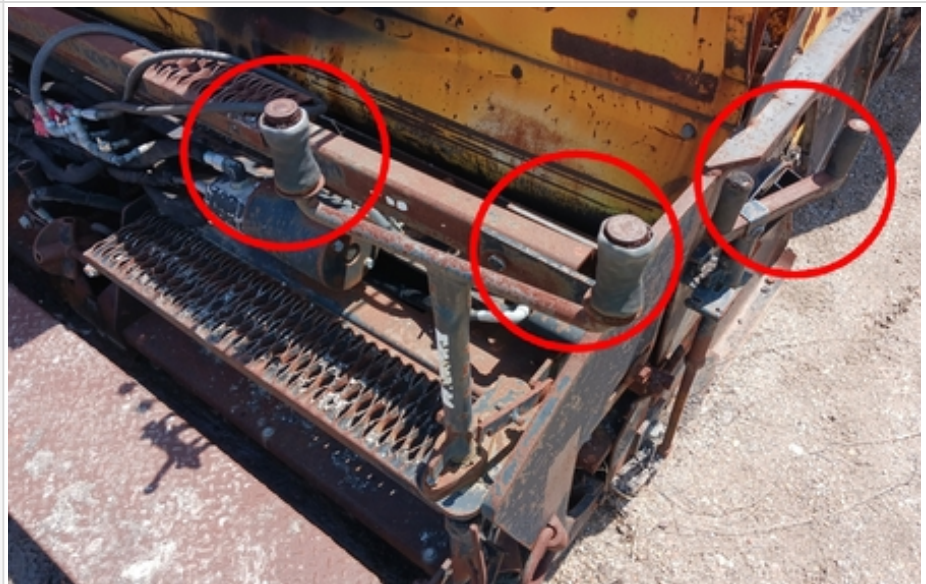
right hand side controls have above normal wear and tear

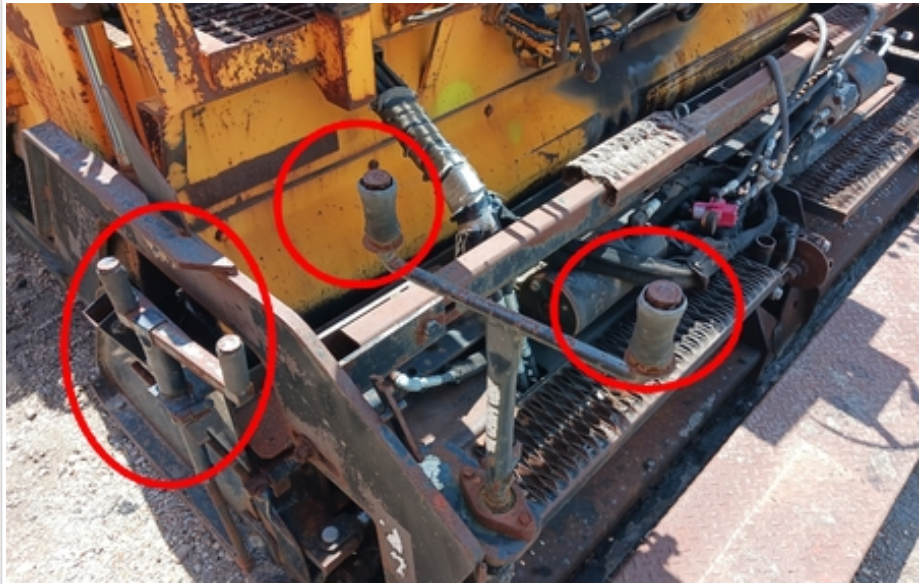
left hand side screed controls have above normal wear and tear

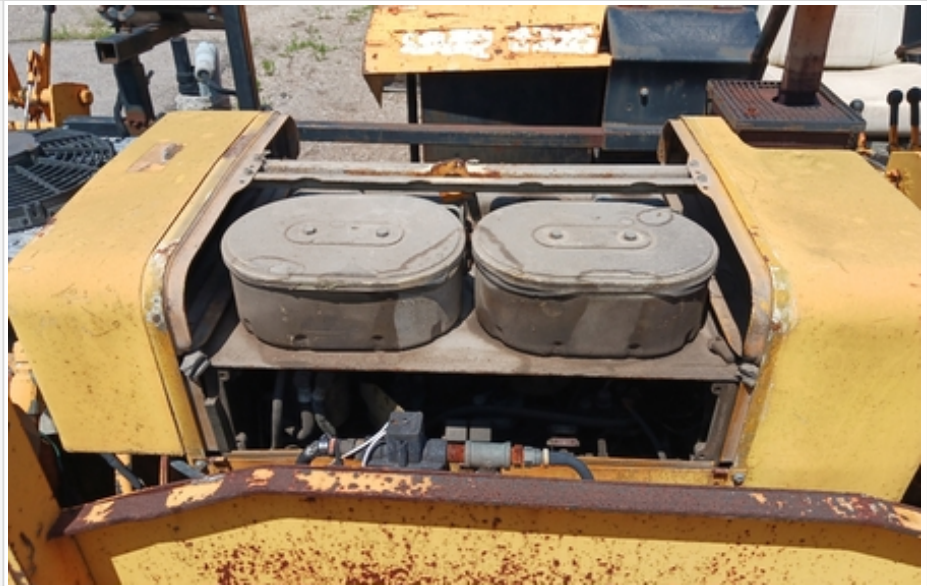
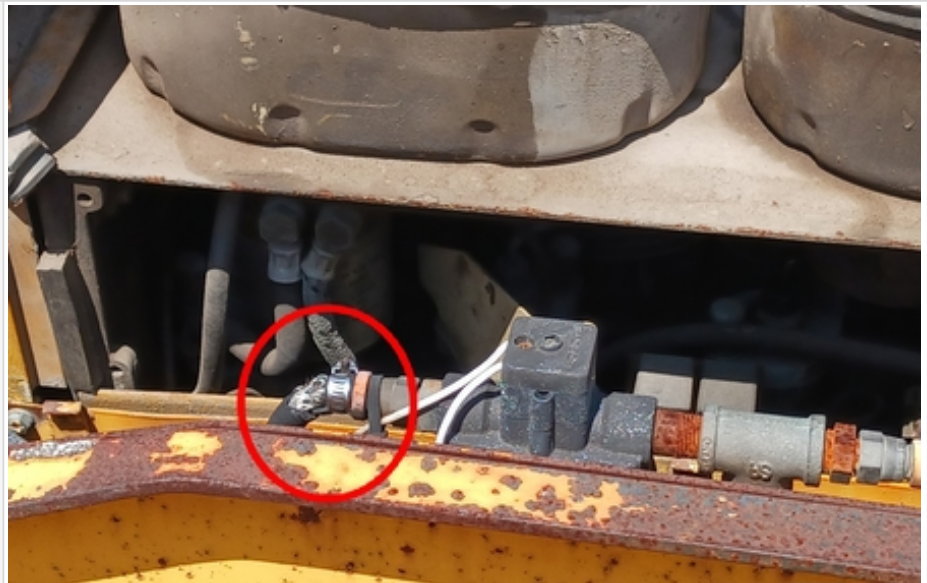
broken hose

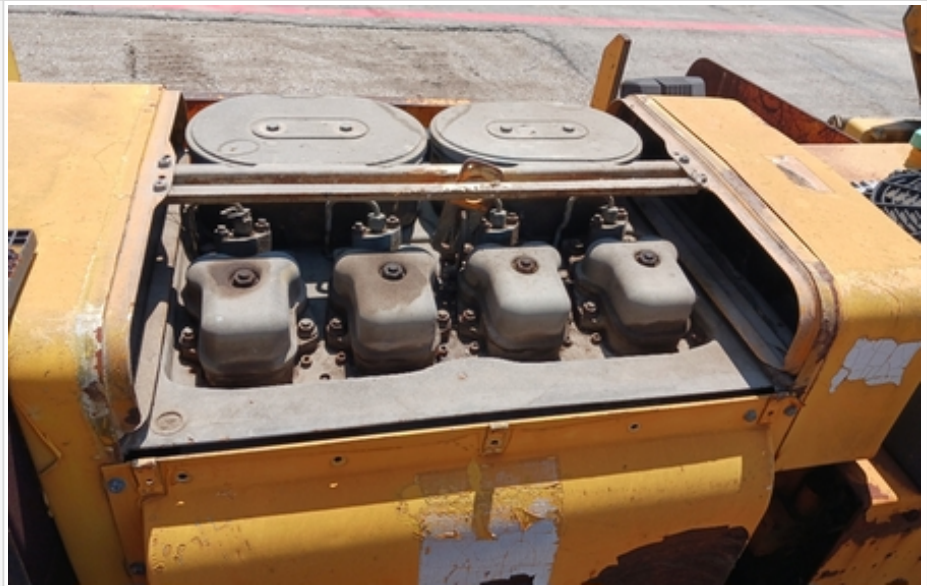
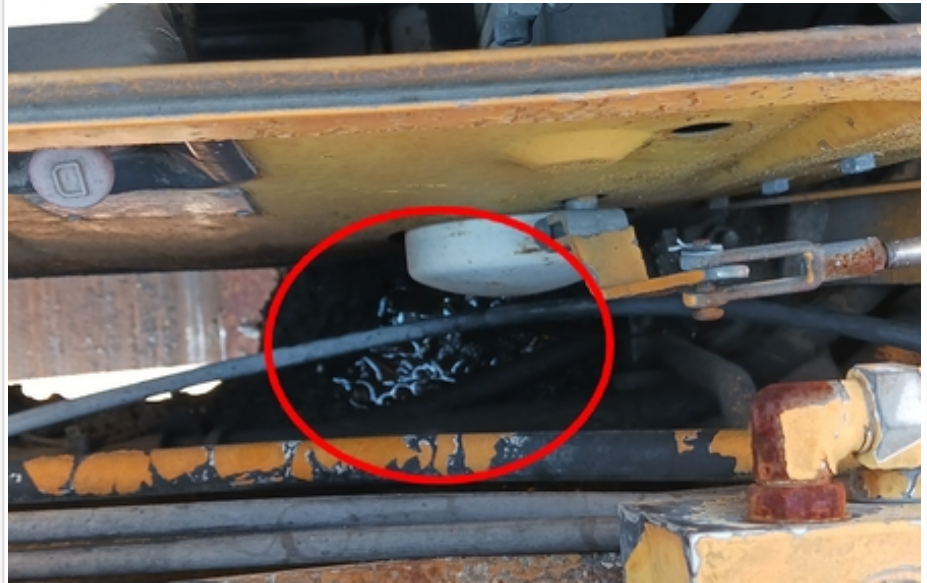
pooling of oil

| Engine Overall Comments | Visible pooling of oils can be seen at bottom of the engine compartment. The engine is dirty and gunky. |

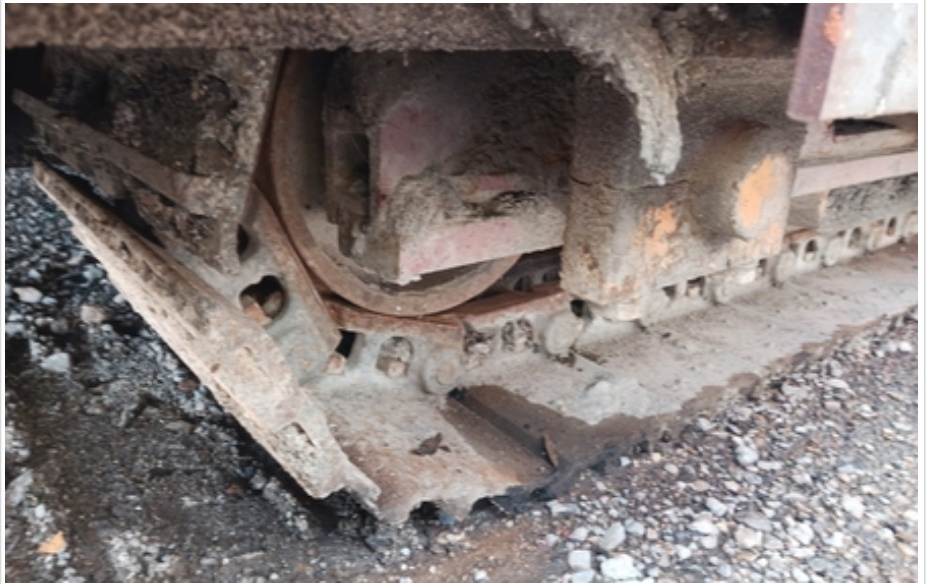
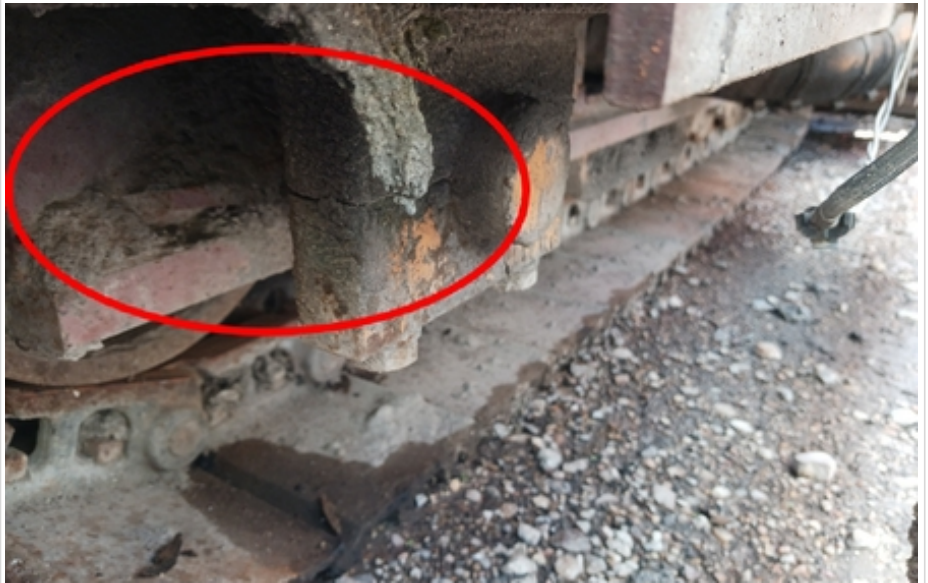
old dried asphalt

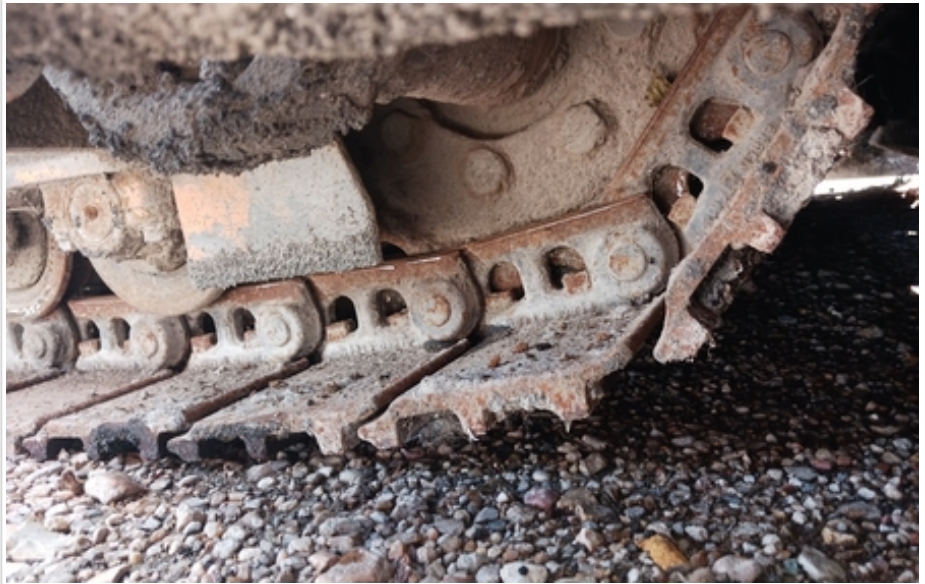
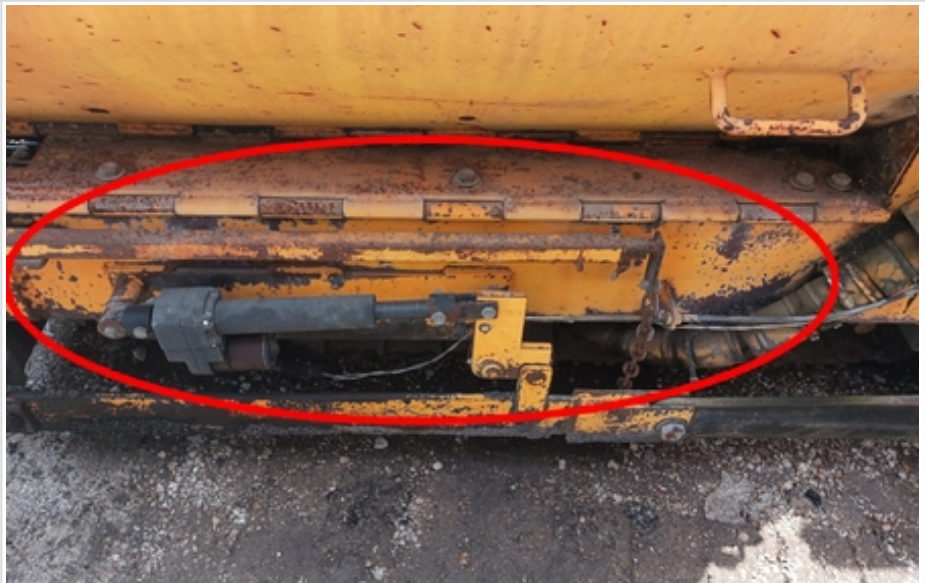
above normal wear and tear

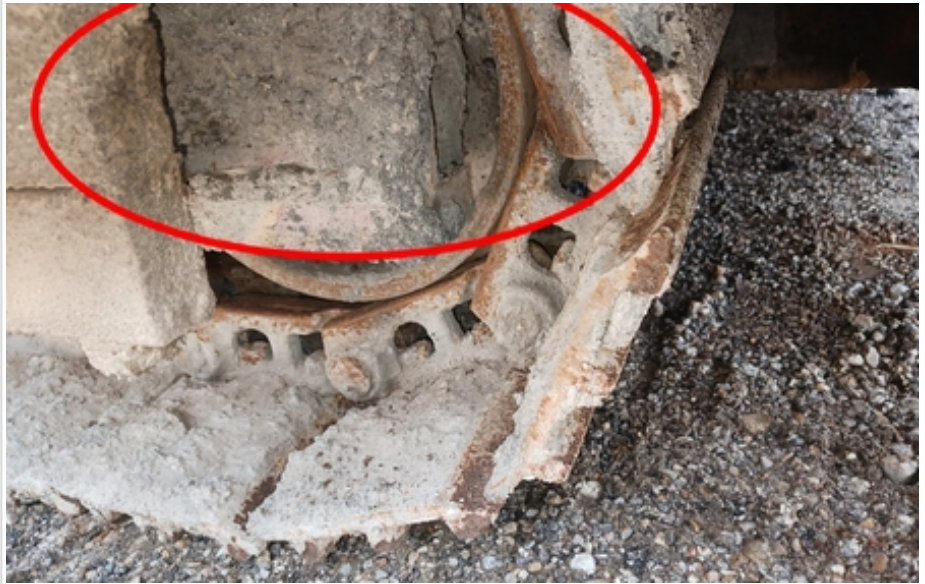
old dried asphalt

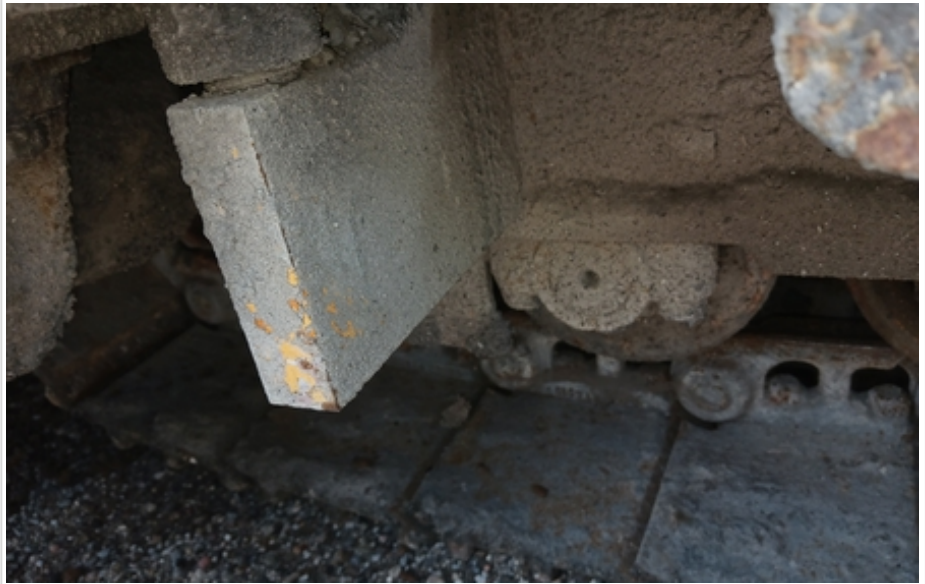
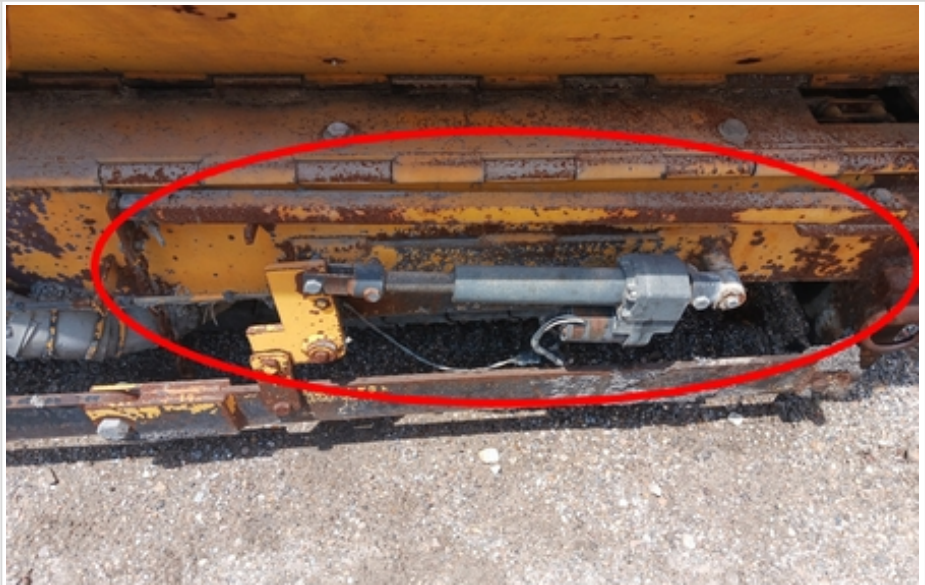
above normal wear and tear

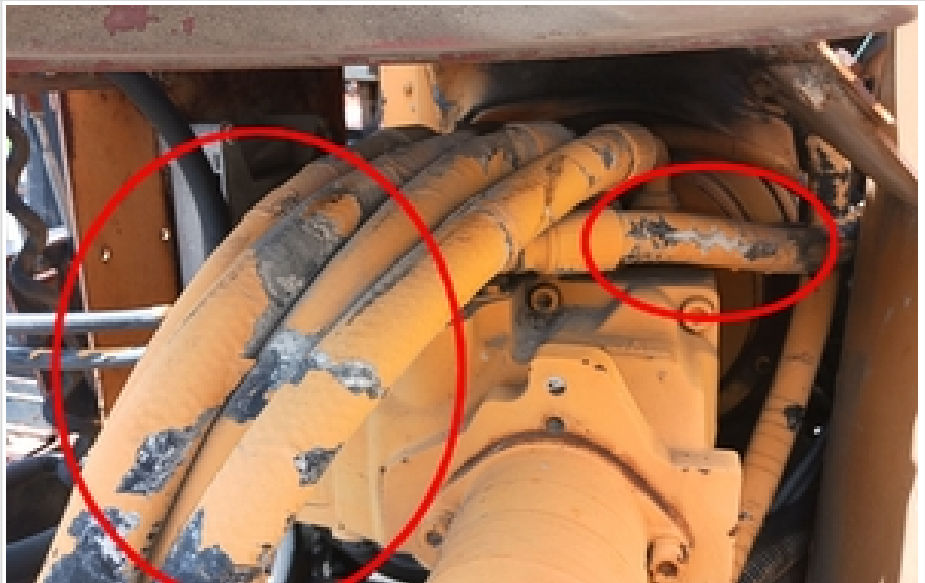
cracked/missing paint

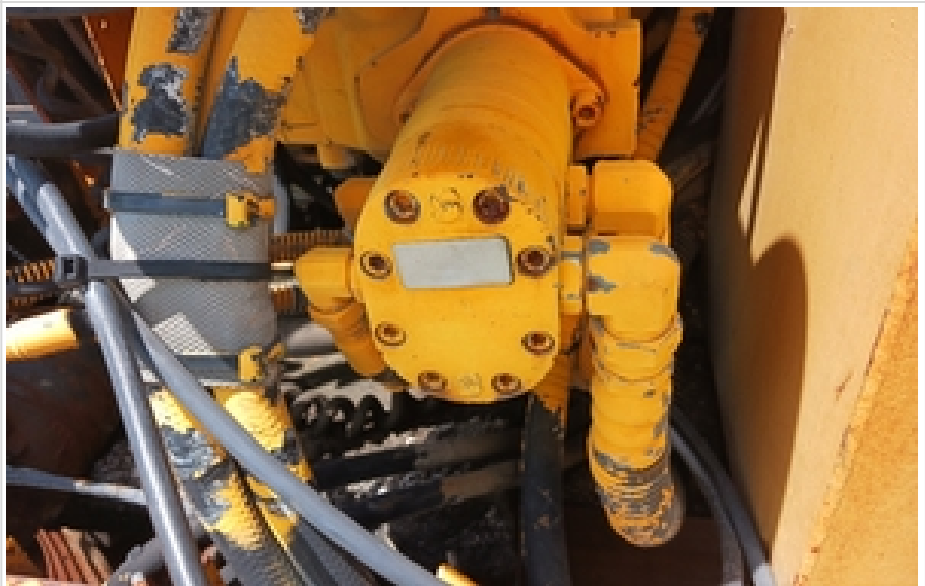
hoses have dried/discolored appearance

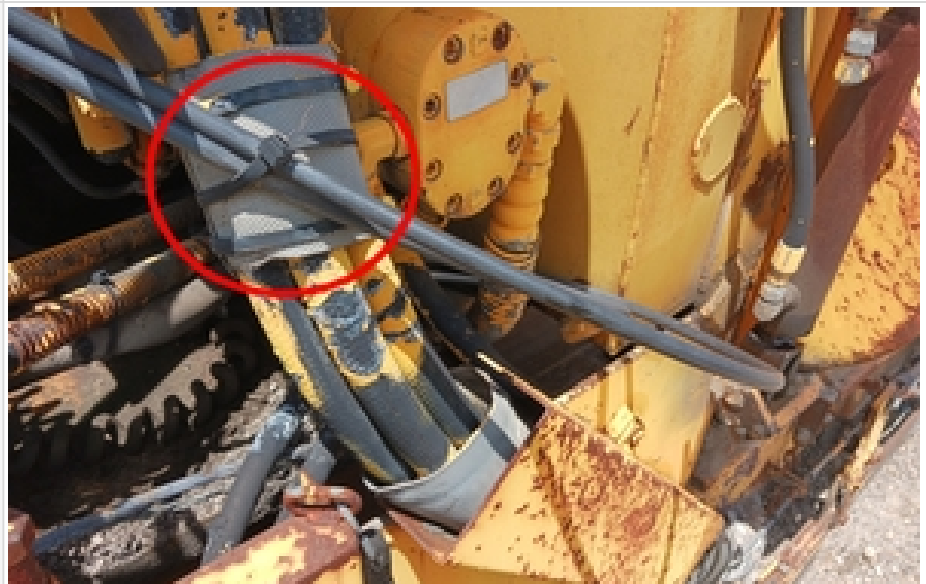
zip ties on hoses

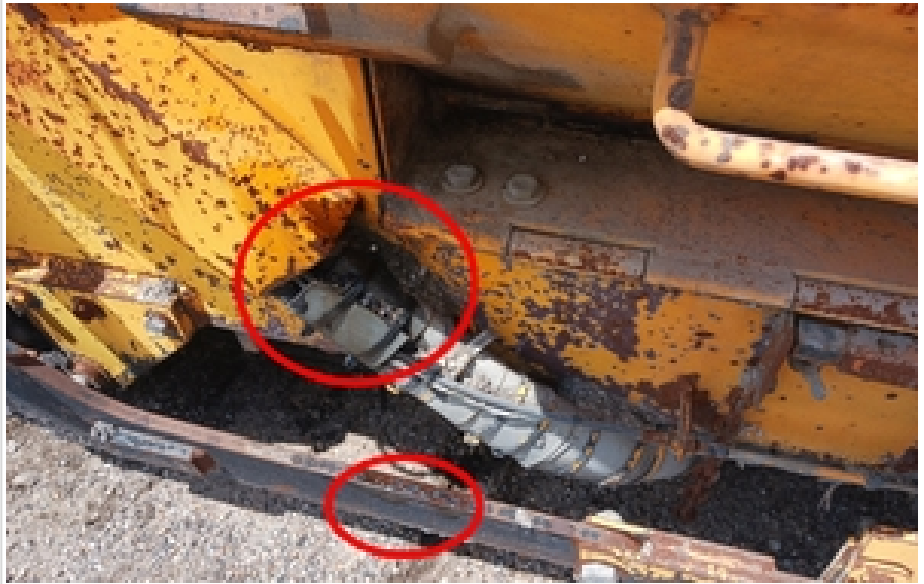
zip ties on hoses and there is a small hydraulic leak

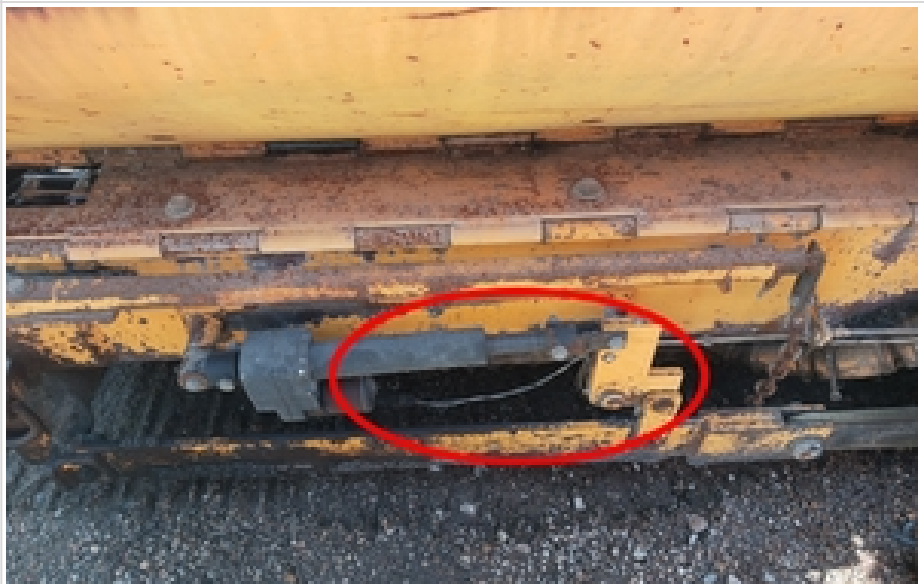
wires exposed

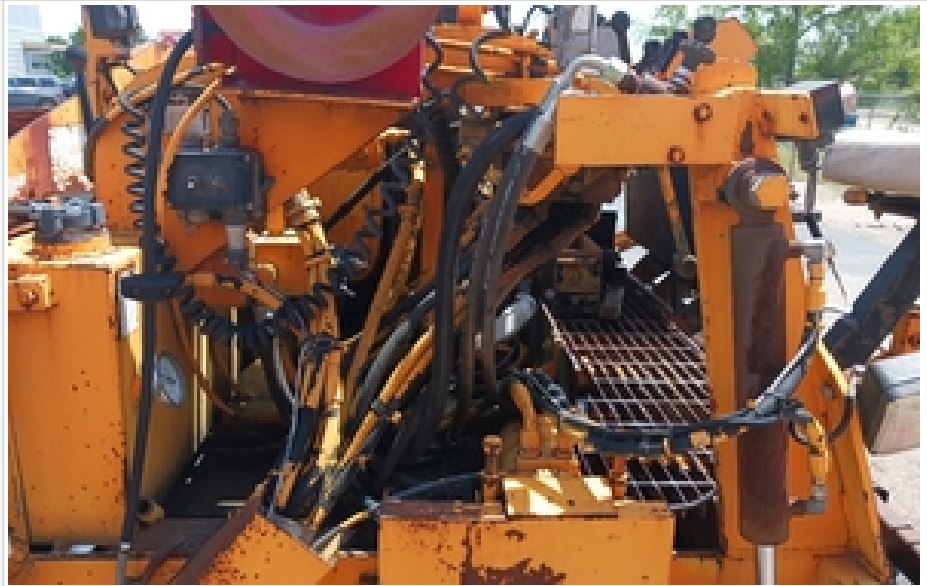
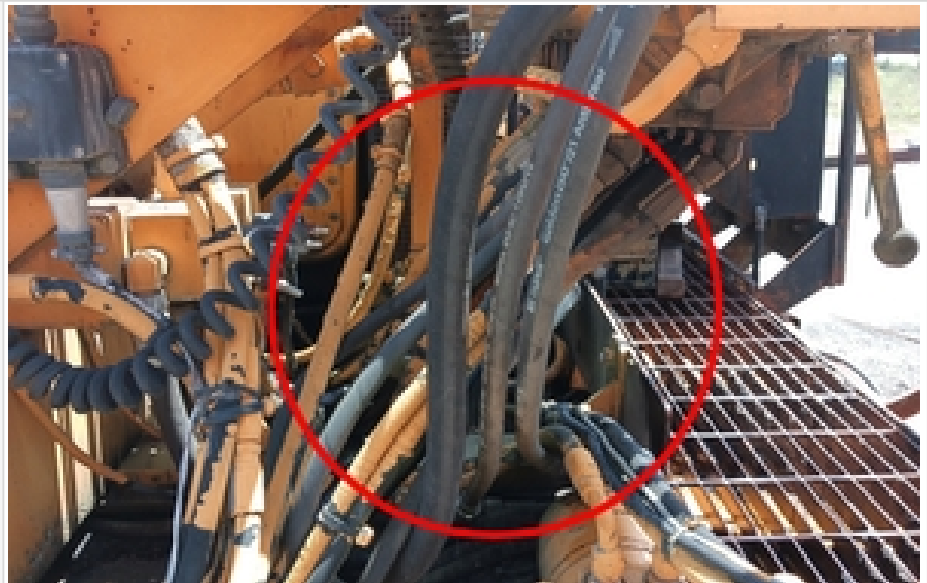
hoses have above normal wear and tear

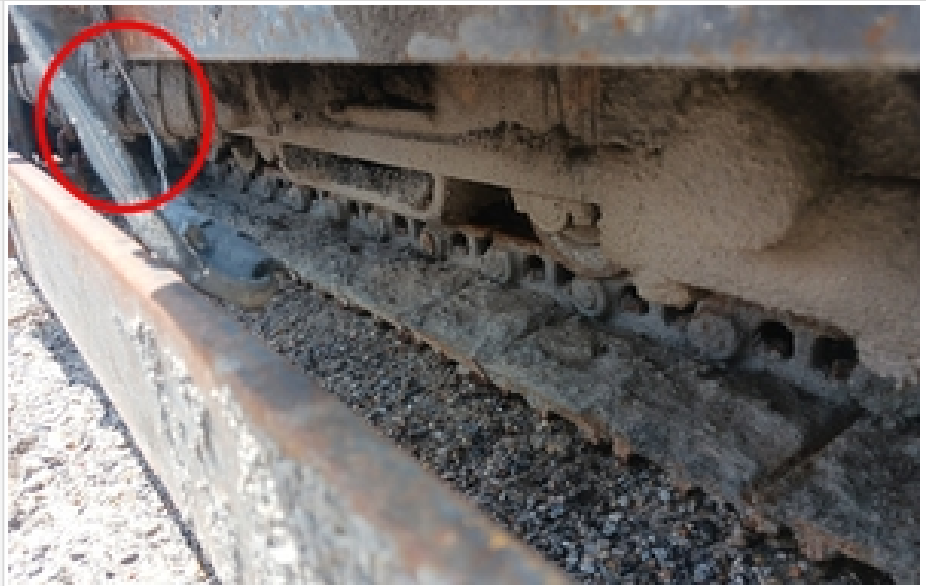
exposed wires
