#### **General Info**

Category	Paver
Travel System	Track Undercarriage
Comments	
Year	2017
Make	weiler
Model	2408
Fleet ID	3236
Serial Number	1W90P385KHB0002408
Serial Number Plate	WEILER Note:  Weiler 815 Weiler Dr. Knoxville, lowa 50138 USA  Model:  P385/B  Product Identification Number:  *1W90P385KHB002408*  38975
Hour Meter Reading	2138.3

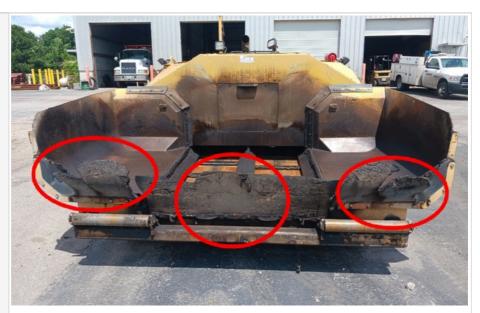
left and right side hoppers have damaged rubber wings. center rubber lip has above normal wear and tear.

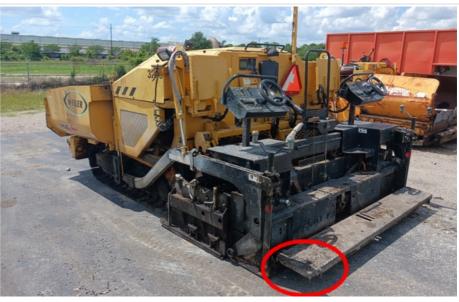
small dent on left hand side screed

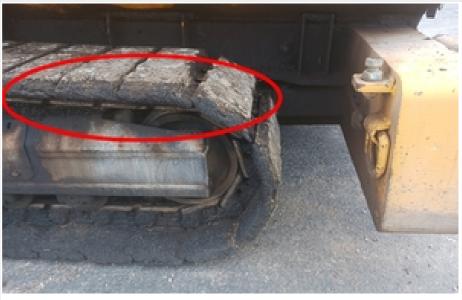
dried asphalt on tracks

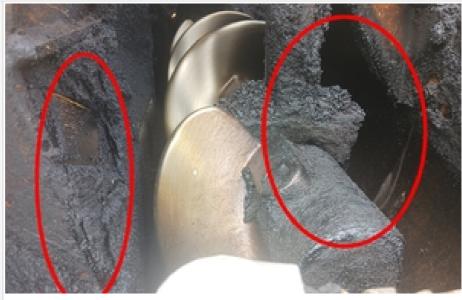
old asphalt

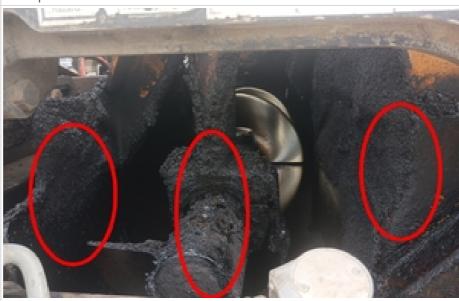
caked up asphalt
