Enterprise Equipment Inspection

Category	Excavator
Travel System	Track Undercarriage
Comments	
Year	2016
Make	Kobelco
Model	SK140SRLC-3
Fleet ID	10283192
Serial Number	YH07-10124
Serial Number Plate

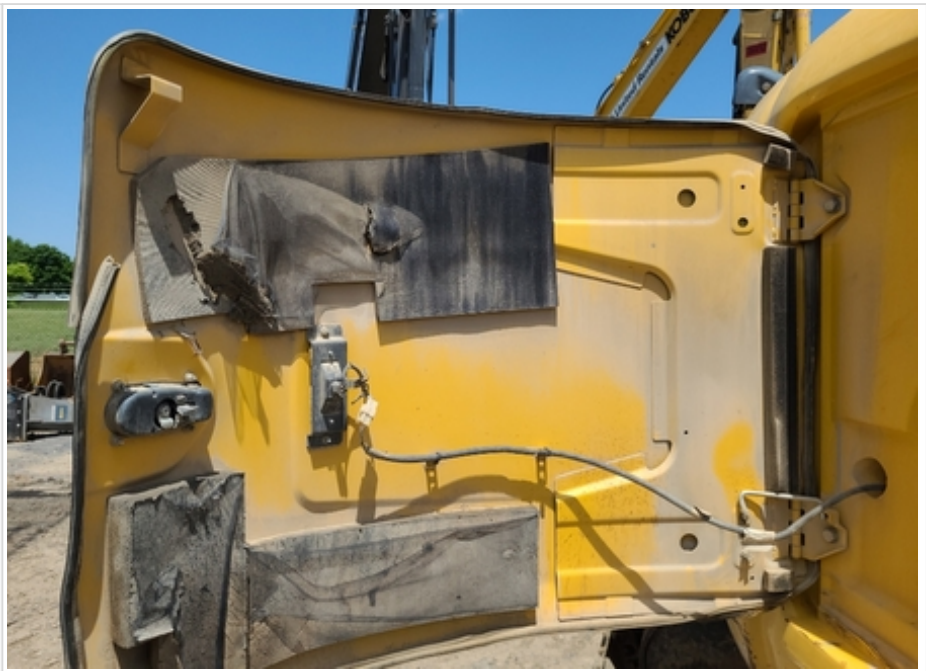
Exterior Rating	3 - Normal Wear & Tear
Exterior Comments	Small dents at r/s light fixture

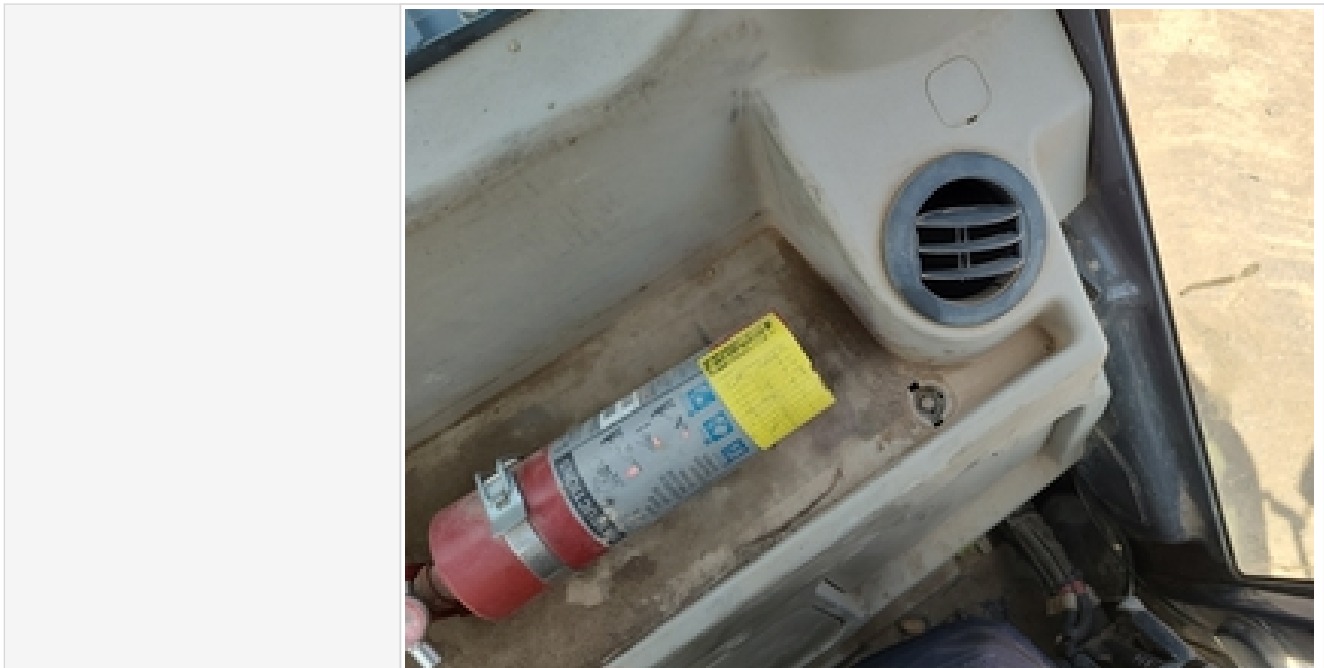
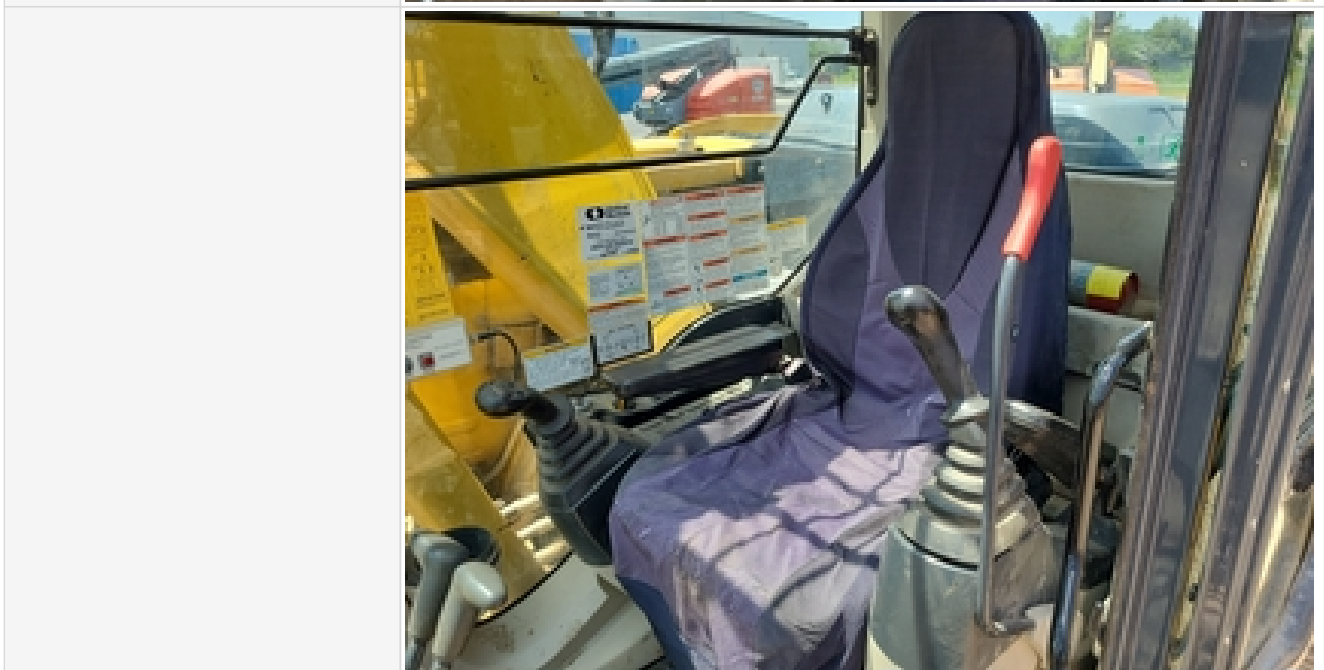
Control Station Rating	3 - Normal Wear & Tear
Control Station Overall Comments	Seat upholstery damaged

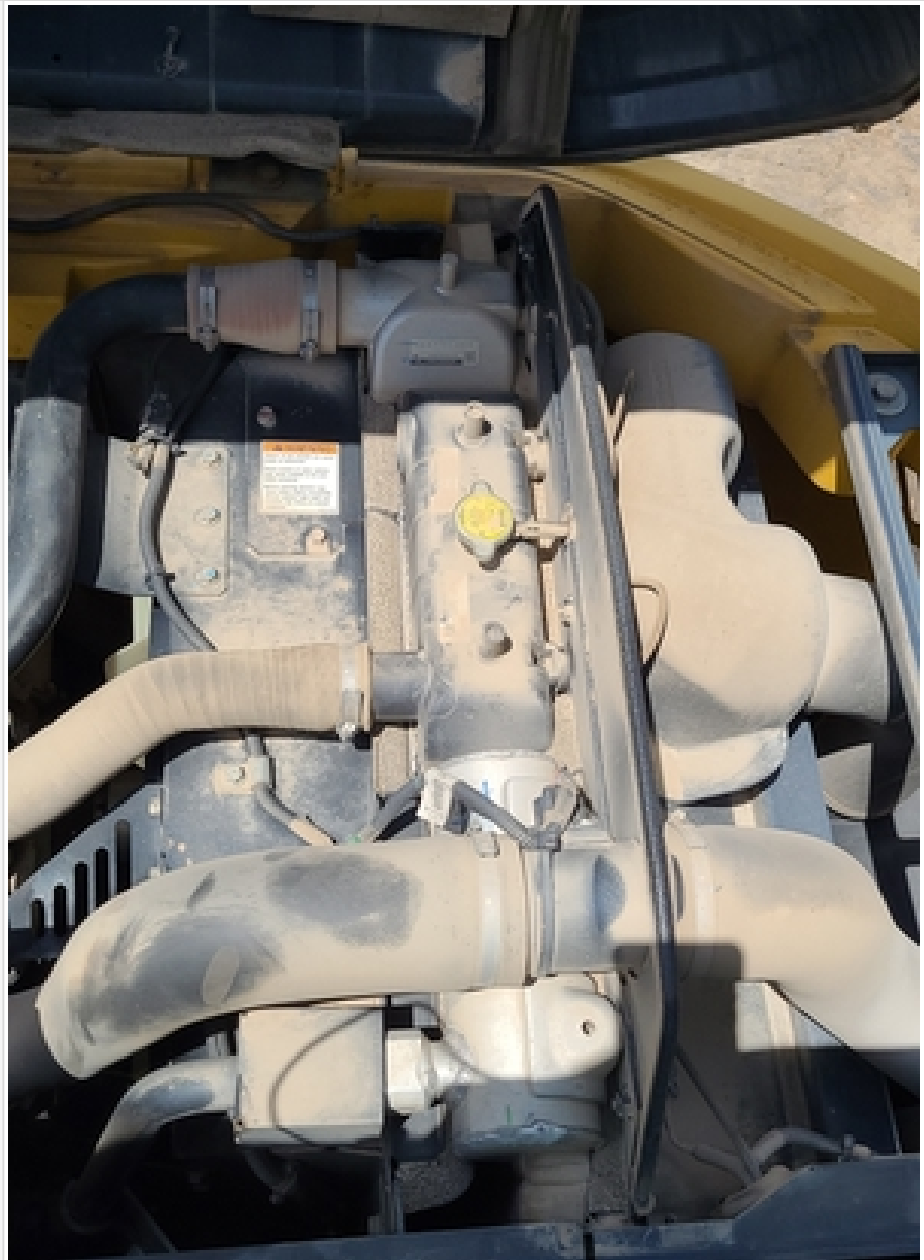
Engine Type (Make, Model, Cylinders, Hp)	Mitsubishi - 4Cyl. -
Emissions Tier	Tier 4i
Engine Rating	3 - Normal Wear & Tear
Engine Overall Comments	Engine overall in good condition with no active leaks seen from topside of engine.

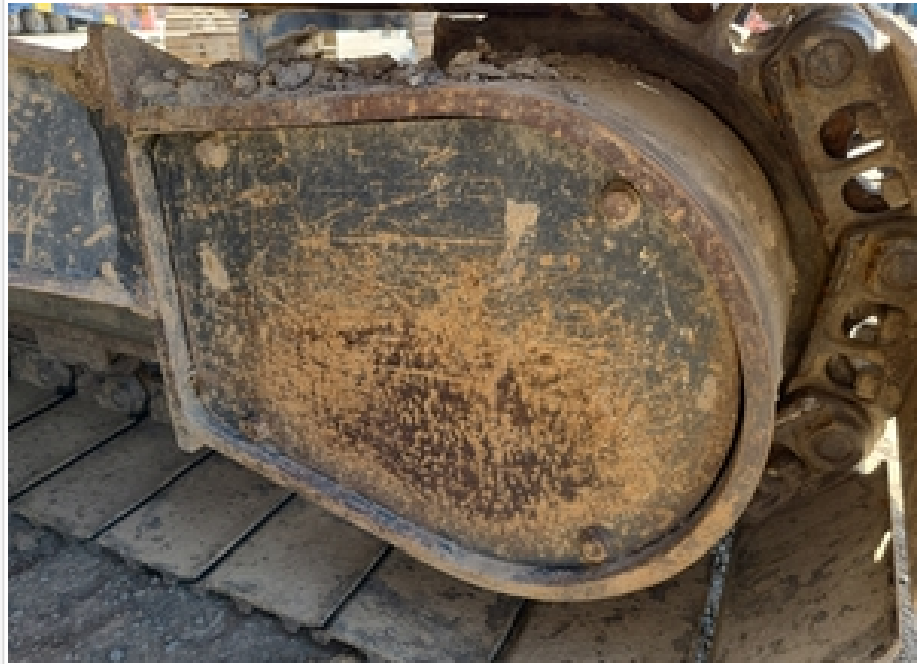
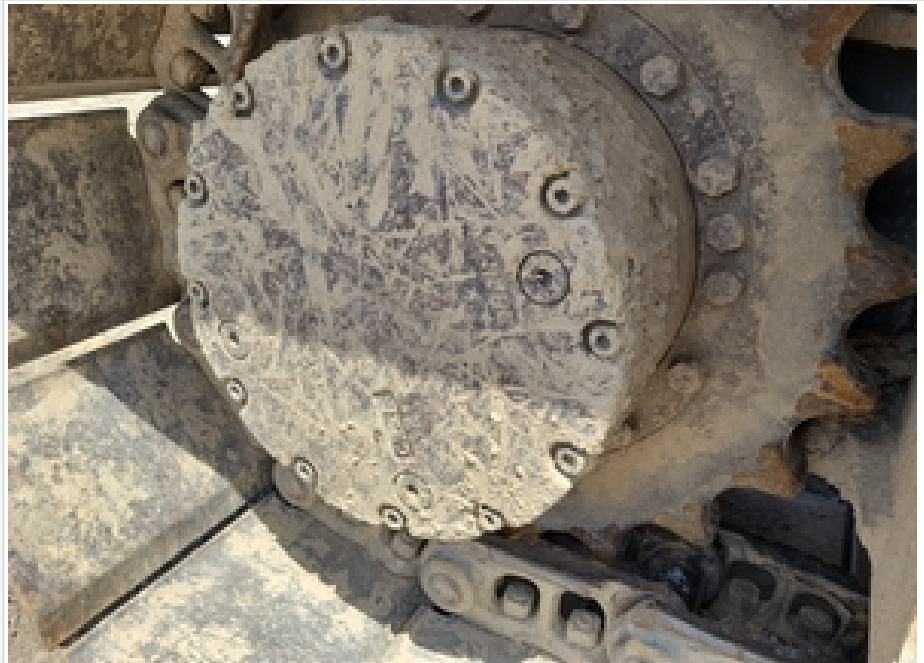
Hydrostatic Transmission?	Yes
2 Speed?	Yes
Hydrostatic Drive Configuration	Split Transmission
Comments	
Transmission Info (Make/Model/Speeds)	
Drivetrain Rating	3 - Normal Wear & Tear
Drivetrain Comments	Machine travels well in all directions.

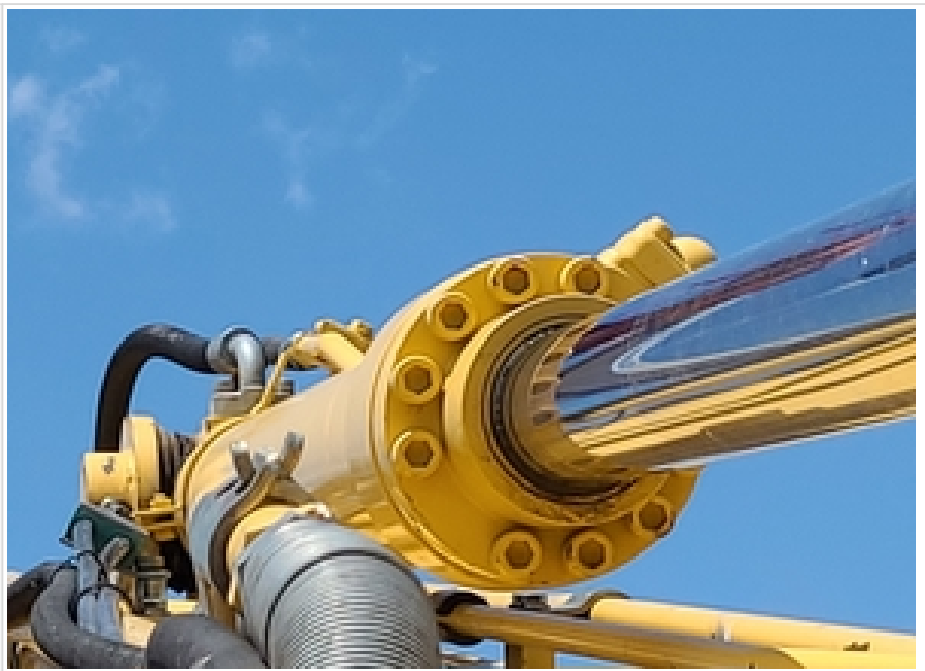
Hydraulic System Rating	3 - Normal Wear & Tear
Hydraulic System Comments	Hydraulic System in good working condition

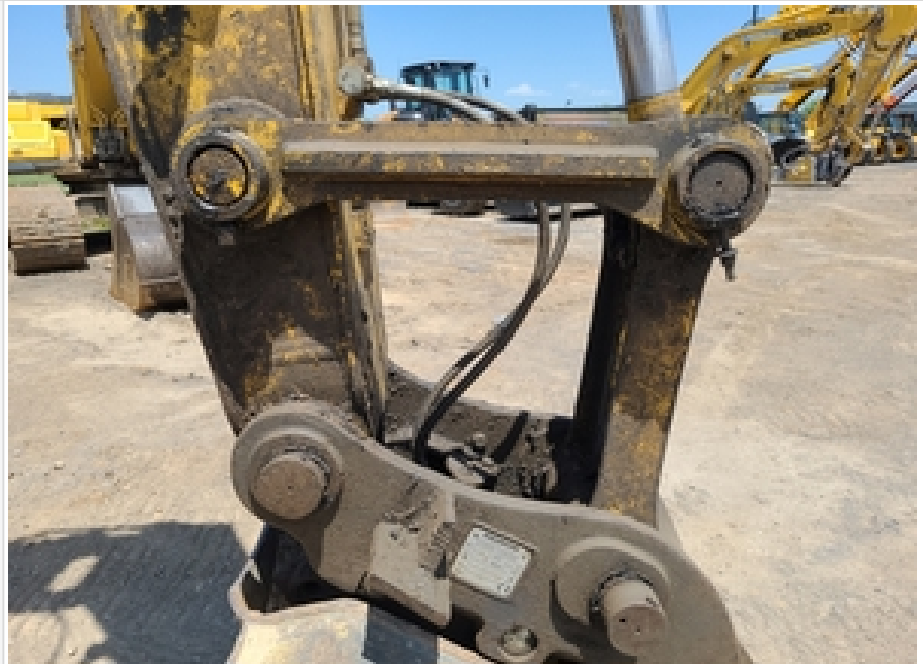
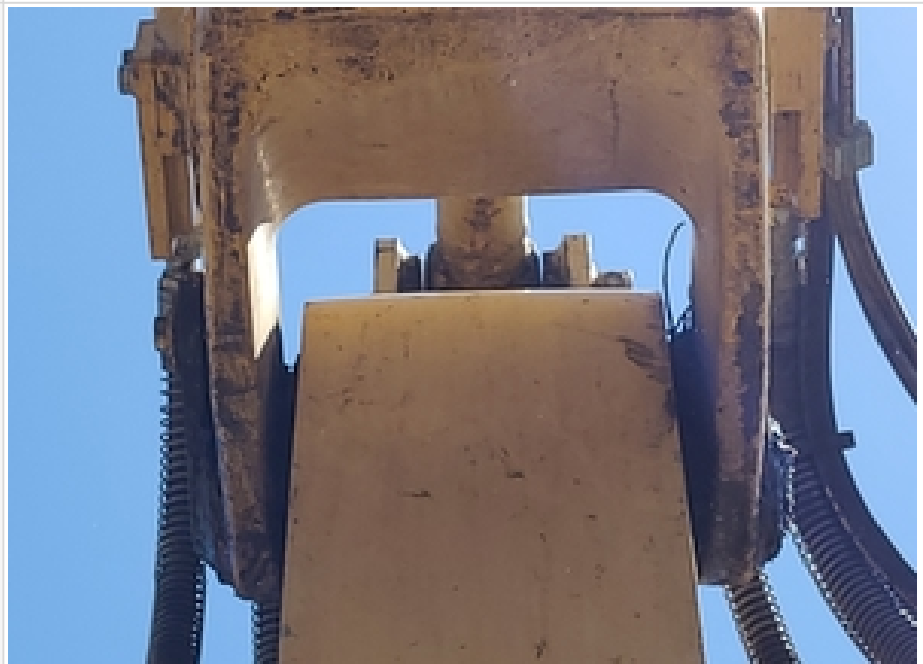
Chassis Rating	3 - Normal Wear & Tear
Comments	Some excess play seen at bucket linkage and at boom to stick connection

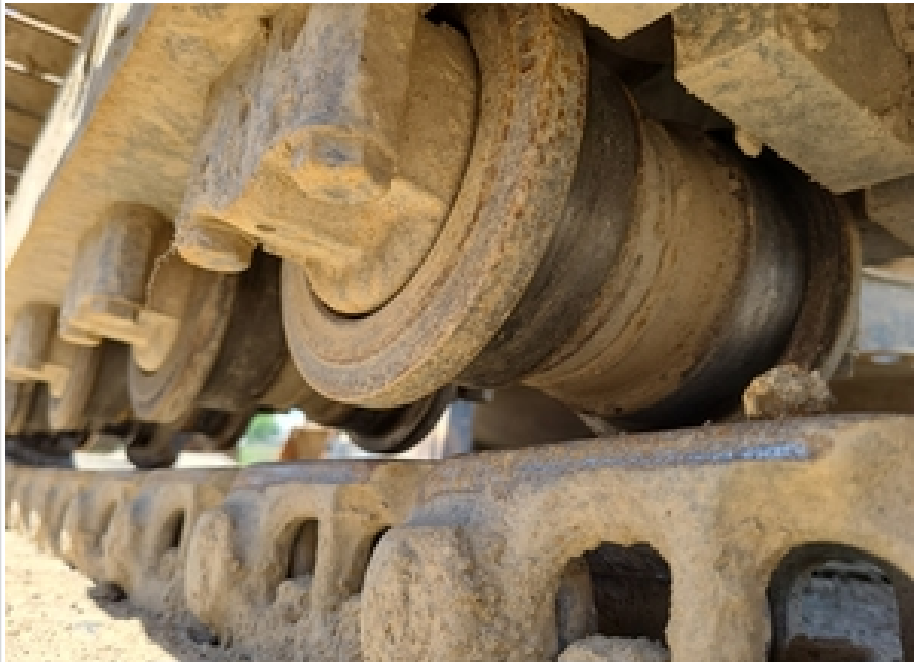
Undercarriage Rating	3 - Normal Wear & Tear
Undercarriage Comments	Undercarriage in good condition.

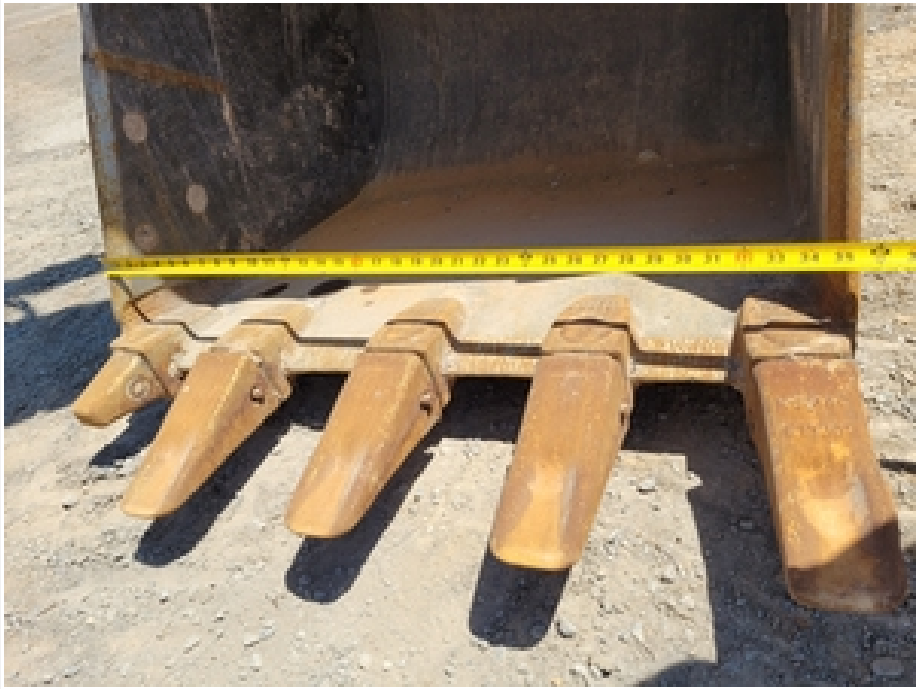
Attachment Rating	3 - Normal Wear & Tear
Attachment Comments	Bucket missing 1 tooth
