Enterprise Equipment Inspection

Category	Forklift
Travel System	Wheels & Tires
Comments	
Year	2016
Make	JCB
Model	512-56
Fleet ID	10497304
Serial Number	JCB5CH2GJG2434835
Serial Number Plate

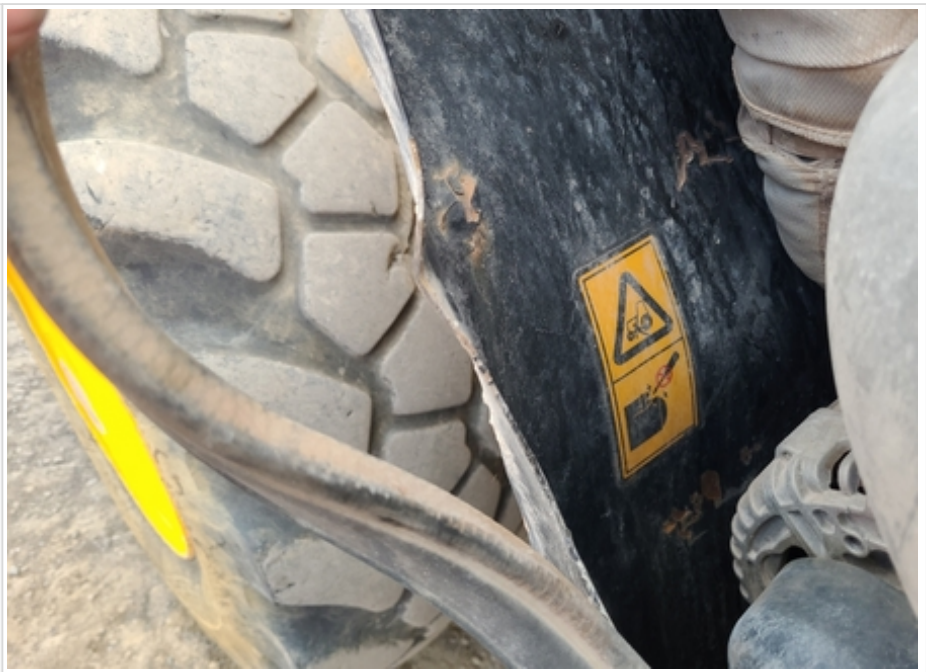
Exterior Rating	3 - Normal Wear & Tear
Exterior Comments	Front r/s mud guard damaged, fuel tank possibly cracked (leaking?) Some mud guard retaining areas cracked.

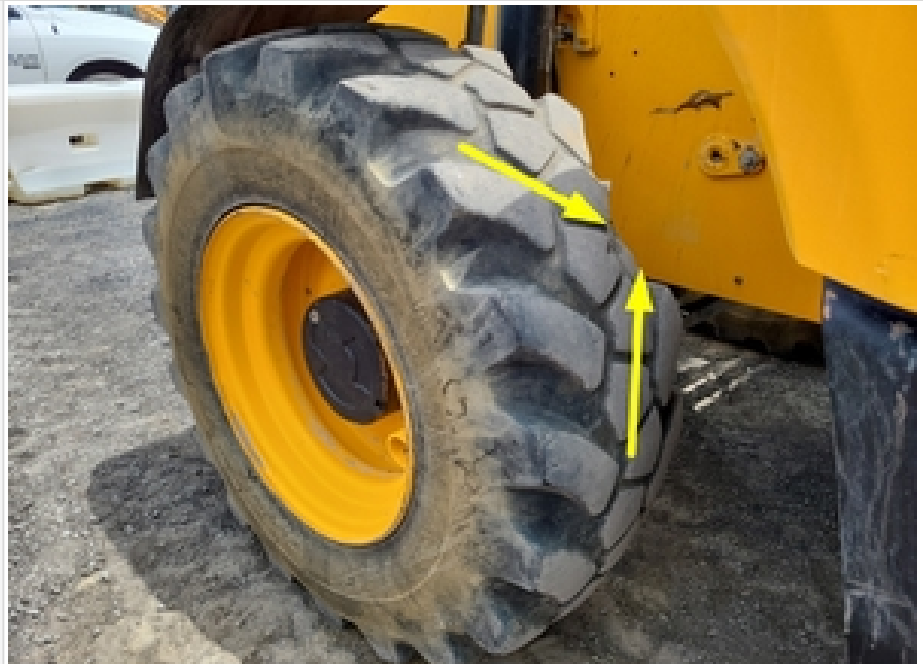
Large Rubber Tread Missing

Undercarriage Rating	3 - Normal Wear & Tear
Undercarriage Comments	All tires Foam/Poly filled. Rear r/s tire needs to be replaced soon (missing chunk of tread)

What Needs Work	Rear R/S tire needs to be replaced soon	
Any Additional Info from the Seller?		
Date/Time	05-17-2023
