## Enterprise Equipment Inspection

Category	Telehandler
Travel System	Wheels & Tires
Comments	
Year	2015
Make	JCB
Model	509-42
Fleet ID	10358713
Serial Number	JCB5CFKGL02437685
Serial Number Plate

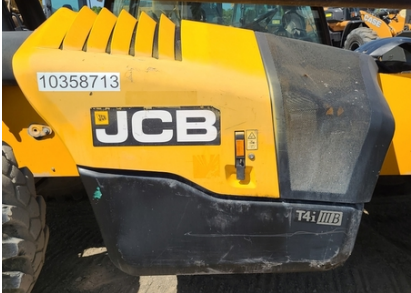
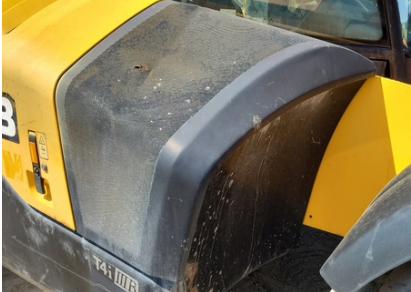
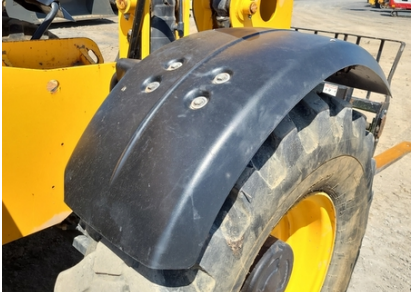
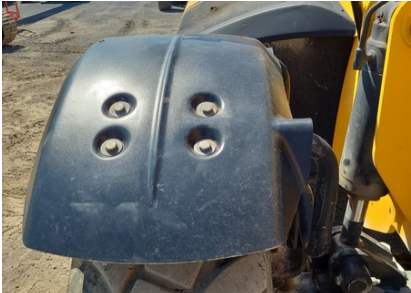
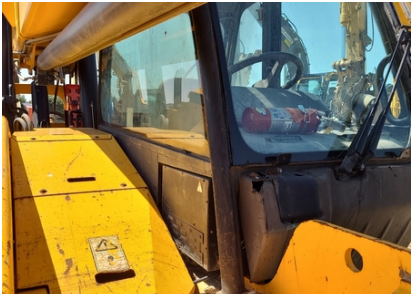
<b>Exterior Rating</b>	3 - Normal Wear & Tear	
<b>Exterior Comments</b>	Some dents on engine hood. Front Cab Exterior panel plastic cracked.

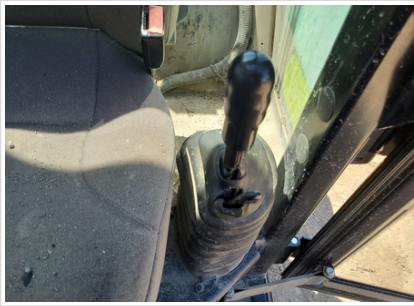
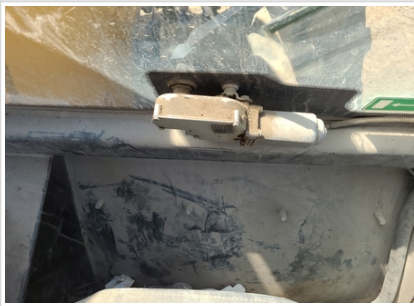
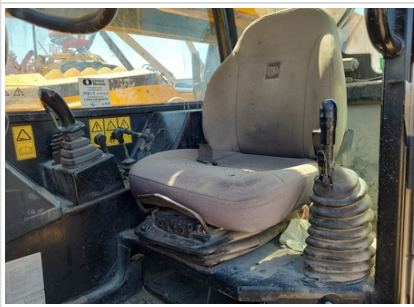
<b>Control Station Rating</b>	3 - Normal Wear & Tear	
<b>Control Station Overall Comments</b>	Normal wear and tear. Fault code present at monitor panel.

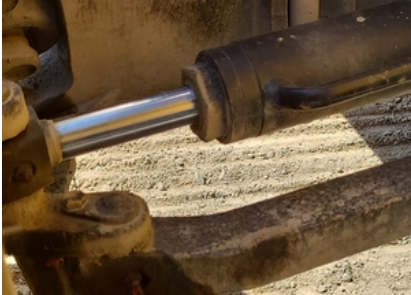
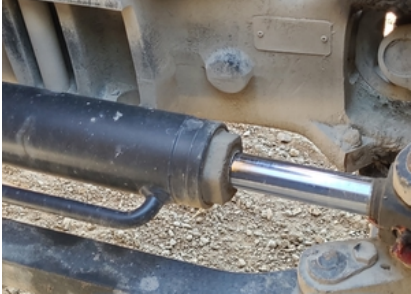
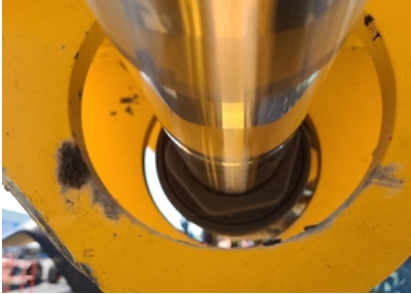
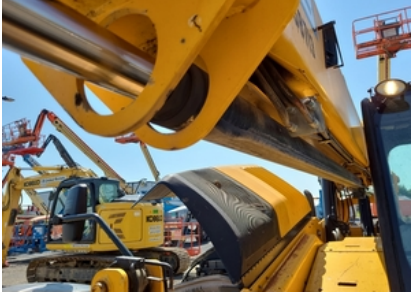
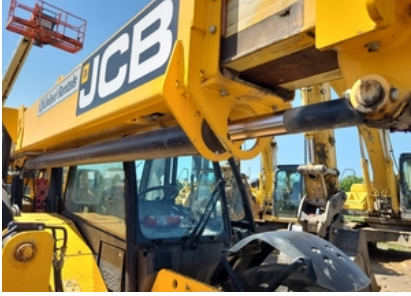
<b>Hydraulic System Rating</b>	3 - Normal Wear & Tear	
<b>Hydraulic System Comments</b>	Front r/s steer cylinder has some seepage. Minor leak at hydraulic pump hoses.

<b>What's Great About the Machine</b>	Machine has been well maintained and no major obvious issues observed during the inspection. Machine equipped with fork side tilt carriage.
<b>What Needs Work</b>	Front right steer cylinder may need to be resealed soon. Cosmetic work may be needed all around. Minor fluid leak at hydraulic pump hose. Fault code present at monitor panel.
<b>Any Additional Info from the Seller?</b>	
<b>Date/Time</b>	05-17-2023

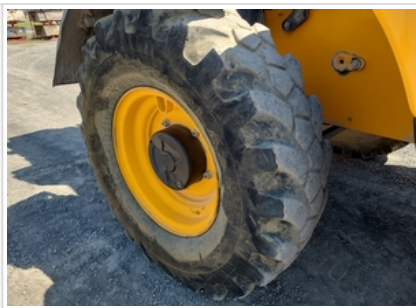
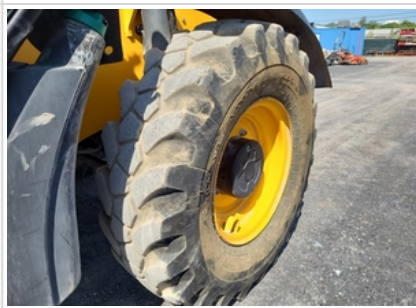
<b>Undercarriage Rating</b>	3 - Normal Wear & Tear	
<b>Undercarriage Comments</b>	All tires foam filled and have about 20% of tread life left

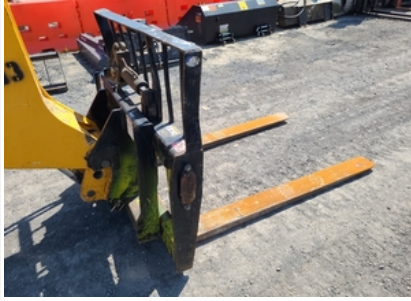
Attachment Rating	3 - Normal Wear & Tear
Attachment Comments	5'L x 6"W x 2&1/2" Thick. Backrest 52" Wide
