General Info

General Info		
Category	Bulldozer	
Travel System	Track Undercarriage	
Comments		
Year	1987	
Make	CAT	
Model	D3B	
Fleet ID	N/A	
Serial Number	23Y02174	
Serial Number Plate	MODEL NUMBER ARRANGEMENT NUMBER MACHINE P SERIAL ENGINE TRANSMISSION CATERPILLAR MITSUBISHI LTD. SAGAMIHARA, KANAGAWA. ADE IN JAPAN SVS847	
Hour Meter Reading	32070

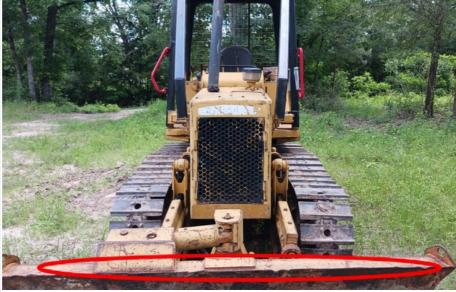
area of rust

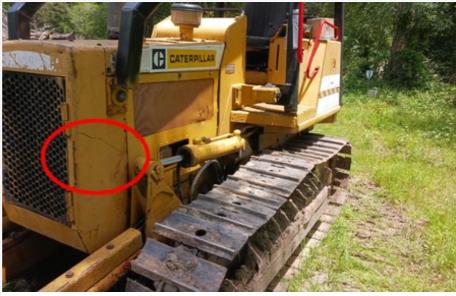
small scratch/missing paint

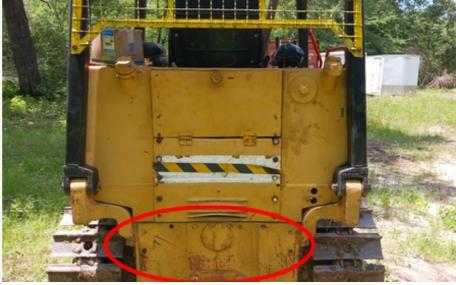
small scratches/area of rust

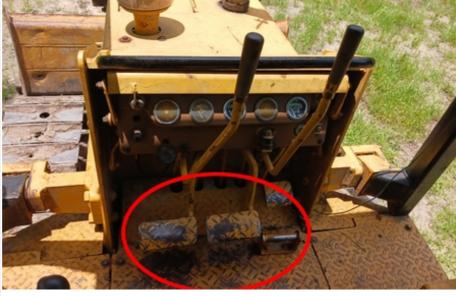
missing paint/minor rust

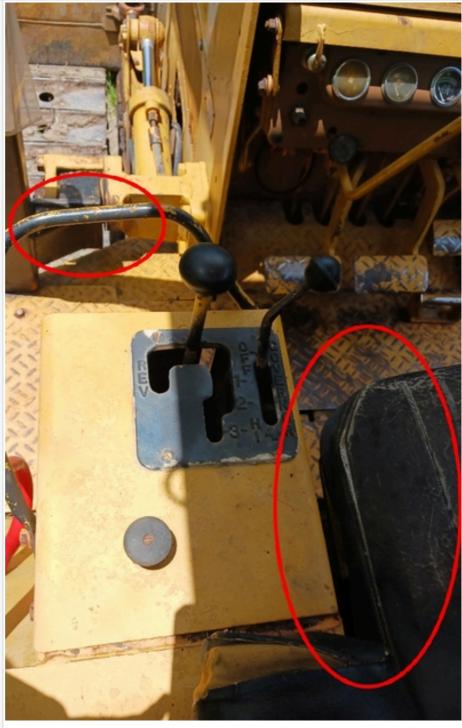
missing paint/the operators seat is old and has rips/tears

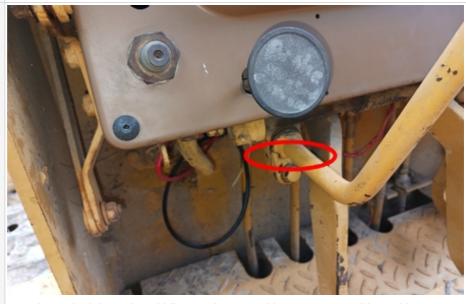
area is cracked down the middle, causing control levers to move side to side

Overall Rating	3 - Normal Wear & Tear			
What's Great About the Machine	This is a good machine that works well. It comes with a blade and a safety cage for the cab			
What Needs Work	Several hoses are dry/cracked. The tracks have above normal wear and tear. The lever controls to turn have a crack in the center of both of them.			
Any Additional Info from the Seller?				
Date/Time	05-18-2023

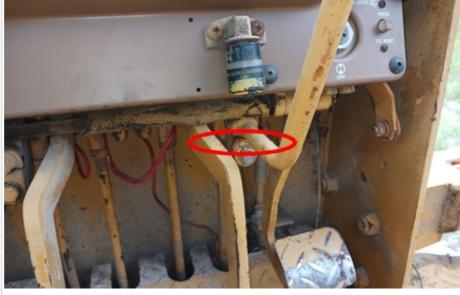
area is cracked down the middle, causing control levers to move side to side

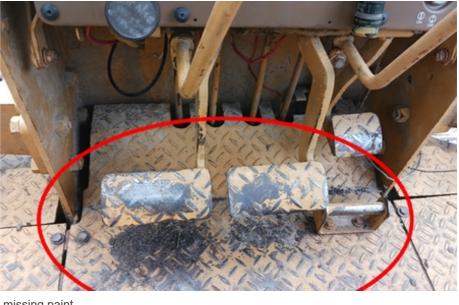
missing paint

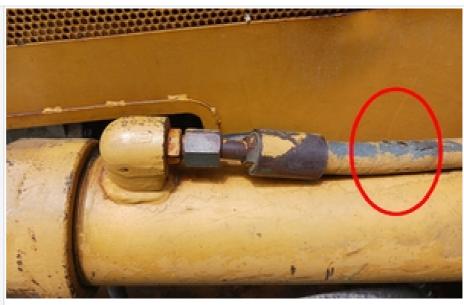
dry/cracked hoses

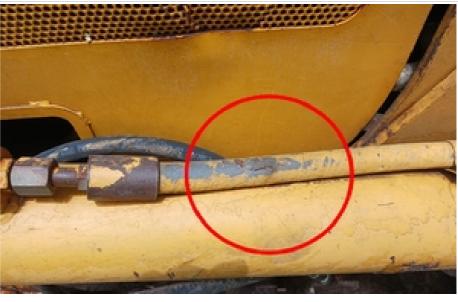
dry/cracked hose

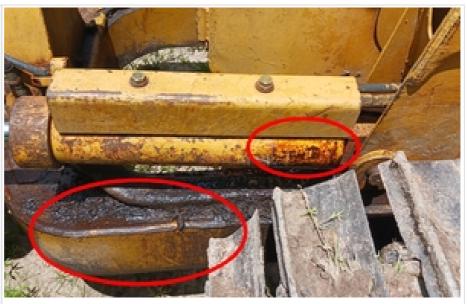
there is a hydraulic leak under the guard

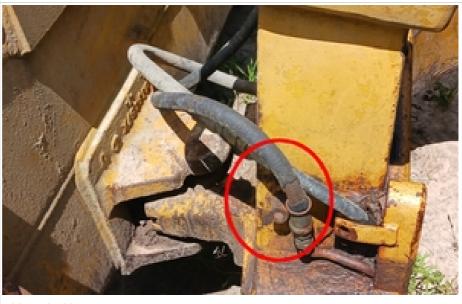
old cracked hoses

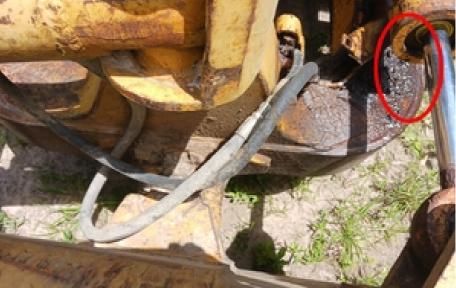
leak from under hose guard on left hand side arm cylinder

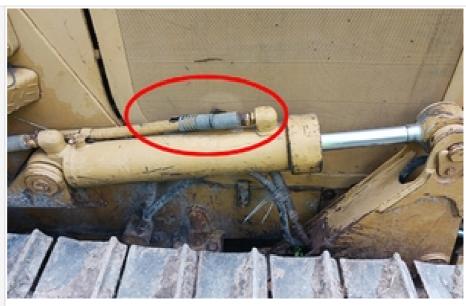
cracked hose

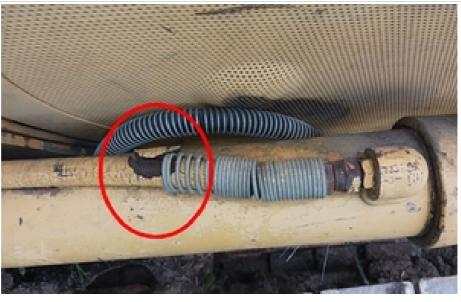
dry/cracked hose

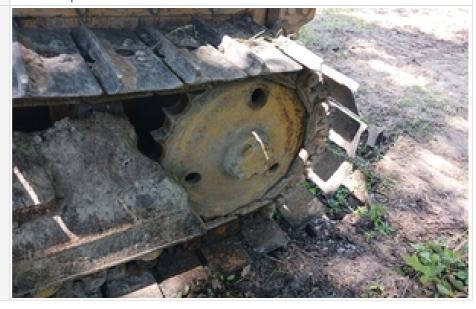
dirt build up

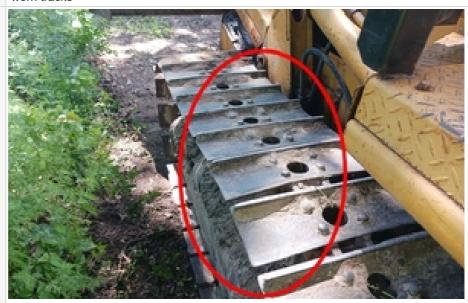
above normal wear and tear on tracks

Undercarriage Rating	2 - Above Average Wear & Tear
Undercarriage Comments	Tracks have above normal wear and tear but the system works just fine

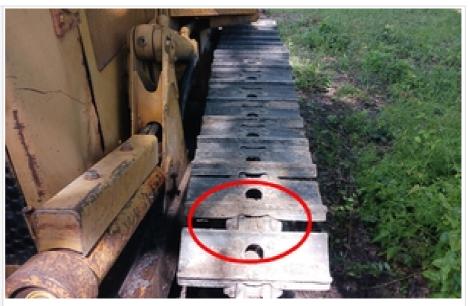
above normal wear and tear on the tracks

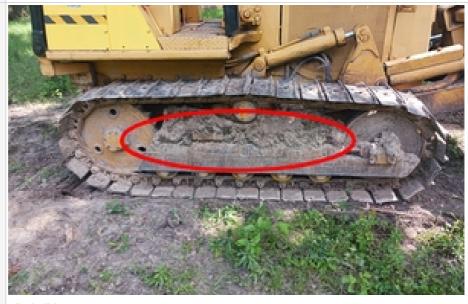
dirt build up

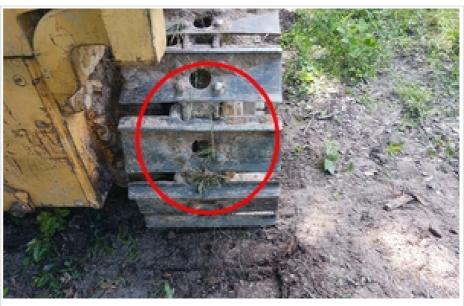
above normal wear and tear on the tracks

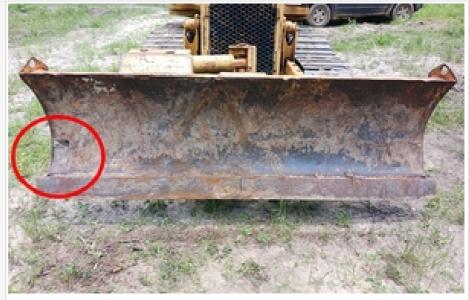
damaged area on blade

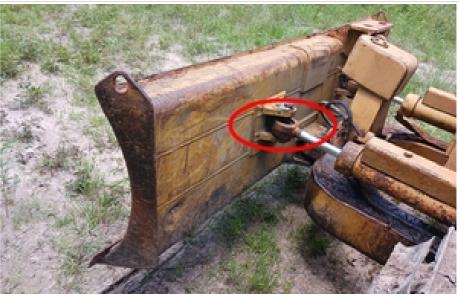
area has some play

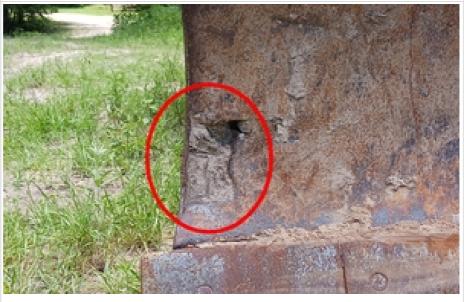
damaged area on blade
