Enterprise Equipment Inspection

Category	Excavator
Travel System	Track Undercarriage
Comments	
Year	2017
Make	Kobelco
Model	SK210 LC
Fleet ID	310835NF
Serial Number	YQ13 - 10835
Serial Number Plate

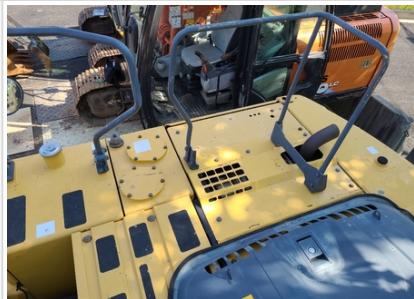
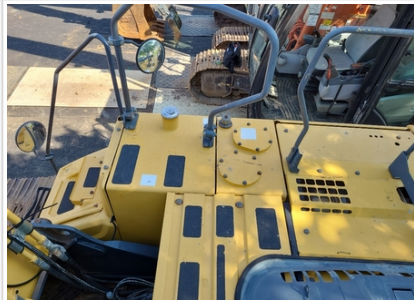
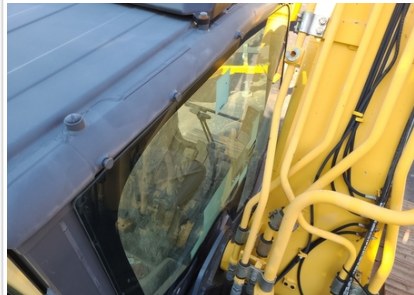
Exterior Rating	3 - Normal Wear & Tear
Exterior Comments	Some minor dents and scuff marks on all sides. Front r/s step bent

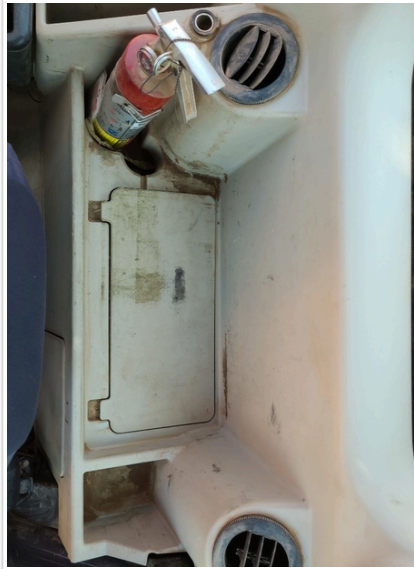
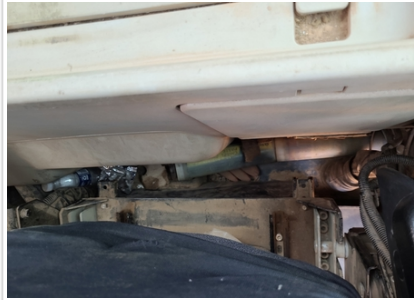
Control Station Rating	3 - Normal Wear & Tear
Control Station Overall Comments	Operator cab in good shape. Seat upholstery damaged.

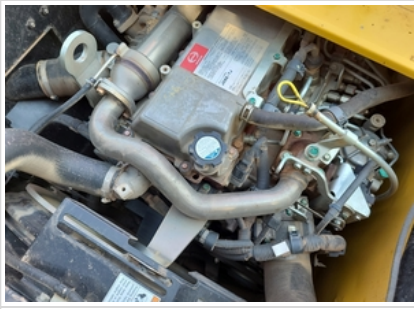
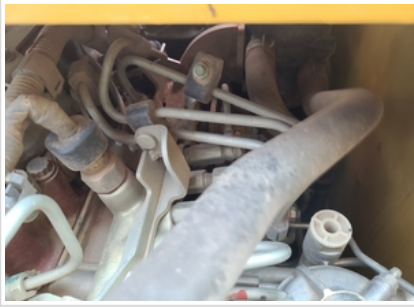
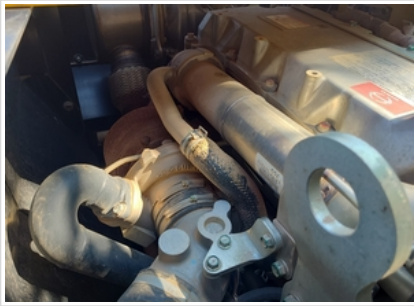
Engine Compartment

Engine Type (Make, Model, Cylinders, Hp)	Hino - 6Cyl - 166HP - 5.1L	
Emissions Tier	Tier 4i	
Engine Rating	3 - Normal Wear & Tear	
Engine Overall Comments	Engine has a clean, well maintained appearance. Engine sounds healthy at idle and under load.

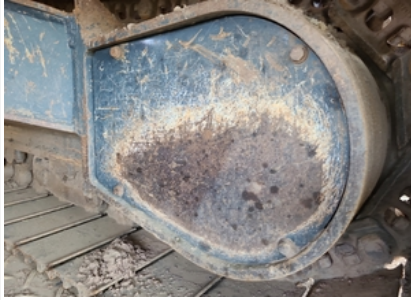
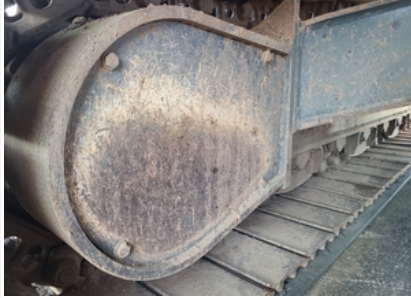
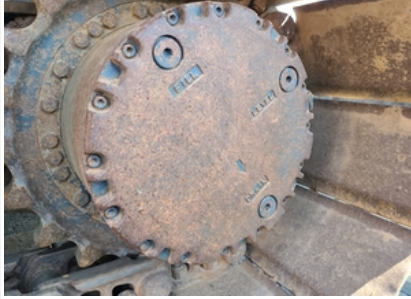
Drivetrain Photos	 	
--------------------------	---	--

Hydrostatic Transmission?	Yes	
2 Speed?	Yes	
Hydrostatic Drive Configuration	Split Transmission	
Comments		
Transmission Info (Make/Model/Speeds)		
Drivetrain Rating	3 - Normal Wear & Tear	
Drivetrain Comments	Drivetrain in great shape. Tested travel in short distance.

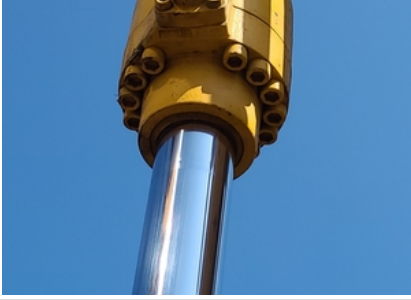
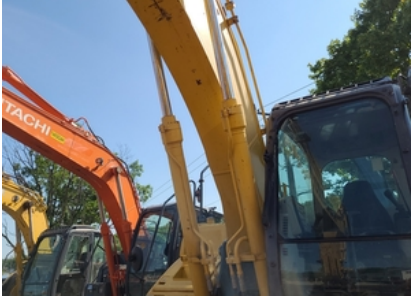
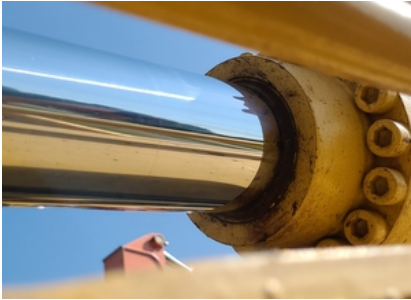
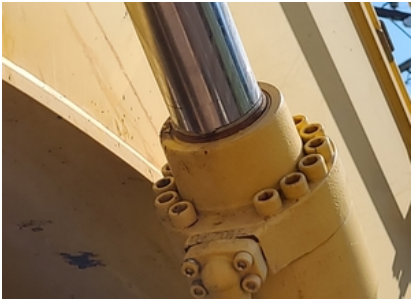
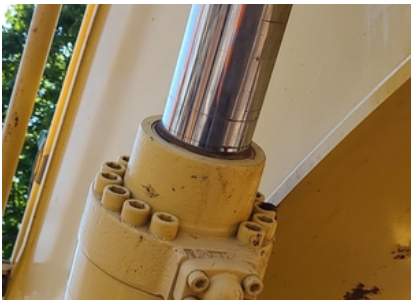
Hydraulic Cylinders & Mounting Pins

Hydraulic System Rating	4 - Very Light or Minimal Wear	
Hydraulic System Comments	Hydraulics in great condition with no active leaks seen from any major component.

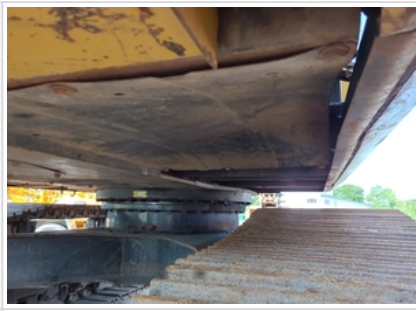
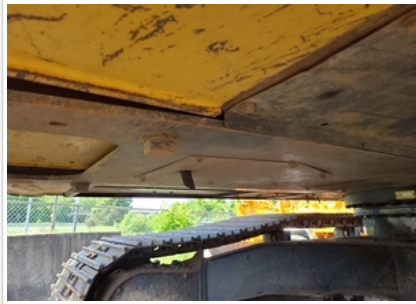
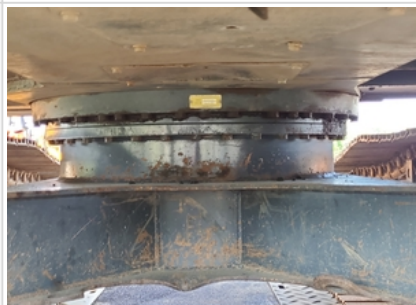
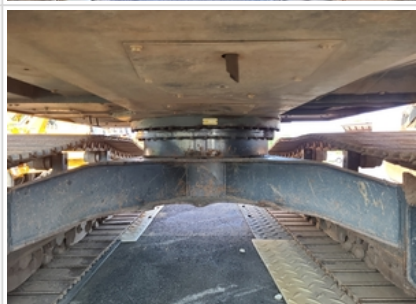
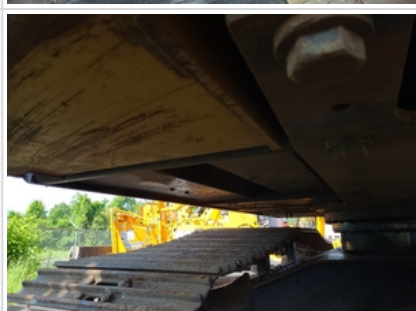
Chassis Photos

Chassis Rating	3 - Normal Wear & Tear
Comments	Main frame and implements in solid shape.

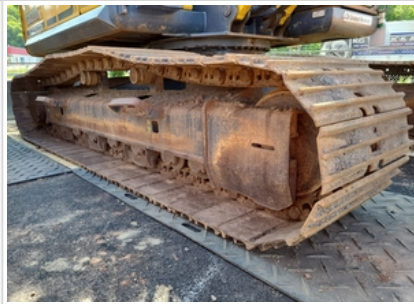
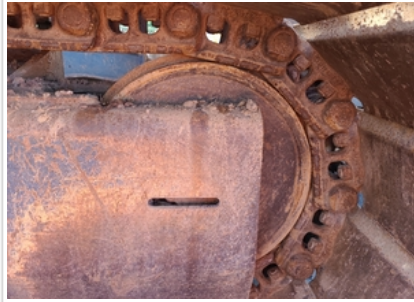
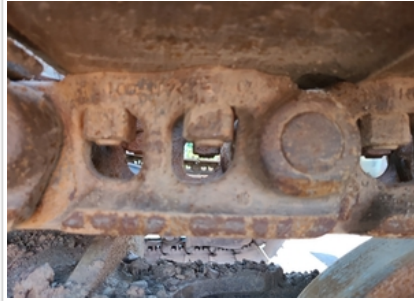
Undercarriage Photos

Undercarriage Rating	3 - Normal Wear & Tear	
Undercarriage Comments	Undercarriage in great condition.

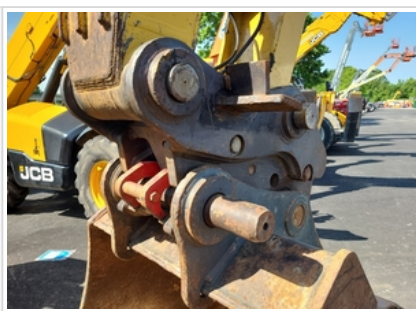
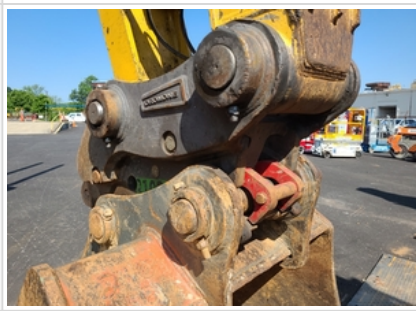
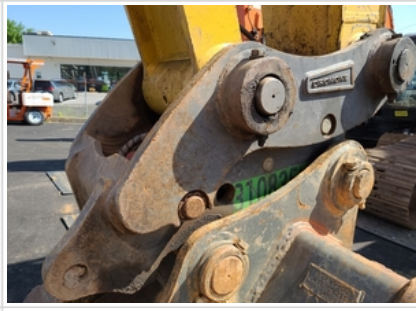
Attachment Photos

Attachment Rating	3 - Normal Wear & Tear	
Attachment Comments	41" bucket
