Enterprise Equipment Inspection

Category	Excavator
Travel System	Track Undercarriage
Comments	
Year	2016
Make	Kobelco
Model	SK140SRLC - 3
Fleet ID	10468734
Serial Number	YH07 - 10075
Serial Number Plate

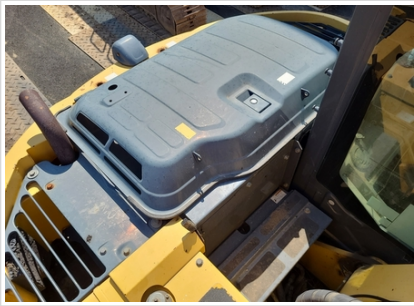
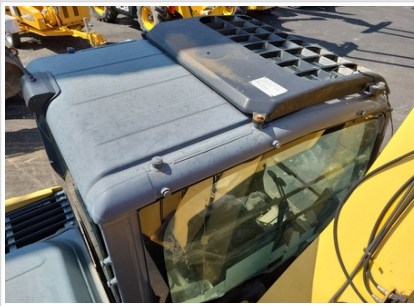
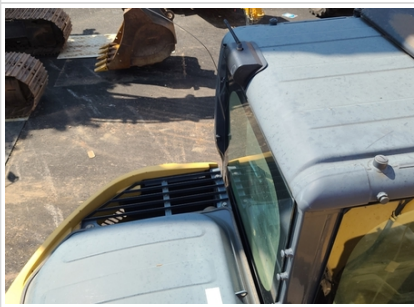
Exterior Rating	3 - Normal Wear & Tear	
Exterior Comments	Dents and scuff marks all around exterior panels. Front r/s, light fixture panel damaged.

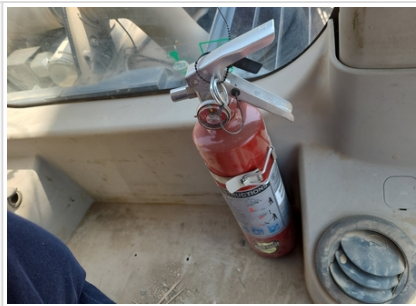
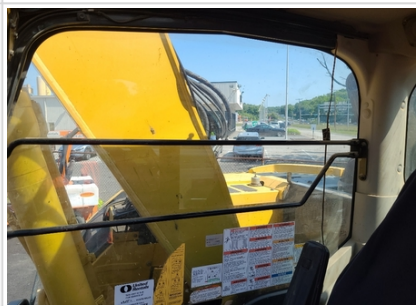
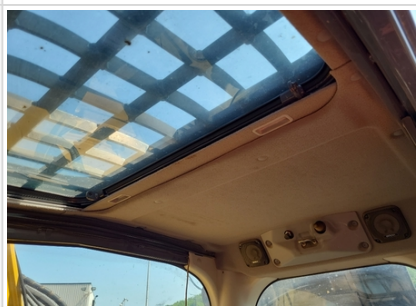
Control Station Rating	3 - Normal Wear & Tear	
Control Station Overall Comments	Seat upholstery torn. Cab in good condition.

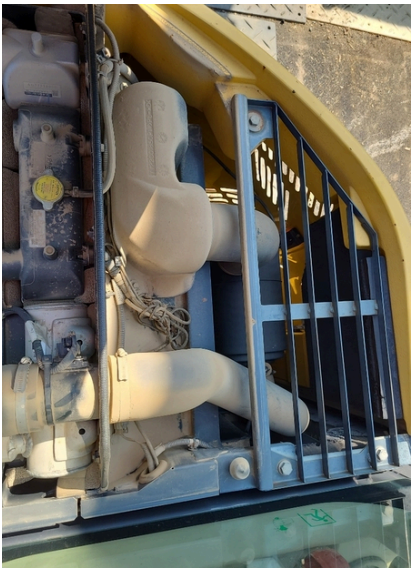
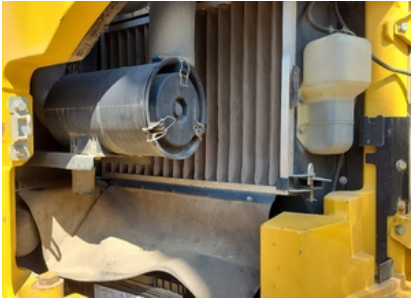
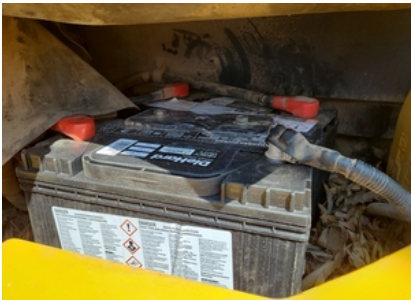
Engine Compartment

Engine Type (Make, Model, Cylinders, Hp)	Mitsubishi - 4Cyl. - 99HP - 3.3L	
Emissions Tier	Tier 4i	
Engine Rating	3 - Normal Wear & Tear	
Engine Overall Comments	Engine sounds like it has a small misfire. Engine has no major active leaks observed from the topside compartment. Blowby observed from breather hose.

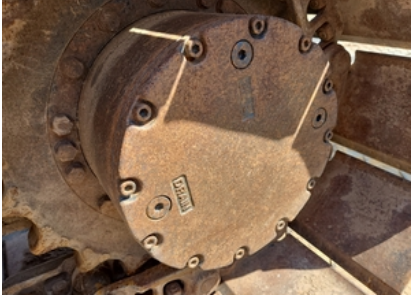
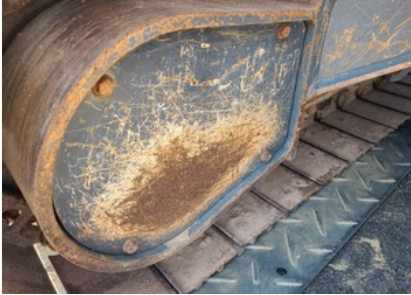
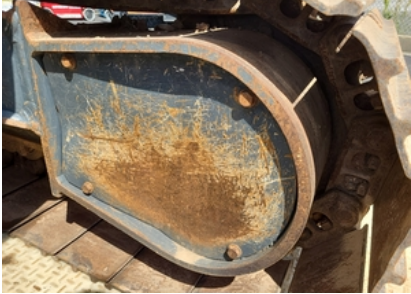
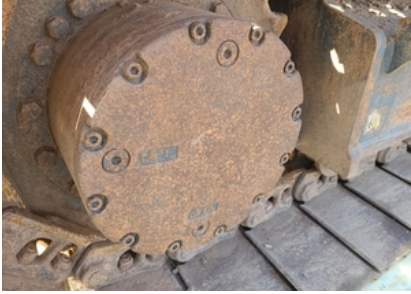
Drivetrain Photos

Hydrostatic Transmission?	Yes
2 Speed?	Yes
Hydrostatic Drive Configuration	Split Transmission
Comments	
Transmission Info (Make/Model/Speeds)	
Drivetrain Rating	3 - Normal Wear & Tear
Drivetrain Comments	Drivetrain in good condition.

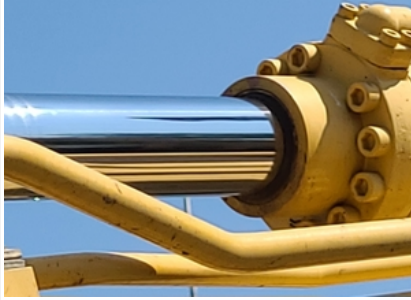
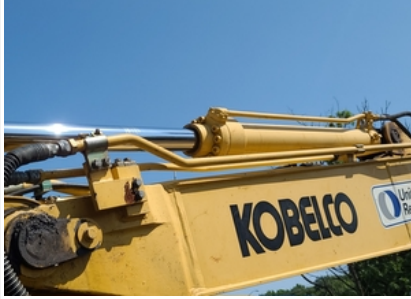
Hydraulic System Rating	3 - Normal Wear & Tear	
Hydraulic System Comments	Hydraulics in good shape with no active leaks observed.

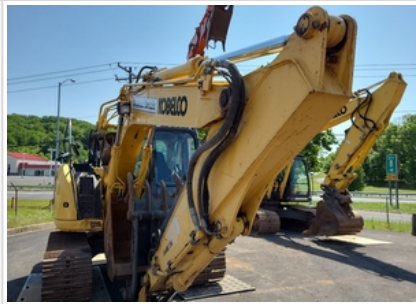
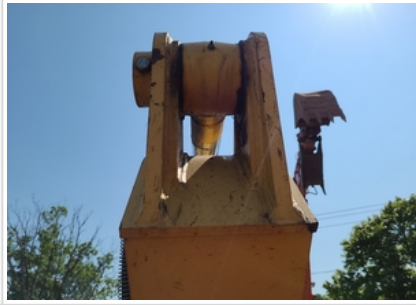
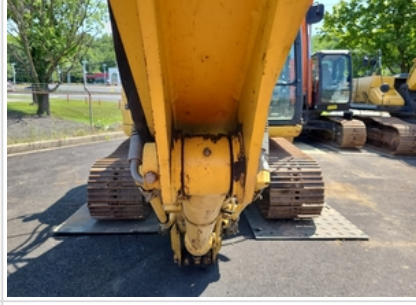
Chassis Rating	3 - Normal Wear & Tear	
Comments	Frame and implements in good condition. Minor play observed at bucket linkage.

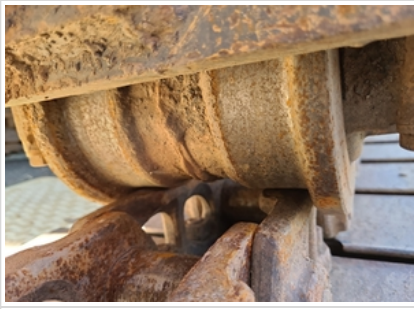
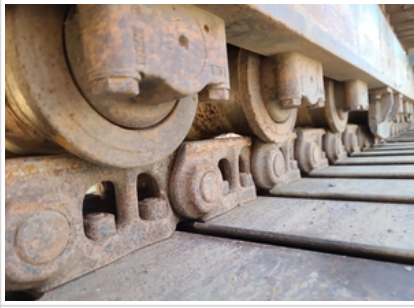
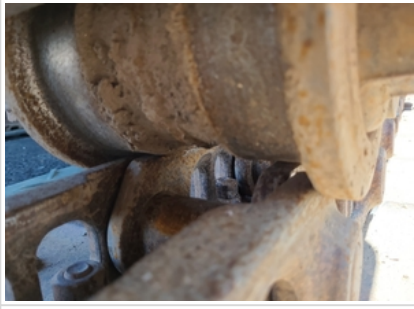
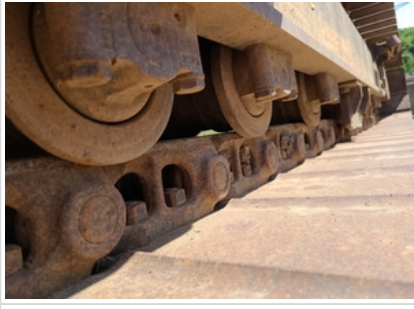
Undercarriage Rating	3 - Normal Wear & Tear	
Undercarriage Comments	Undercarriage in good shape.

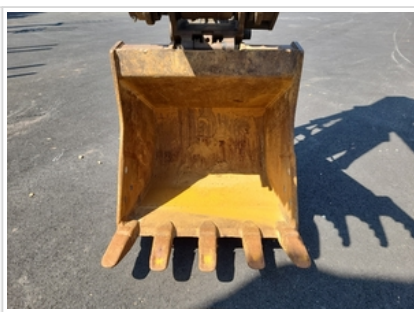
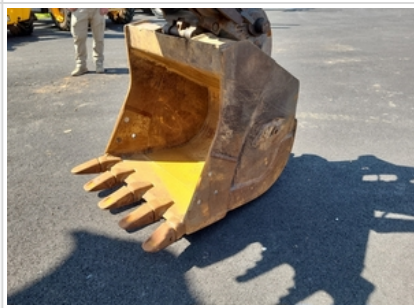
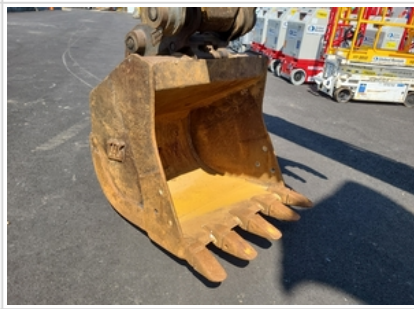
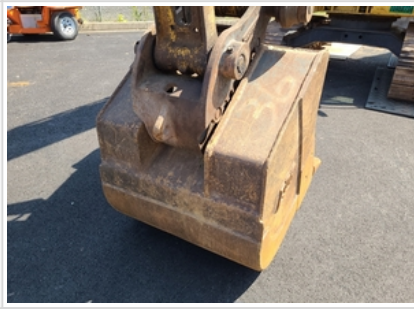
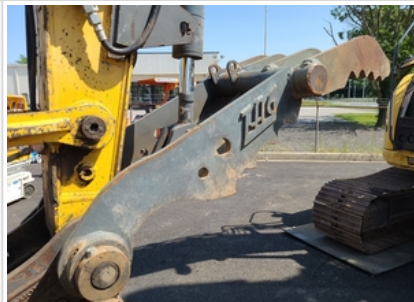
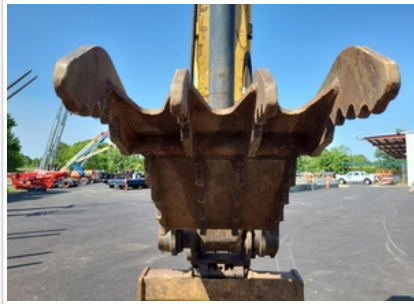
Attachment Photos

Attachment Rating	3 - Normal Wear & Tear
Attachment Comments	36" Bucket and 20" thumb
