Enterprise Equipment Inspection

Category	Excavator
Travel System	Track Undercarriage
Comments	
Year	2018
Make	Kubota
Model	KX033-4
Fleet ID	212619AH
Serial Number	12035
Serial Number Plate

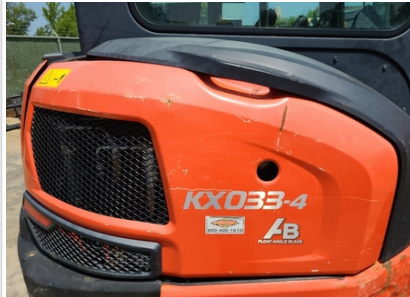
Minor Impact Damage

Exterior Rating	3 - Normal Wear & Tear	
Exterior Comments	Some panel misalignment and scuff marks on exterior panels.

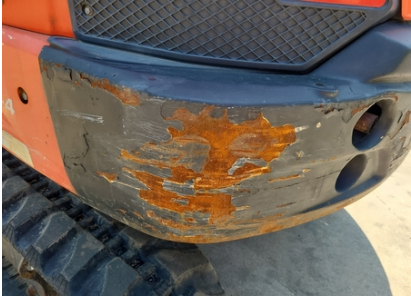
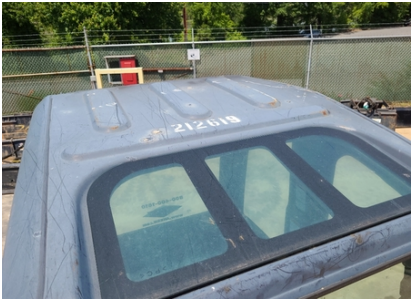
<p>Minor Hood Panel Misalignment</p>

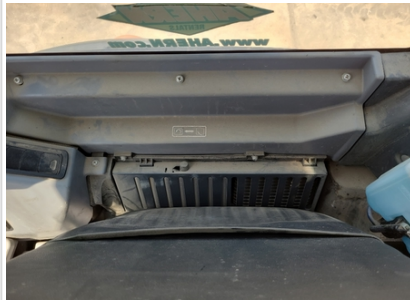
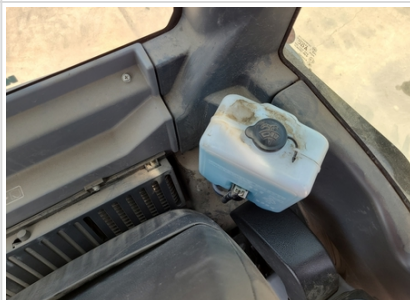
Minor Seat Damage

Control Station Rating	3 - Normal Wear & Tear	
Control Station Overall Comments	Operator Cab in good condition

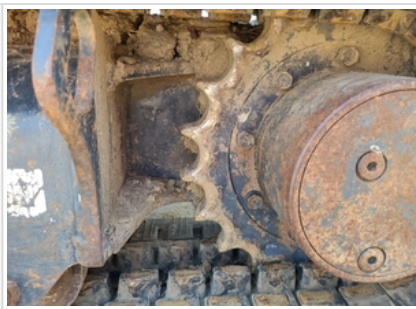
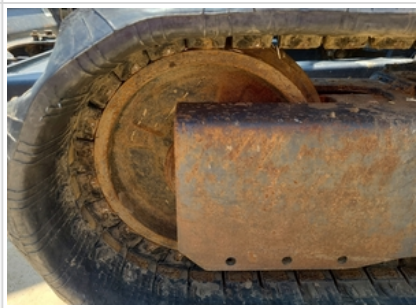
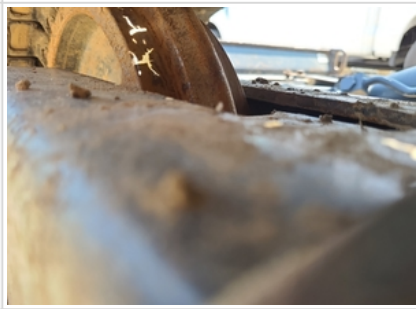
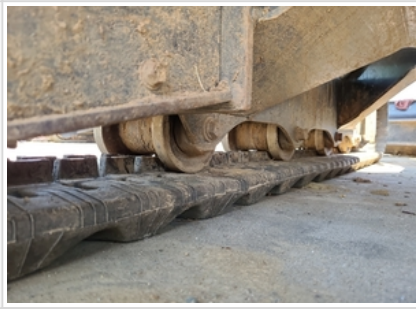
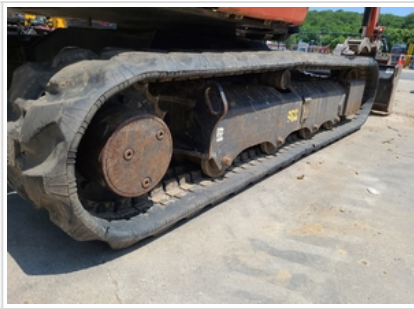
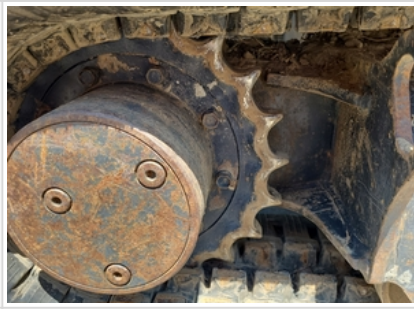
Undercarriage Photos	 	
-----------------------------	---	--

Undercarriage Rating	4 - Very Light or Minimal Wear	
Undercarriage Comments	Undercarriage 75% to 80% of life left.

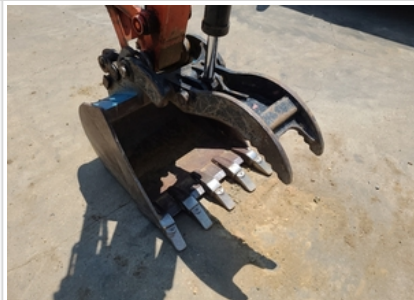
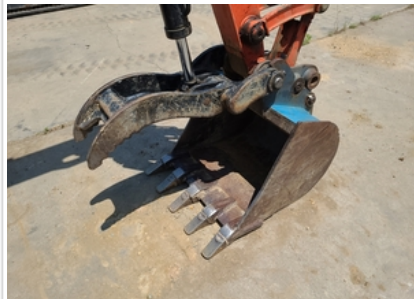
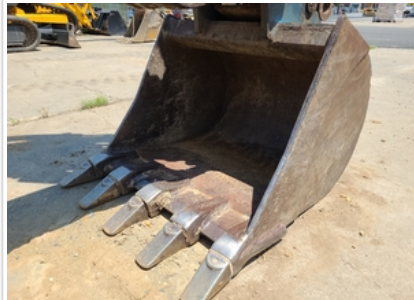
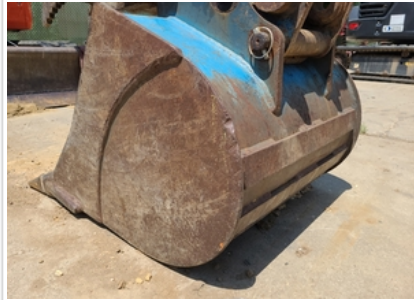
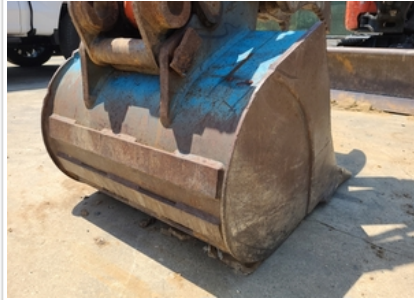
Attachment Photos

Attachment Rating	3 - Normal Wear & Tear
Attachment Comments	24" Bucket and 8" Thumb
